November 30, 2021

Westview Projects Inc.
18 Louisa Street, Suite 180
Ottawa, Ontario
K1R 6Y6

Re: Slope Stability Evaluation
Assessment of Slope Stability and Limit of Hazard Lands Setback
Proposed Residential Development
38 Carss Street, Almonte, Ontario.

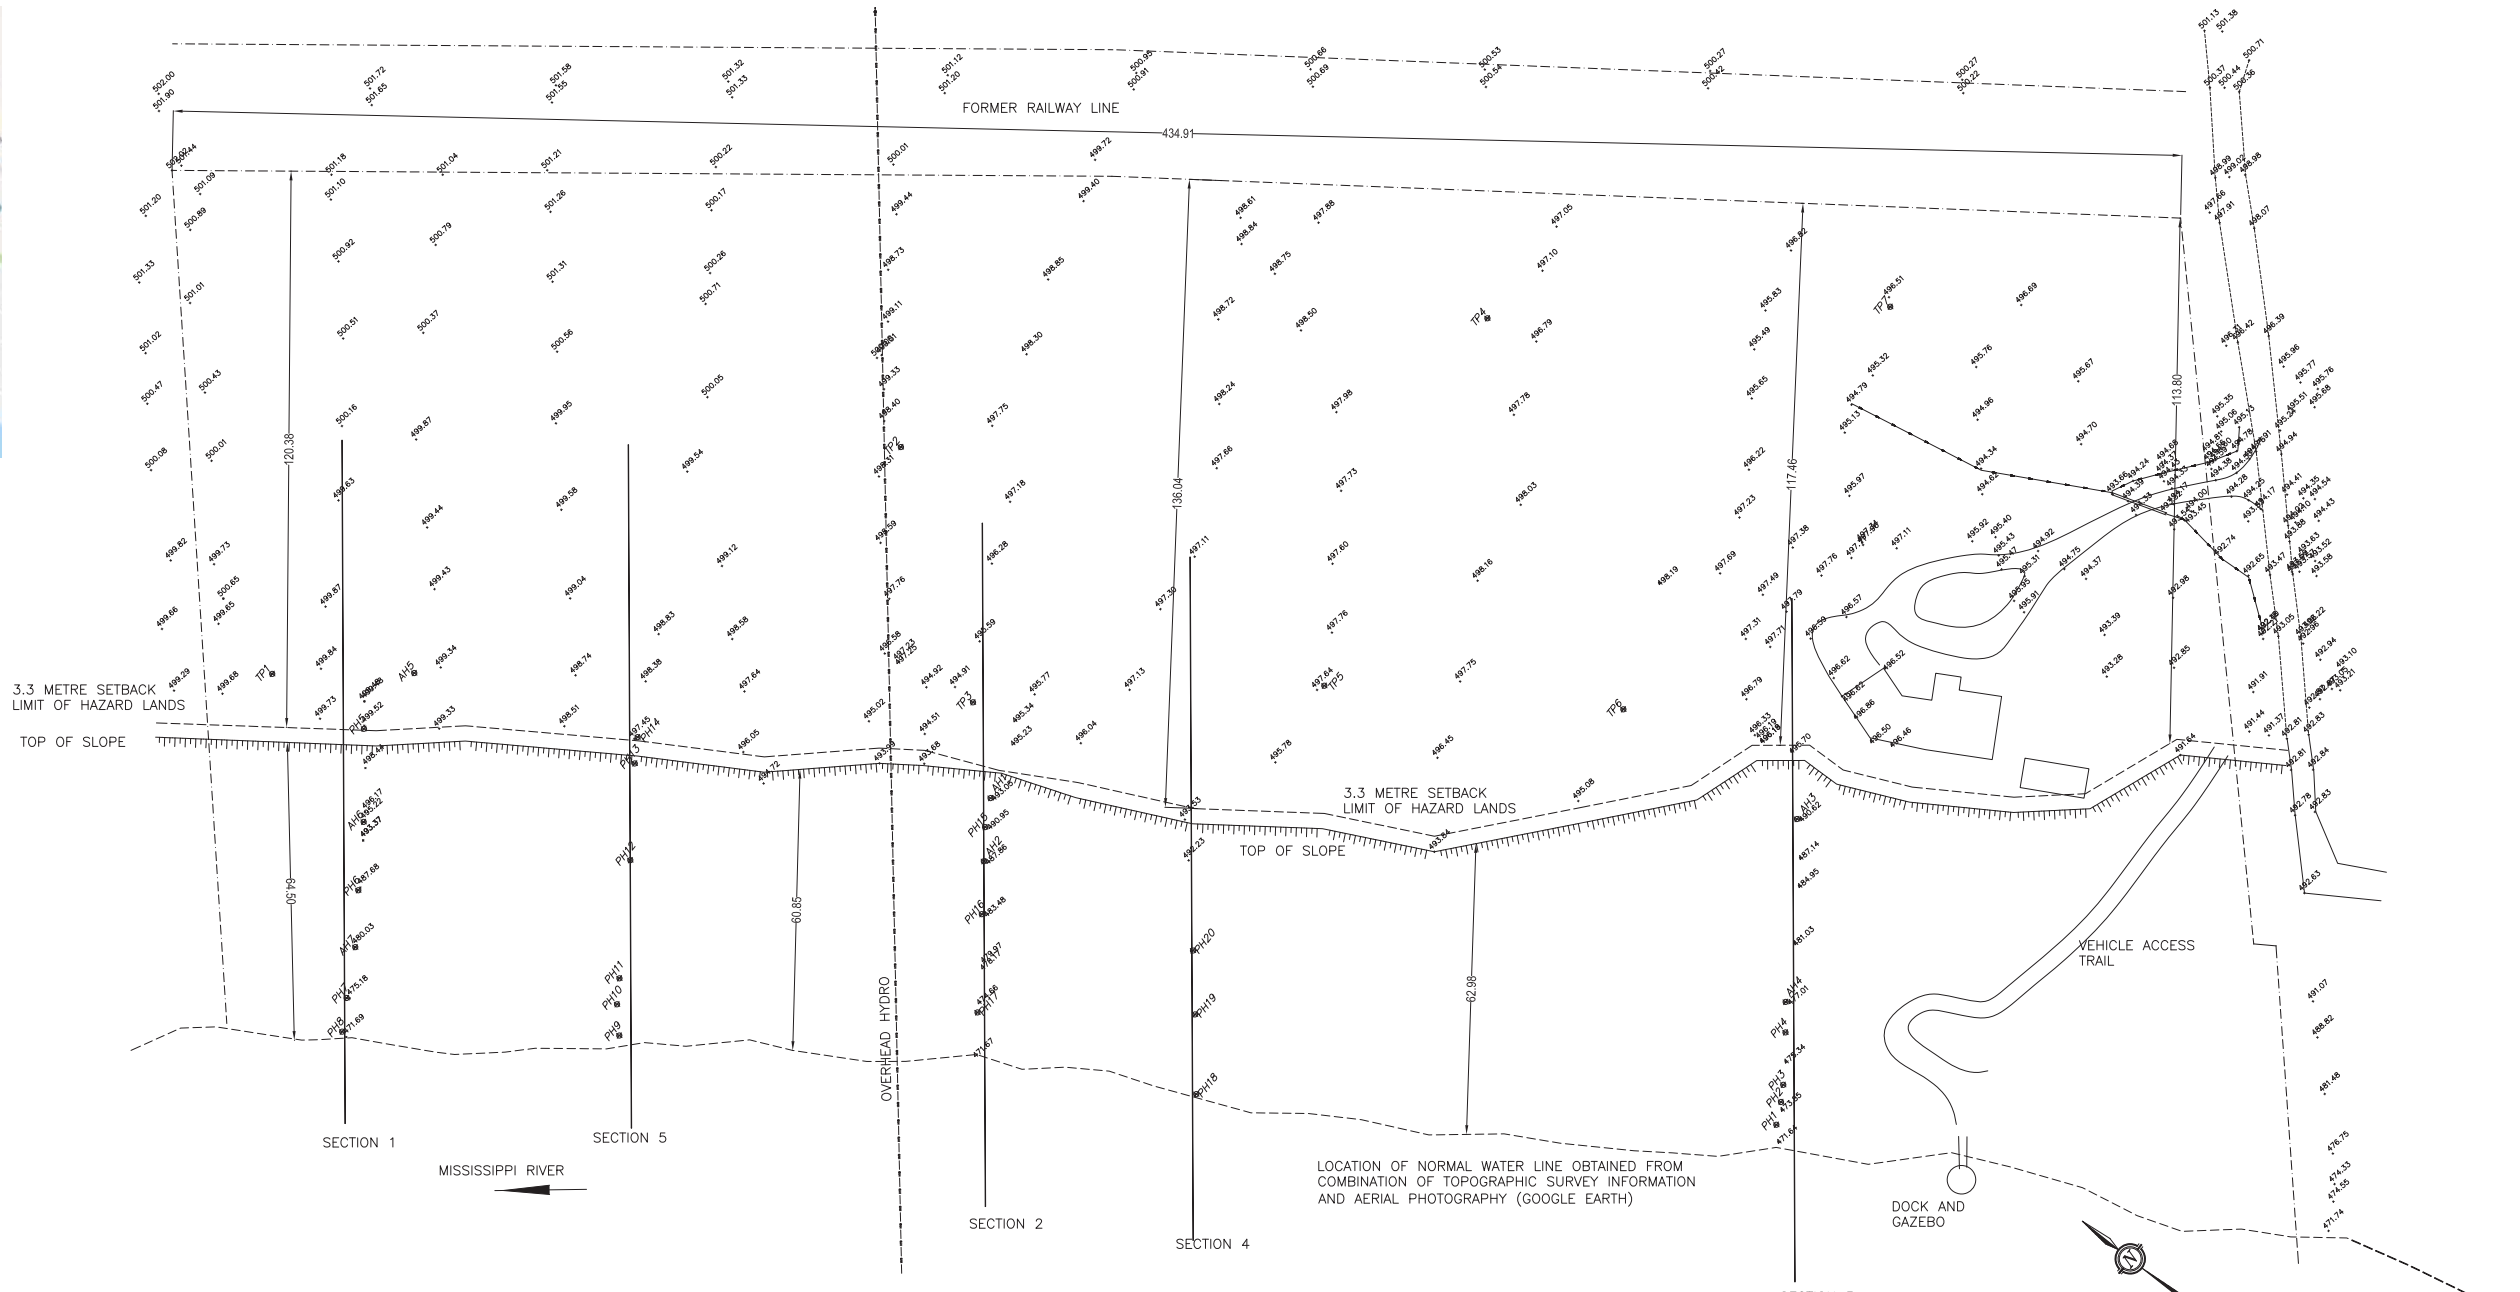
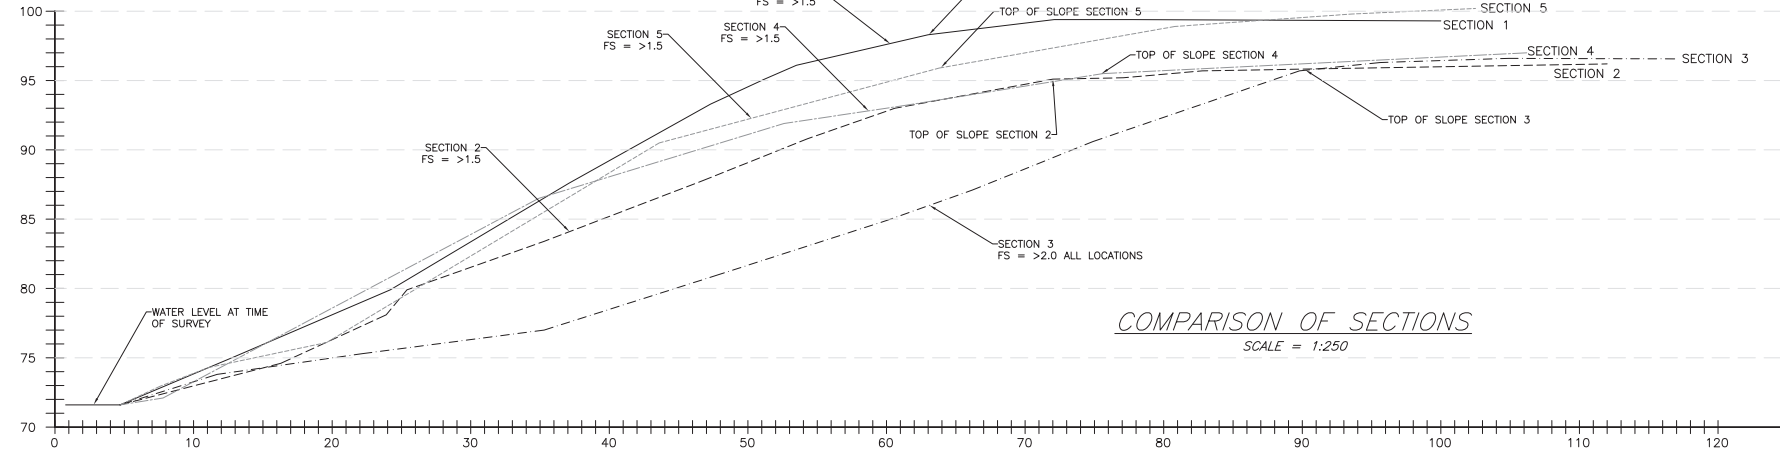
CLIENT NAME	PROJECT No.
ALFRED POTVIN	190712
PROJECT NAME	DATE
PROPOSED RESIDENTIAL DEVELOPMENT	18.SEP.2019
PROJECT LOCATION	SCALE
CARRS STREET, ALMONTE, ONTARIO	AS SHOWN
DRAWING	DRAWING No.
EXISTING SITE CONDITIONS	190712-EX

The results of the topographic survey are provided on Kollaard Associates drawing 190712-EX. This drawing indicates the location of the existing dwelling as well as the locations where test holes were put down at the site. The drawing also indicates where the various sections used in the slope stability analysis were obtained. The locations where the slope sections were obtained were visually selected during the site visits as being representative of the various slope conditions (in terms of height and slope angle) encountered at the site.

Drawing 190713-EX also provides an overly lay of the cross sections used in the analysis. The sections indicate that the height and inclination of the slope increase from south to north along the site.
