# ANDREWSVILLE BRIDGE

## SUMMARY OF EVENTS FROM 2005 TO 2022

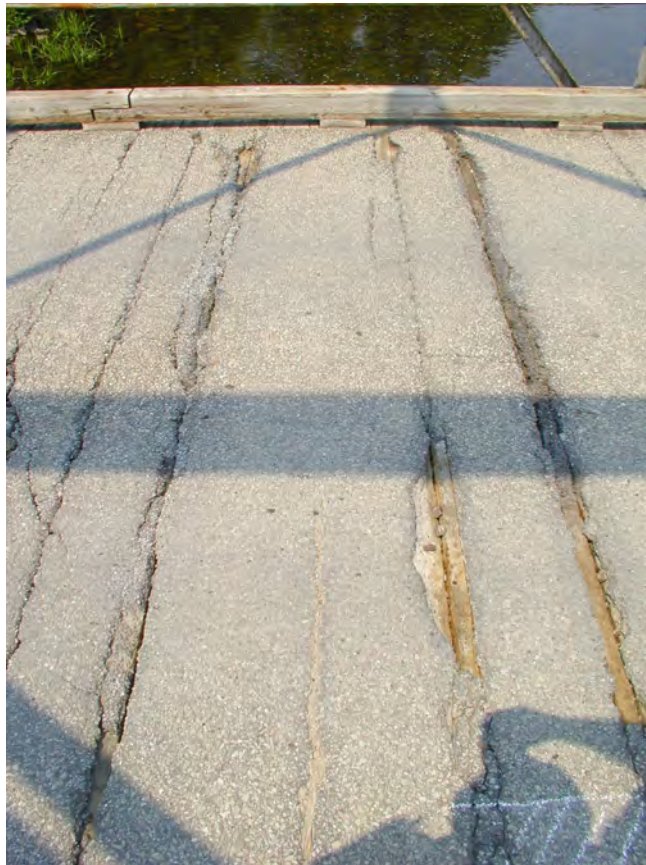
Photograph 8: Detail of asphalt deterioration on timber deck.

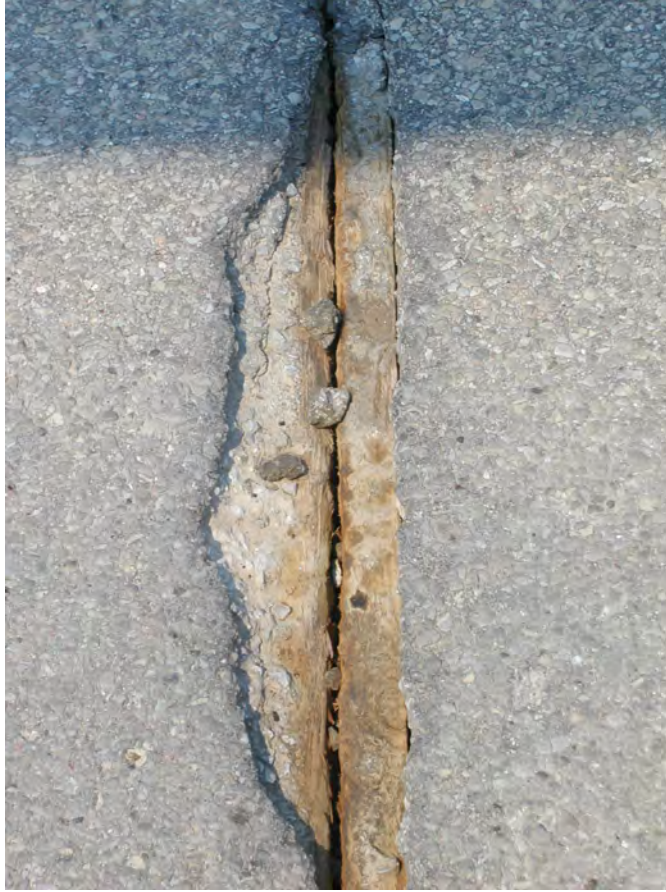
Photograph 9: Detail of deteriorated asphalt showing gap between underlying timbers.

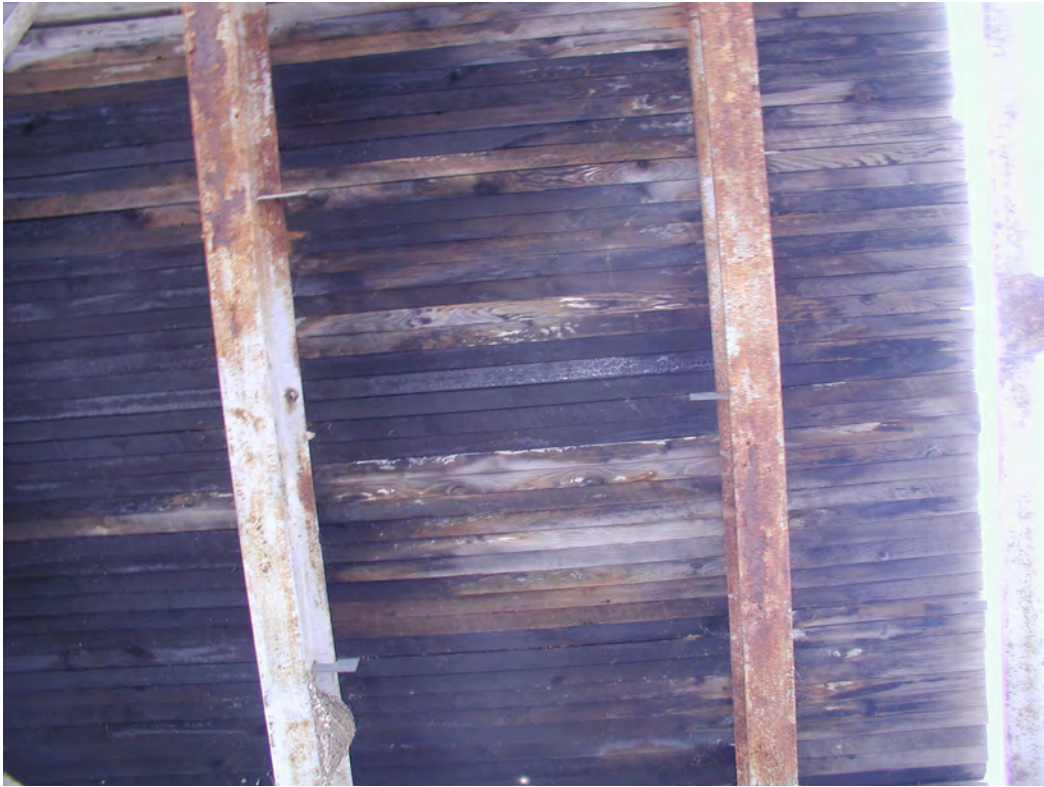
Photograph 11: Exterior stringers typically exhibit more corrosion than interior stringers.

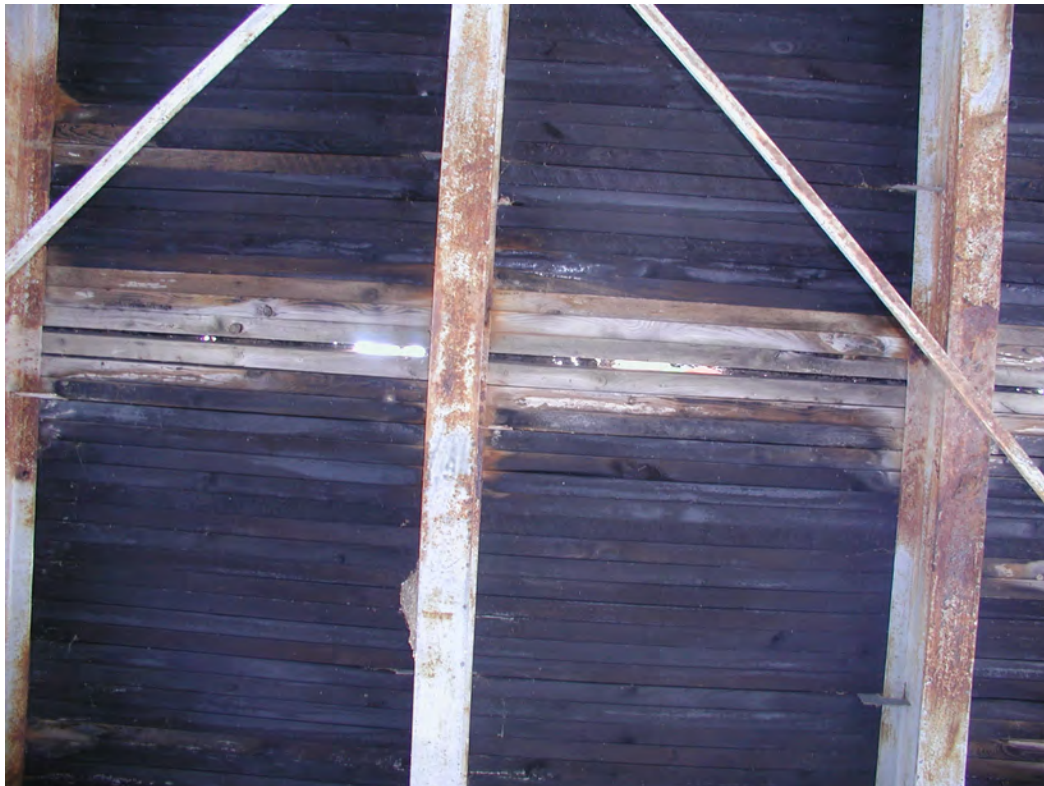
Photograph 12: Creosote is generally missing on timbers in locations of gaps, which have allowed penetration of water.

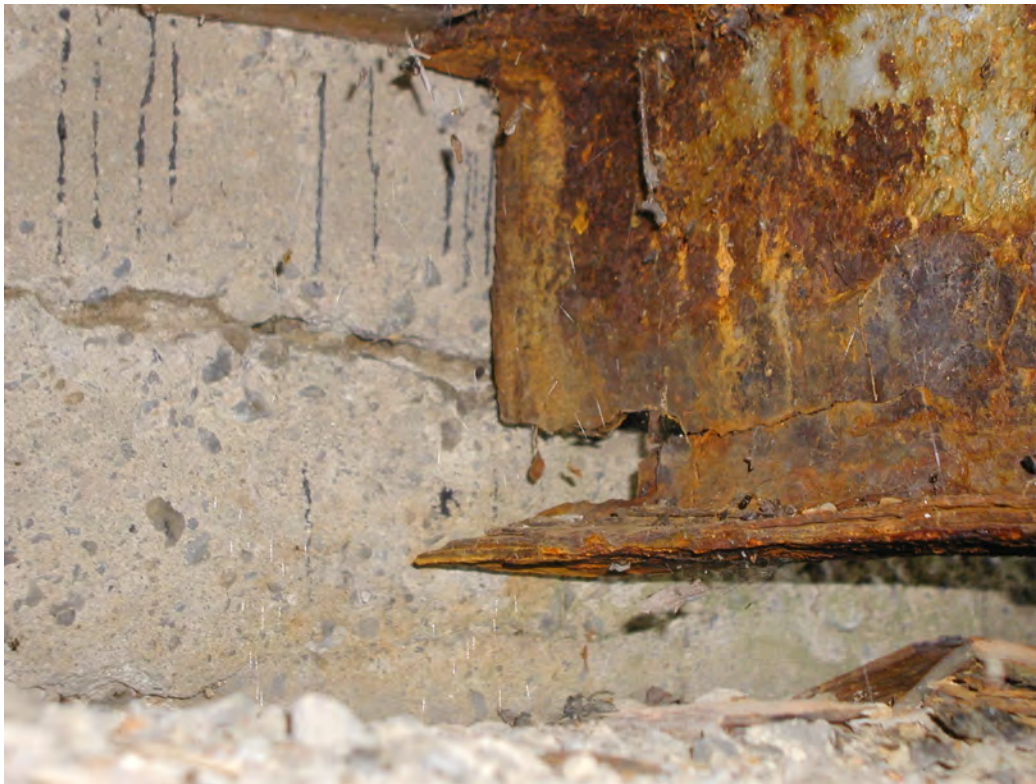
Photograph 20: Section loss and crack in web of exterior stringer, West Abutment.

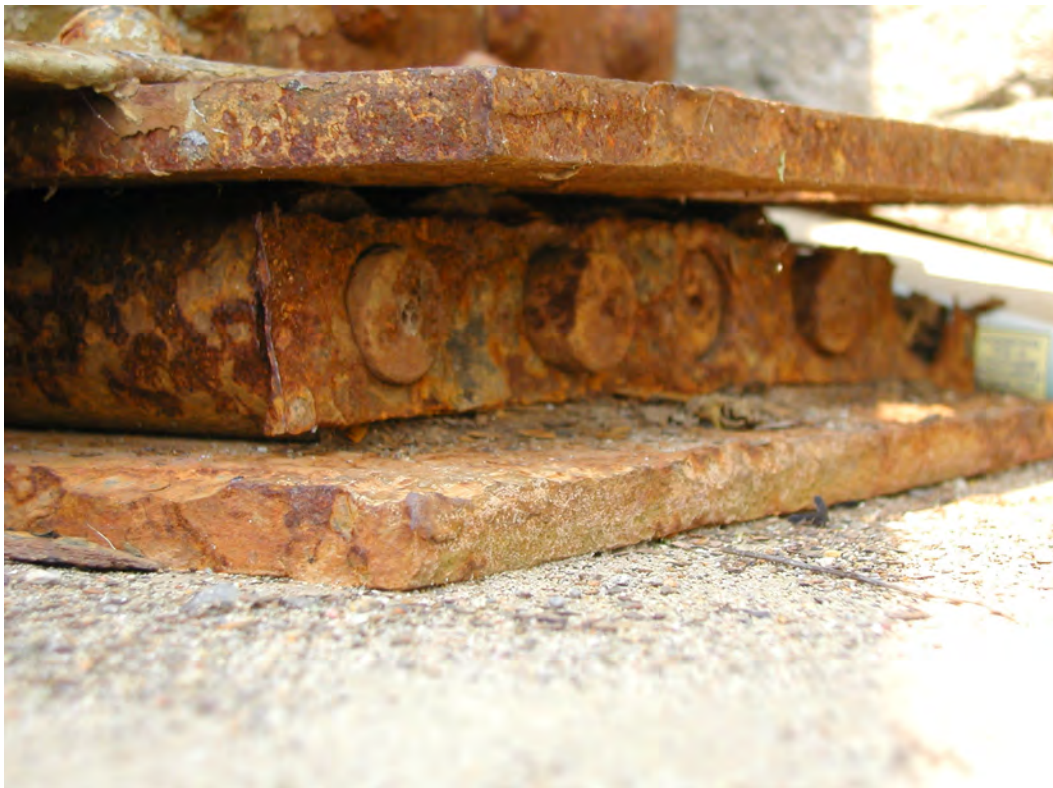
Photograph 22: Detail of deterioration of north roller bearing, West Abutment.

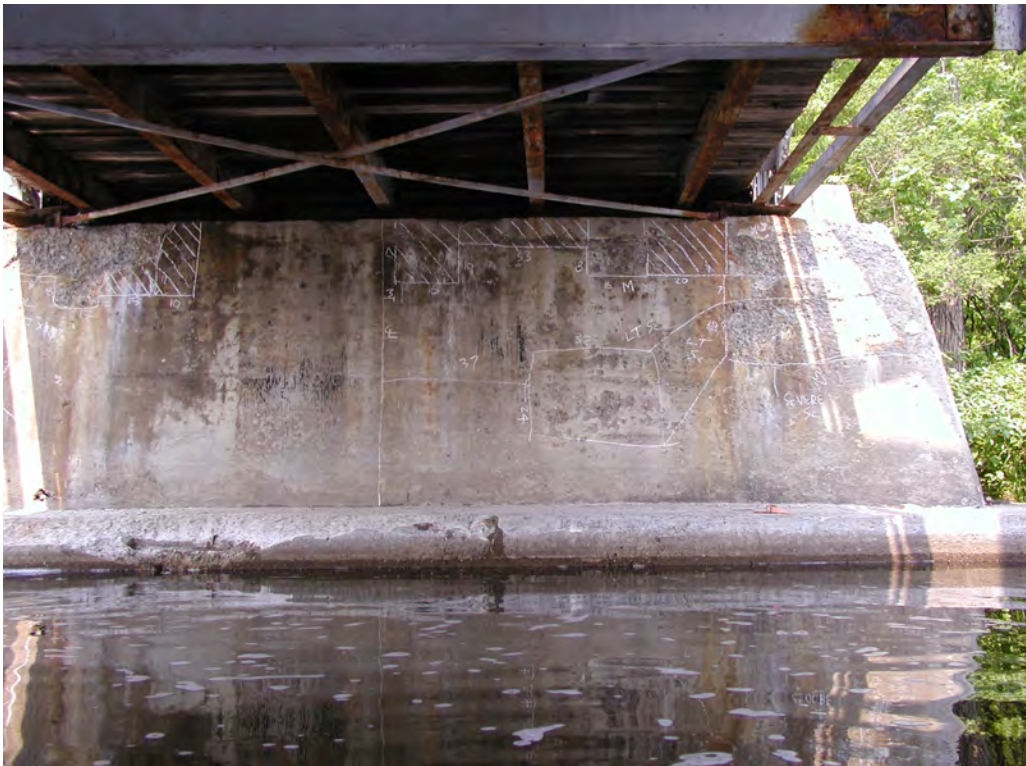
Photograph 26: Face of West Abutment is characterized by extensive scaling, delaminations, and alkali-aggregate reaction. Condition of face of East Abutment is similar.

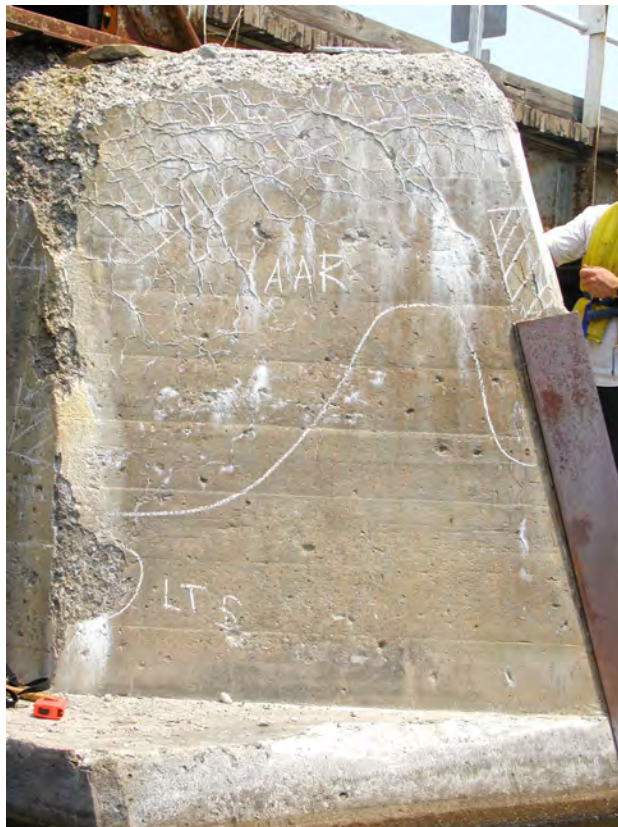
Photograph 28: Deterioration of west face of pier nosing. Note extensive deterioration and alkali-aggregate reaction. Condition of east face is similar.

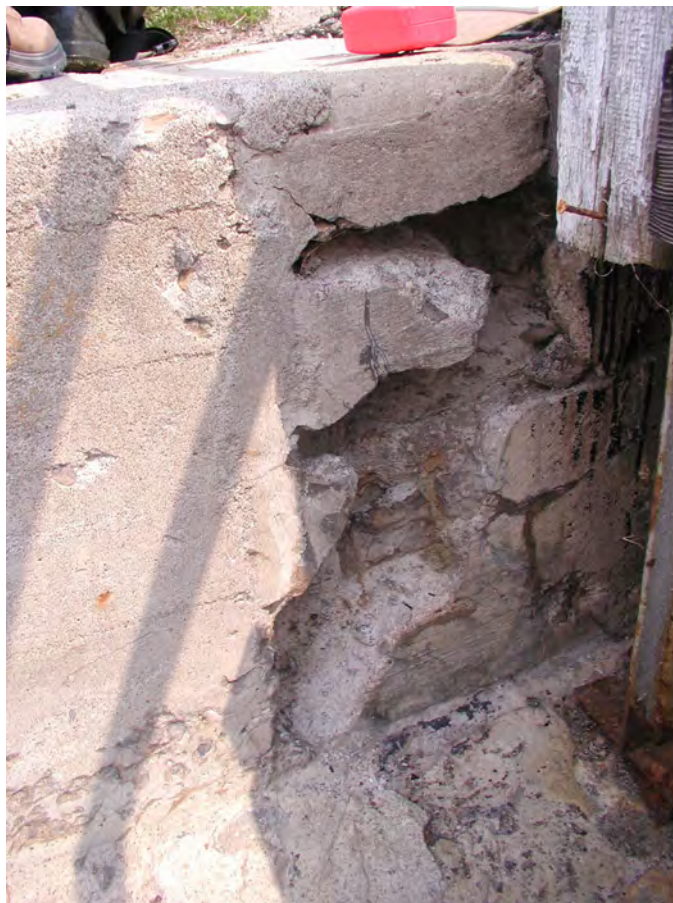
Photograph 30: Detail of deterioration of ballast wall of East Abutment, north side.

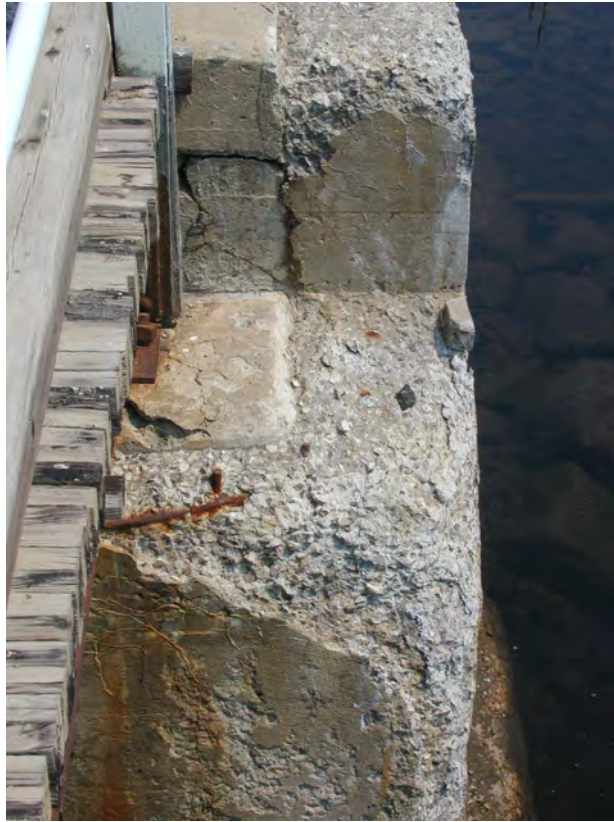
Photograph 31: Deterioration of bearing seat and ballast wall, East Abutment.

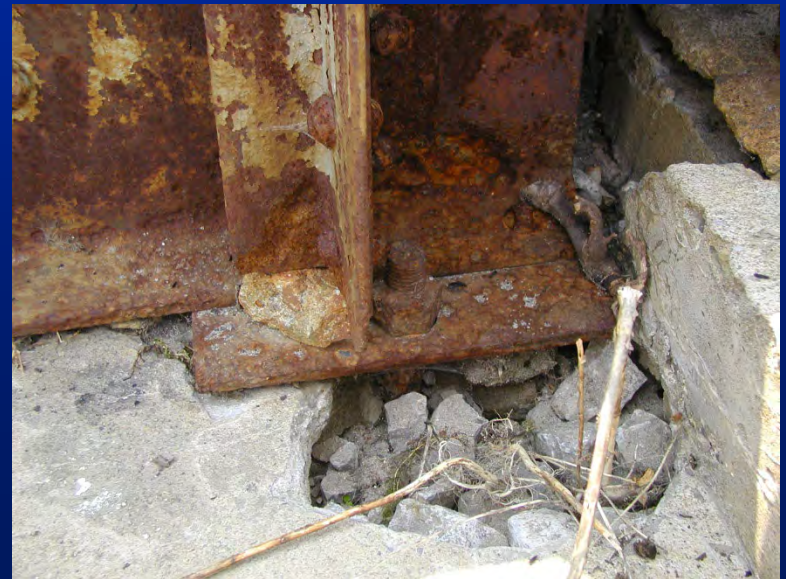
Undermining of south pier bearing

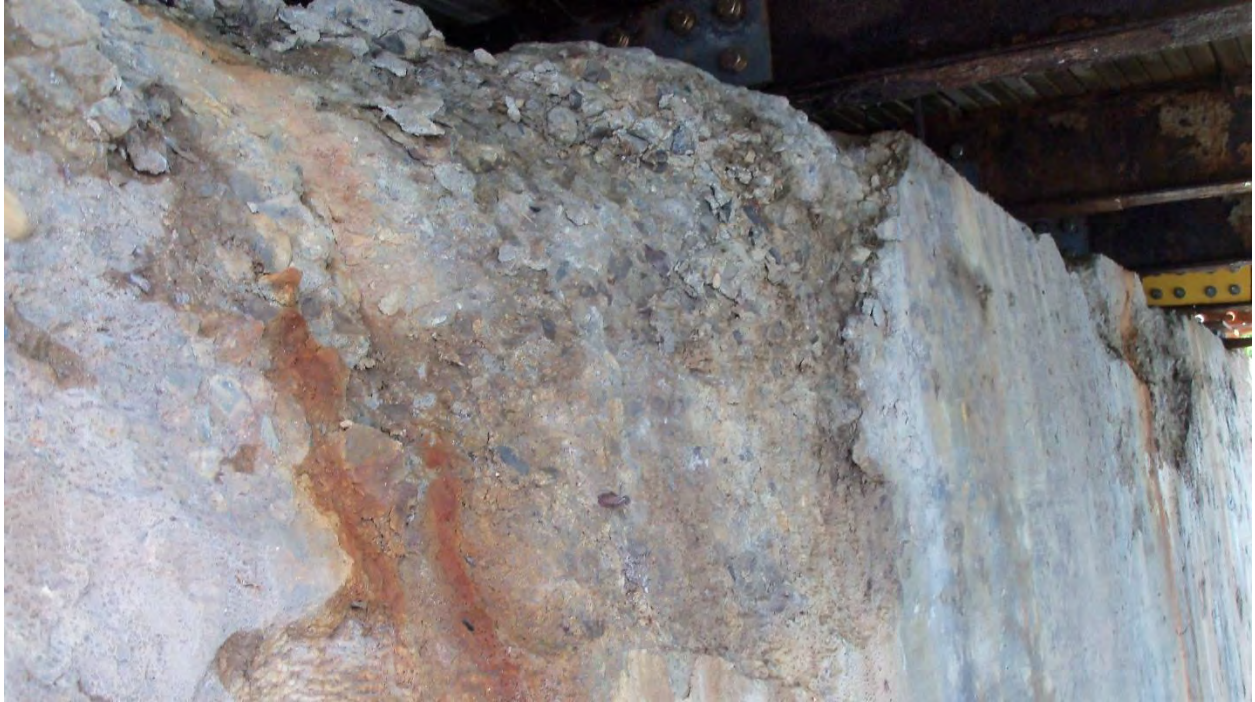
View showing severe spalls and disintegration on abutment

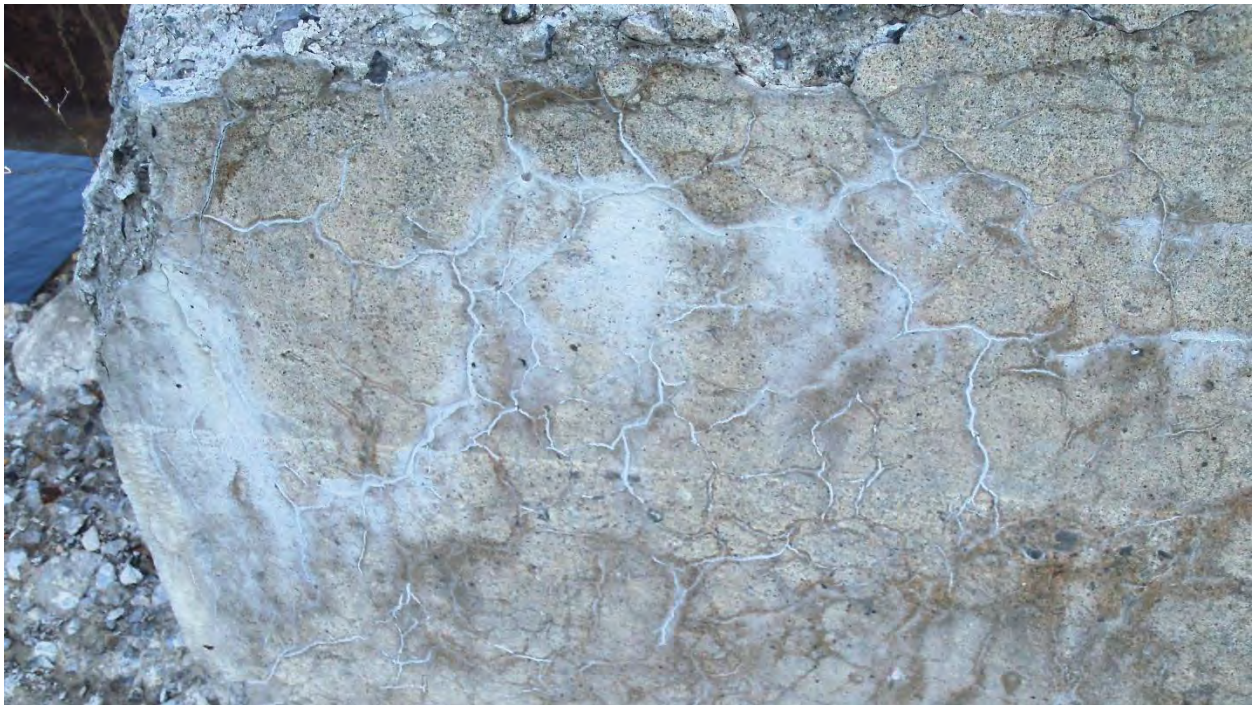
View showing cracking with efflorescence and spalling on the abutment

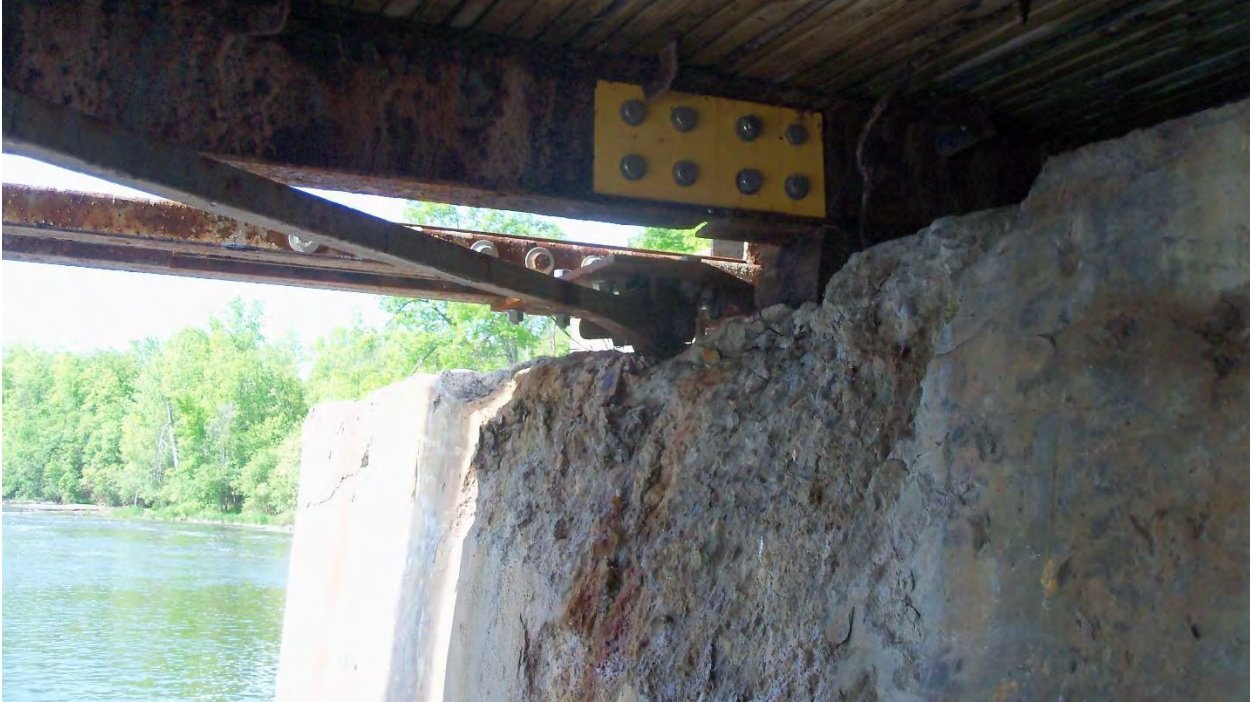
View showing severe spalling of abutment and replaced bolted end plates

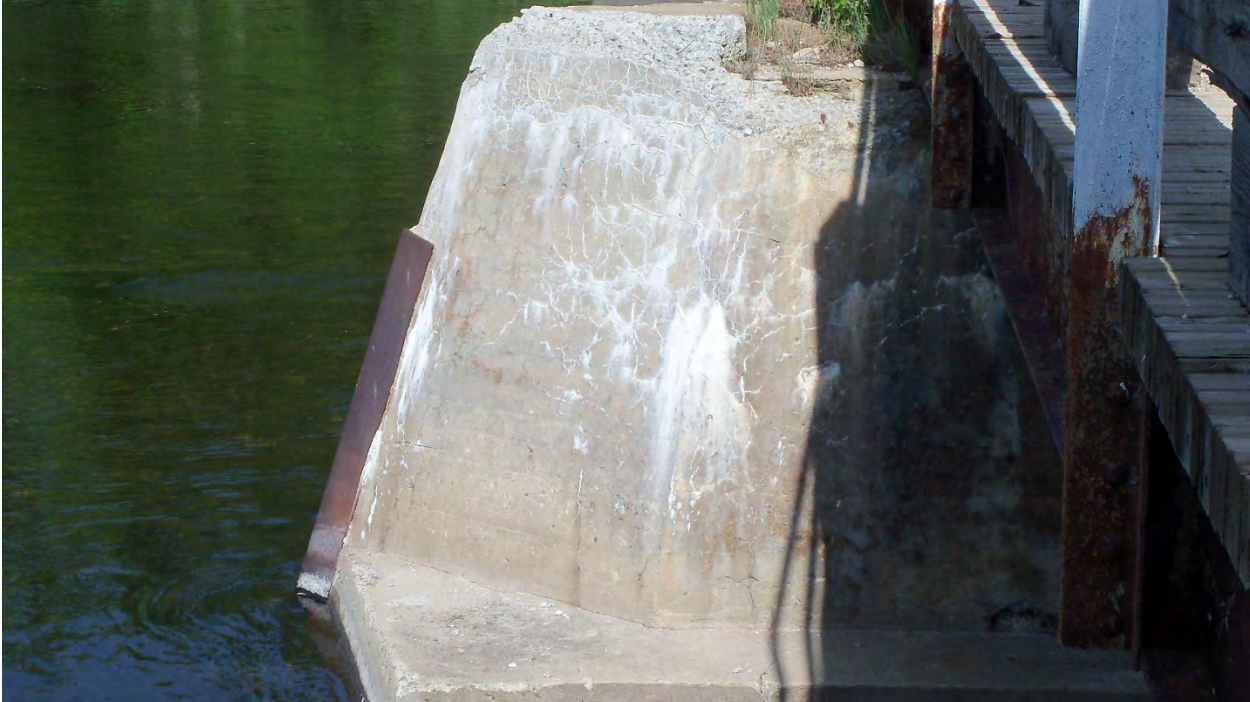
View of pier showing major spalling and efflorescence

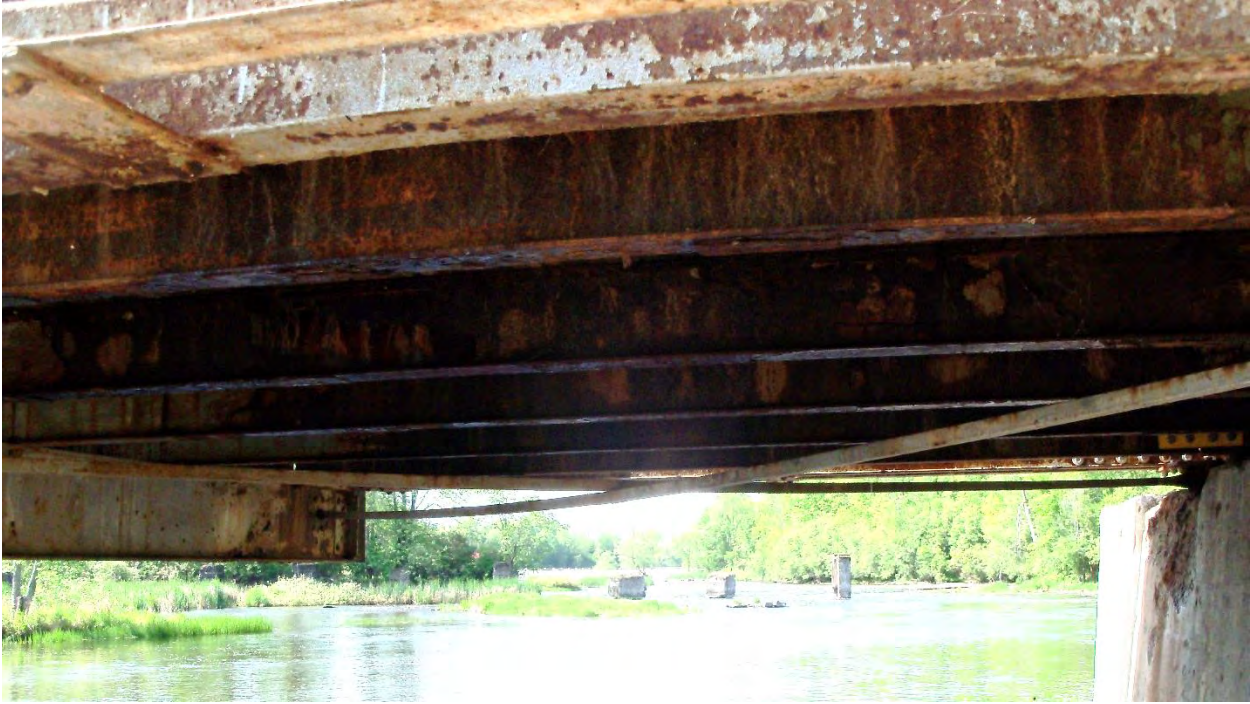
View showing cross bracing and corrosion on girders

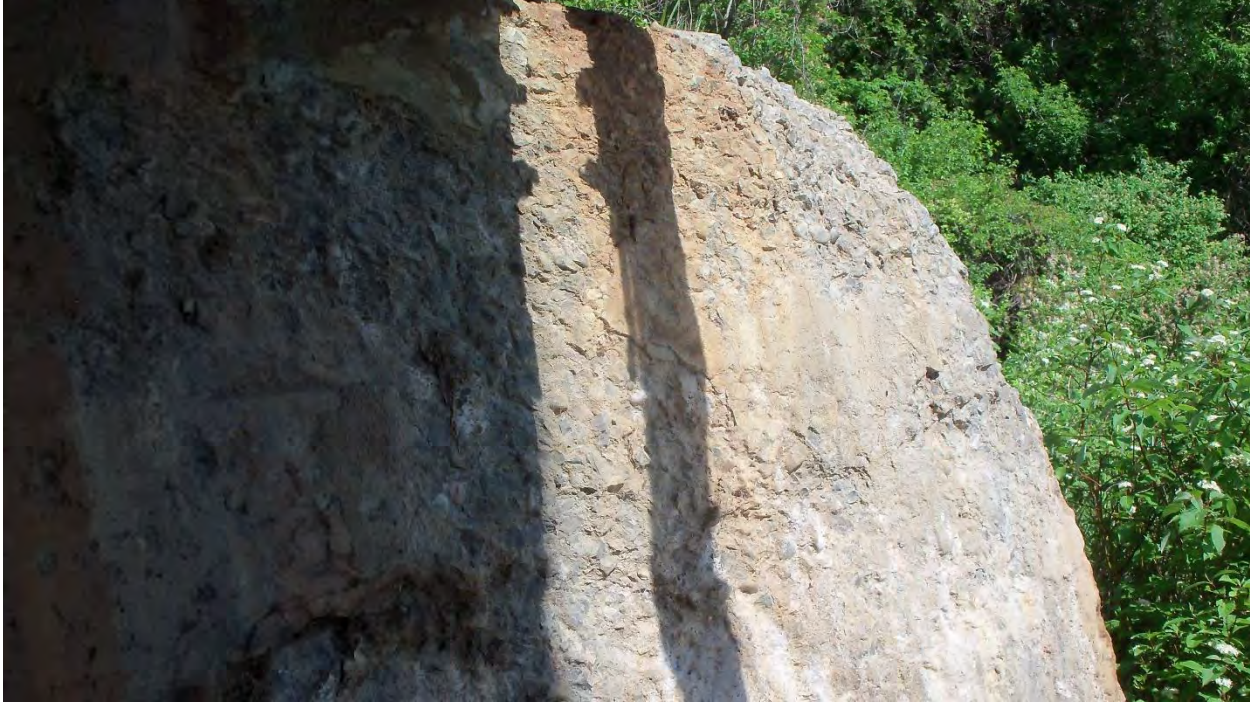
View showing mass spalling and corrosion stains

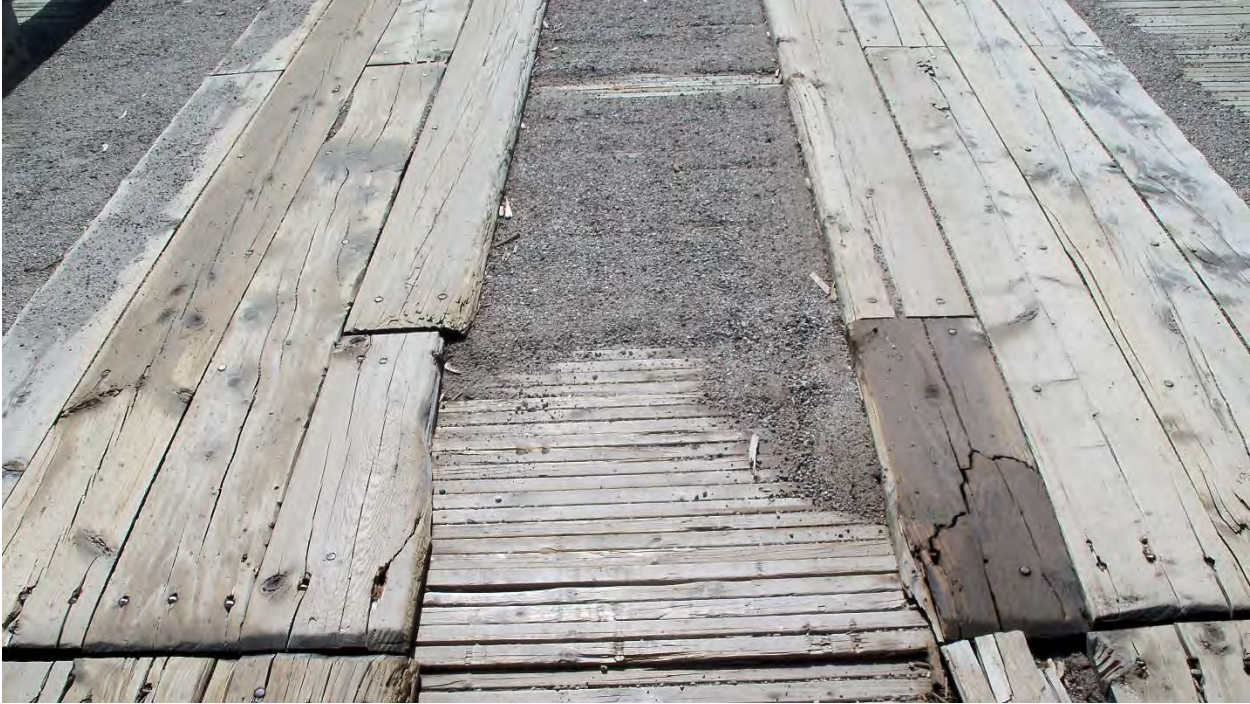
View of deck wearing surface with rot, splits, and checks

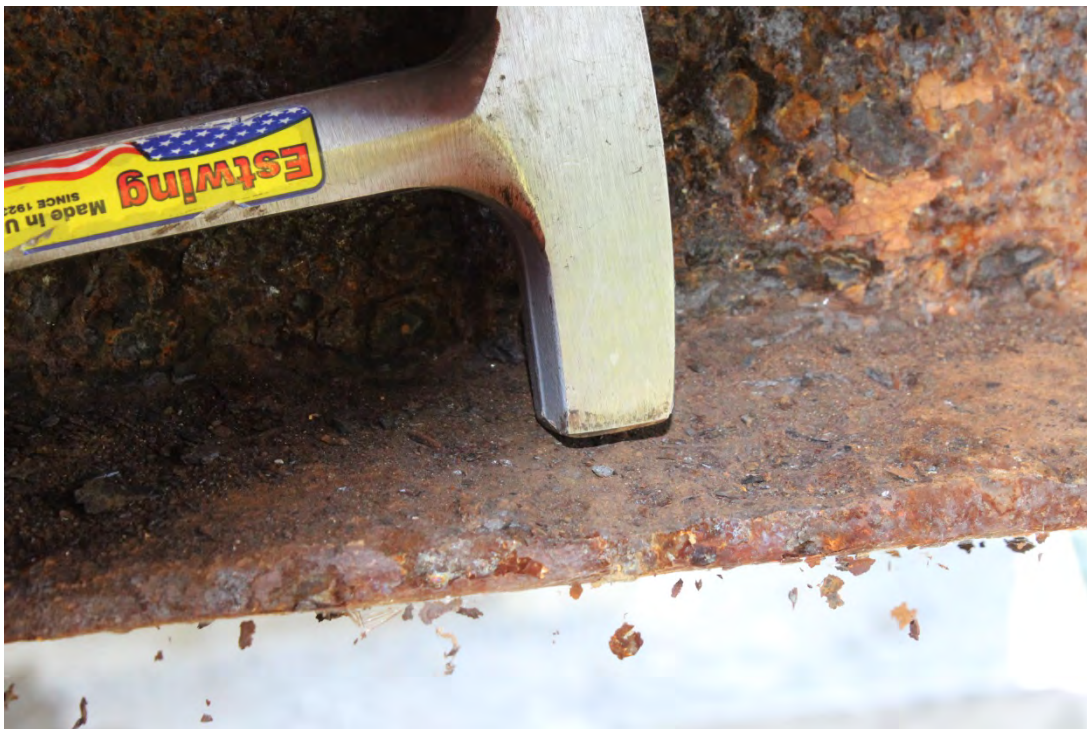
Image 4. Close up of Image 3. Rust dangling from spider webs

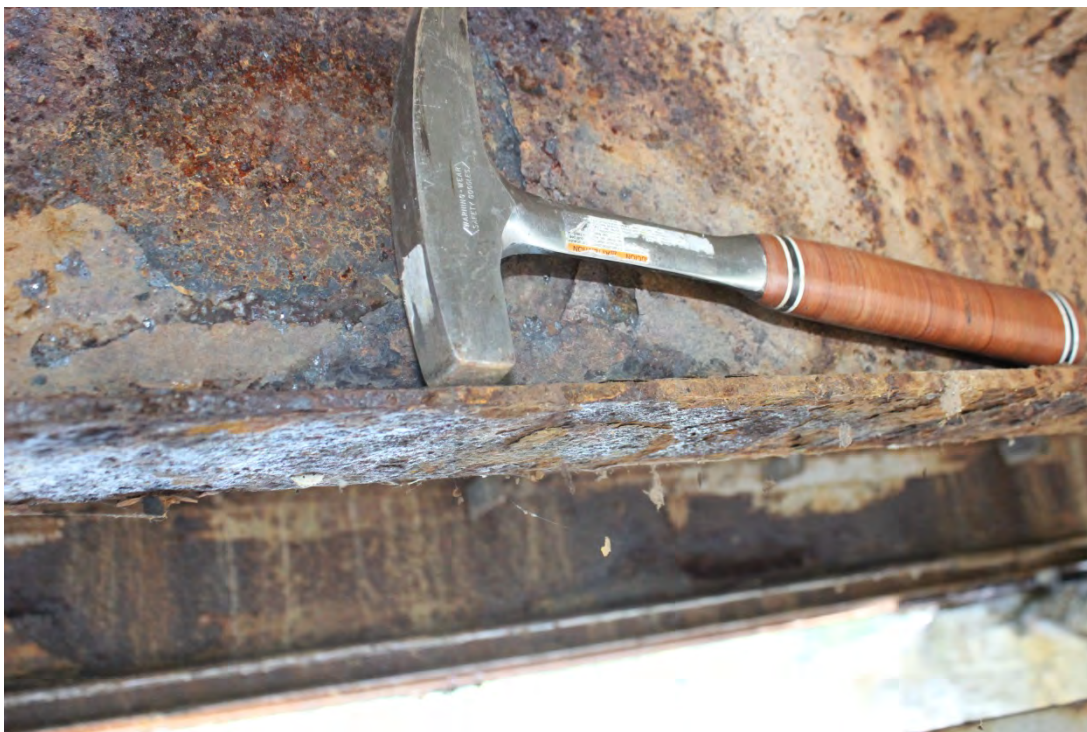
Image 6. Typical corrosion on stringers Bay 1

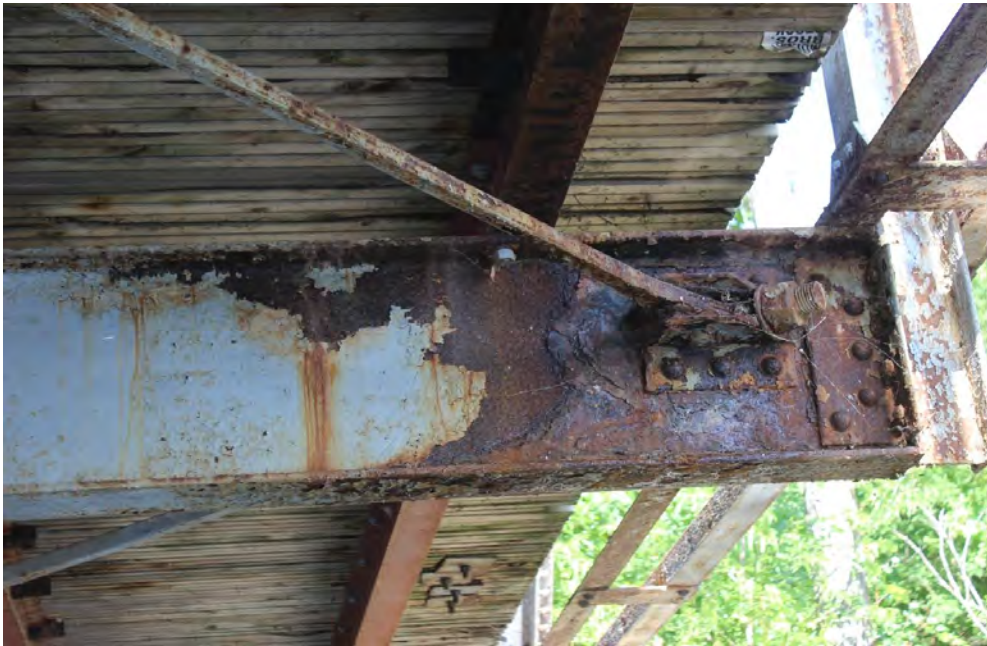
**Image 2. North end of Floor Beam 1 (FB 1) with slab rust evident**

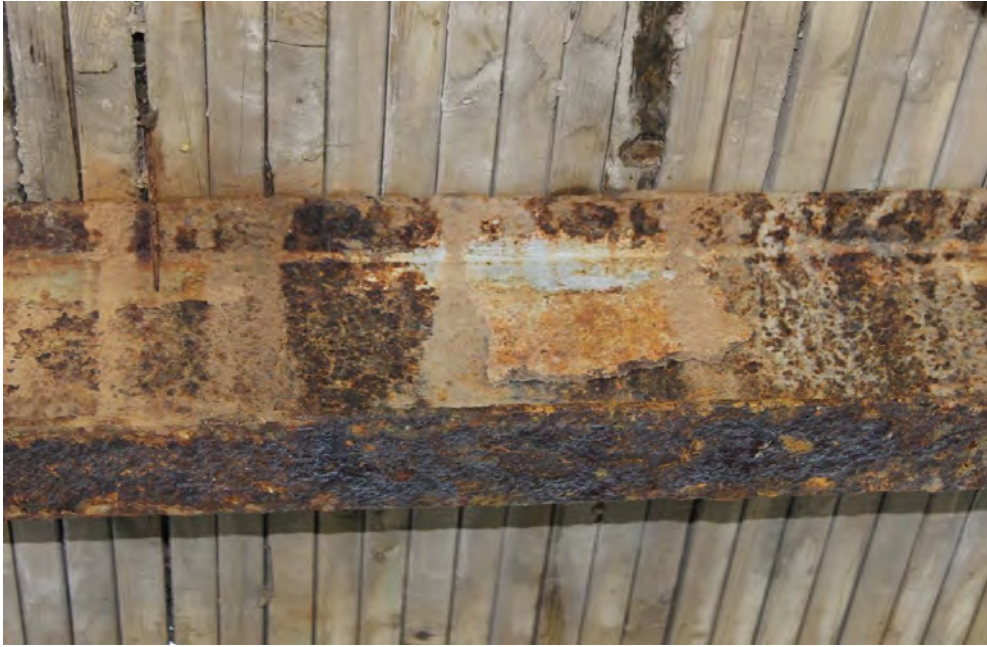
**Image 3. Stringer 4 north side adjacent FB 2, slab rust, severe corrosion**

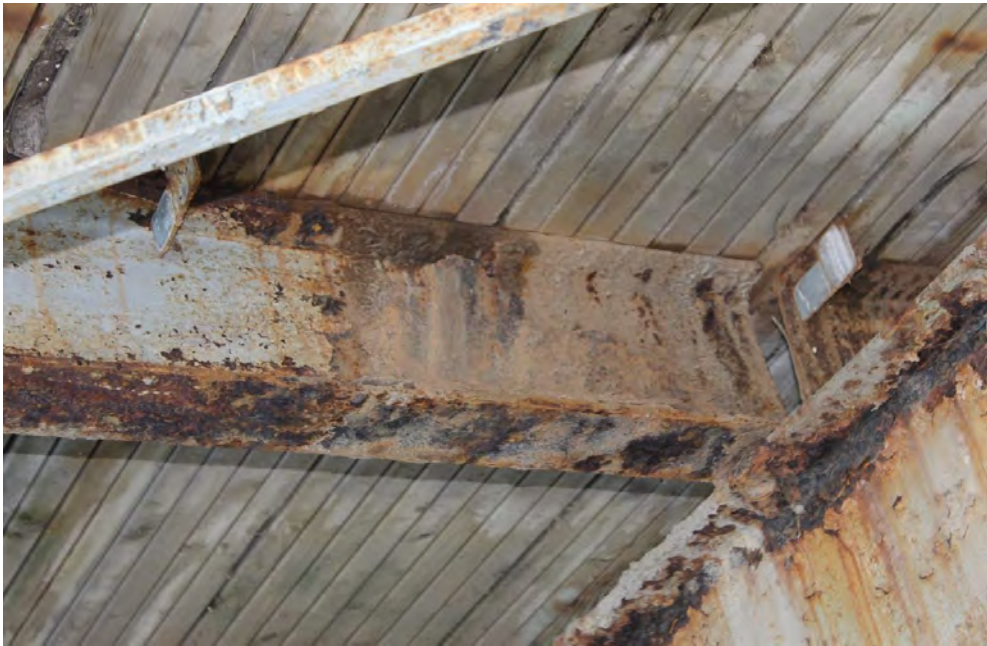
**Image 6. Slab rust on north face of web of Stringer 4 adjacent FB 3**

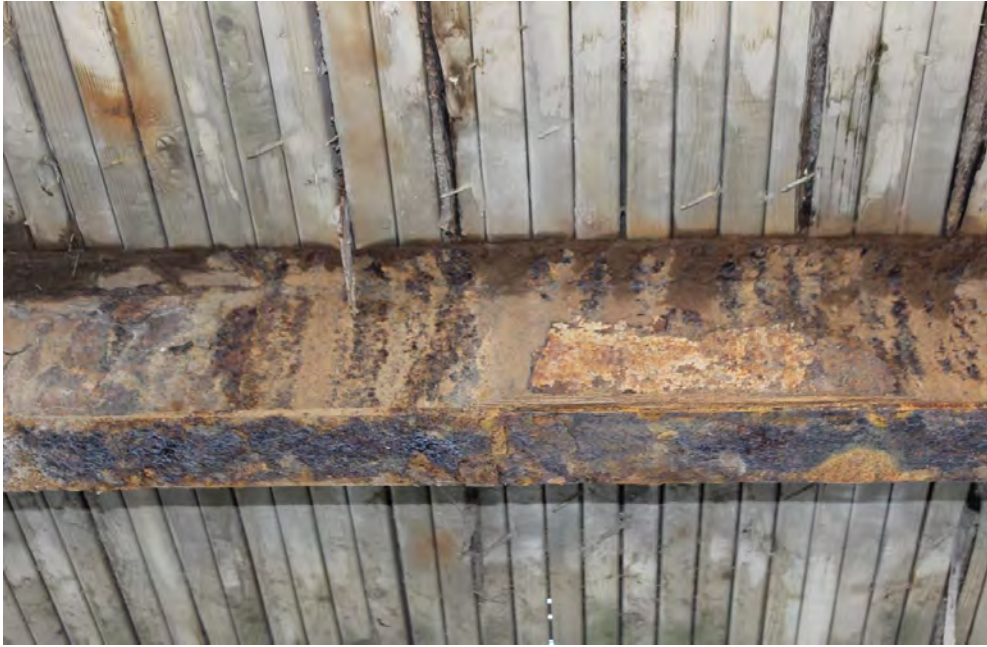
**Image 7. North face Stringer 4 between FB 4 & 5, flange & web thinning, slab rust present**

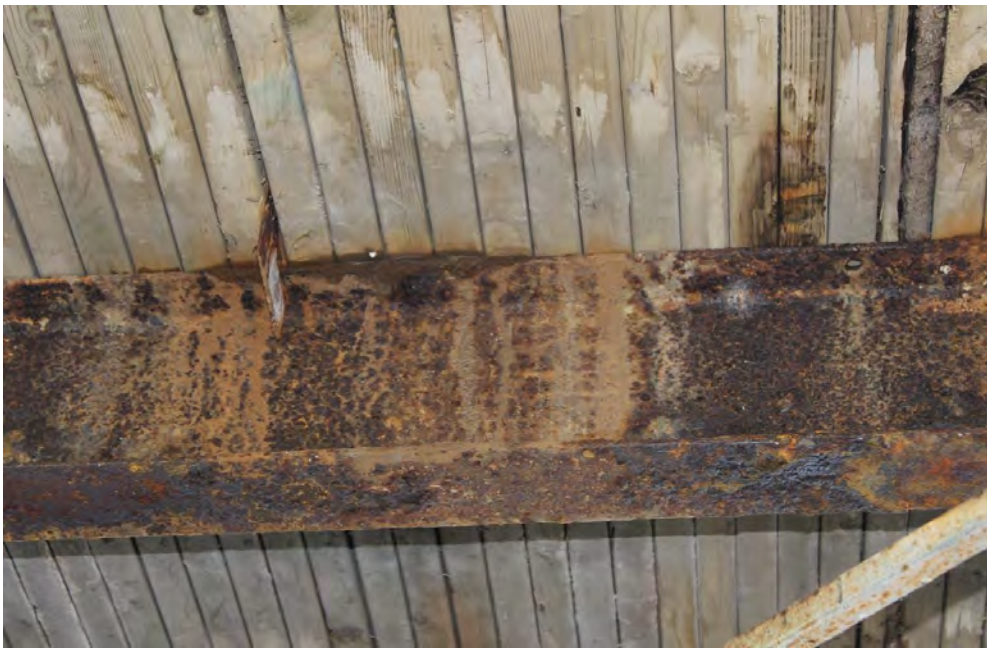
**Image 8. South face Stringer 2 between FB 5 & 6, representative corrosion for most stringers**

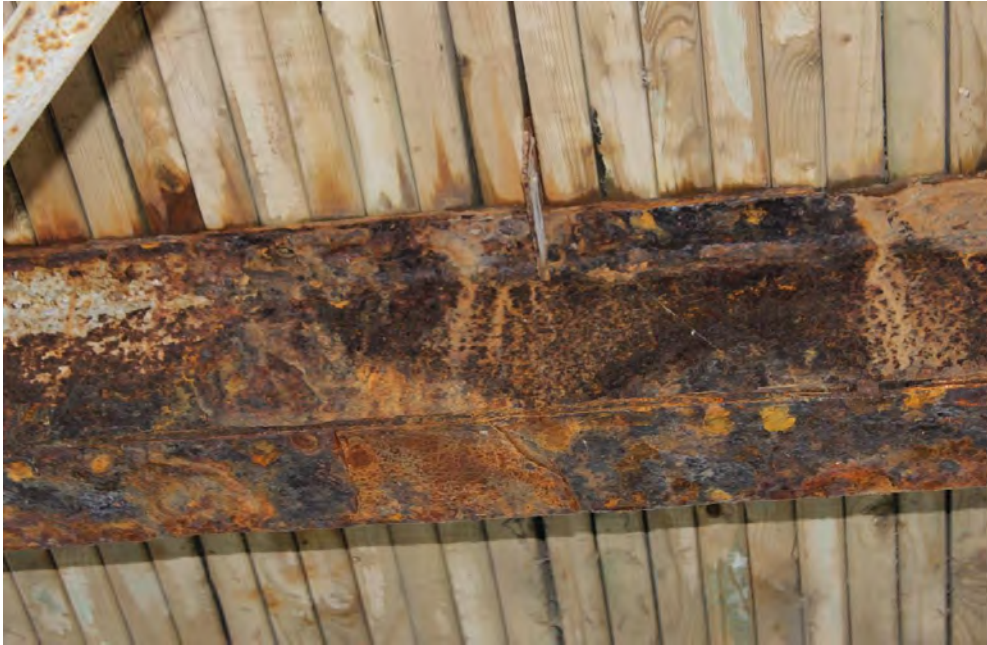
**Image 9. South face of Stringer 3 between FB 7 & pier, slab rust and general section loss**

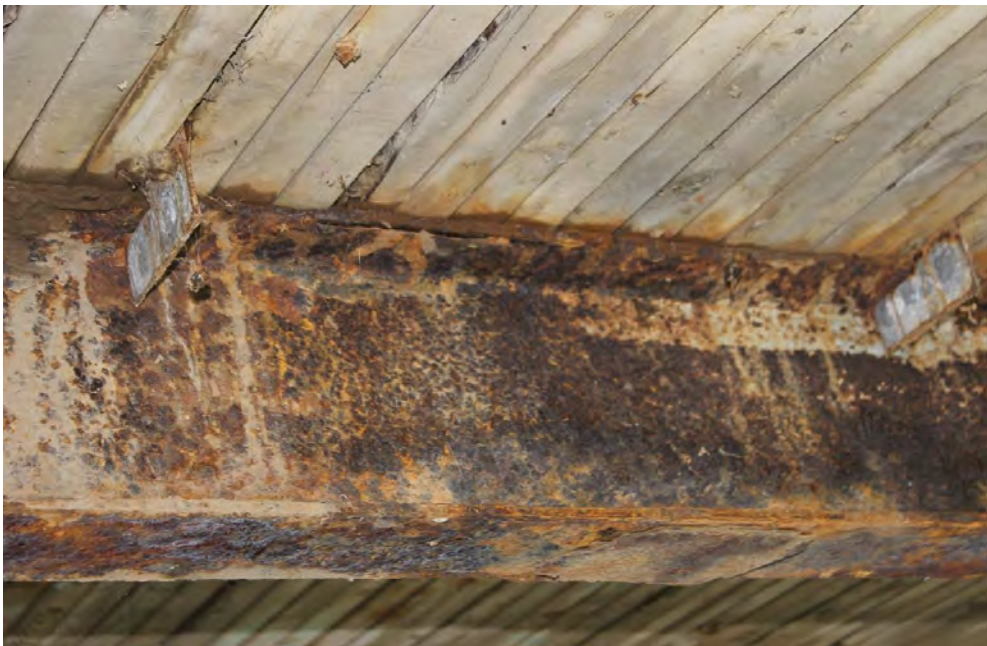
**Image 10. North face of Stringer 4 between FB 7 & pier, severe thinning of top flange**

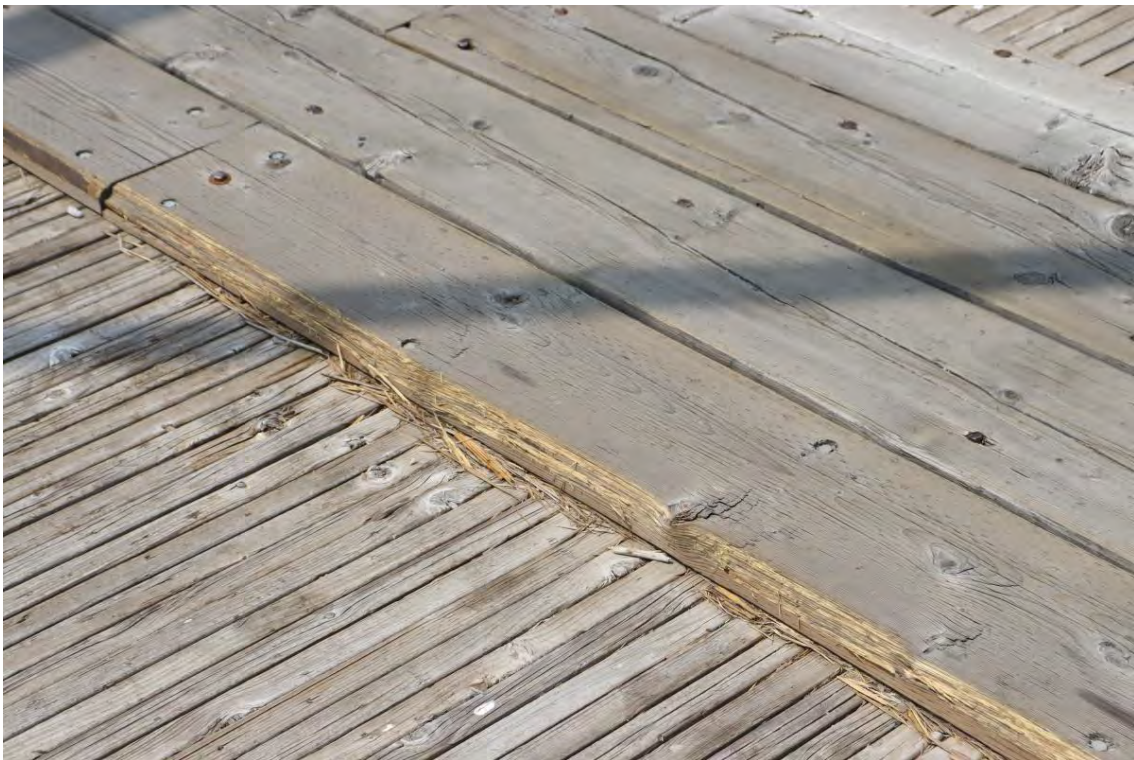
*Figure 60: Damaged running boards*

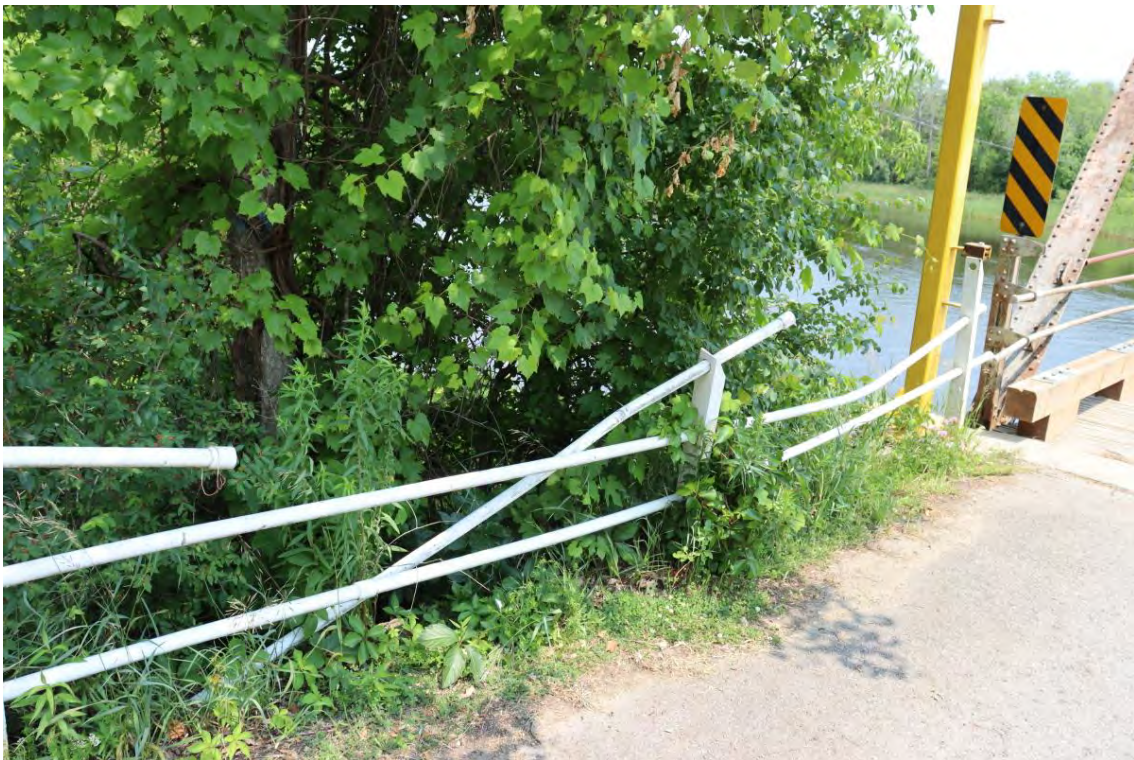
Figure 68: NW damaged approach railing
