ANDREWSVILLE BRIDGE WADING INSPECTION REPORT- JULY 2021

Lanark County, United Counties Leeds & Grenville

Keystone Bridge Management Corp.
Your Bridge Asset Management Specialist

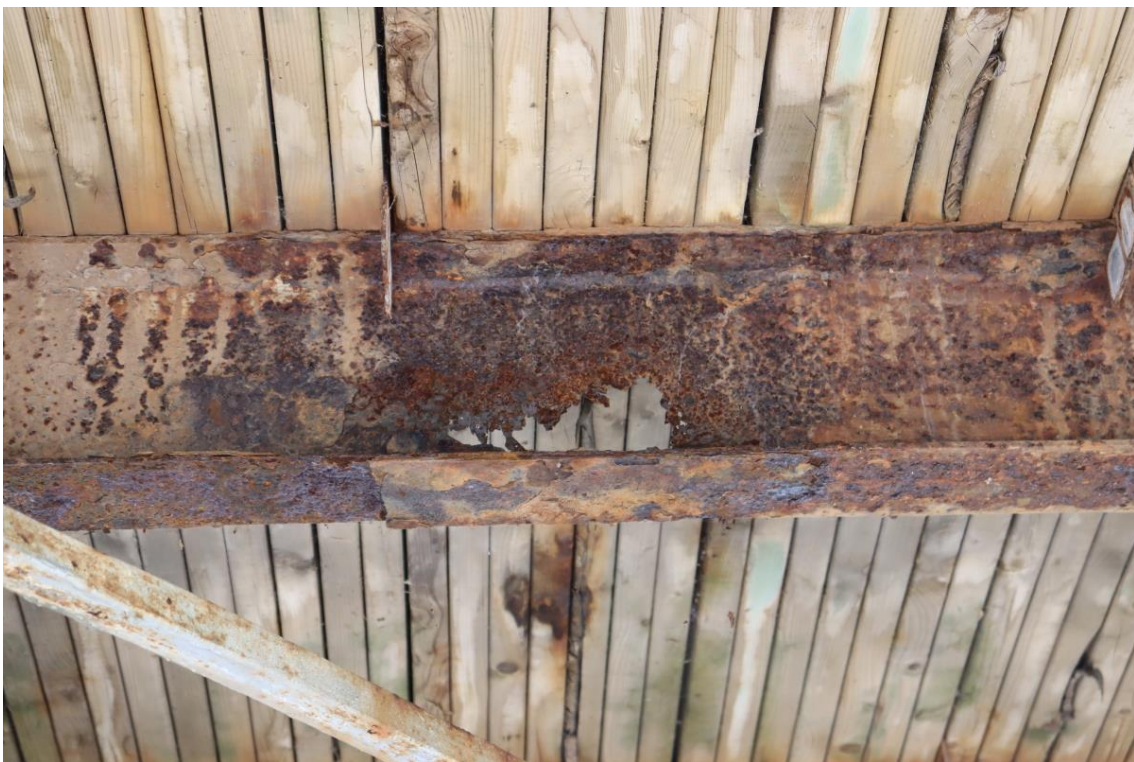
During the 2021 wading inspection select areas with heavy slab rust (laminar corrosion) were hammer tapped as in previous inspections. This time, the stringers were found to have perforated webs in two locations. Perforation of a web signifies a 6.9 mm thickness of steel section loss. Generalized web thinning of the stringers and significant section loss of the stringer flanges was also noted. It is estimated that the five stringers acting together as a deck system have lost approximately 50% of their intended strength at this time.

Figure 10: Stringer 2 perforation in bay 8

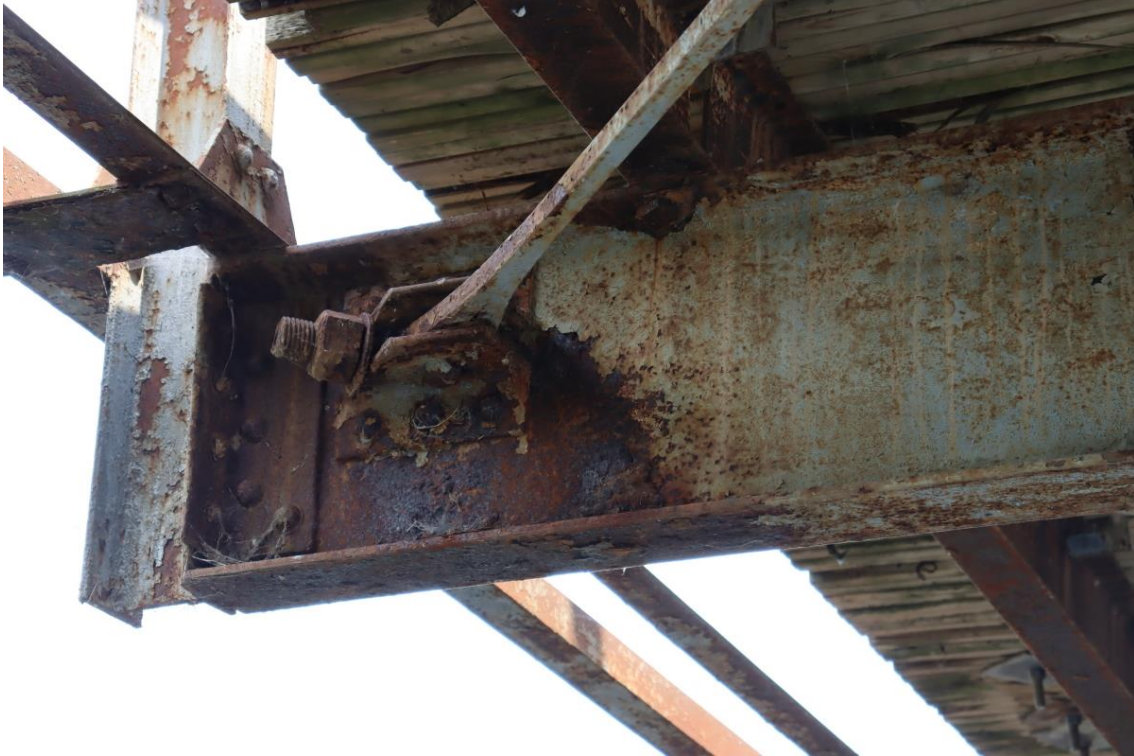
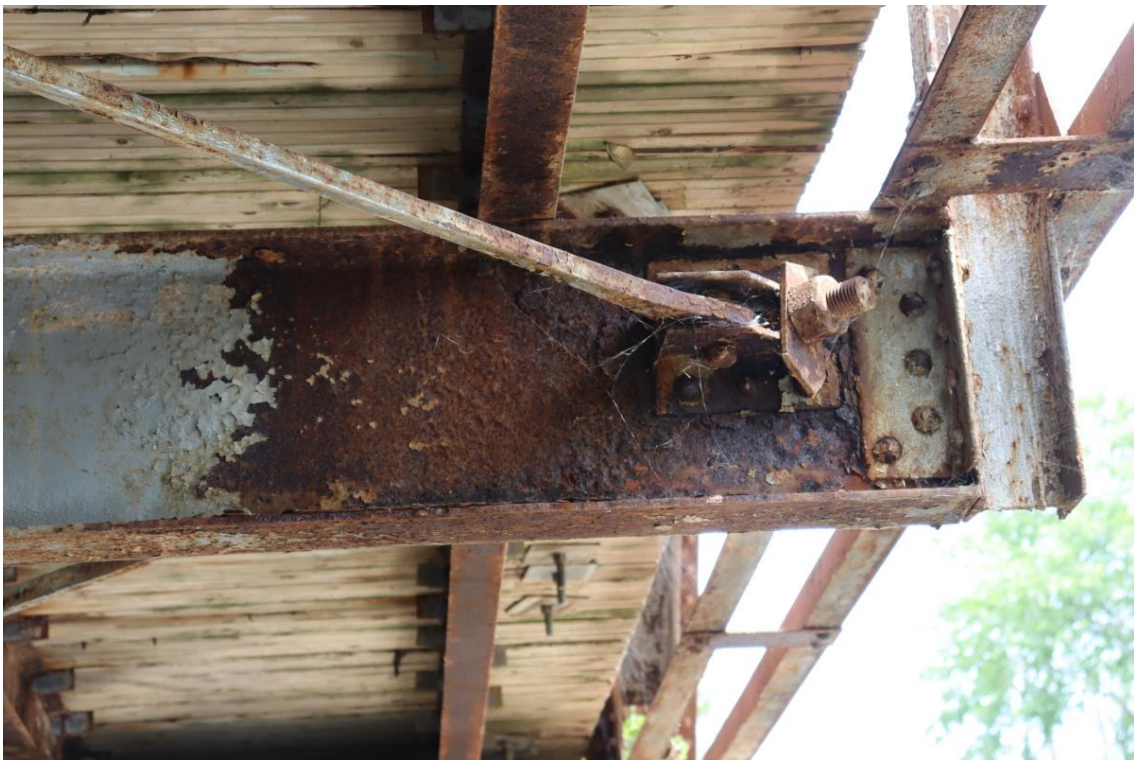
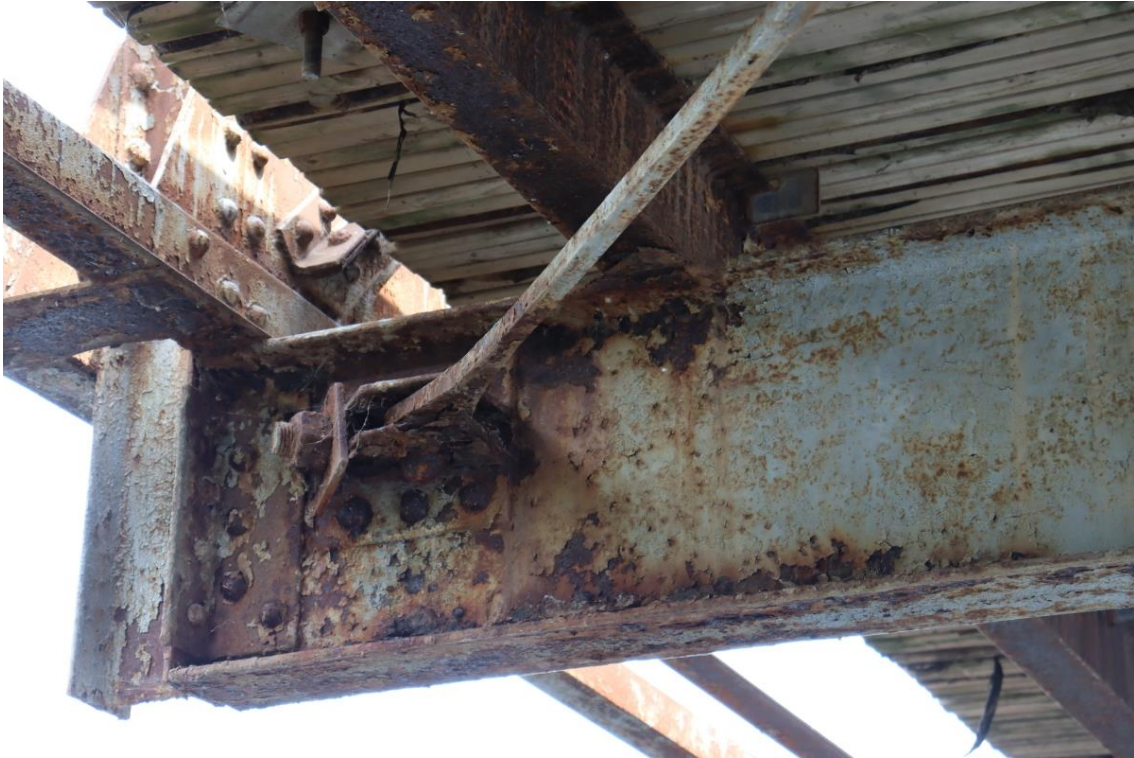
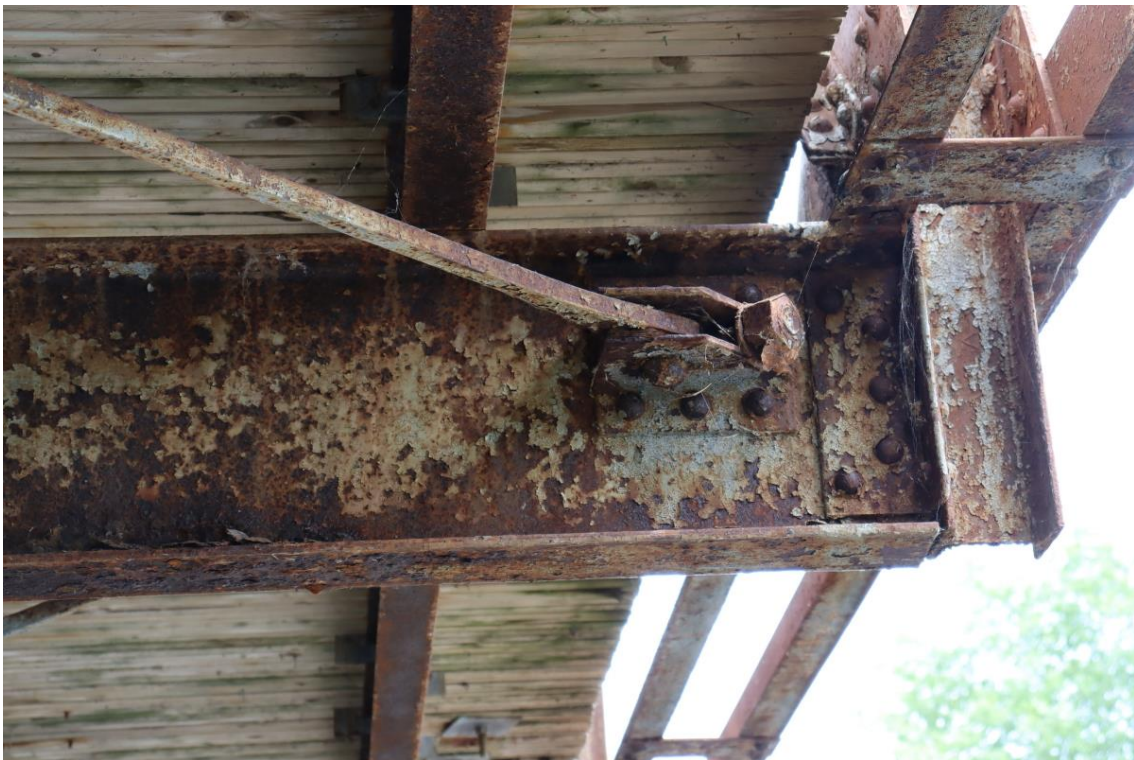
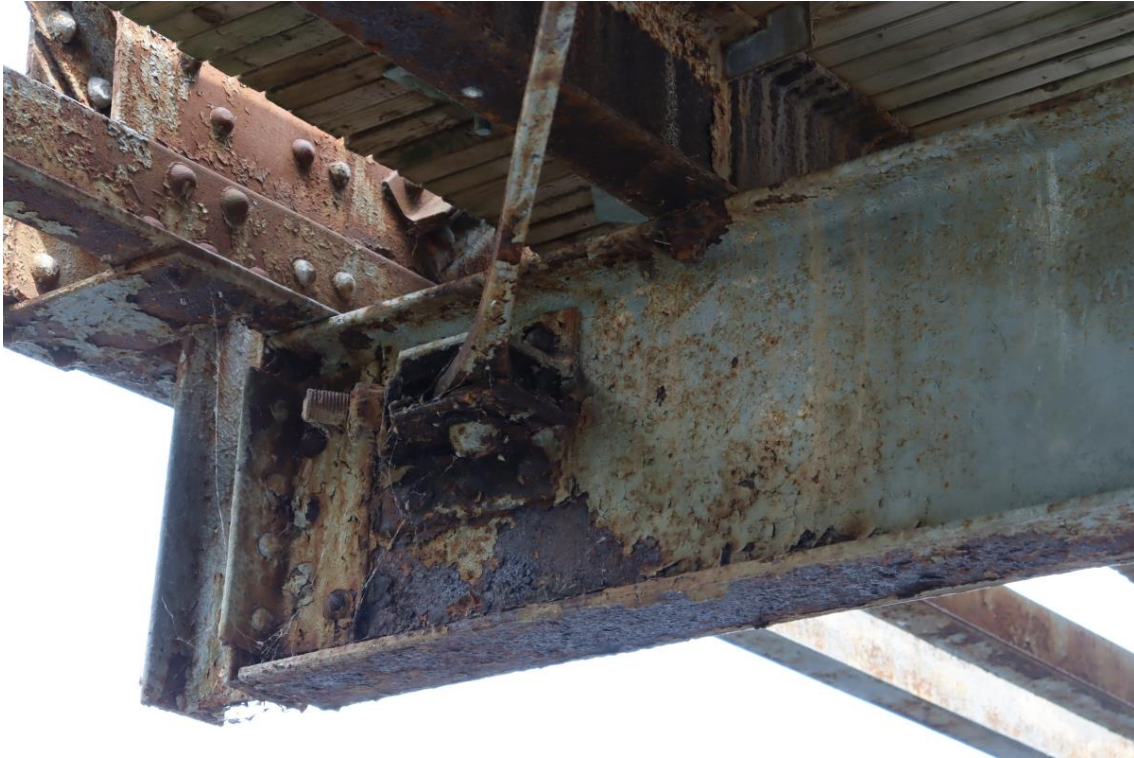
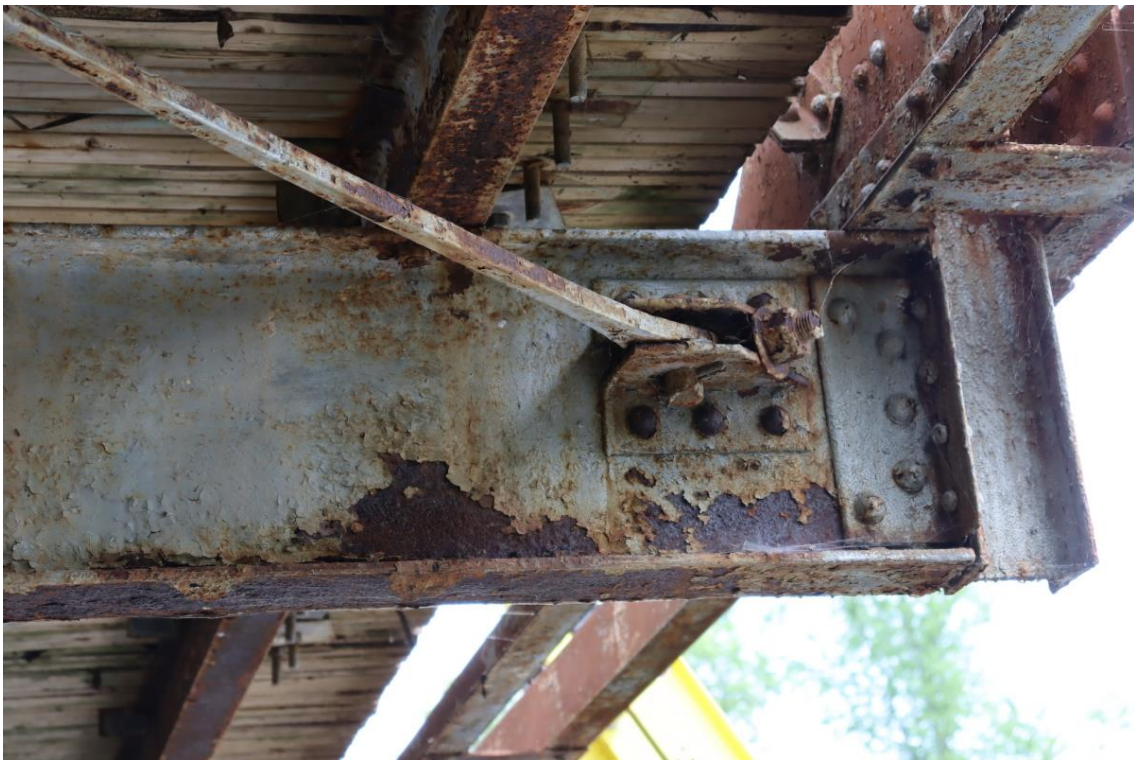
has changed very little in the past seven years. The upstream and downstream ends of each of the seven floor beams are generally more heavily corroded than the middle sections. None of the corrosion on the floor beams is of a critical nature. That is, the load capacity of the truss is not governed by the floor beam condition.

A comparison of the floor beam condition change over time was made by careful comparison of 2018 imagery to 2021 imagery. A small increase in paint loss is clear. It was not possible to discern an increase in section loss. A small amount of additional section loss would be expected.

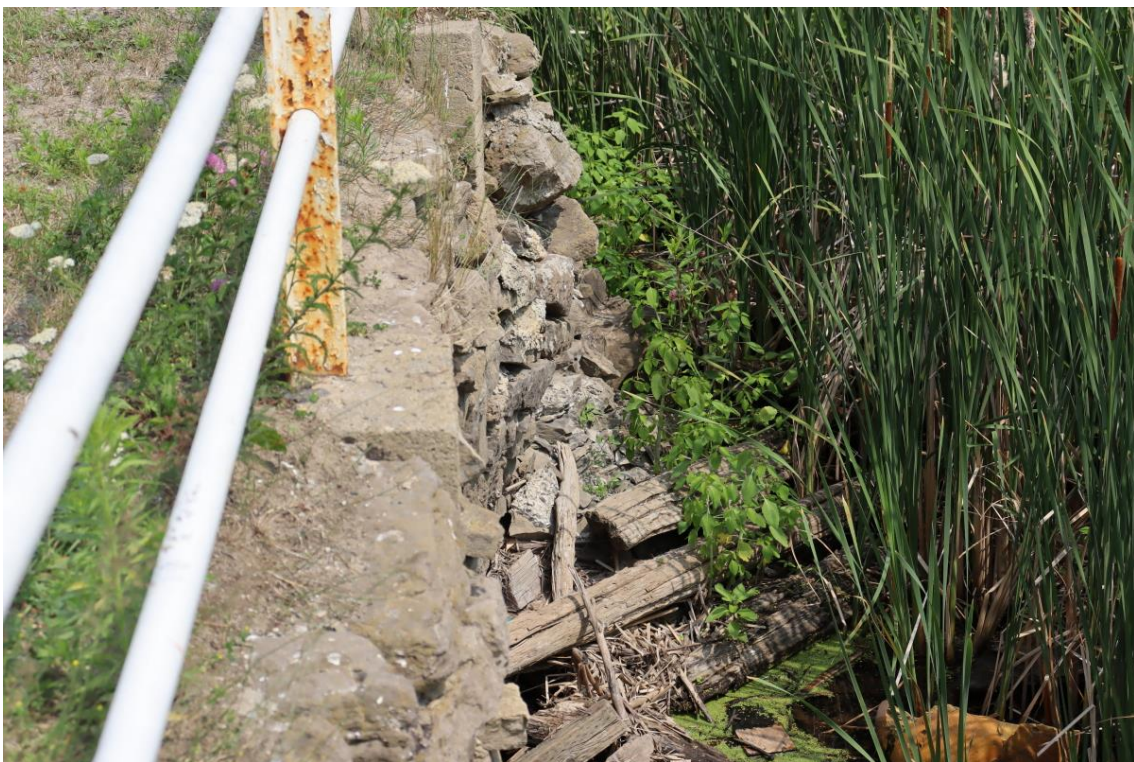
The walls exhibit bulging, displacement, and localized dislodgement of stone. It is remarkable that they are still standing.

Figure 32: Bulging retaining wall in SE

Restoration of the walls would require almost complete reconstruction using salvaged material from the walls, most likely augmented by modern practises such as internal ties.

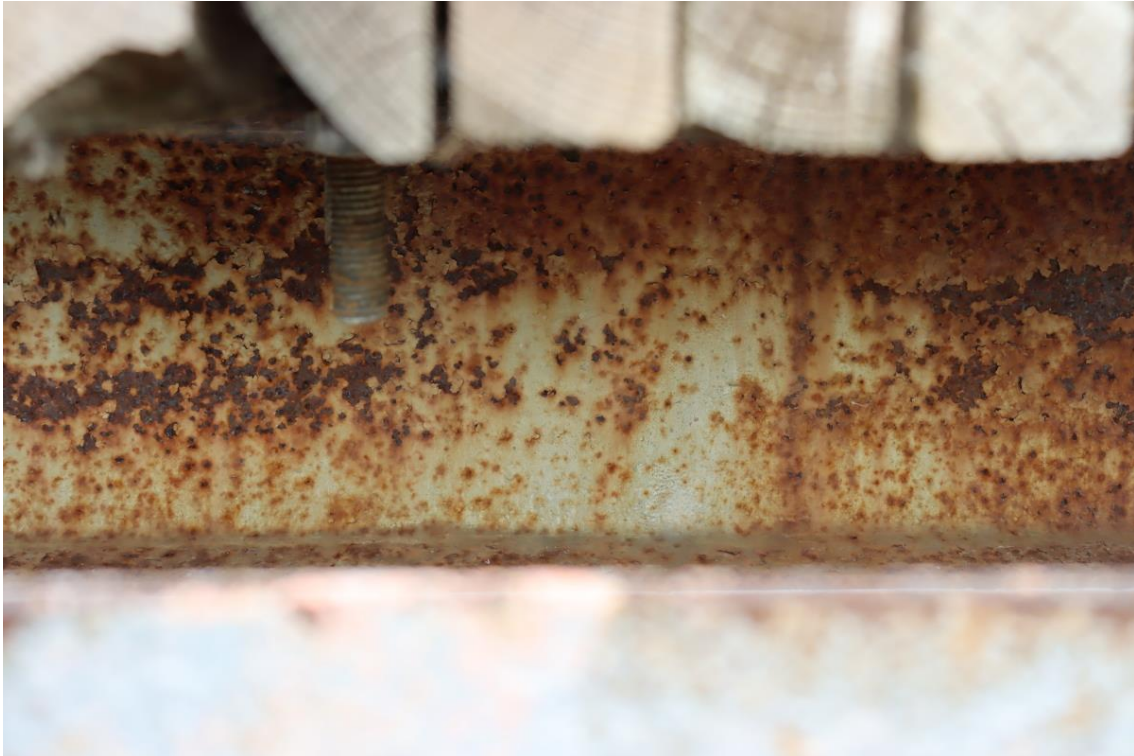
Figure 35: External stringer 1 condition Bay 6

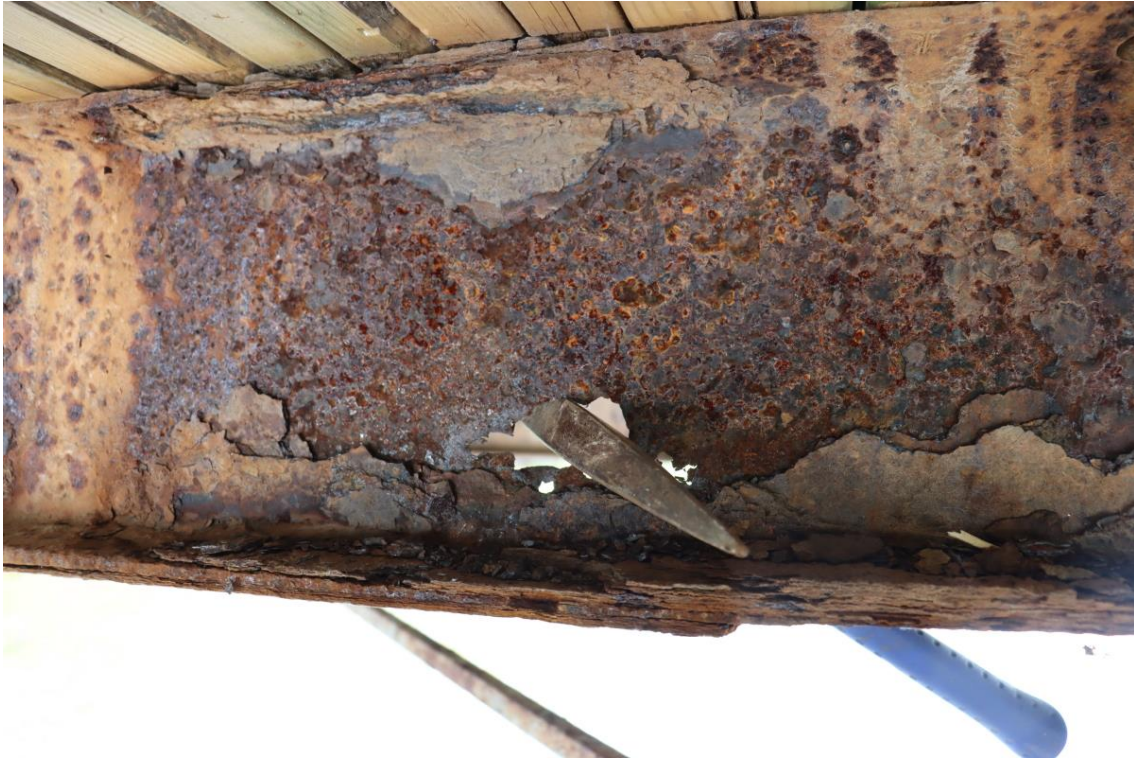
Figure 39: Stringer 3 perforation in bay 5

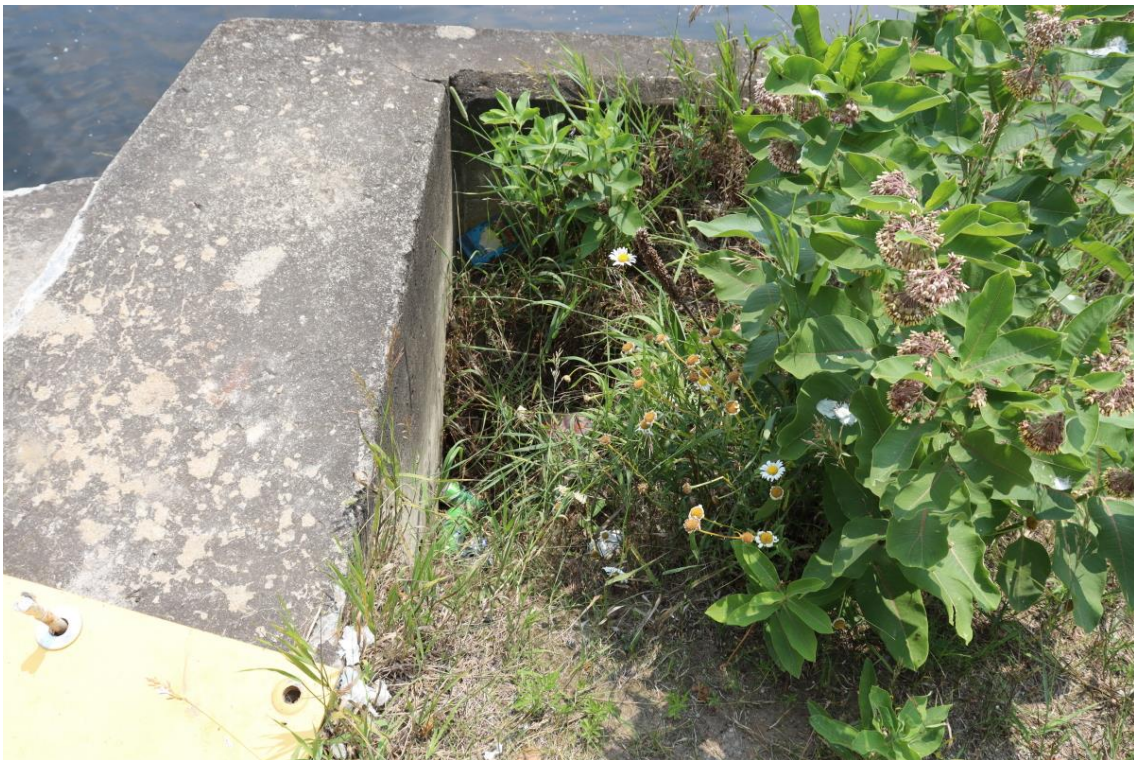
A nominal 0.5 m deep depression in the embankment in the upstream west corner of the truss was noted for the first time in 2021. The embankment is enclosed at this location by the west abutment and a reinforced concrete retaining wall.

Significant scour in front of the west abutment footing appeared after 2018 spring flooding. It is possible that some embankment material is “leaking” from gaps under the abutment footing or retaining wall footing. This would explain the noted depression in the embankment.

Figure 42: Sinkhole in SW corner

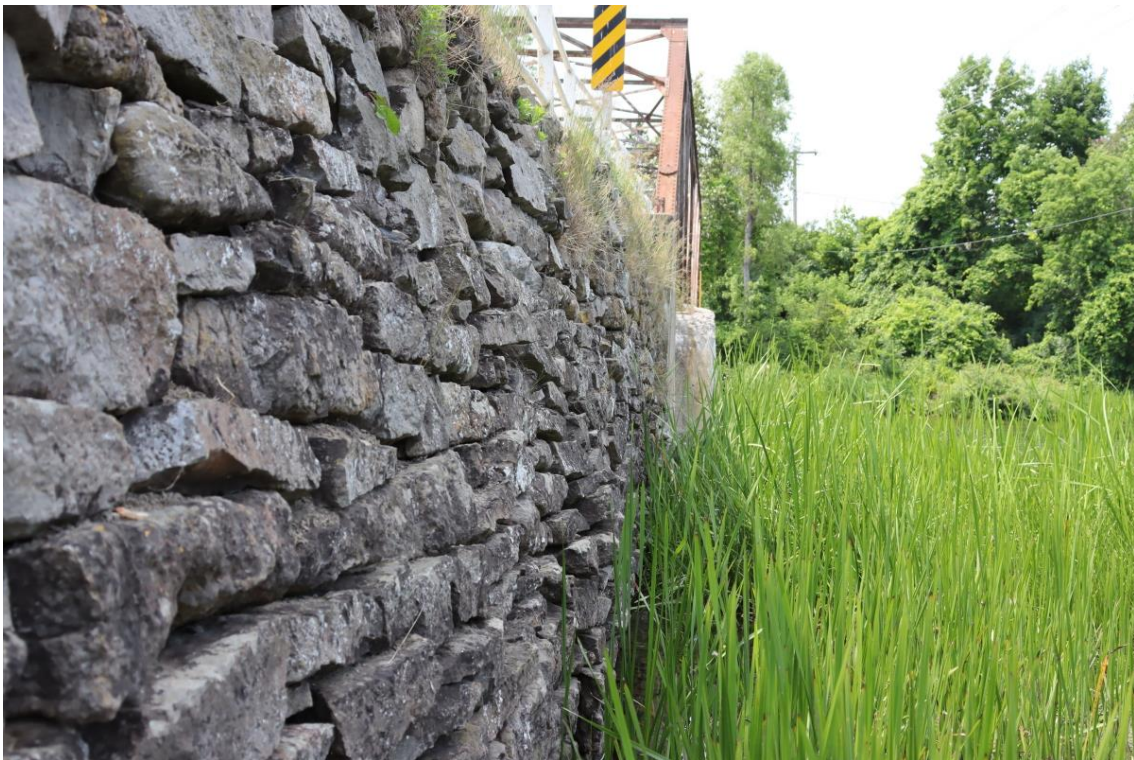
Figure 48: Bulging retaining wall north-east quadrant

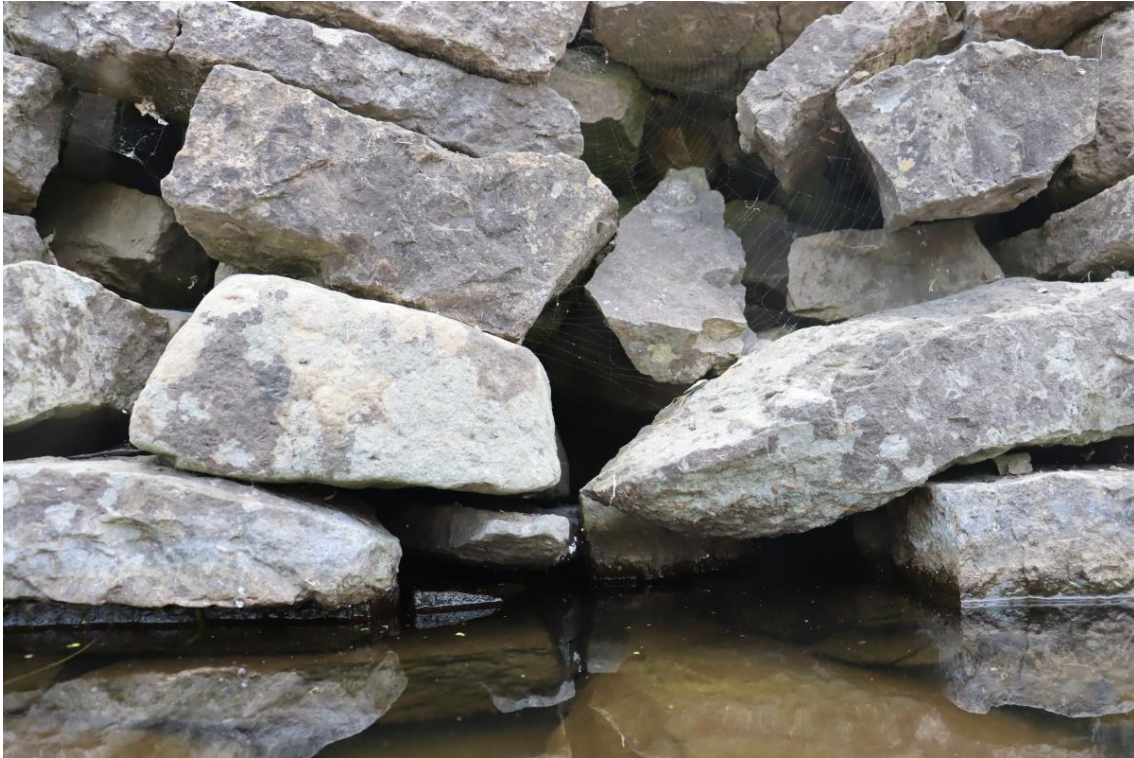
Figure 49: Blocked drainage opening through causeway

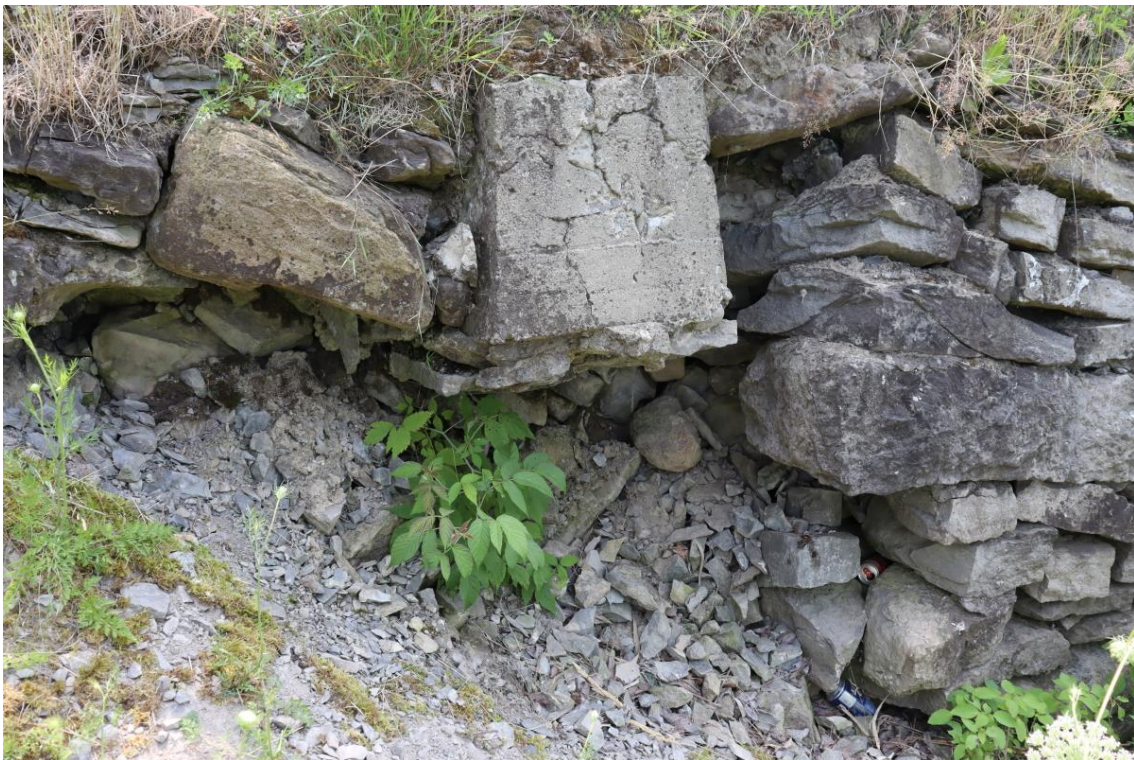
The approaches and bridge possess “safety” railings. All the railings are generally in a neglected state of repair, and do not conform to any current codes for guide rail or bridge railings. The deterioration of the dry-stone walls has resulted in settlement and displacement of the footings for the approach railings.

Figure 52: Undercut railing base in north retaining wall east end

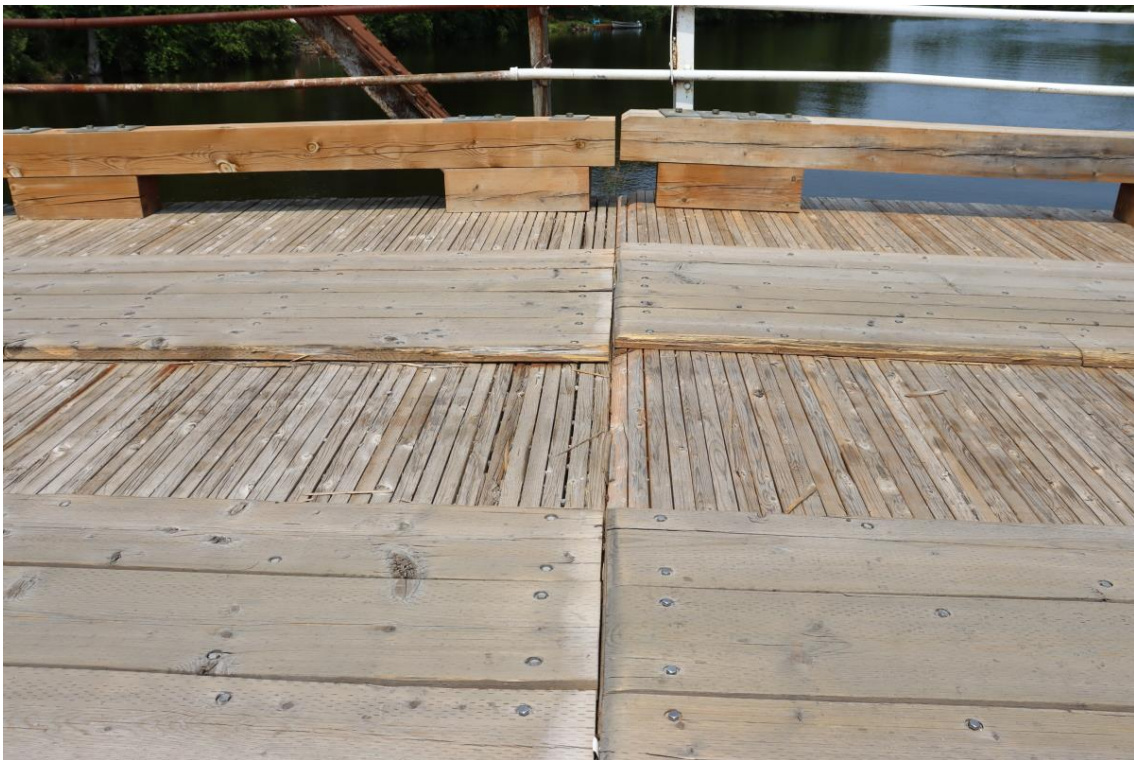
Figure 54: Grade change / bump over pier

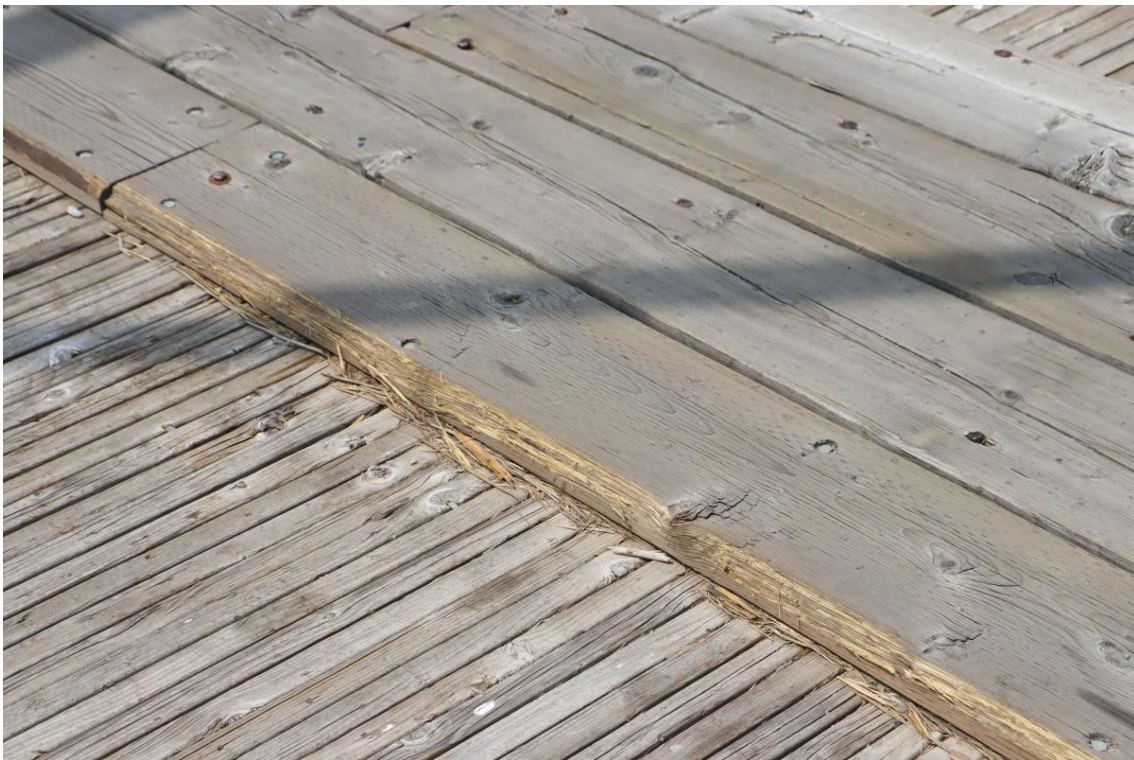
The timber deck could be visually examined from above and below. The deck on the truss dates to 2008. The deck on the east approach span was replaced in late 2018. The timber is generally sound and competent. The timber is nail-laminated, so that wheel loads are shared by multiple planks acting in unison. Thus, the system is tolerant of limited deterioration such as checking and decay. The timber deck on the main truss has at least five years of estimated remaining service life. The timber curbs on either side of the deck were replaced in 2018 and are in good condition. The anchor bolts fastening the curbs to the deck have loosened due to drying shrinkage of the curbs and should be tightened. The running boards are in fair-to-good condition with some spot replacement indicated on the main truss.

Figure 60: Damaged running boards

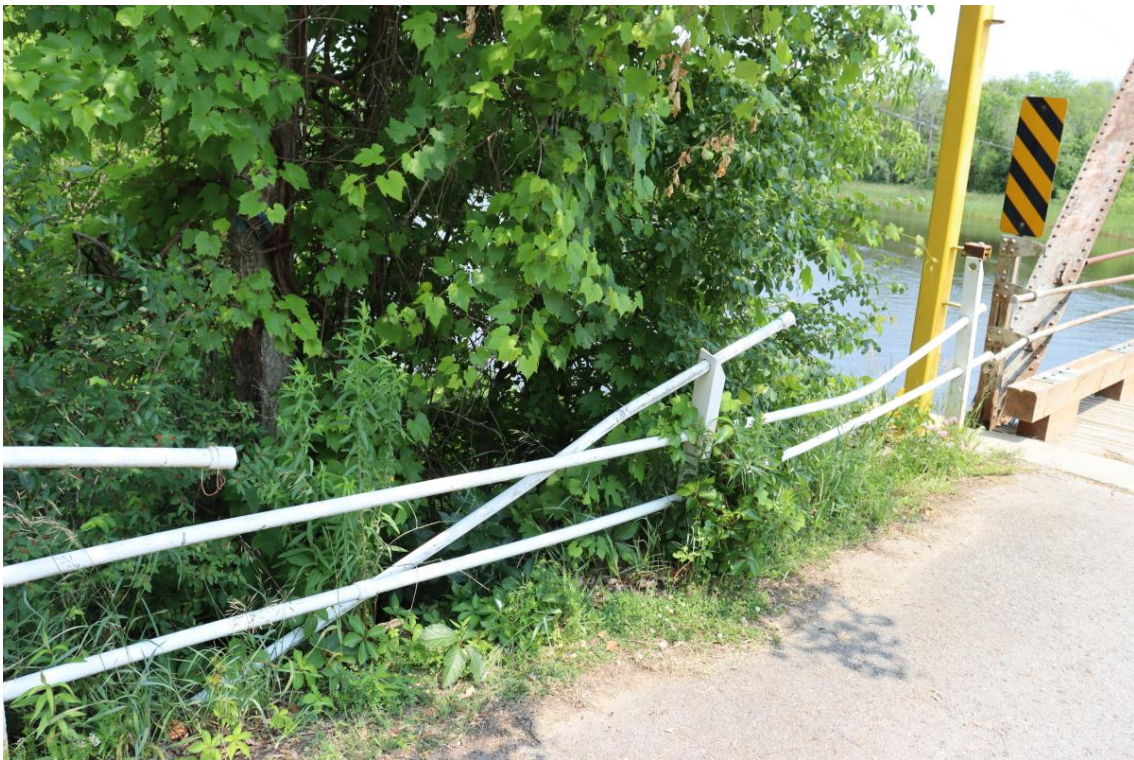
Figure 68: NW damaged approach railing
