Phase I - Environmental Site Assessment

Country Road 29 at Strathburn Street
Almonte, Ontario

May 16, 2022

Report: PE5727-1

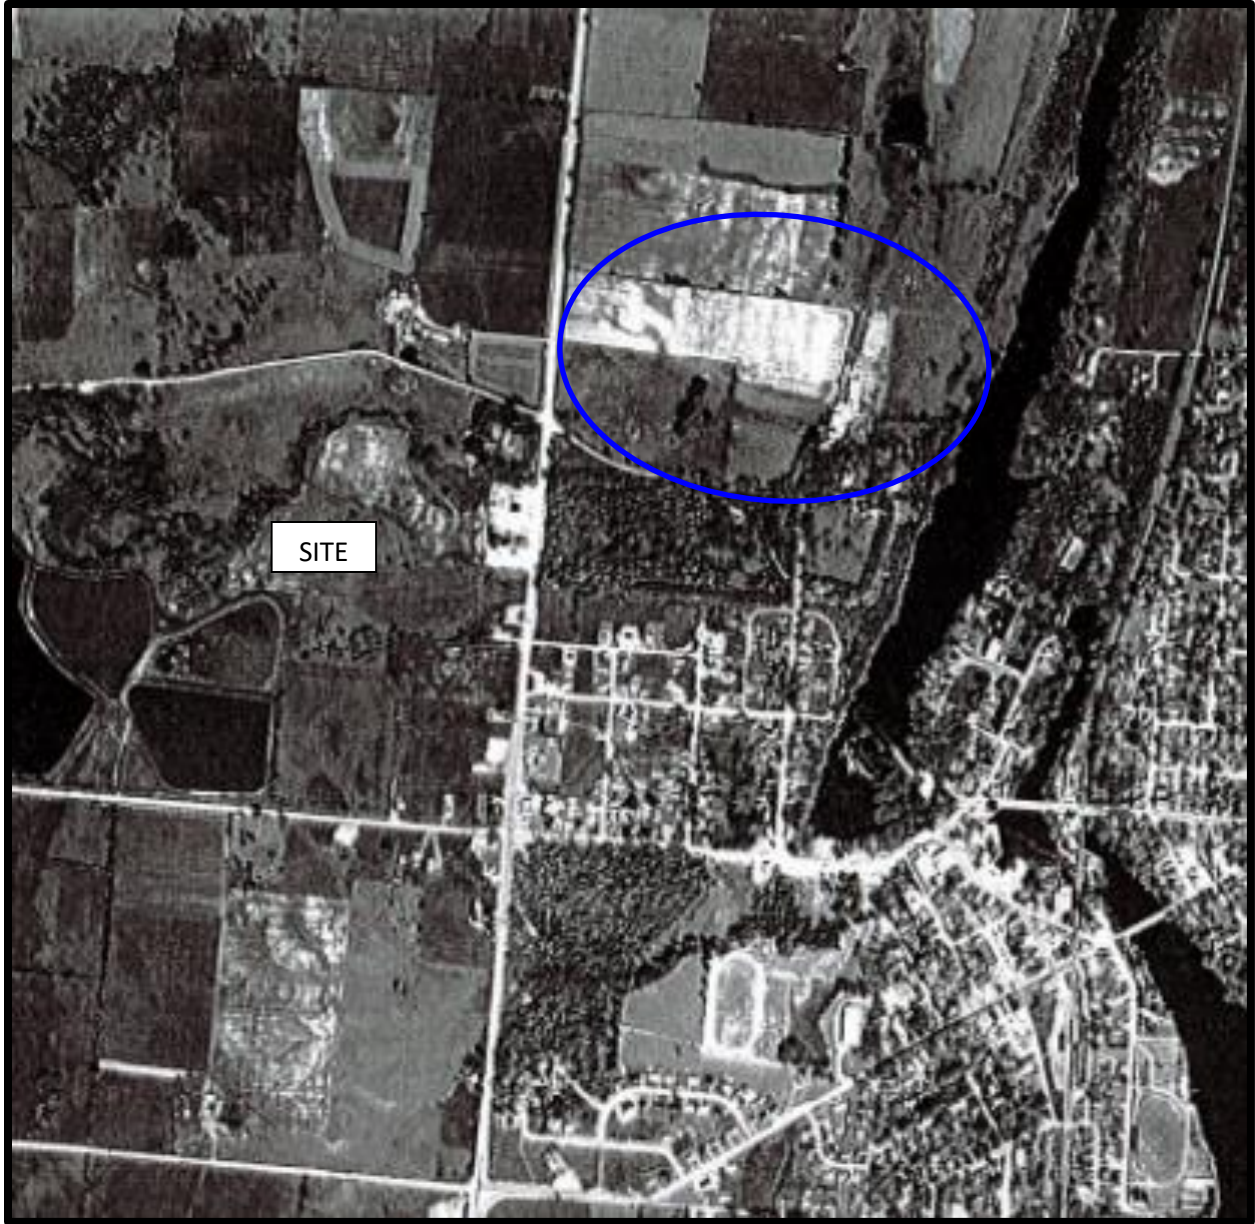
AERIAL PHOTOGRAPH
1959

| 1959 | The subject site and neighbouring lands remain unchanged from the previous photograph. |

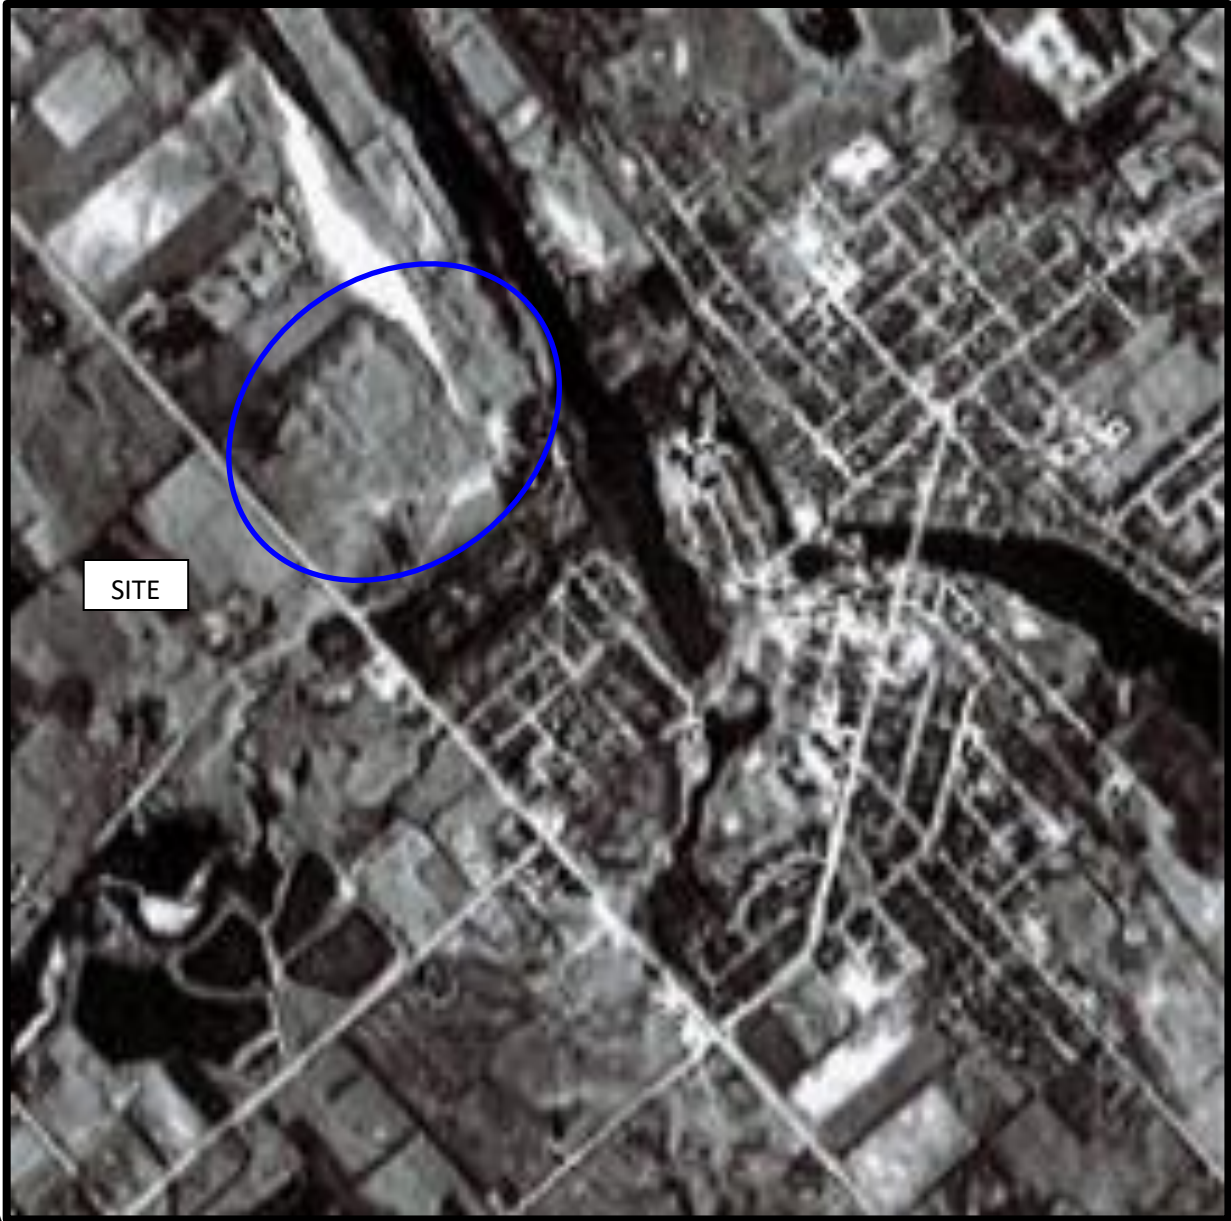
AERIAL PHOTOGRAPH
1978

| 1978 | Based on the poor quality of the image, there appears to be no significant changes to the subject site or neighbouring lands. |

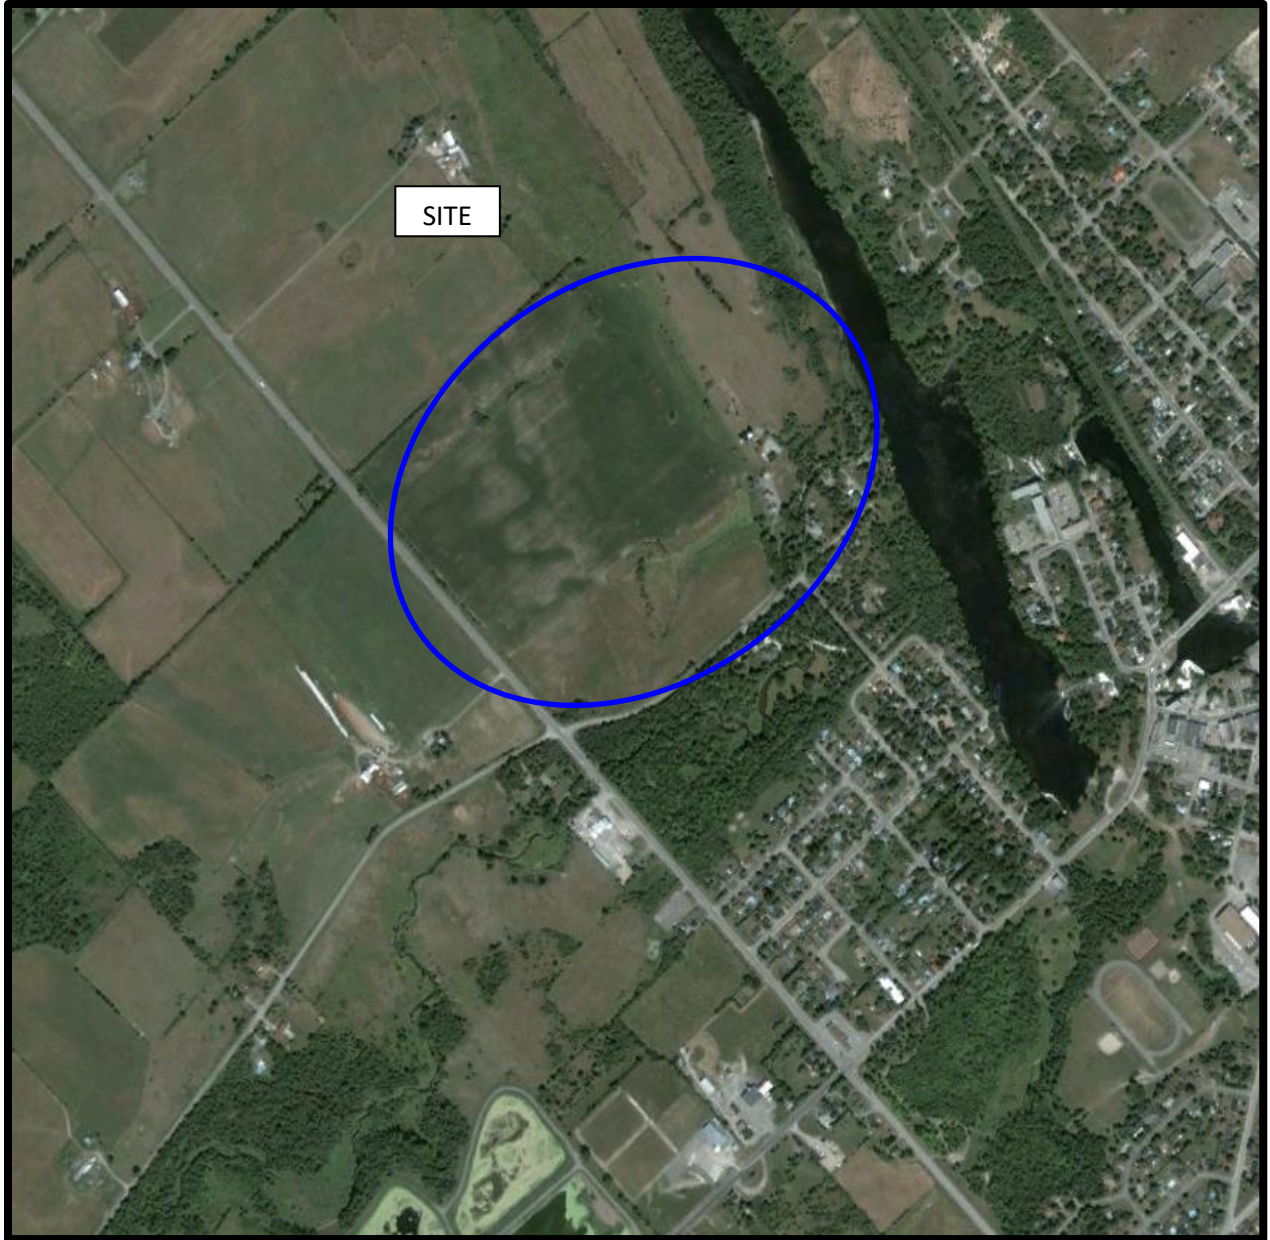
AERIAL PHOTOGRAPH
2005

| 2005 | (Google Earth) No significant changes have been made to the subject site with the exception of a barn structure removed at some point. No other changes have been made to the subject site or the neighbouring properties. |
