**Environmental Impact Study (EIS)
&
Tree Conservation Report**

CARLETON/LANARK STREET SUBDIVISION

Part of Lot 1, Concession 7,

February 6, 2023

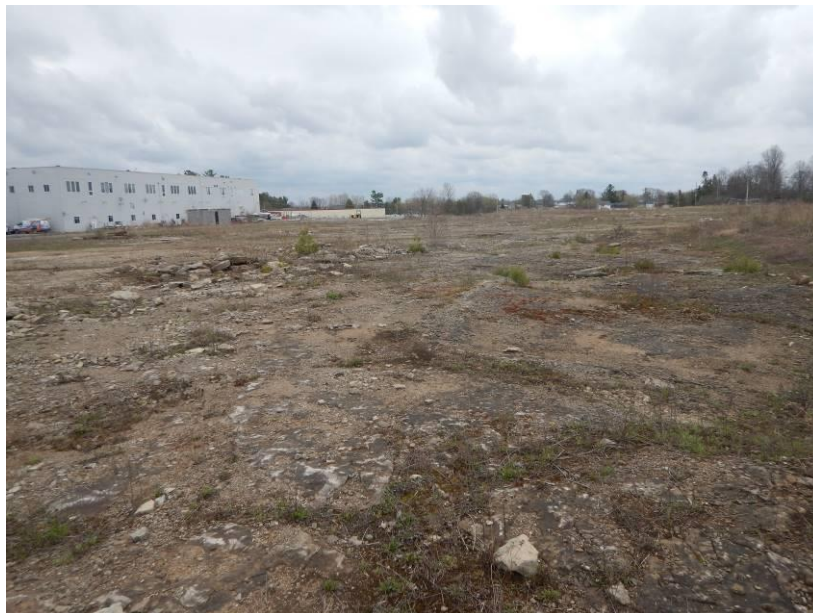
This area makes up the bulk of the subject lands and portions of the adjacent lands. The entirety of the area has been cleared, soil stockpiling was noted within the north western side, and some portions have been stripped of soils down to bedrock. Vegetation has semi re-established in the portions that still contained soil. These areas were similar to a cultural meadow dominated by grasses followed by goldenrods, wild carrot, and clovers. The occasional balsam poplar, black locust, wild red raspberry, and black raspberry were noted (maximum 2m tall). Within the south eastern side a portion of this area has been regularly mowed. A windrow was present along the south eastern edge of the property, this windrow consisted of 41 trees with a DBH of 20cm and over (sugar maple, Freemans maple, Manitoba maple, white cedar, black cherry, American elm, bitternut hickory, bur oak and apple ; 8-12m tall, Average DBH 20-30cm). See sections 7.0 for further discussion.

Photo 1: Cleared Area (May 3, 2022).

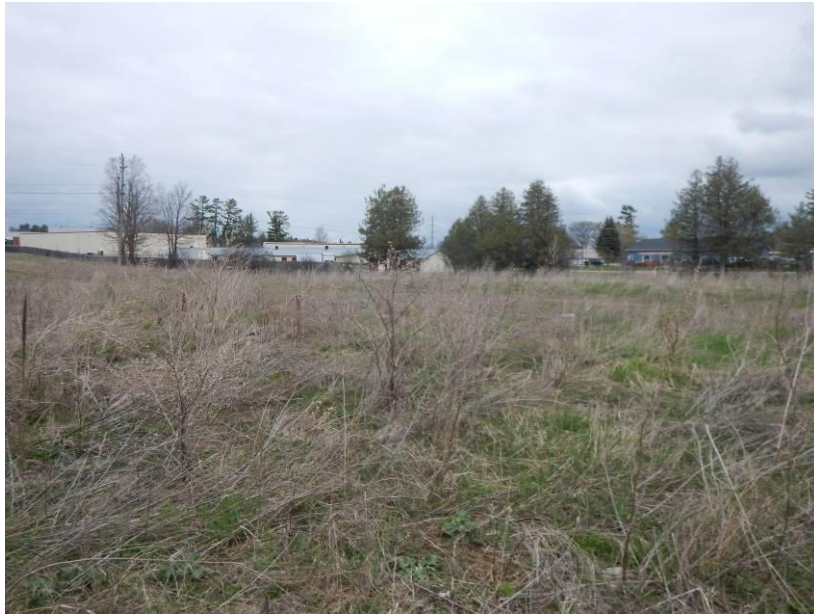
Photo 2: Cleared Area (May 3, 2022).

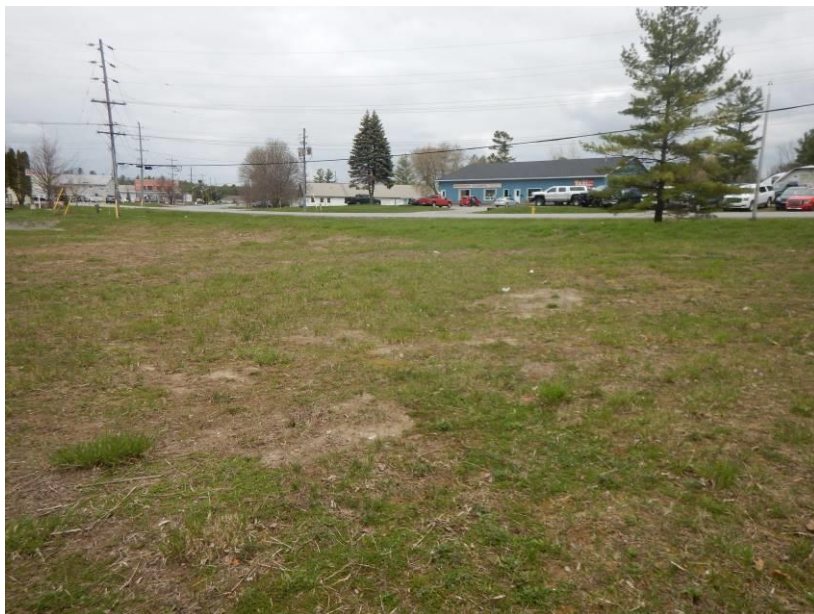
Photo 3: Cleared Area – Mowed Area (May 3, 2022).

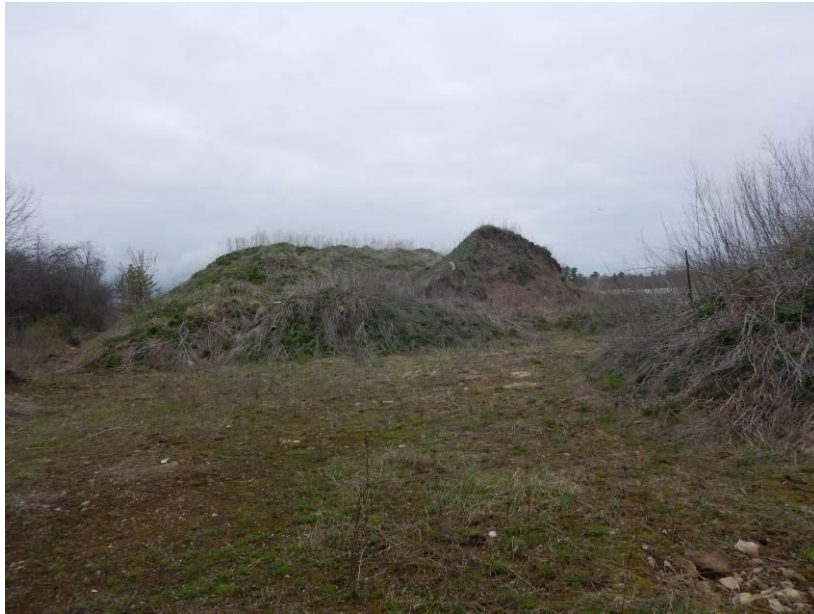
Photo 4: Soil Stockpiles (May 3, 2022).

- 16- Any stockpiled material will be properly managed to prevent these materials from entering the sewer systems. The stockpiles as well as equipment fuelling and maintenance areas will be located a minimum of 30 meters from conveyance routes.

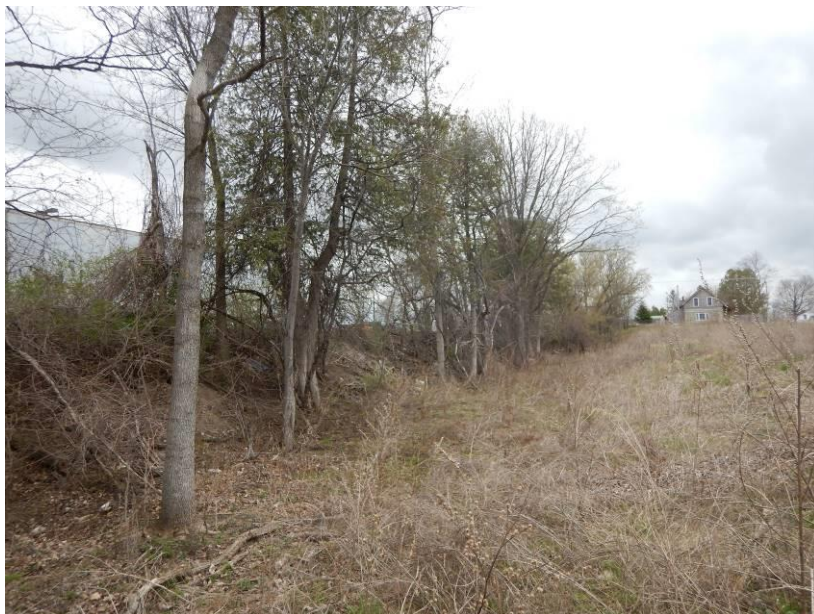
Photo 5: Windrow (May 3, 2022).

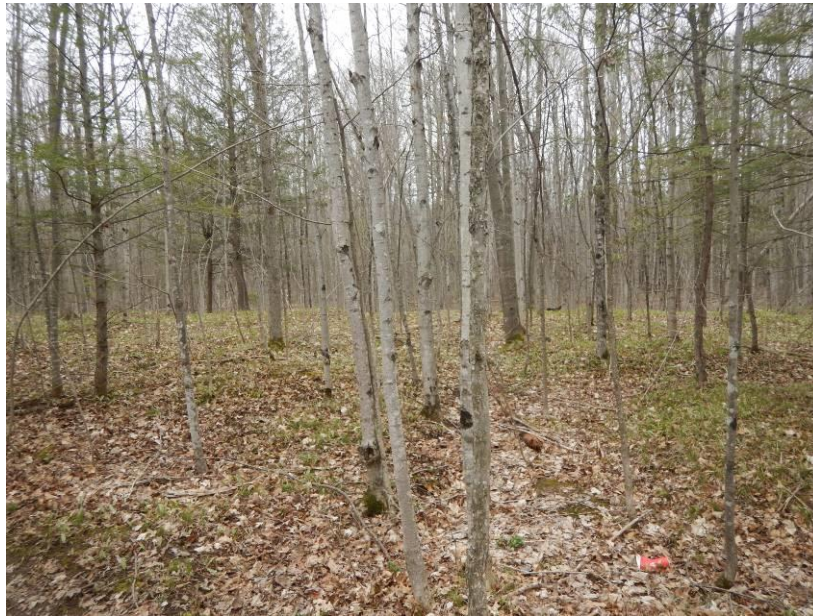
This community was present within the northern portion of the adjacent lands approximately 100m away from the subject lands. The tree composition provided 100% cover and consisted of a mix of deciduous and coniferous trees. The average tree diameter was 10-20cm with a couple of larger trees scattered throughout (DBH 35-40cm). The sub-canopy (6m tall; 70% cover) was dominated equally by red oak and sugar maple followed by eastern hemlock, balsam poplar, and trembling aspen. The canopy (8-10m tall; 20% cover) consisted equally of white pine, red oak, eastern hemlock, and sugar maple. The understory (1-4m tall; 20% cover) consisted of ironwood, white ash, white cedar, eastern hemlock, American basswood, and honeysuckle. The ground layer provided 75% cover and included grasses, trout-lily, and white trillium. A tiny remnant clump of this forest is present immediately north of the subject lands, this area has been severed from the main forest by clearing activities. Trails are present within this forest.

Photo 6: Dry – Fresh Coniferous – Hardwood Mixed Forest (May 3, 2022).

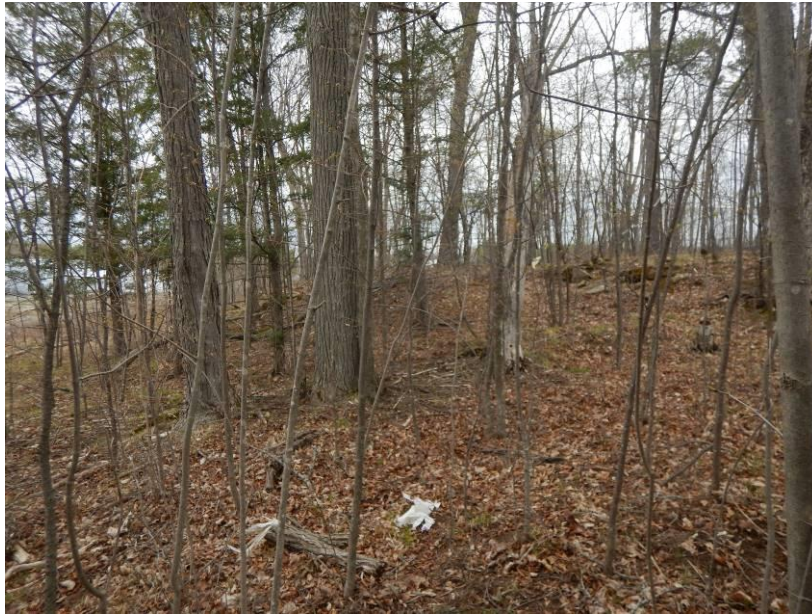
Photo 7: Dry – Fresh Coniferous – Hardwood Mixed Forest – Remnant Patch (May 3, 2022).

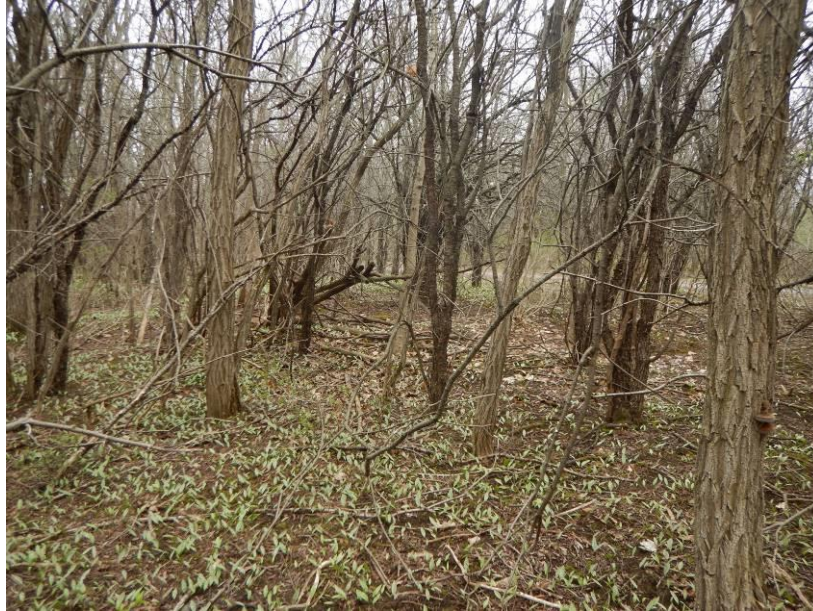
This community was present within the eastern adjacent lands along the property line. The tree composition provided 100% cover and consisted of deciduous trees. The canopy was dominant and the average tree diameter was 5-15cm, with the occasional larger tree scattered throughout. The canopy (10m tall; 75% cover) was dominated by black locust with the occasional maple. The sub-canopy (6m tall; 60% cover) consisted of common buckthorn which was more than apple, which was more than hawthorn. The understory (1-2m tall; 20% cover) consisted of black locust, common buckthorn, and tartarian honeysuckle. The ground layer provided 20% cover and included trout lily and grasses.

Photo 8: Dry – Fresh Black Locust Deciduous Forest (May 3, 2022).

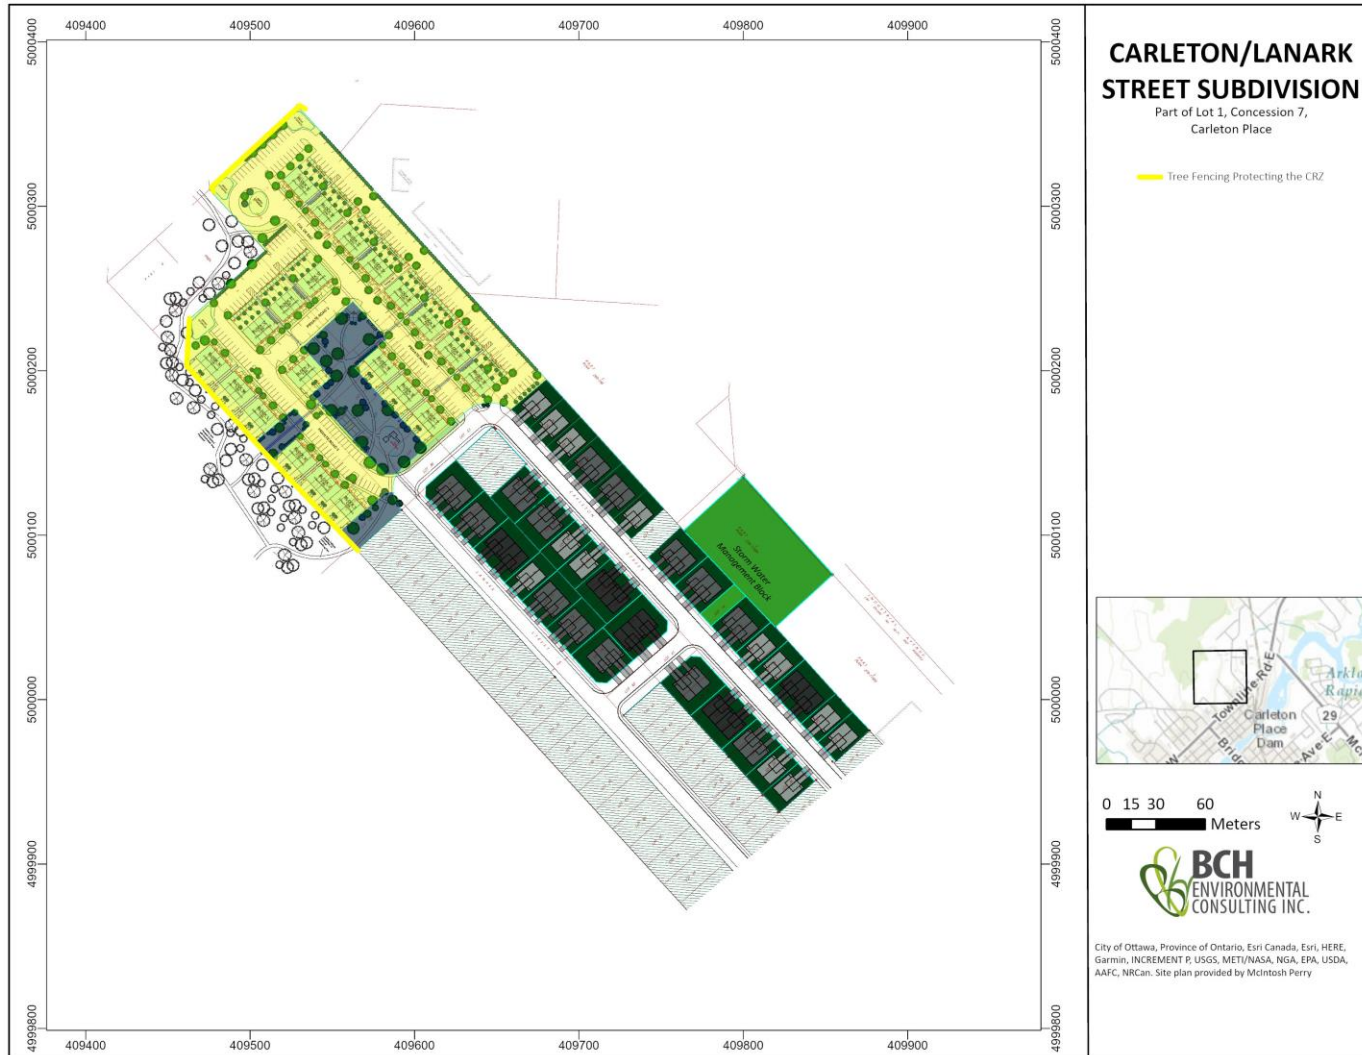
FIGURE 2: ENVIRONMENTAL CONSTRAINTS

As demonstrated, development constraints are limited to tree protection measures which are outlined in section 9.

- 1- Erect a fence at the critical root zone (CRZ) of retained trees (see Appendix C), and at a distance of 3.5m from any adjacent forest or forest patch.
