**RE: Gardiner's Grove Subdivision, Township of Beckwith
Environmental Impact Statement**

NATURAL ENVIRONMENT FEATURES

Gardiner Property
Beckwith

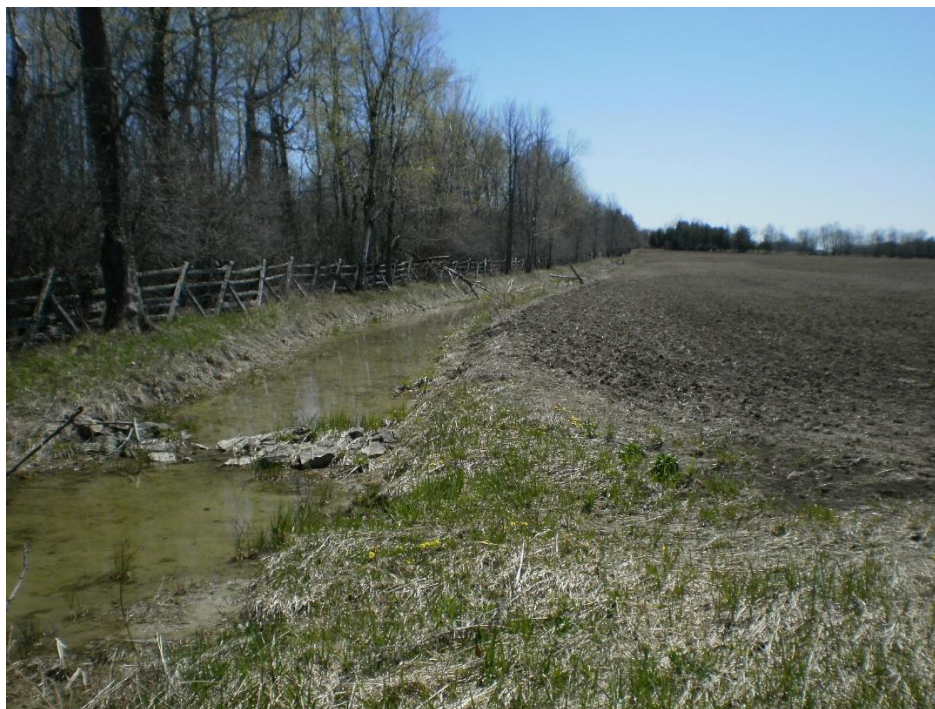
The only channel with fish habitat potential observed on the site was in the northeast corner, south of Tenth Line (Photo 1). The channel has been dug both on the site and further downstream, north of Tenth Line. Three CSP culverts, each approximately 80cm diameter, under Tenth Line were not perched and did not appear to represent a potential barrier to any fish passage. The channel is wide, with a channel width of about five metres. On May 13th the water depth was shallow, generally less than 5cm and the water was clear. Further south of Tenth Line, a low flow channel was partially developed within the main wide channel. Approximately 475 metres south of Tenth Line, the channel turns ninety degrees to the east, extending off the site to the east. No forage fish were observed on May 13th, though the search was only visual in the shallow clear water and no fish sampling was completed. There was no vegetation on the site (west) side of the channel, with the field cultivated to the channel edge. A deciduous forest was along the east side of the channel, to the east of the site and canopy cover is better downstream, to the north of Tenth Line. The exposed substrate was dominated by fine material. Aquatic vegetation, small woody debris, and rock protection associated with the ninety degree turn and a breached stone weir provide some in-stream structure. The channel has a 30 metre regulation limit associated with it on MVCA mapping (due to mapped unevaluated wetlands in this area, which are not present on the site).

*Photo 1 – Dug channel and adjacent cultivated field in the northeast corner of the site.
View looking south, upstream, from Tenth Line*

The channel in the northeast corner of the site may support direct fish habitat, though no fish were observed on May 13th with just visual observations in shallow, clear water. As the channel is along the site periphery and will be used to convey site runoff, it is recommended that the channel be left in place with a 30 metre setback to impervious surfaces or structures. The setback should be allowed to naturalize, which will improve its protective properties over the existing cultivated field that extends to the channel edge.

A channel in the northeast corner may provide direct fish habitat and likely contributes to downstream habitat. To retain and protect this channel, a 30 metre setback which is allowed to naturalize is recommended west of the channel. This will provide better protection than the existing cultivated field which extends to the channel edge. Similarly, a 30 metre setback which is allowed to naturalize is recommended for a wetland in the southwest corner of the site.

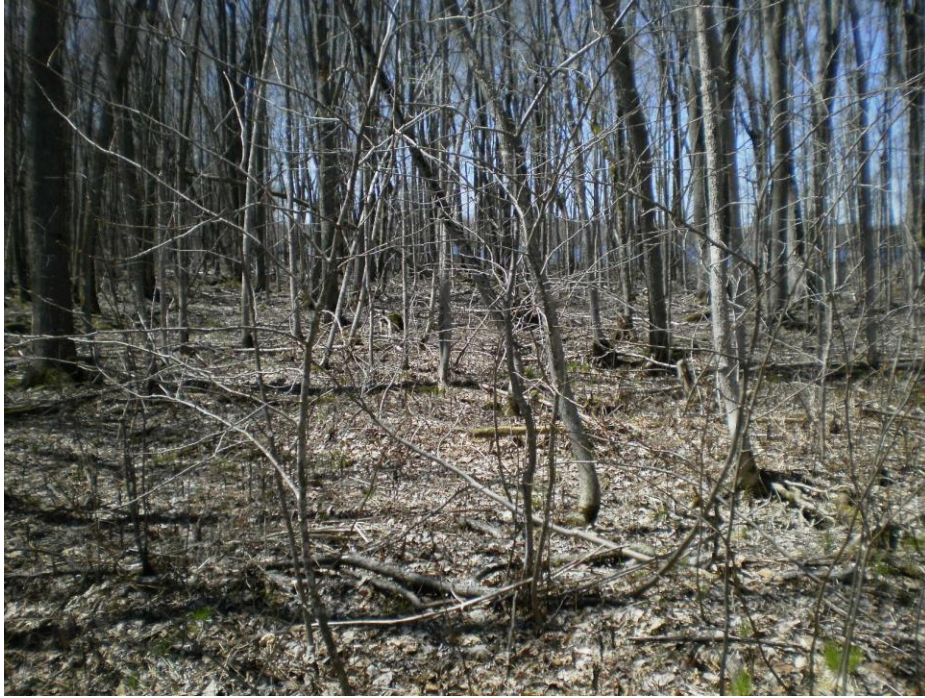
As indicated above, the evaluated, but not provincially significant, McGibbon Creek Wetland is in the southwest corner of the site, to the south of Mississippi Lake. The mapped edge of the wetland on the site generally begins in the range of five to ten metres west of the forest edge. This wetland boundary between an ash deciduous swamp and narrow piece of upland ash deciduous forest was confirmed in the field. As shown on Figure 2, the building envelopes for the closest lots will be at least thirty metres from the wetland edge. Young black ash and green ash stems are dominant in the southwest wetland (Photo 2), with a few scattered red maples up to 45cm dbh also present. Smaller white elm were common and the ground flora was dominated by sensitive fern, with ostrich fern, dwarf raspberry, and joe-pye-weed also present. In the narrow transition area between the east wetland boundary and a cultivated field to the east, white ash, green ash, and white birch were common, with prickly ash in the understory.

*Photo 2 – Young ash deciduous swamp in the southwest corner of the overall site.
View looking northwest towards Mississippi Lake*

The southwest corner of the site contains an east edge of the McGibbon Creel wetland. This wetland will not be directly disturbed and will be protected with a setback of at least 30 metres to the closest building envelopes. The setback is to be allowed to naturalize from the existing cultivated field, which will improve the protective properties of the setback, including potential impacts associated with noise, dust, light, and sedimentation. The only activity within the wetland setback will be a passive recreation trail that will utilize an existing gravel driveway. The driveway will receive a 10cm layer of stone dust and be repurposed into a walking trail, which will be owned and maintained by the municipality.

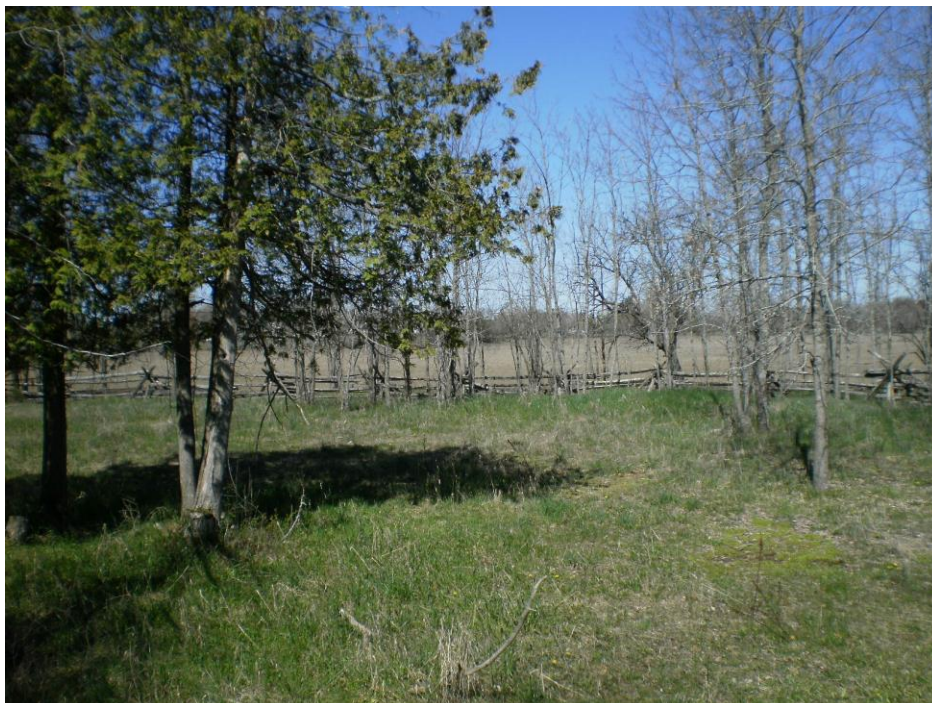
A small unevaluated wetland area appears on MVCA mapping in the central portion of the site. There is no regulation limit associated with this area on the MVCA mapping, and no wetland habitat was observed during the site review in this area (Photo 3).

*Photo 3 – An upland cultural woodlot is in the vicinity of a small area mapped as wetland in the
central portion of the site. View looking north*

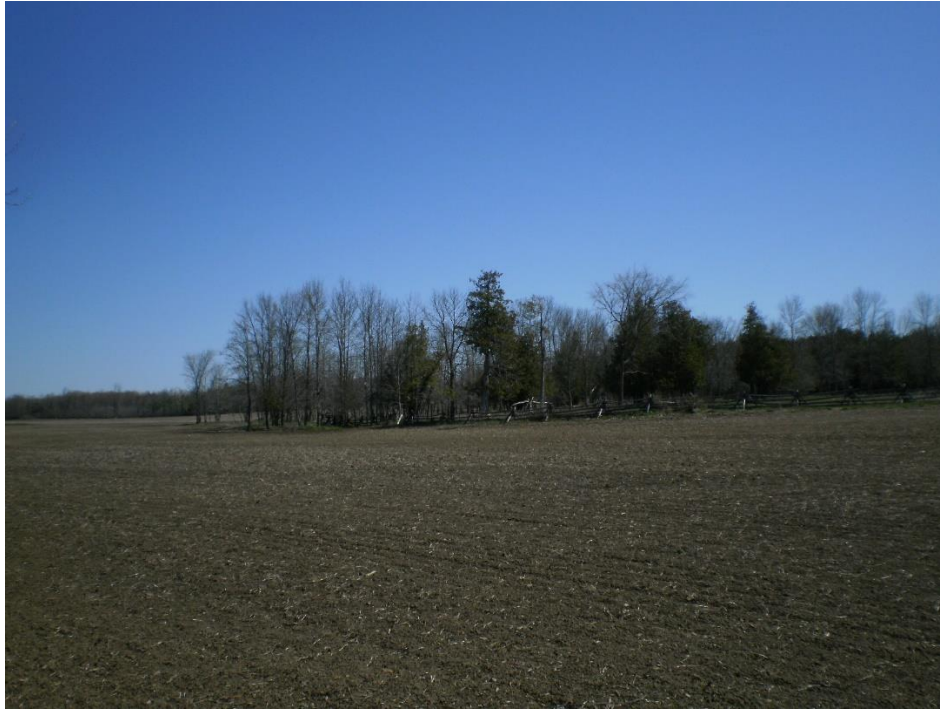
As shown by vegetation community 'A' on Figure 1, cultivated fields dominate many portions of the site (Photos 4 and 5). The fields were planted in soybeans in 2020.

*Photo 4 – Cultivated field and cultural woodland in the central portion of the site.
View looking east*

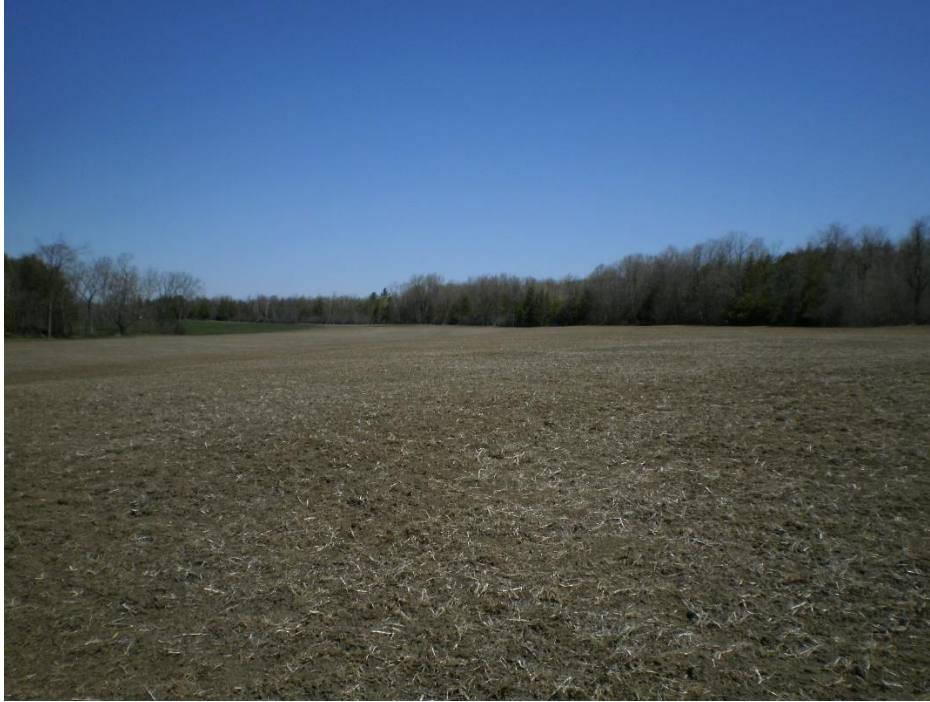
*Photo 5 – Cultivated field in the north portion of the site.
View looking northeast corner towards Tenth Line and forest to the east of the site*

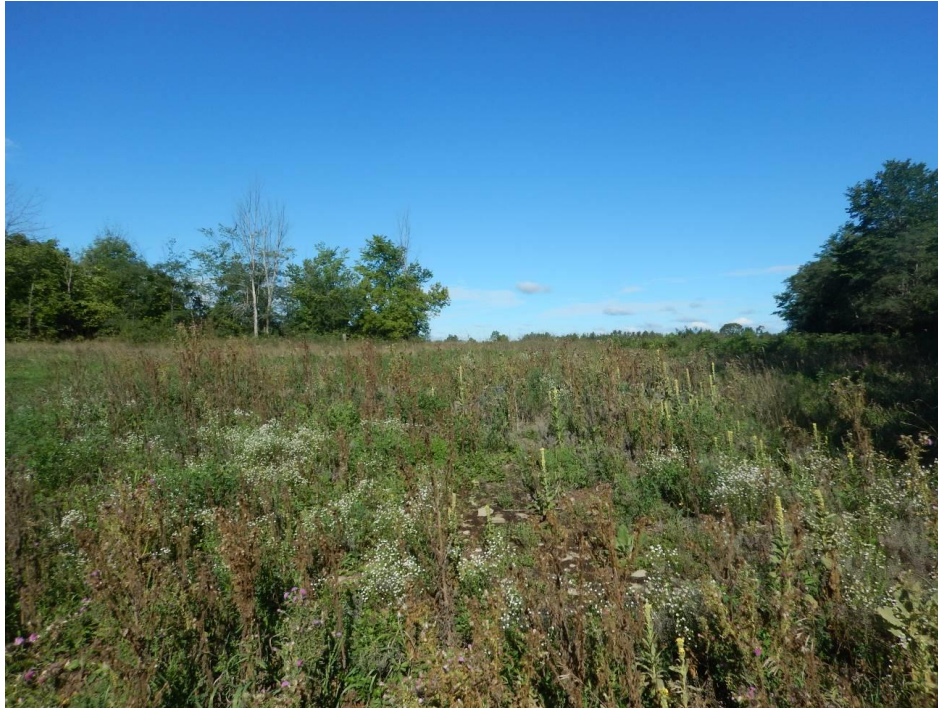
Cultural meadows were common in the west and central-east portions of the site (Photos 6, 7, and 9). The meadows are used for pasture and hay and rock is common at the surface in many areas. Common brome grass, June meadow grass, blue-eyed grass, lesser chickweed, white clover, white-sweet clover, lower hop clover, red clover, tall buttercup, cow vetch, common mullein, pearly everlasting, blueweed, silvery cinquefoil, daisy fleabane, common milkweed, crown vetch, common plantain, tall buttercup, bladder campion, wild carrot, timothy, barnyard grass, bird's-foot trefoil, common yarrow, bull thistle, horseweed, yellow goat's-beard, New-England aster, Canada goldenrod, and common dandelion are common species. A few of the meadows contained scattered larger trees including mature sugar maple and bur oak up to 80cm dbh, with smaller apple trees.

*Photo 6 – Cultural meadow habitat used for pasture in the central-west portion of the site.
View looking north*

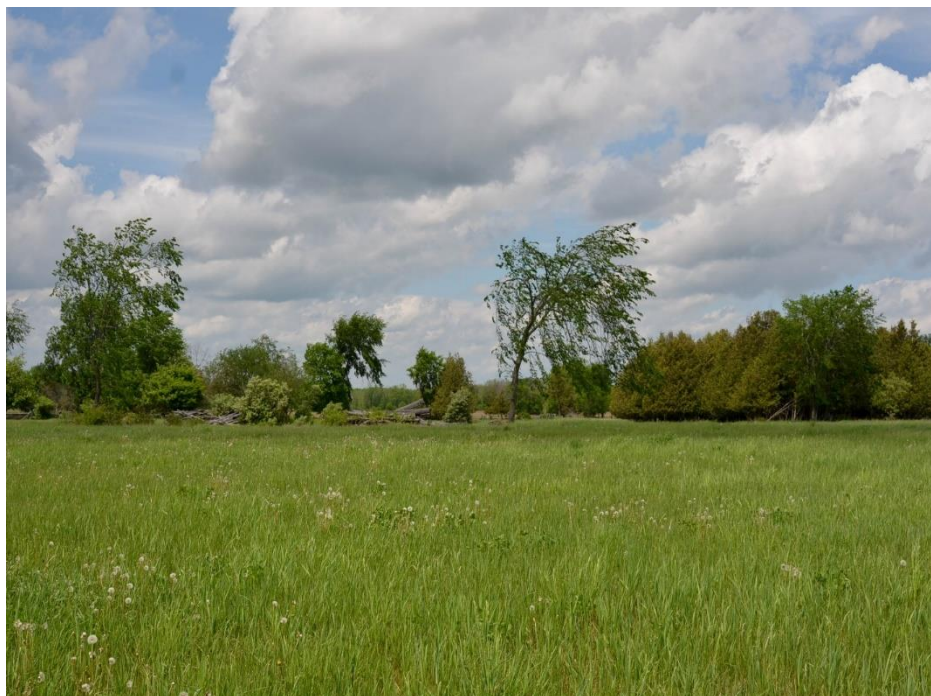
*Photo 7 – Meadow habitat used as a hayfield in the central portion of the site.
View looking north to deciduous hedgerow and, on right, cedar forest*

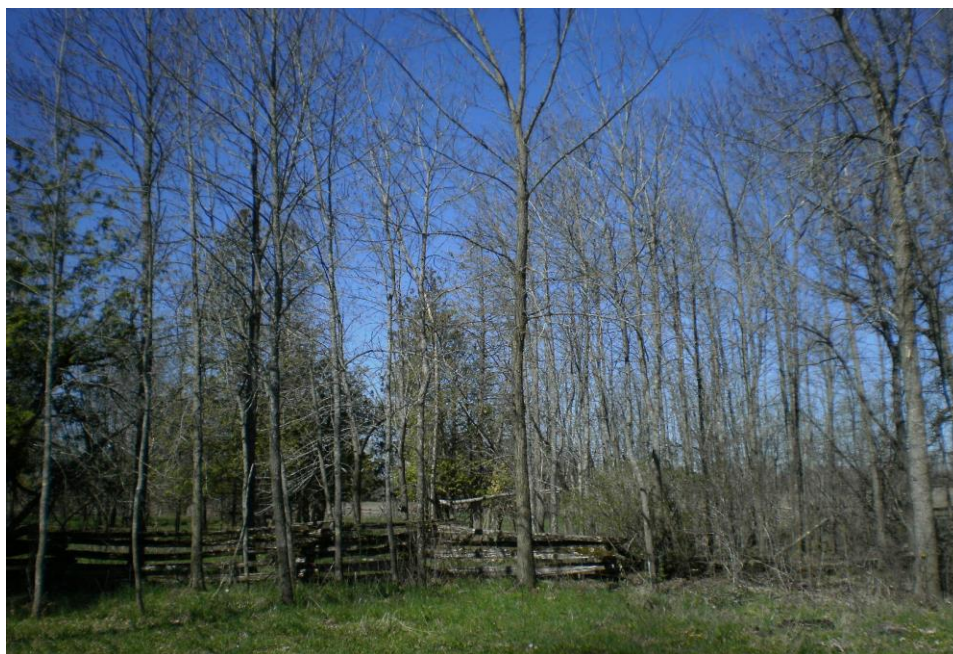
White ash and white cedar were common in the central larger cultural woodland representation on the site (Photo 8). Many of the cultural woodland areas seemed to be used for pasture and tree dominance, size and cover was highly variable within these communities (e.g. Photo 9). The average dbh was variable and ranged from 10-25cm. The largest ash trees were up to 60cm dbh but are in poor condition with extensive emerald ash borer damage. Green ash, basswood, black maple, bur oak, white elm, black walnut, and apple were also present. The ground flora is generally reflective of disturbed conditions and includes white clover, red clover, common brome grass, timothy, June meadow grass, barnyard grass, common mullein, blueweed, common mugwort, daisy fleabane, common milkweed, crown vetch, common plantain, bladder campion, wild carrot, bird's-foot trefoil, New England aster, Canada goldenrod, St. John's wort, and common strawberry, with trout lily also noted. Red raspberry, prickly-ash, common juniper, and staghorn sumac shrubs were well established in areas. Rock was common at the surface and electric fences in good condition indicated the area is used for pasture.

Photo 8 – Cultural woodland in the central portion of the site. View looking north

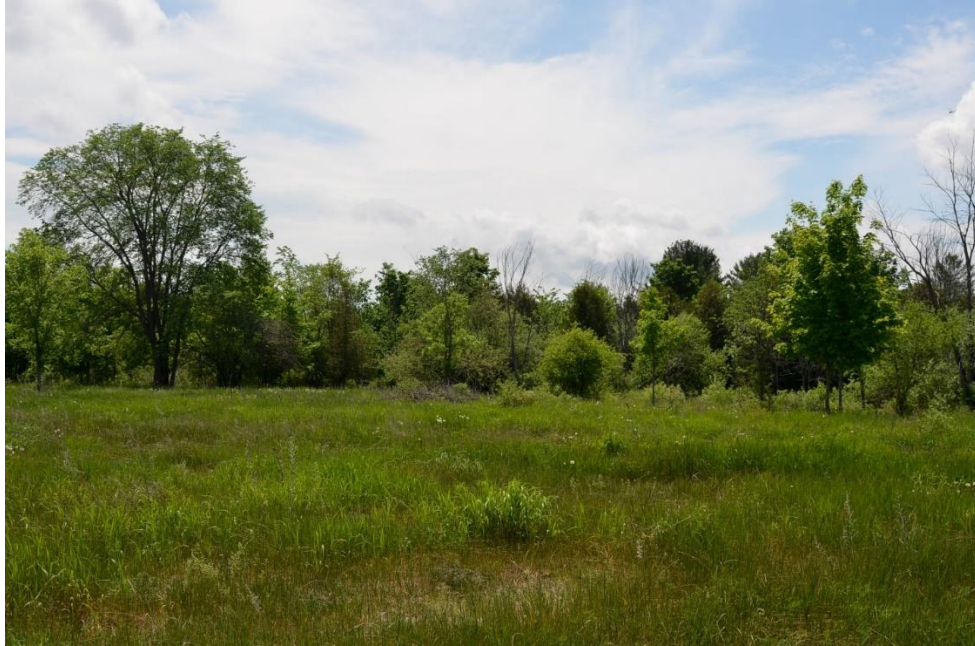
*Photo 9 – Cultural woodland in the west portion of the site.
View looking west from pasture meadow habitat*

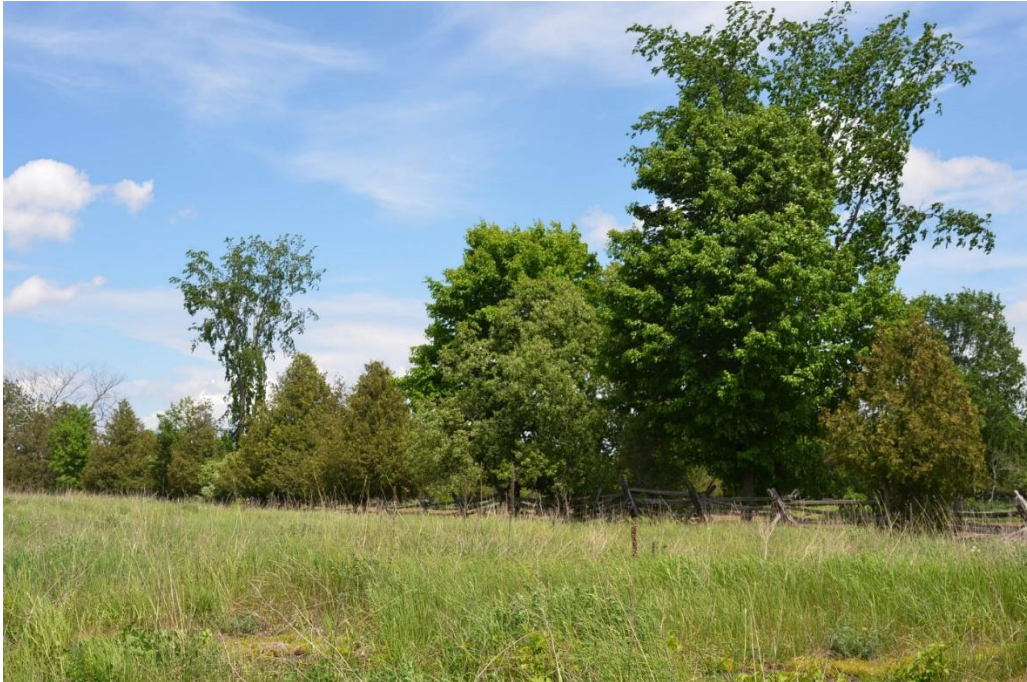
Scattered mature trees in the hedgerows included sugar maple, white ash, bur oak, and basswood up to 70cm dbh, with smaller bitternut hickory, white cedar, trembling aspen, and white elm also present (Photos 7, 10, and 11). Fungus was extensive on many of the aspens and the elm and ash often had reduced leaf-out. Hawthorn, common buckthorn, prickly ash, and apple shrubs were among the hedgerow trees, with June meadow grass, red clover, and bird's-foot trefoil typical of the ground flora.

*Photo 10 – Deciduous hedgerow in the west-central portion of the site.
View looking northeast*

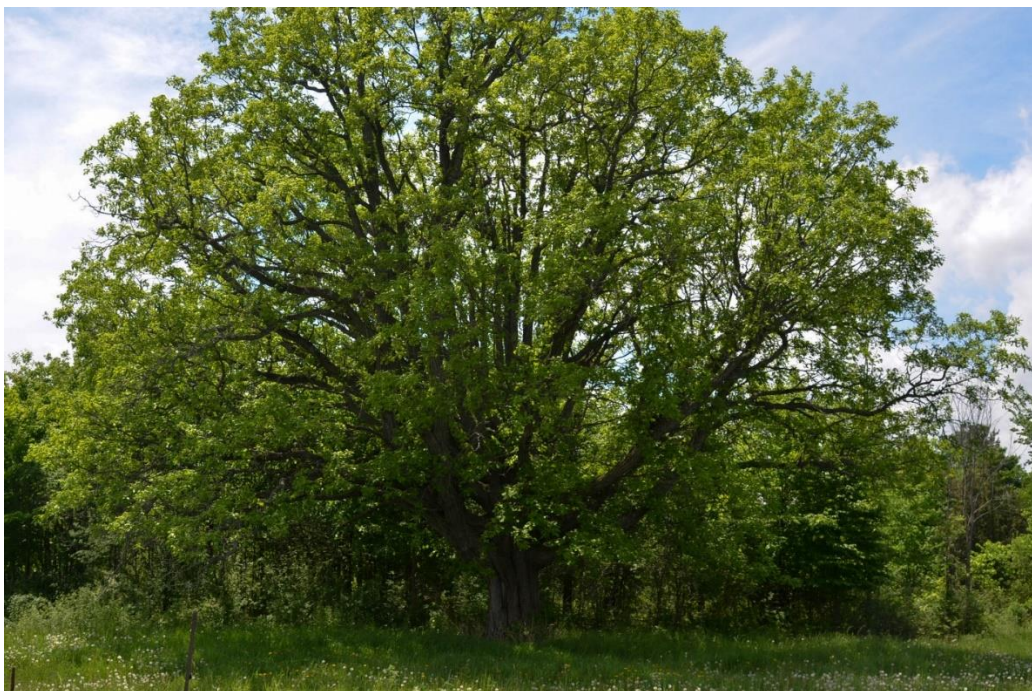
*Photo 11 – Mature bur oak in a deciduous hedgerow in the central portion of the site.
View looking north*

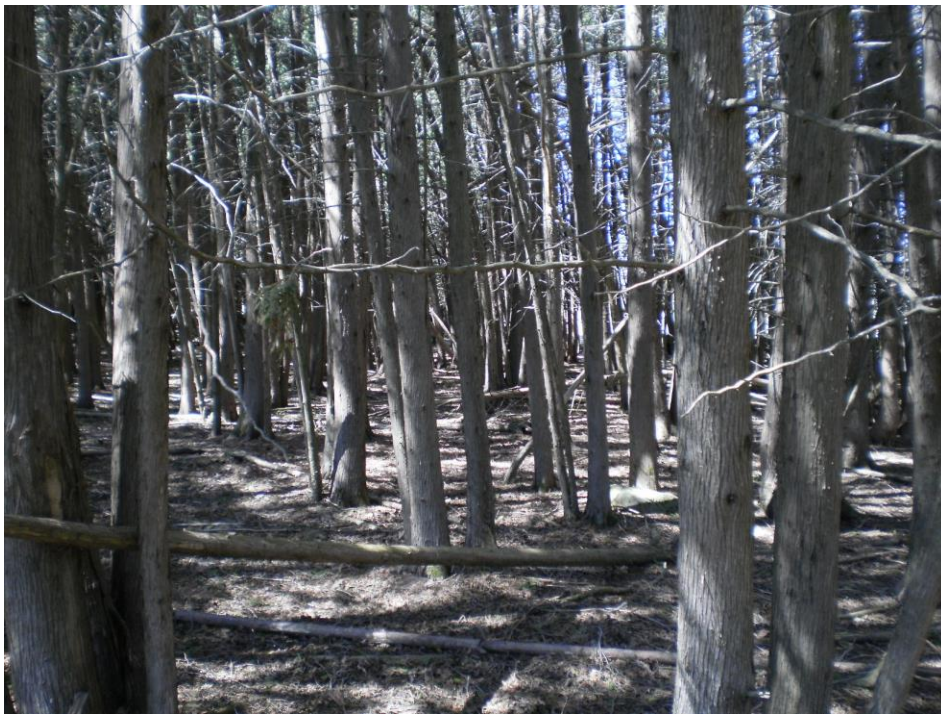
Pockets of upland white cedar coniferous forest up to 0.8 hectares were in the central and central-east portions of the site. Dense white cedars were up to 30cm dbh with an average dbh of 10 - 20cm (Photo 12). Some portions where harvesting was more intense have a more scattered clumping of cedars with the same kind of vegetation as the cultural meadow such as common burdock, common dandelion, common brome grass, June meadow grass, and red raspberry, filling the gaps (Photo 14). Where the cedar was very dense, there was limited understory or ground flora. Windthrow was extensive in many areas of the small upland cedar forests (Photo 13). Stumps were extensive in the forests and log piles suggest the cedars are used for fence posts and firewood.

*Photo 12 – Dense young white cedar in upland coniferous forest in the east portion of the site.
View looking northeast*

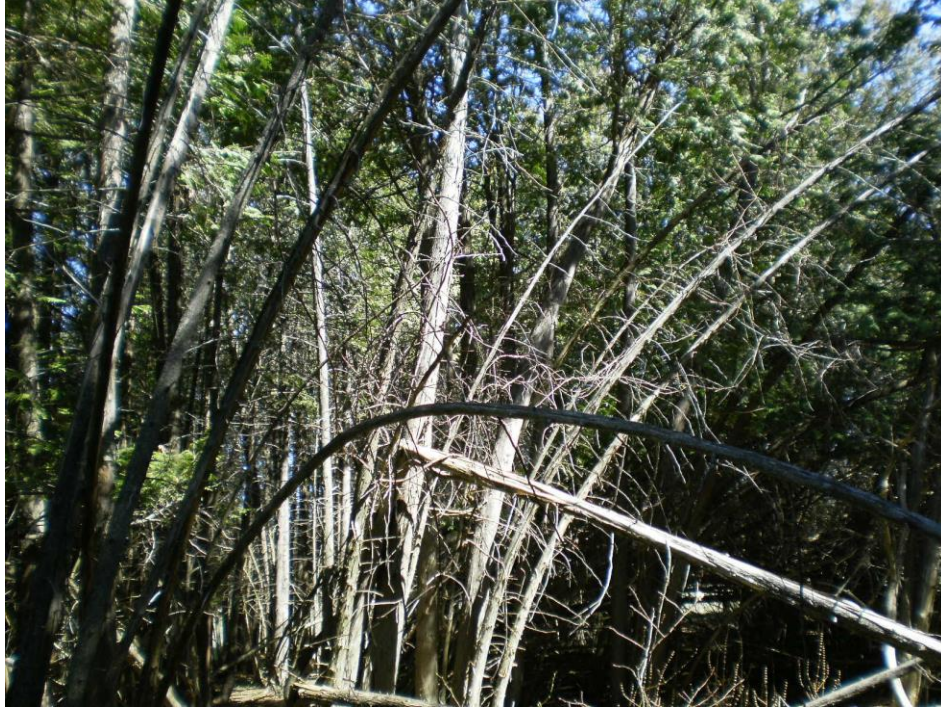
Photo 13 – Windthrow was extensive in many portions of the small upland cedar forests. This example is in the central portion of the site

Small portions, all less than one hectare, of upland coniferous, mixed, and deciduous forests are scattered in the central and east portions of the site. Windthrow was extensive in many areas of and selective logging was common. However, the small forests still provide local wildlife habitat and aesthetic, climate, and nature appreciation benefits and portions of the forests should be retained wherever building envelopes, grading, and drainage requirements permit. Figure 2 shows the anticipated tree retention for the lots considering these requirements. Additional detailed engineering studies may identify additional grading and drainage requirements that may modify the areas of tree retention.

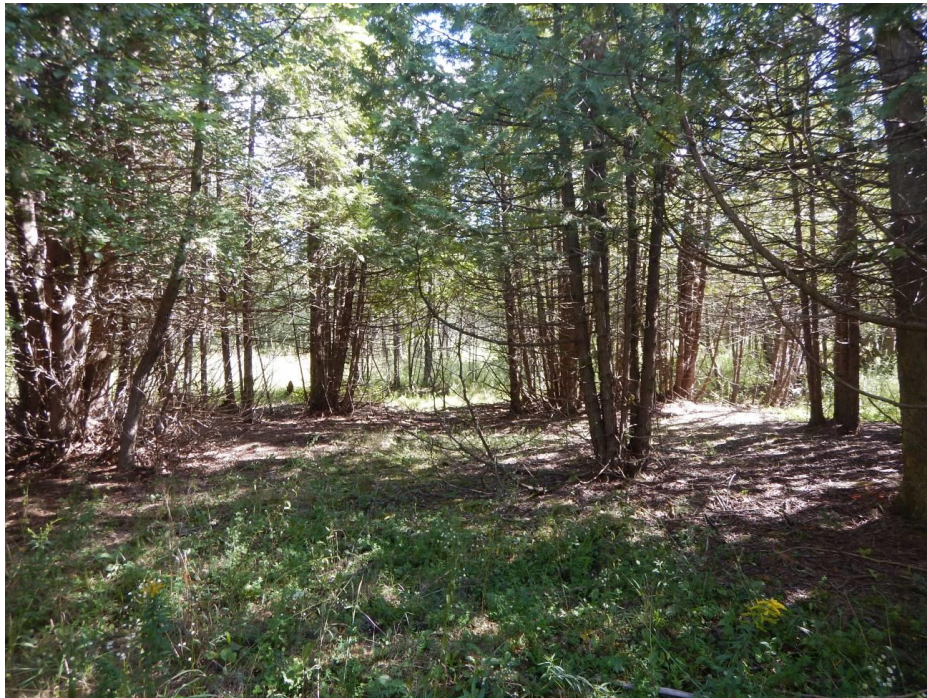
Photo 14 – Other portions of the upland cedar forests were open and used for pasture and/or harvesting. This example is in the central-east portion of the site.

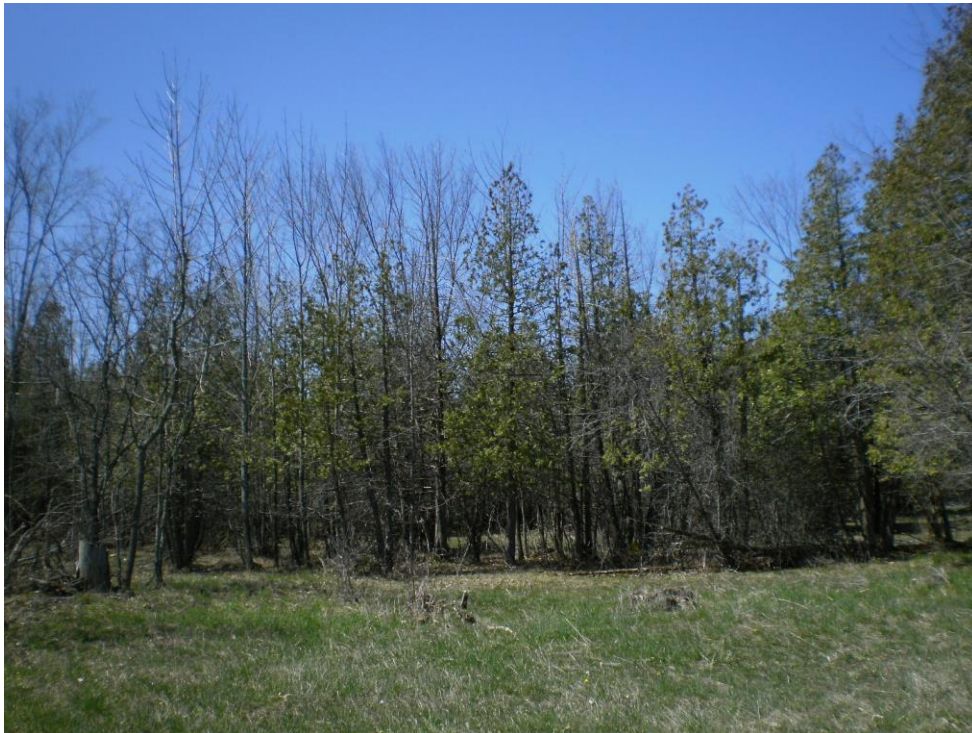
A 1.5 hectare upland mixed forest was in the east-central portion of the site. White cedar was dominant in areas, with white elm, apple, white ash, green ash, basswood, bur oak, and Manitoba maple common elsewhere. The largest trees were in the 40cm – 45cm dbh range but most trees are in the 15cm – 25cm dbh range. A few of the white elm trees appeared dead.

Red raspberry, prickly ash, and common barberry shrubs were the understory, along with regenerating cedar and ash stems. Common dandelion, field mustard, garlic mustard, and wild grape were representative of the ground flora. Stone piles were noted along the forest edge.

*Photo 15 – Mixed forest in the southeast portion of the site.
View looking northeast to south forest edge*

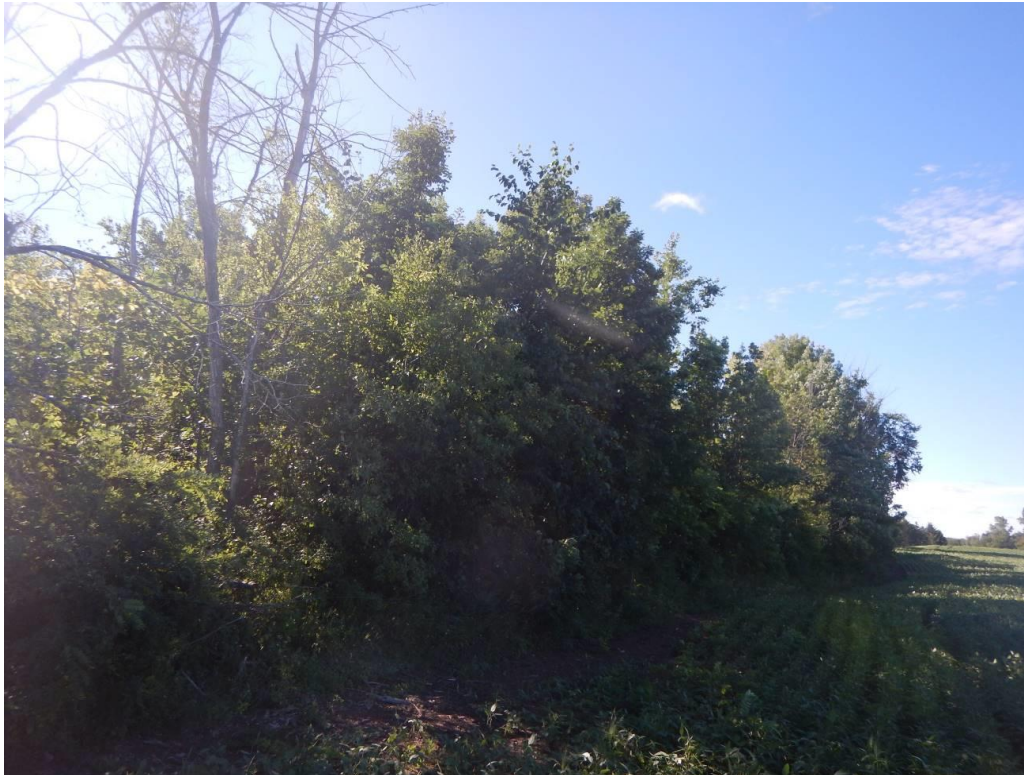
A 0.6 hectare representation of upland ash deciduous forest was in the southeast corner of the site (Photo 16), with other parcels in the southwest corner. In addition to the dominant green ash, white ash and white elm were also present. The average DBH was 10cm with the occasional ash up to 30cm dbh. Much of the ash present were dead due to emerald ash borer giving rise to a thick understory consisting of regenerating stems of white ash, green ash, and bur oak, along with staghorn sumac, prickly-ash, and common buckthorn shrubs. Ground flora included daisy fleabane, Canada goldenrod, small white aster, New England aster, St. John's wort, and common strawberry.

*Photo 16 – Upland ash deciduous forest in the southeast corner of the site.
View looking northeast*

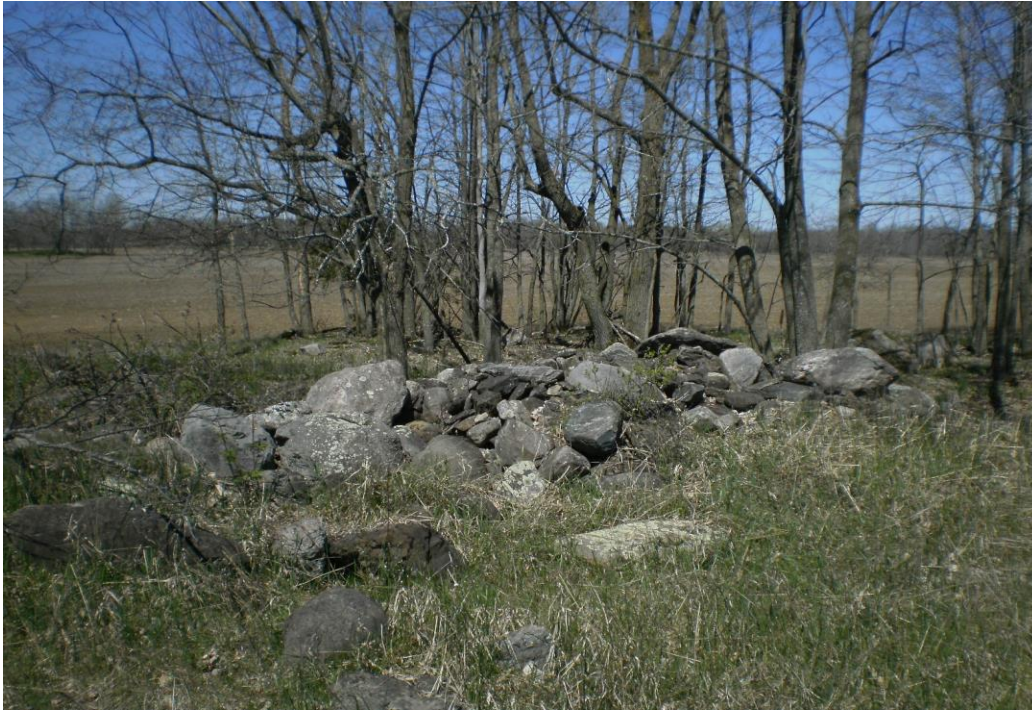
Wildlife observed during the field surveys included American crow, Canada goose, killdeer, American kestrel, northern harrier, red-winged blackbird, European starling, mourning dove, wild turkey, tree swallow, barn swallow (around barn not to be disturbed on the existing severance), eastern phoebe, eastern kingbird, white-breasted nuthatch, black-capped chickadee, downy woodpecker, hairy woodpecker, American robin, blue jay, yellow warbler, yellow-rumped warbler, red-eyed vireo, common yellowthroat, bobolink (seen flying to the north in central-west portion of the site), song sparrow, savannah sparrow, American goldfinch, white-tailed deer, red squirrel, eastern cottontail, and woodchuck, with great-blue heron, osprey, and turkey vulture flying overhead. A few piles of stones and rock were observed adjacent to the agricultural fields (Photo 17) and at the forest edges. These piles may be used by snakes and other hibernating wildlife.

*Photo 17 – Stones and rock may be used by wildlife.
This example is in the east portion of the site with view looking south*

Significant wildlife habitat may be present in association with the stone and rock piles at the edge of fields and forests. Mitigation measures are presented below to protect any wildlife utilization of these features.

4. Disturbances to stone piles is to occur in early April or late August to end of October to ensure wildlife that may use these features during the winter or breeding period are not impacted;
