HYDROGEOLOGICAL ASSESSMENT GARDINERS SHORE SUBDIVISION, BECKWITH ON

Project No.: CCO-20-0203

McIntosh Perry Consulting Engineers Ltd.
115 Walgreen Road
Carp, Ontario
K0A 1L0

June 6, 2021

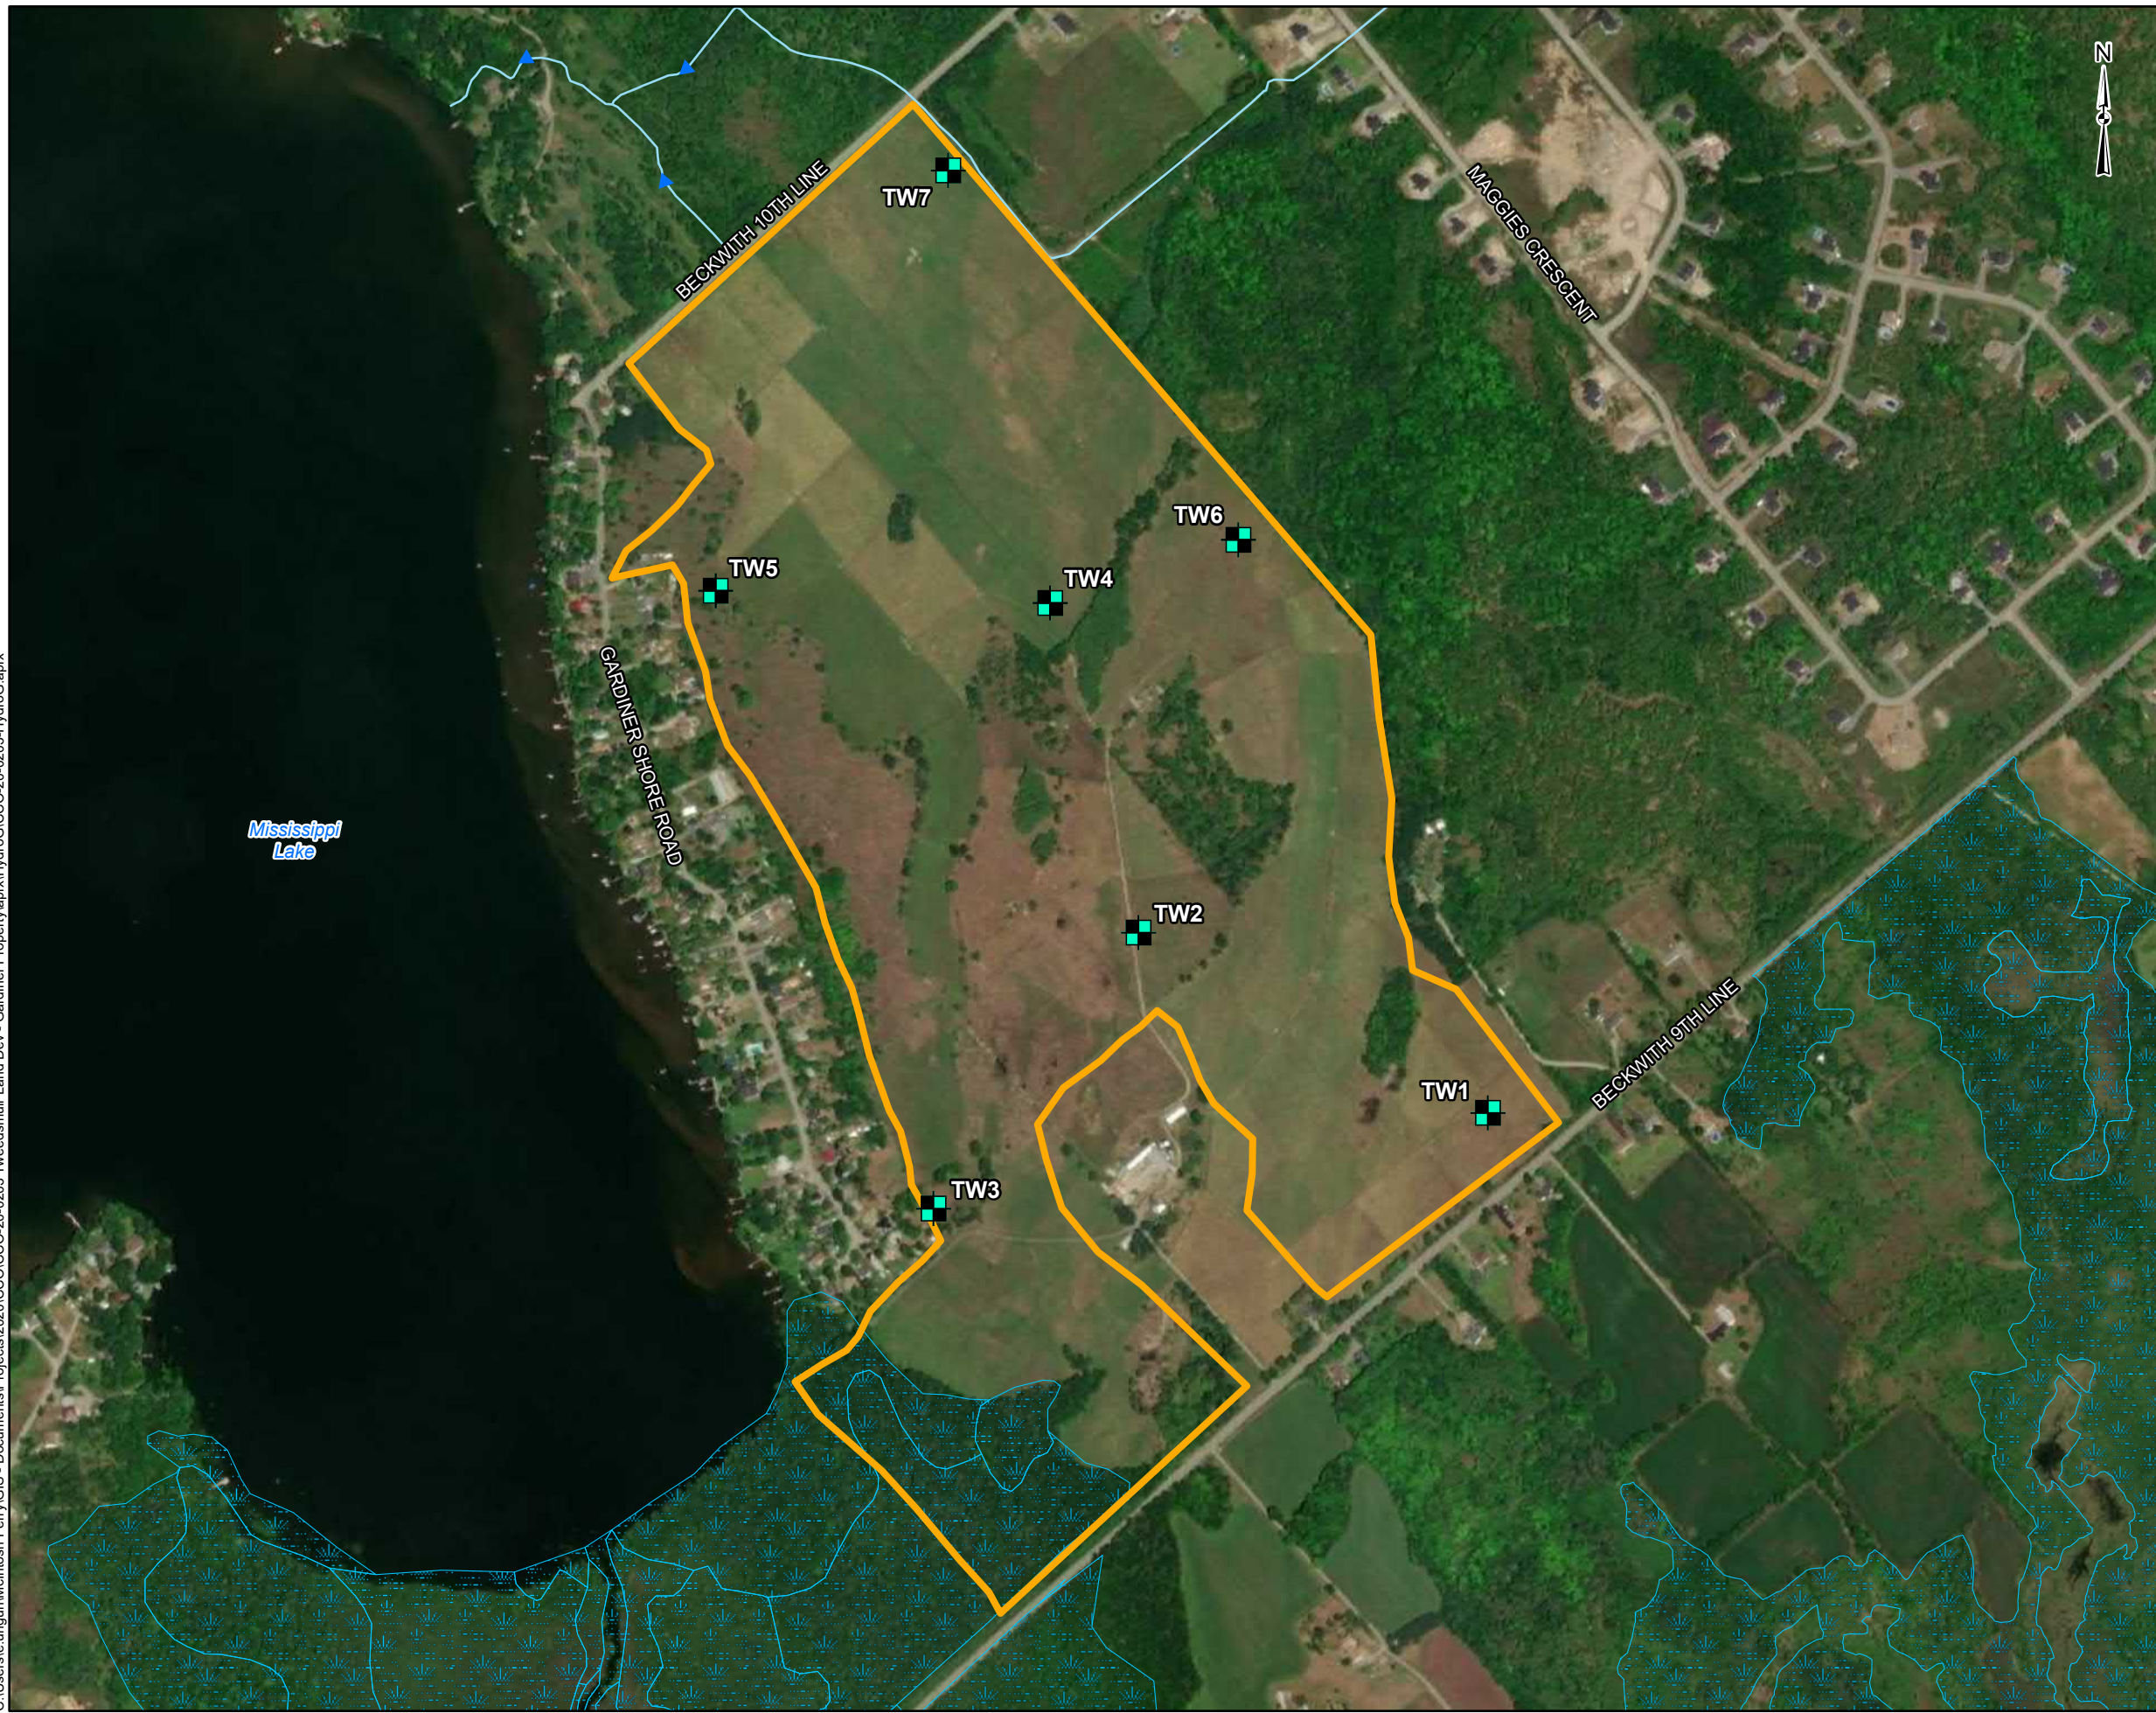
- LEGEND
- Test Well Location
 - Approximate Property Boundary
 - Watercourse
 - Unevaluated Wetland

McIntosh Perry supervised the installation of seven on-site water wells, as well as ten on-site test pits. Wells were used for groundwater quality and quantity testing, and all test well locations were slotted for eventual domestic use when the Site is developed. Test pit data were collected for purposes of soil classification and overburden thickness. A summary of the test wells and test pit locations is illustrated on Figure 2.

Air Rock Drilling Ltd. (Air Rock; Well Contractor’s Licence No.1119) was retained by Cavanagh Construction to drill seven water wells at the Site for testing purposes and eventual domestic use when the property is developed. The drilling was conducted by licensed employees of Air Rock, and McIntosh Perry personnel observed the grouting of each well per O. Reg. 903 (Wells), as amended. The driller also provided and installed a pump for all pumping test activities. A summary of the test well construction based on driller-provided well records is presented in Table 1. The location of all on-site wells is noted on Figure 2.

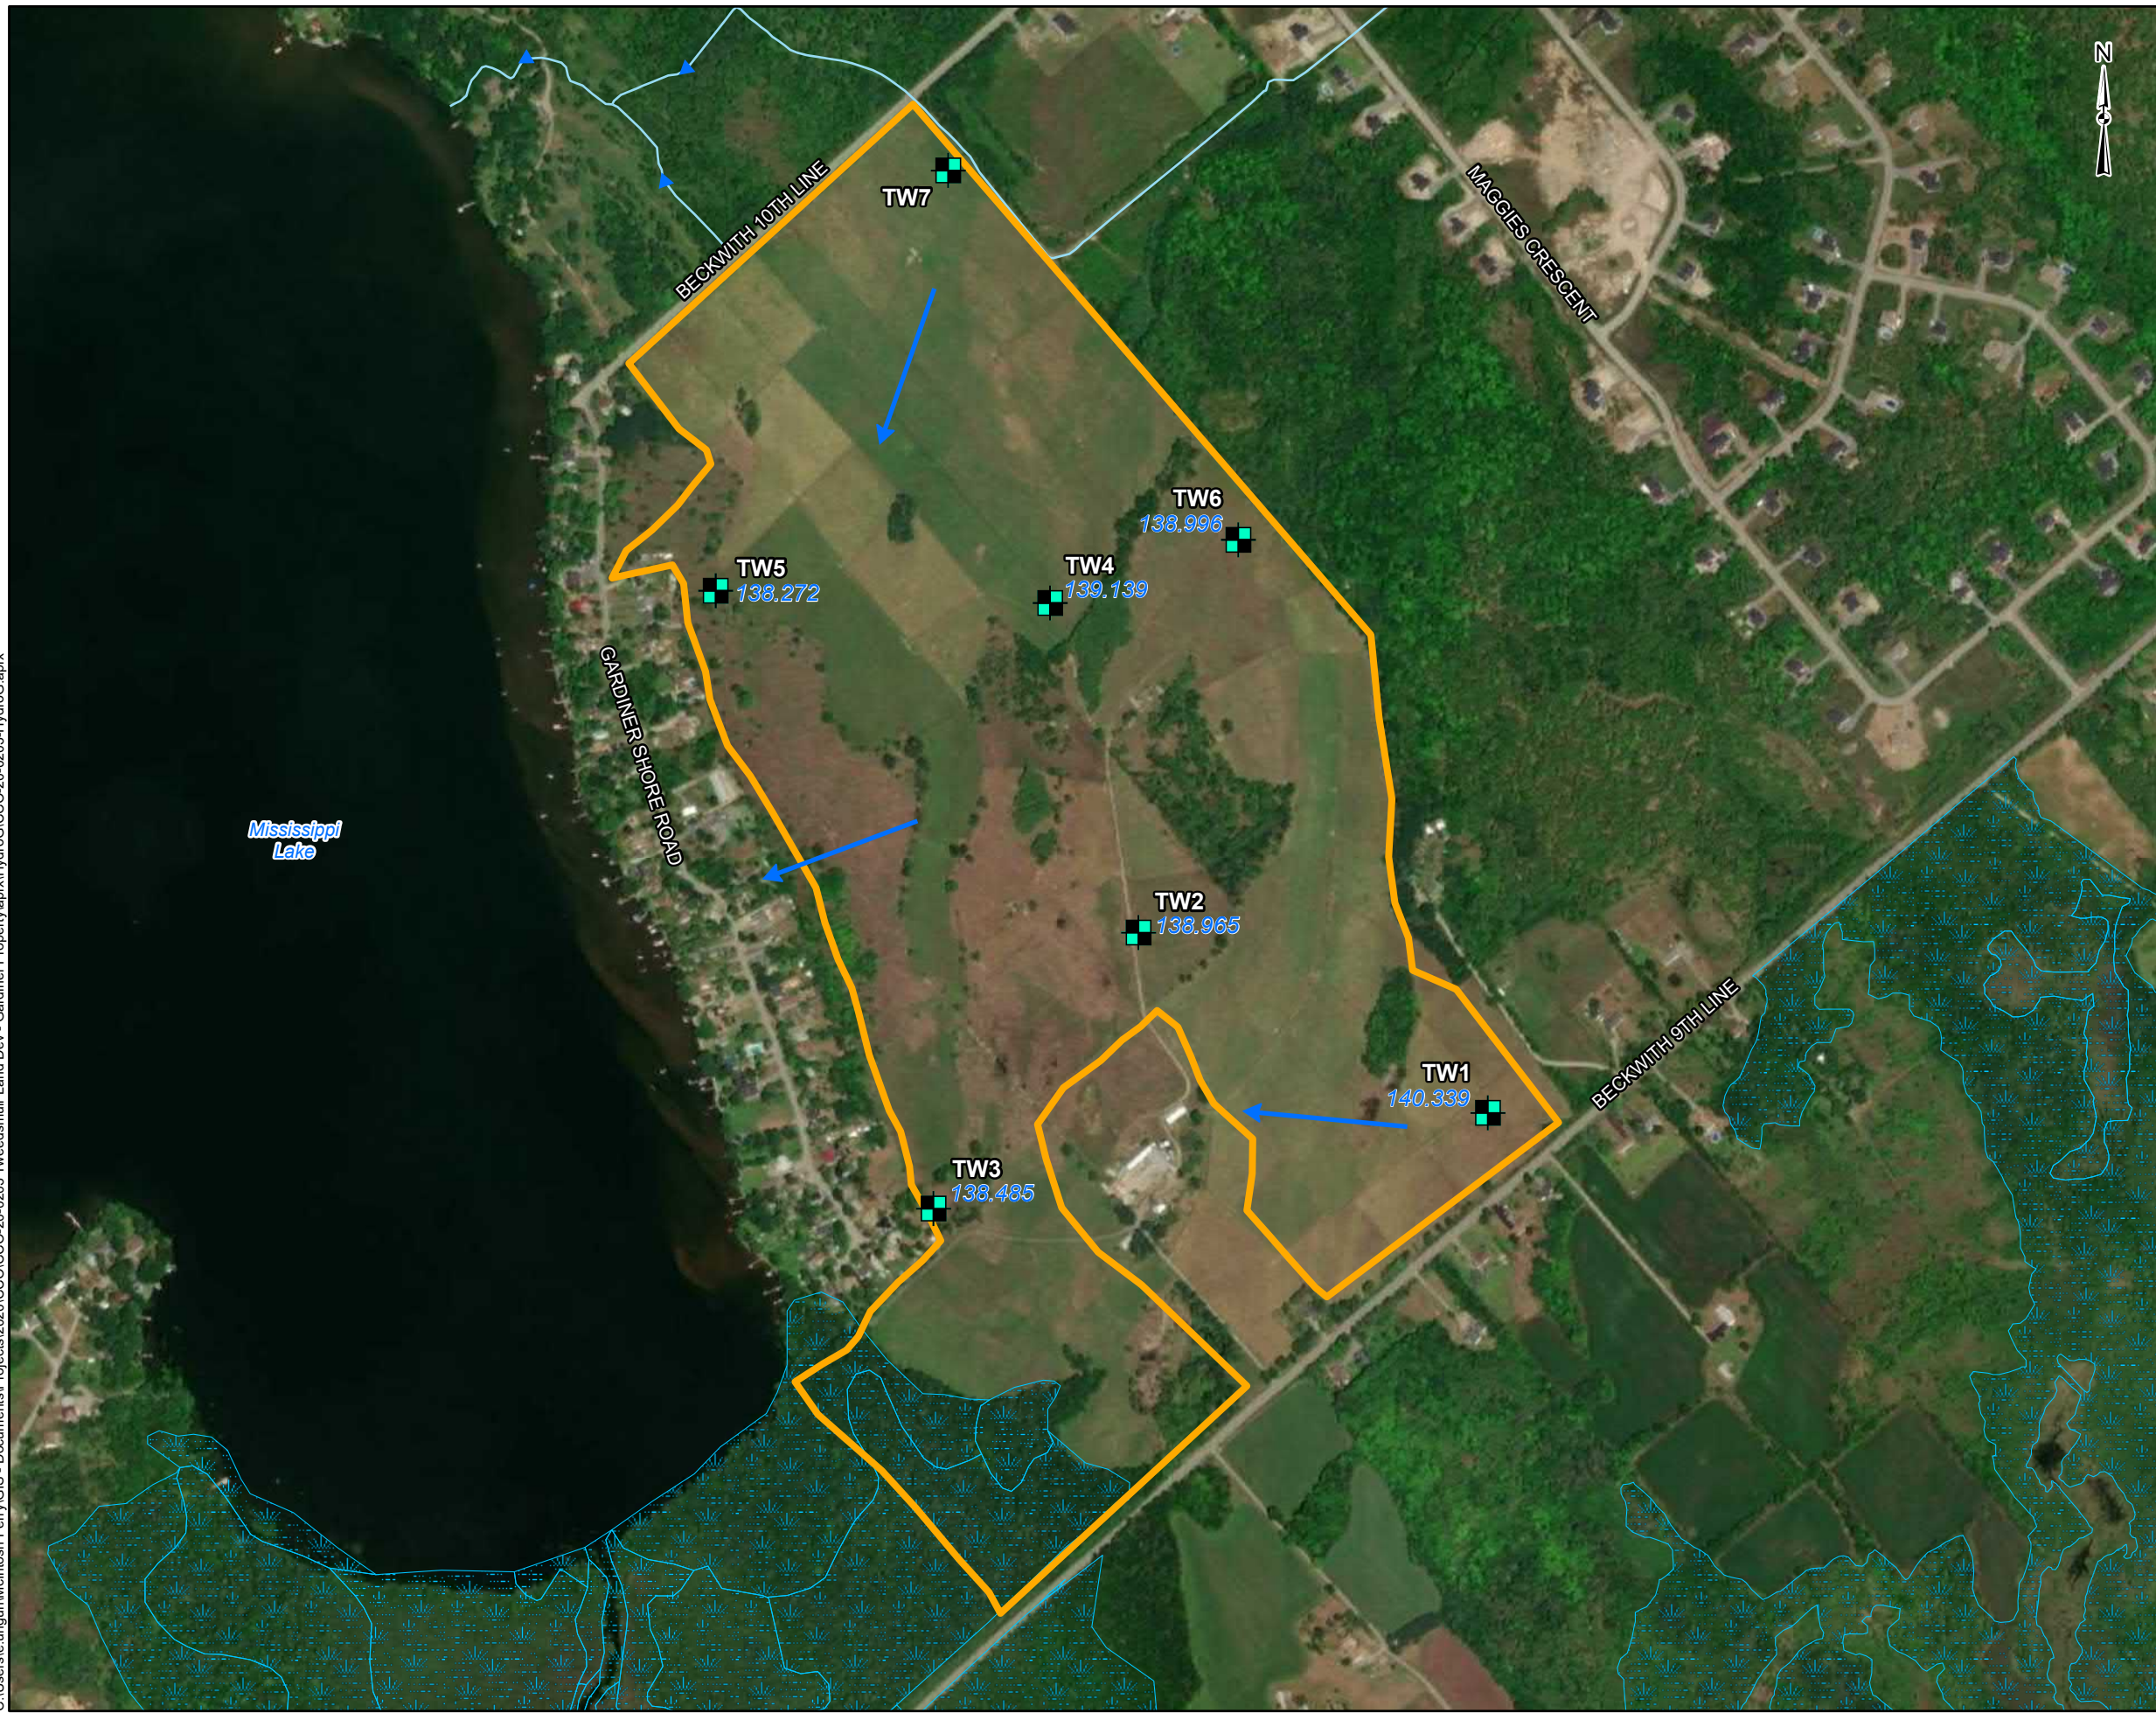
- Test Well Location
- Approximate Property Boundary
- Watercourse
- Unevaluated Wetland
- Groundwater Flow Direction
- 138.996 Groundwater Elevation (masl)

Prior to the initiation of pumping, water levels were measured in the seven test wells (Table 2, below). The static groundwater elevation ranged between 138.485 – 140.339 m asl at the time of the pumping tests (Figure 4). Static groundwater elevations suggest that on-site bedrock groundwater flow is likely to the southwest, toward Mississippi Lake. On-site wells were completed in a similar geologic unit (listed by the driller as “sandstone”). Well depths are noted in Table 2, below.

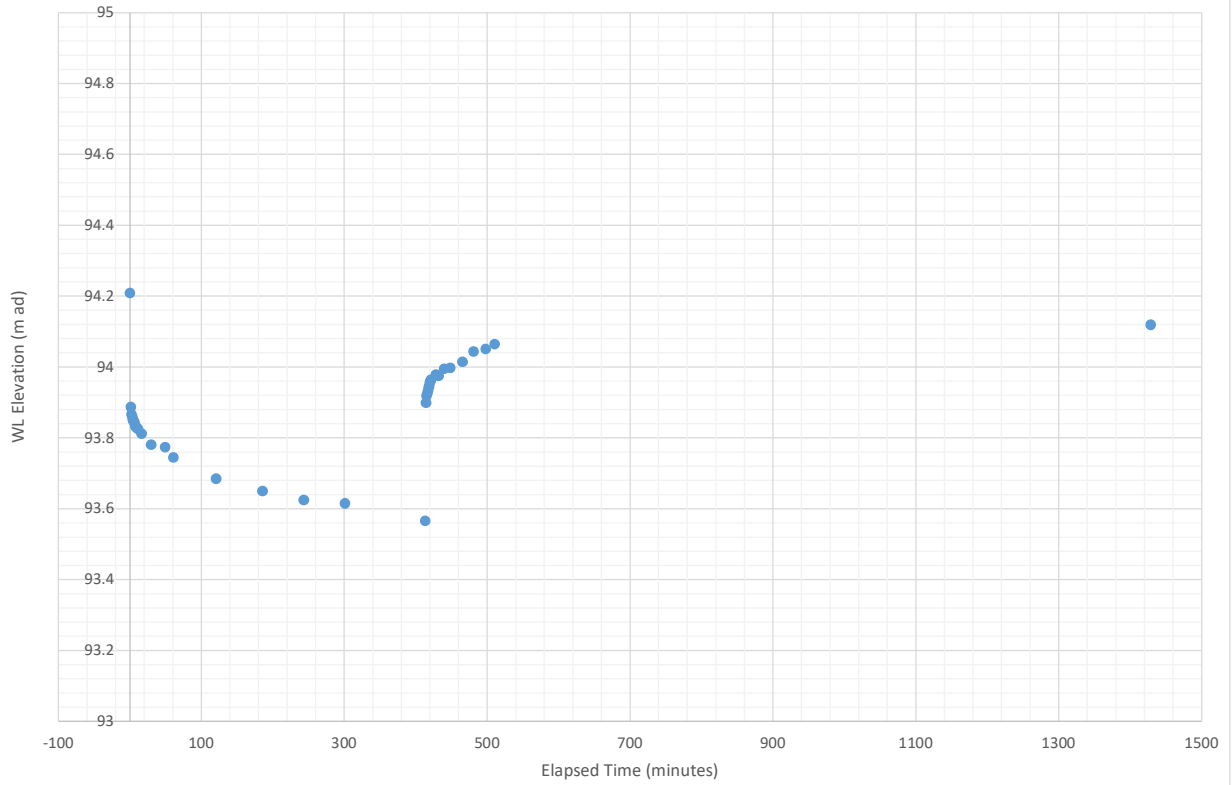
Drawdown vs Time
TW1 Pumping Test (Drawdown), January 11, 2021
Gardiner Shore, Beckwith ON

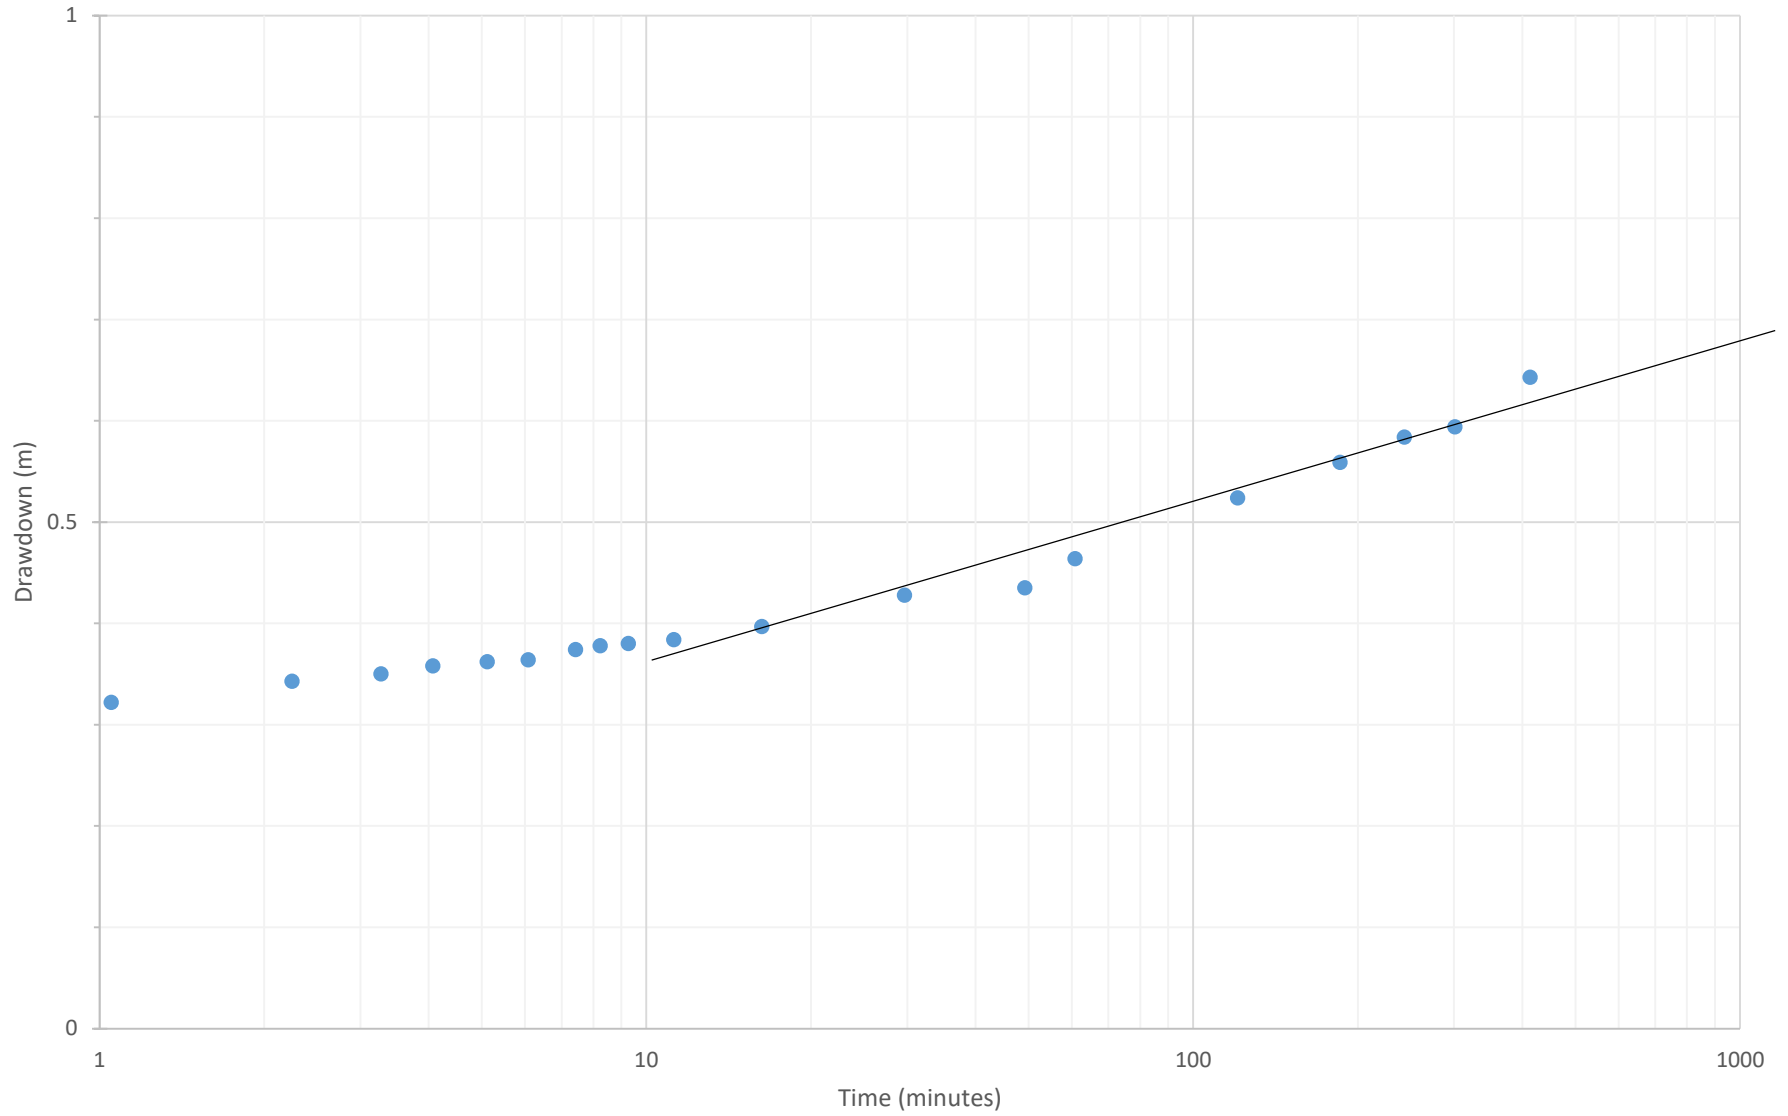
Drawdown vs Log Time
TW1 Pumping Test (Drawdown), January 11, 2021
Gardiner Shore, Beckwith ON

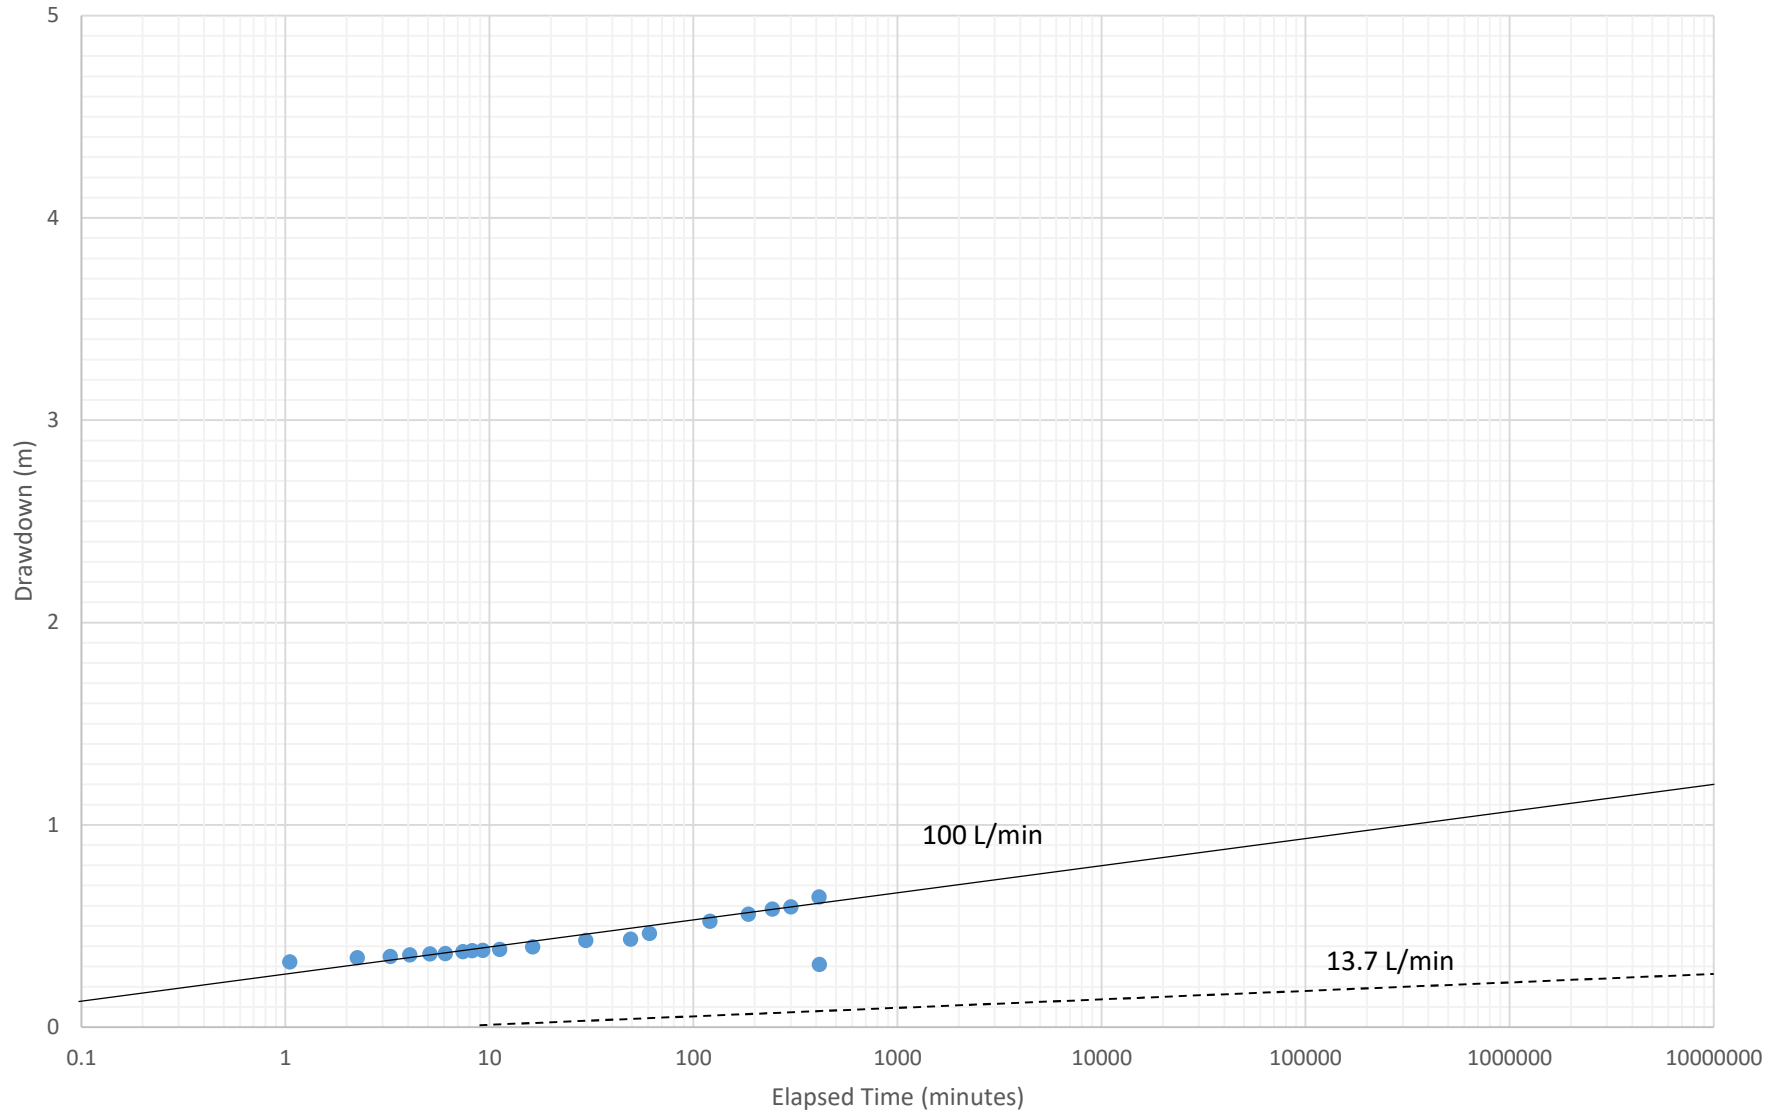
Drawdown vs Log Time
TW1 Pumping Test (Long-Term), January 11, 2021
Gardiner Shore, Beckwith ON

It should be noted that long-term projections of drawdown using the Cooper-Jacob method indicate that all test wells can sustain a constant pumping at rates exceeding 13.7 L/min if pumped constantly for 20 years (see Appendix D). The calculated maximum drawdown for all wells when theoretically pumped at a rate of 13.7 L/min was below 0.75 m, with the exception of TW2 which would be expected to have a drawdown of approximately 1.3 m.

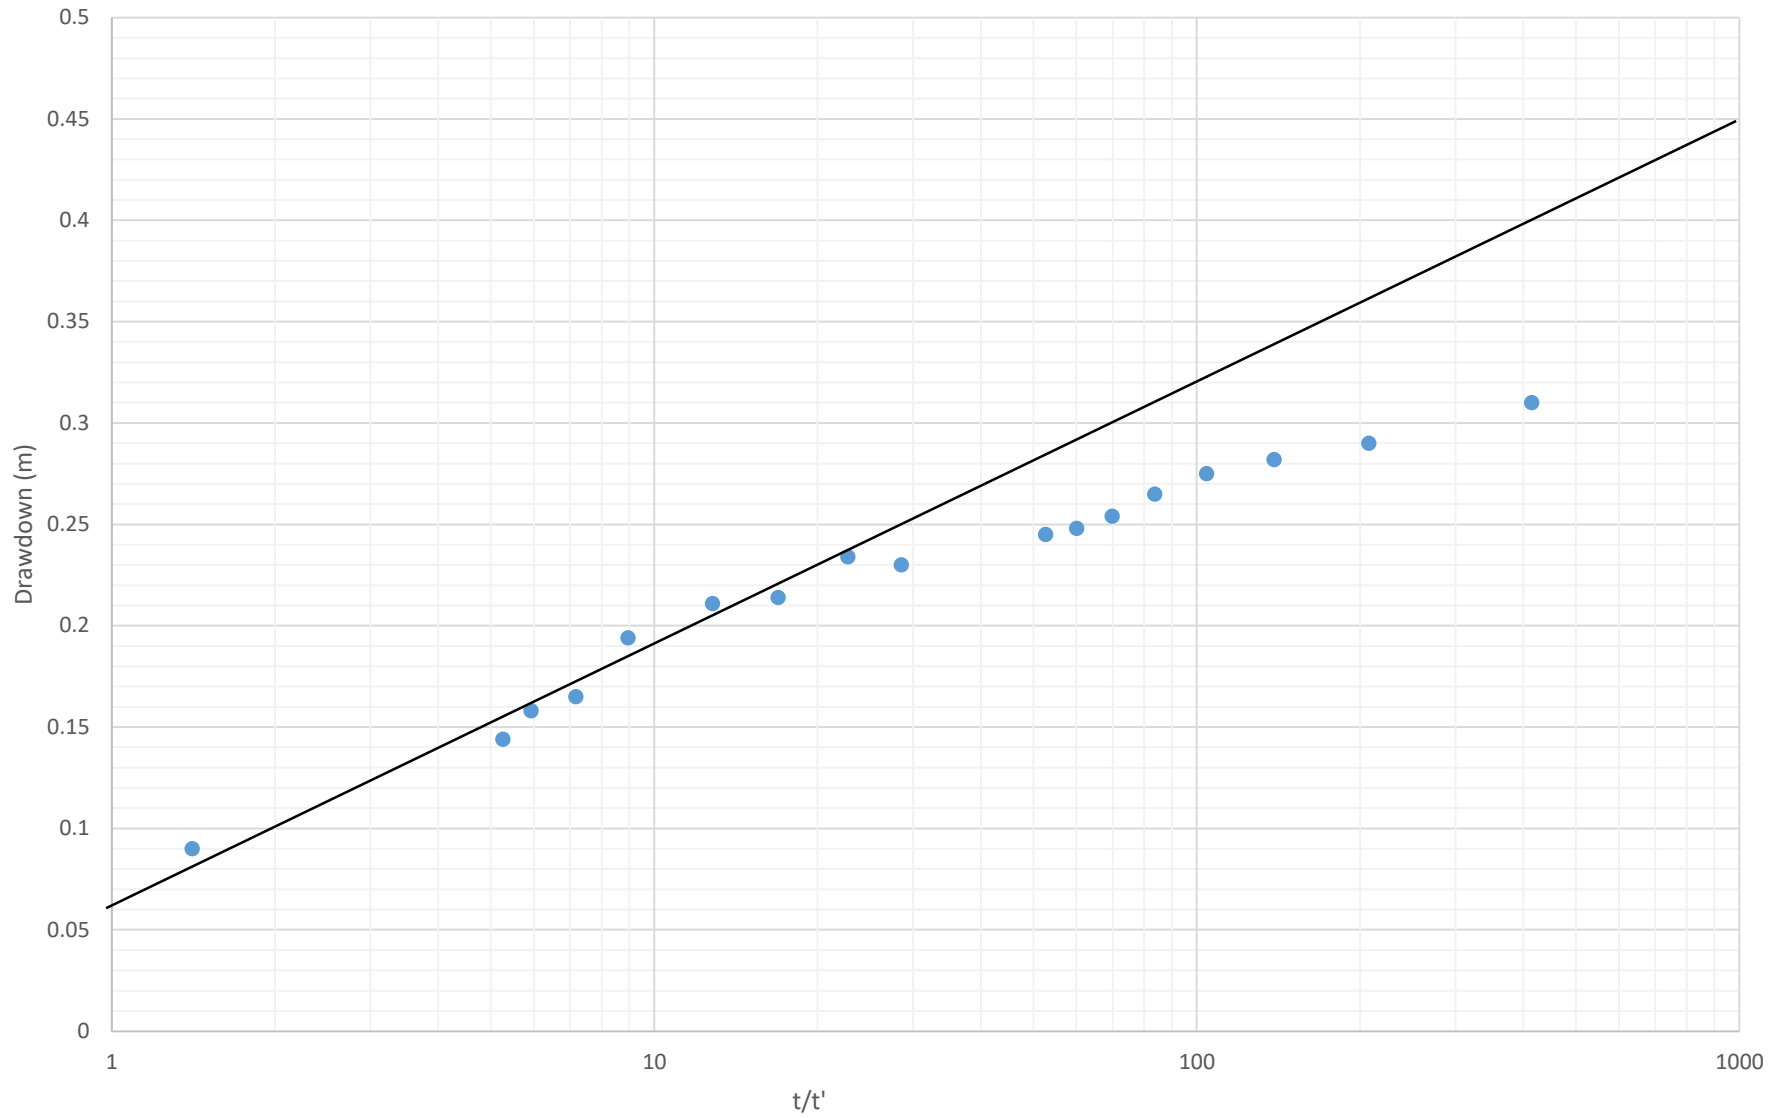
Drawdown vs Log Time
TW1 Pumping Test (Recovery), January 11, 2021
Gardiner Shore, Beckwith ON

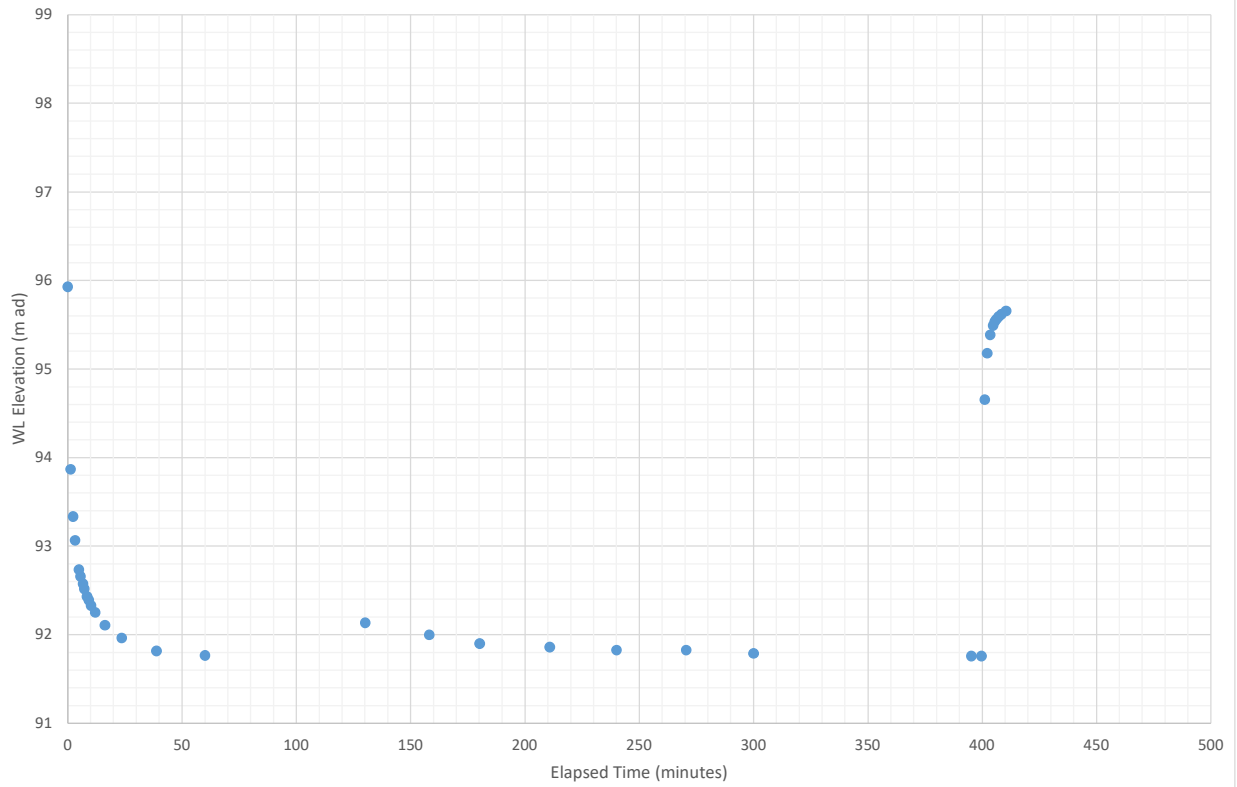
Drawdown vs Time
TW2 Pumping Test (Drawdown), January 13, 2021
Gardiner Shore, Beckwith ON

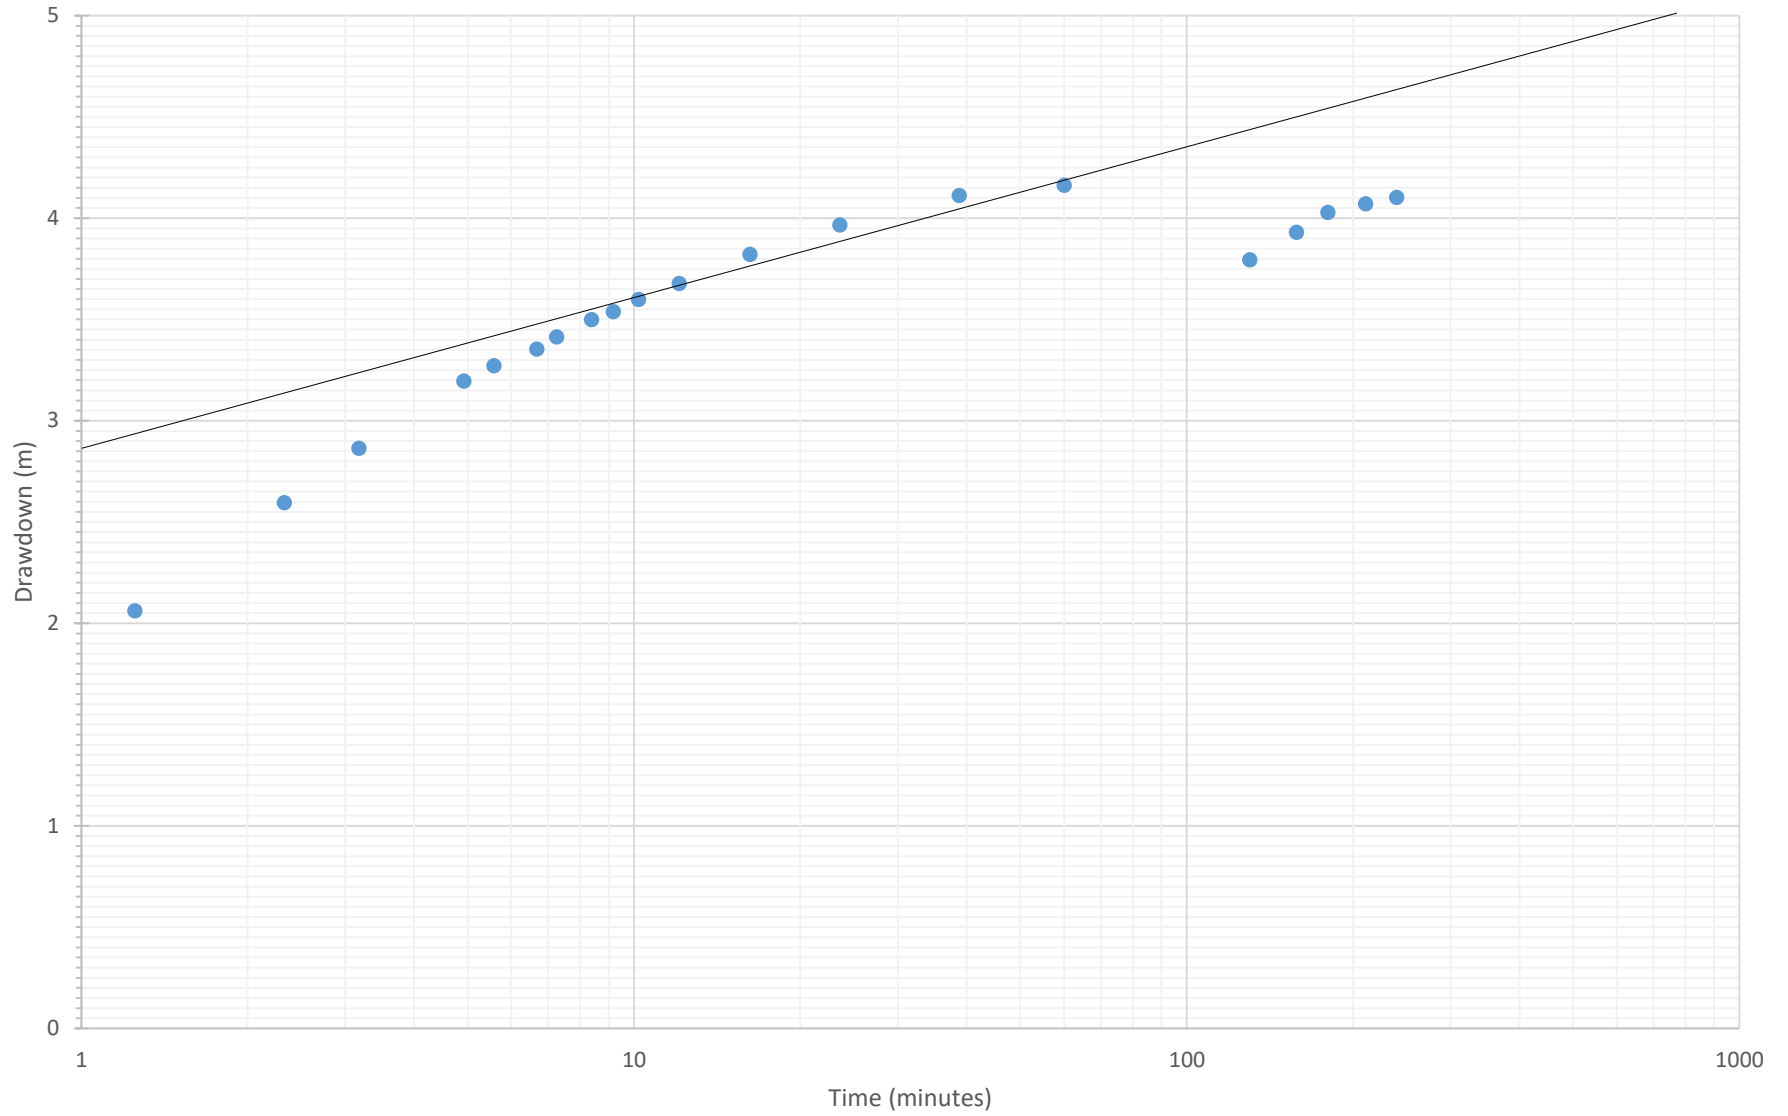
Drawdown vs Log Time
TW2 Pumping Test (Drawdown), January 13, 2021
Gardiner Shore, Beckwith ON

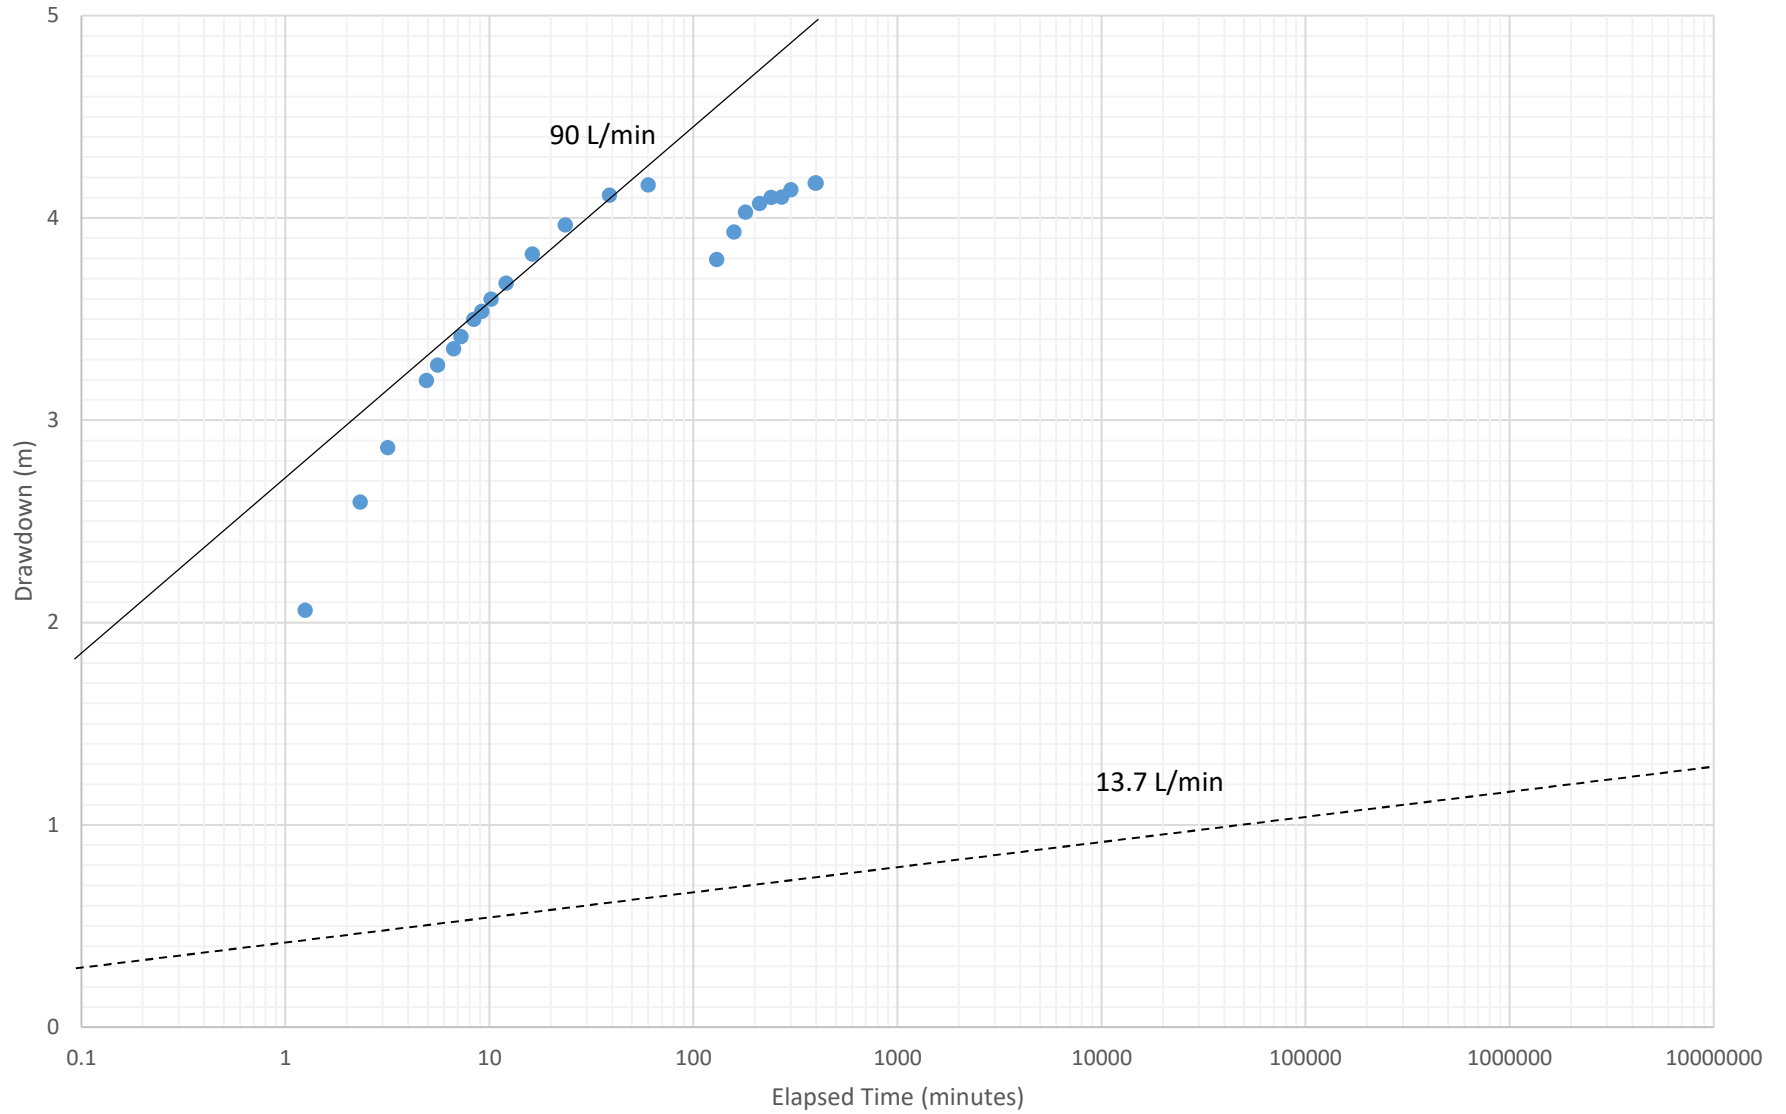
Drawdown vs Log Time
TW2 Pumping Test (Long-Term), January 21, 2021
Gardiner Shore, Beckwith ON

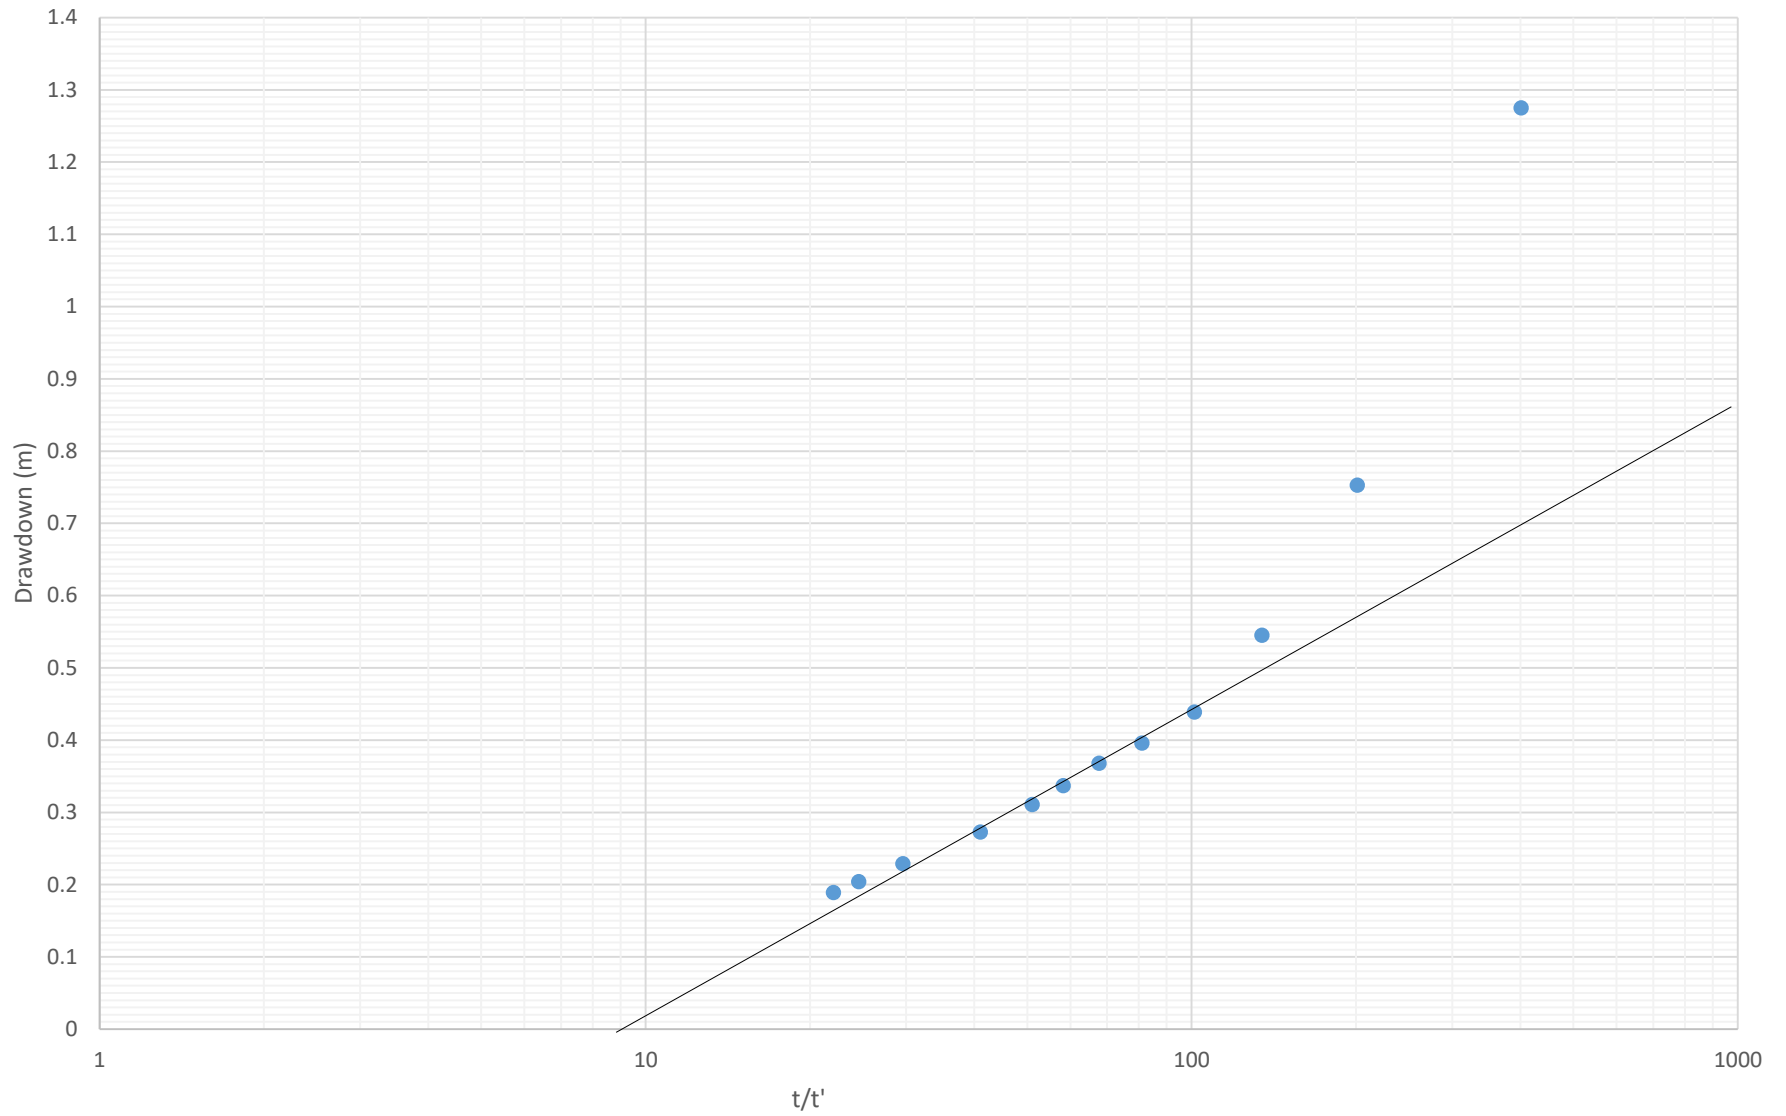
Drawdown vs Log Time
TW2 Pumping Test (Recovery), January 13, 2021
Gardiner Shore, Beckwith ON

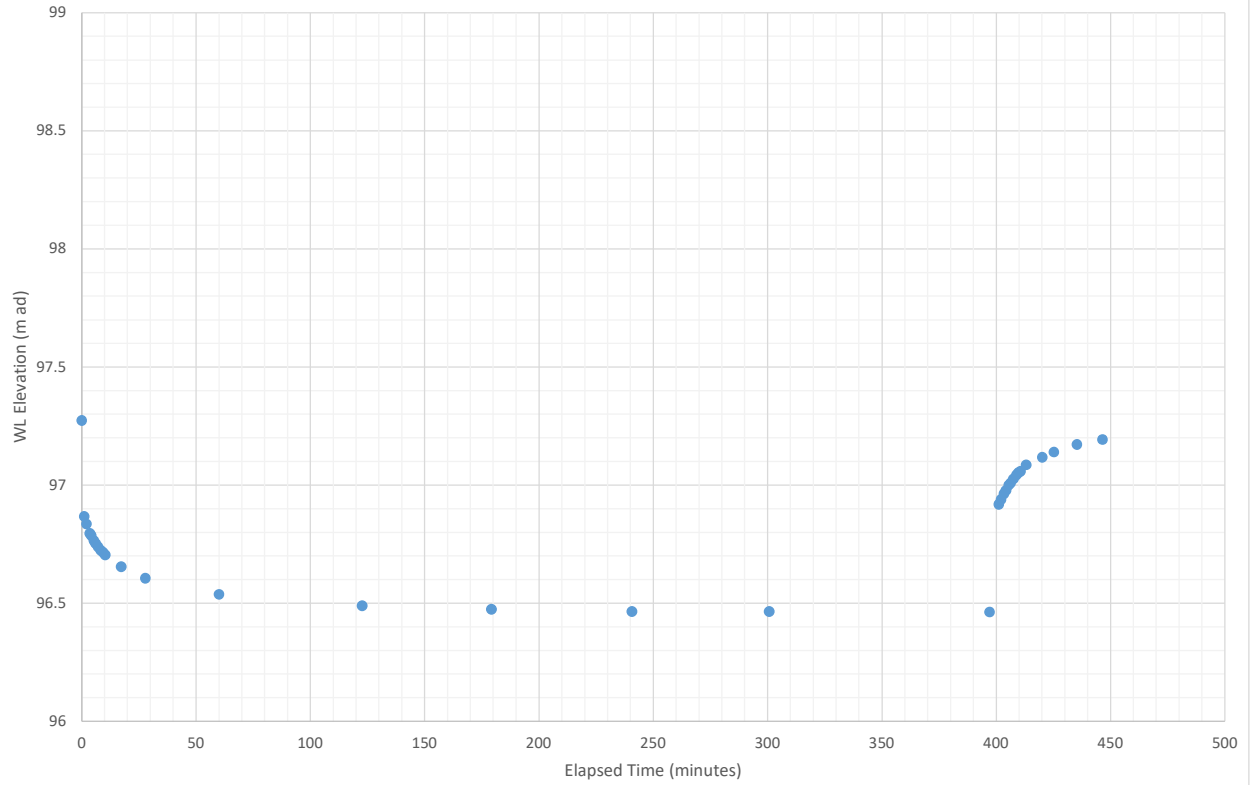
Drawdown vs Time
TW3 Pumping Test (Drawdown), January 12, 2021
Gardiner Shore, Beckwith ON
