HYDROGEOLOGICAL ASSESSMENT GARDINERS SHORE SUBDIVISION, BECKWITH ON

Project No.: CCO-20-0203

McIntosh Perry Consulting Engineers Ltd.
115 Walgreen Road
Carp, Ontario
K0A 1L0

June 6, 2021

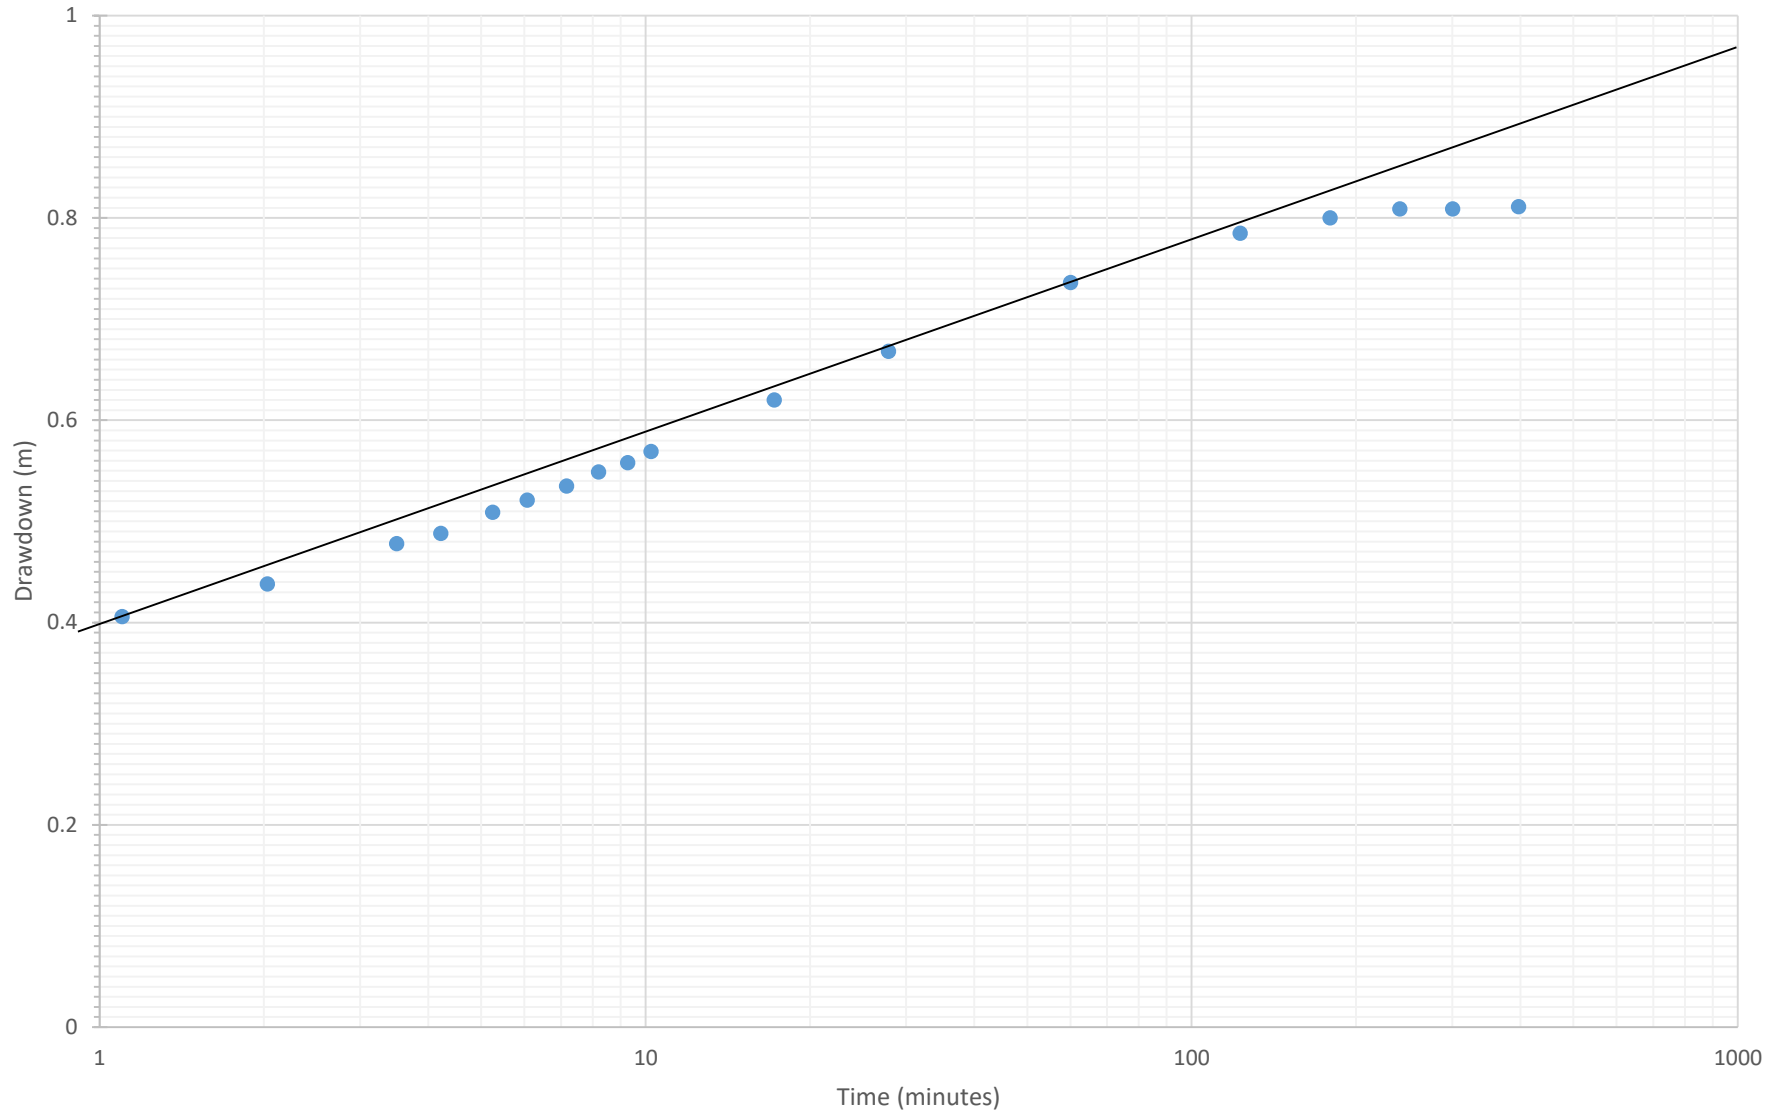
Drawdown vs Log Time
TW3 Pumping Test (Drawdown), January 12, 2021
Gardiner Shore, Beckwith ON

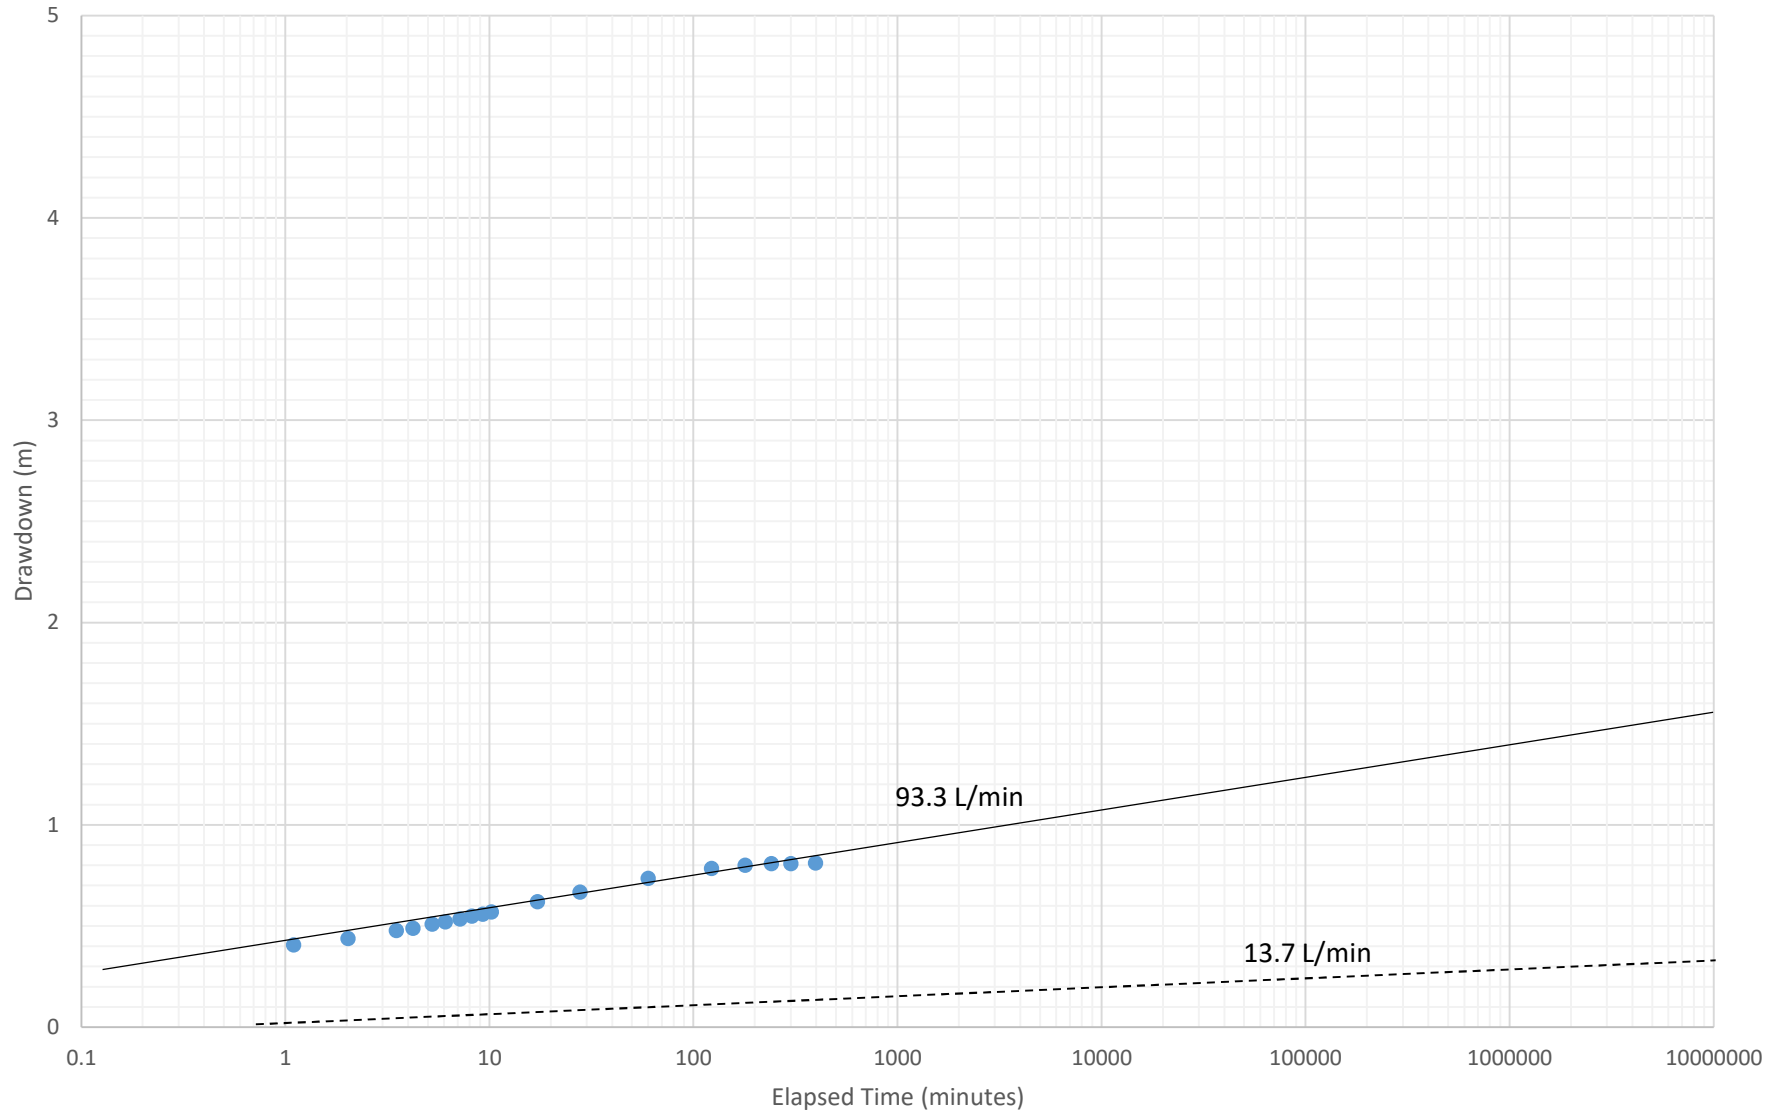
Drawdown vs Log Time
TW3 Pumping Test (Long-Term), January 12, 2021
Gardiner Shore, Beckwith ON

It should be noted that long-term projections of drawdown using the Cooper-Jacob method indicate that all test wells can sustain a constant pumping at rates exceeding 13.7 L/min if pumped constantly for 20 years (see Appendix D). The calculated maximum drawdown for all wells when theoretically pumped at a rate of 13.7 L/min was below 0.75 m, with the exception of TW2 which would be expected to have a drawdown of approximately 1.3 m.

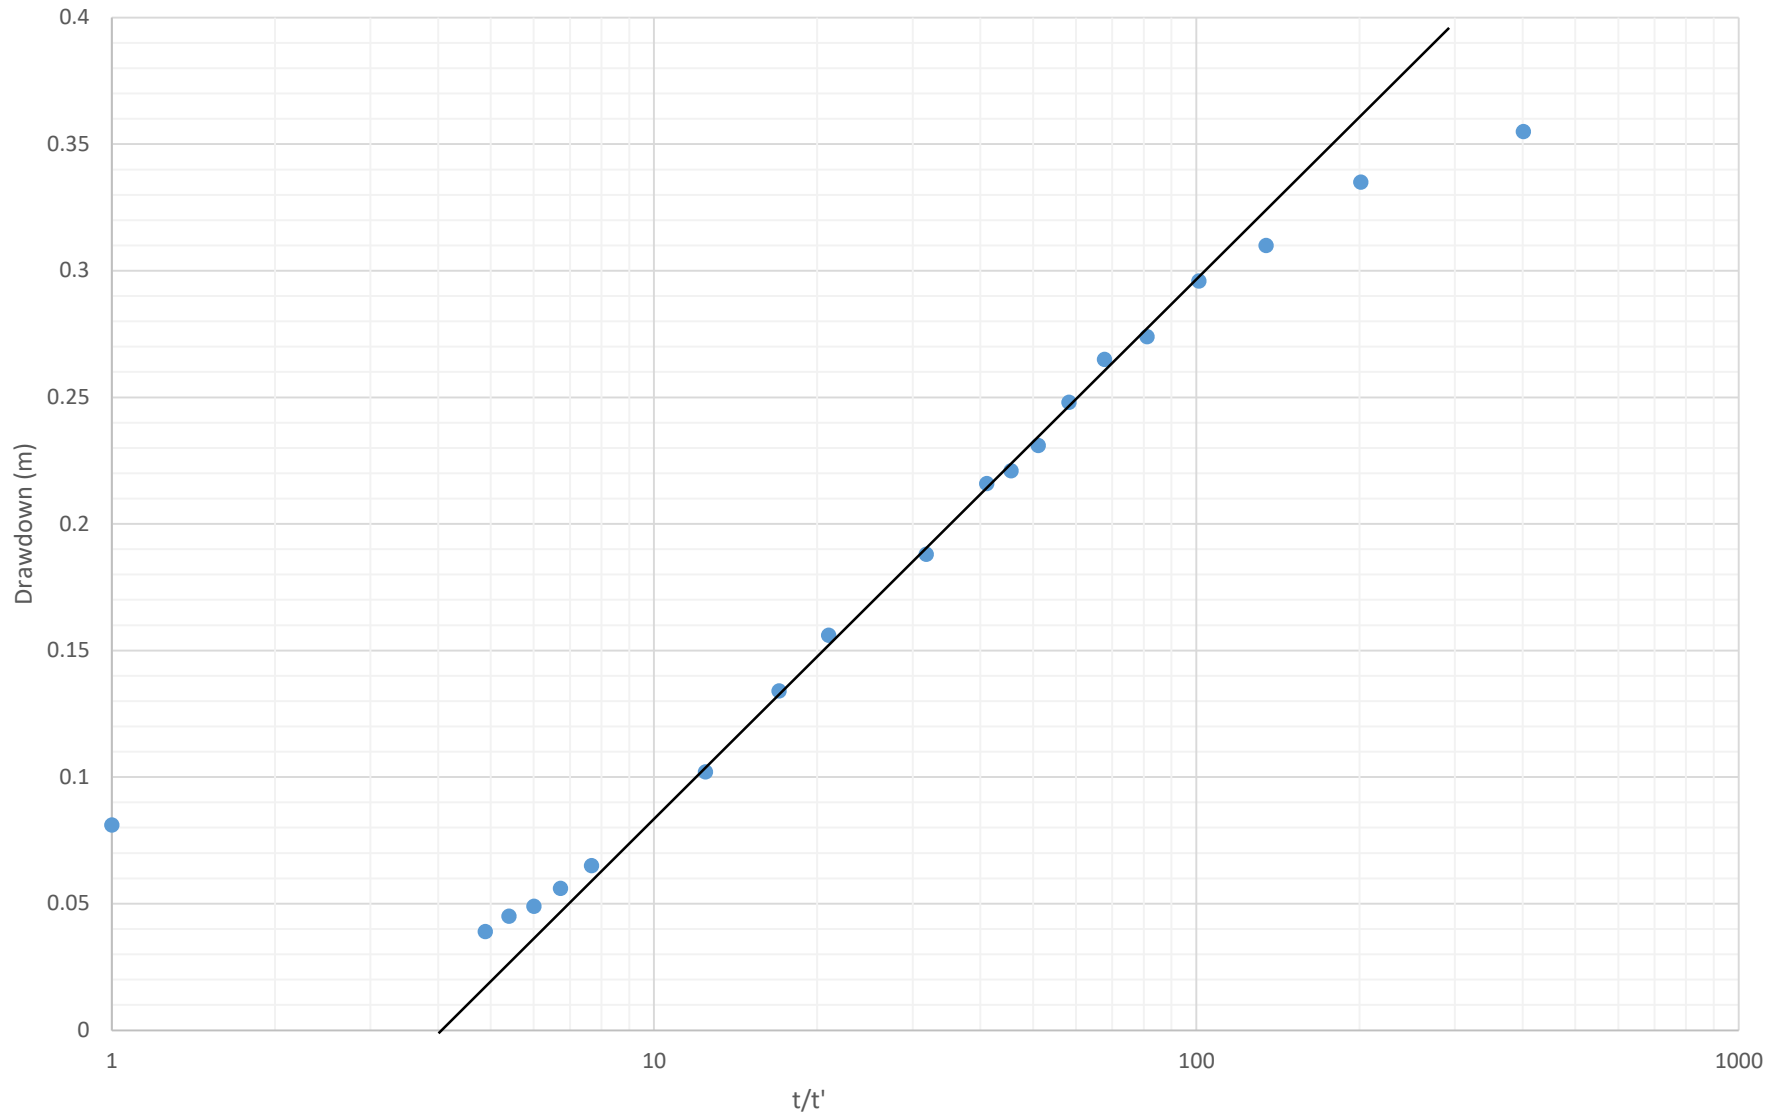
Drawdown vs Log Time
TW3 Pumping Test (Recovery), January 12, 2021
Gardiner Shore, Beckwith ON

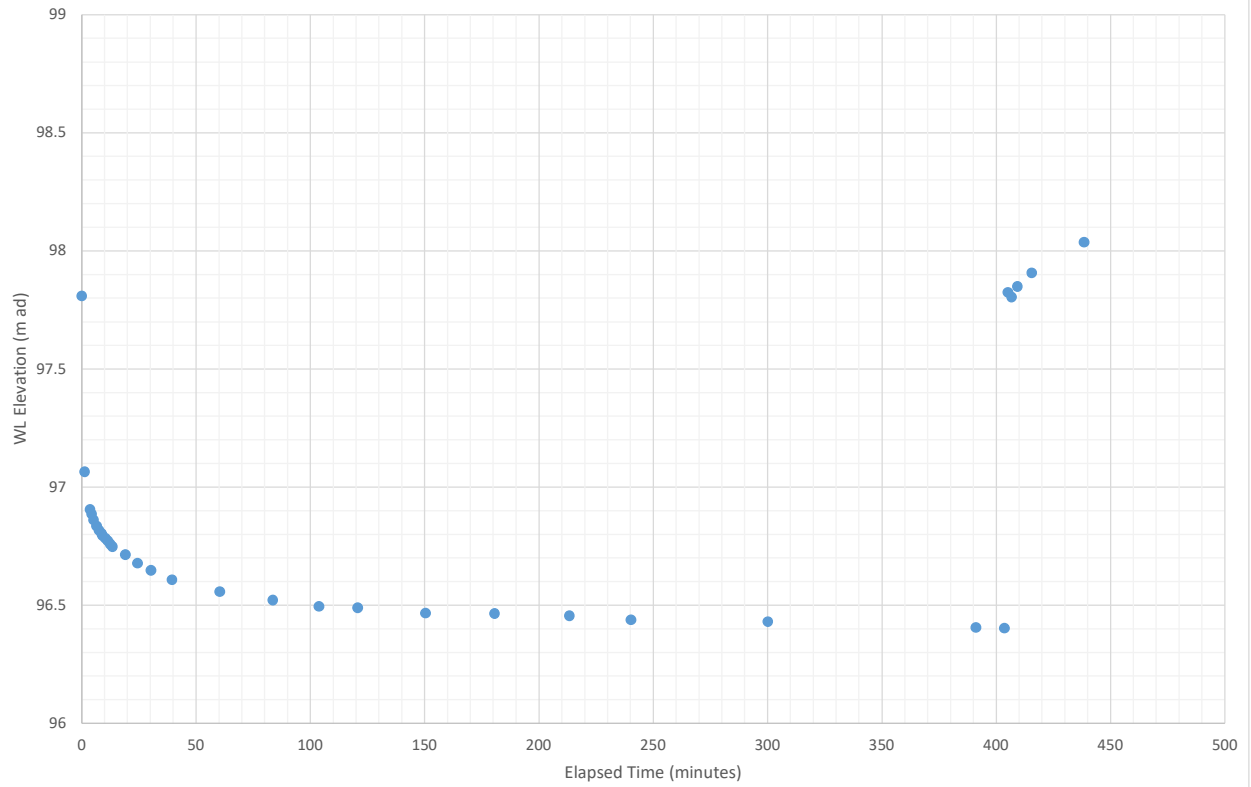
Drawdown vs Time
TW4 Pumping Test (Drawdown), December 21, 2020
Gardiner Shore, Beckwith ON

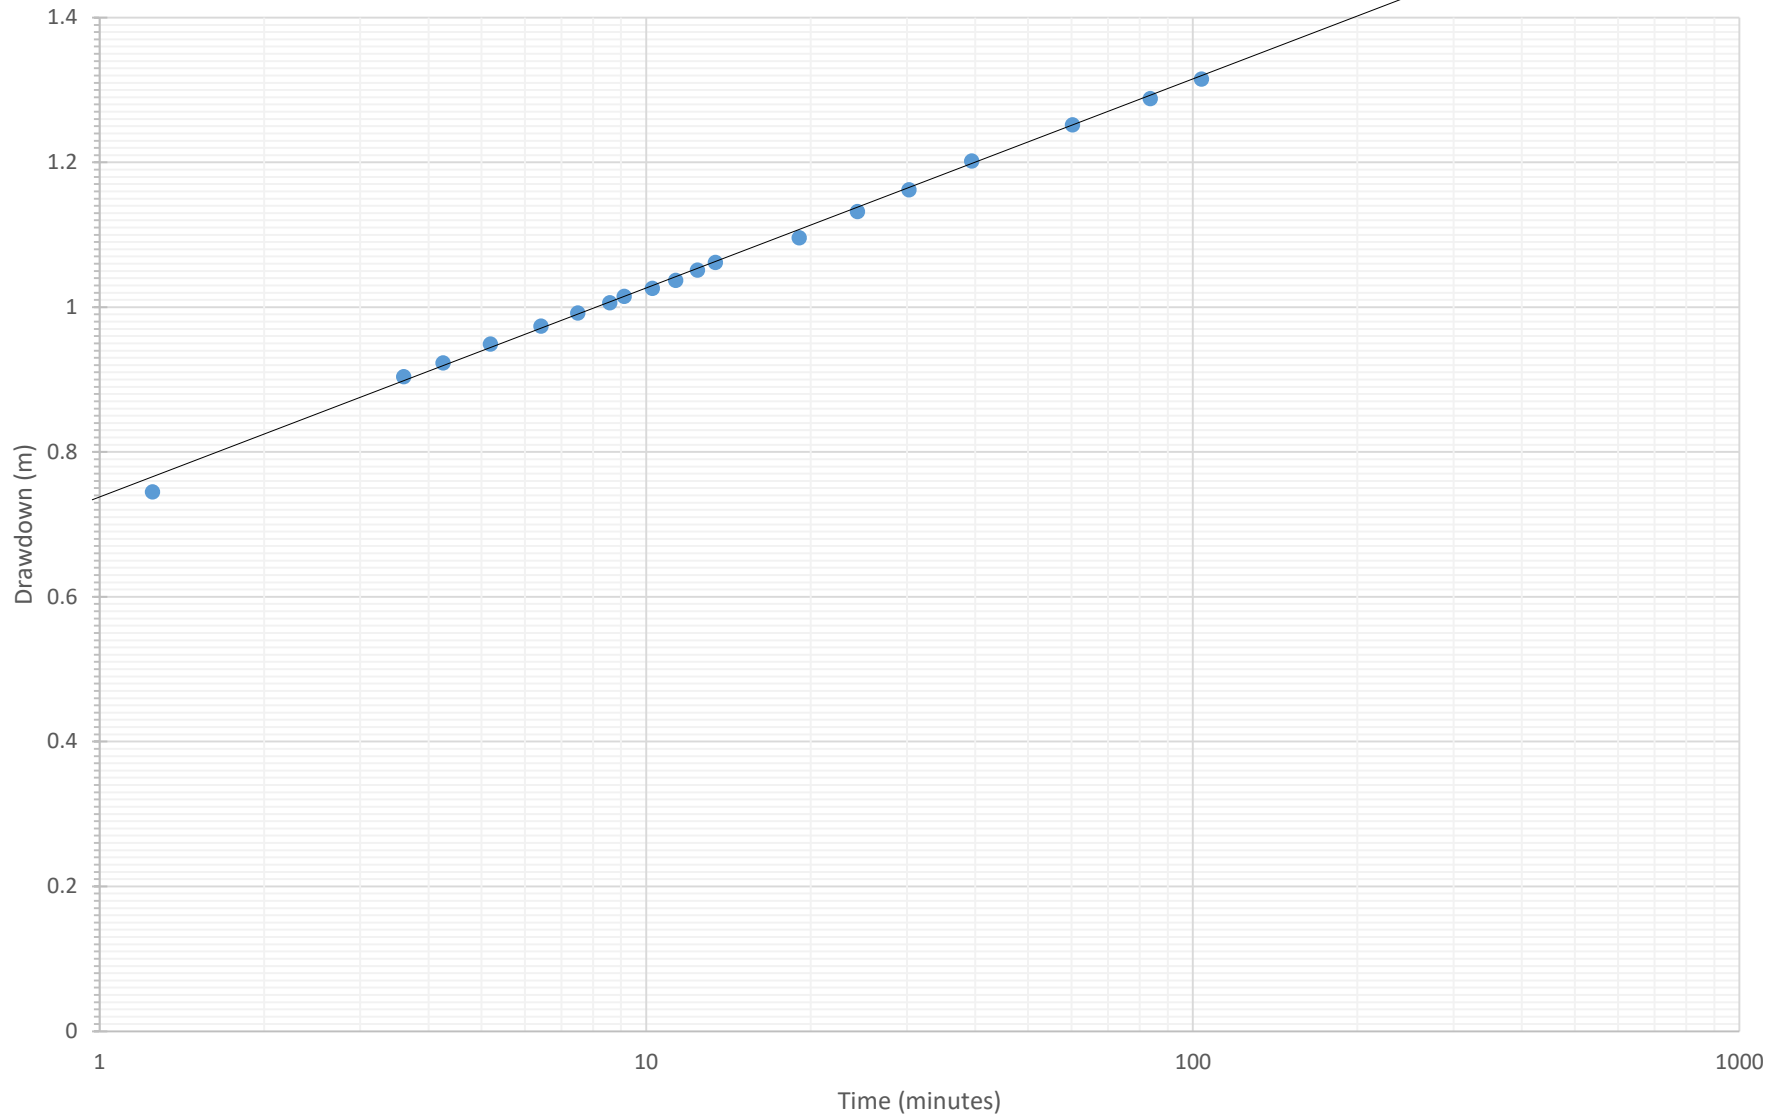
Drawdown vs Log Time
TW4 Pumping Test (Drawdown), December 21, 2020
Gardiner Shore, Beckwith ON

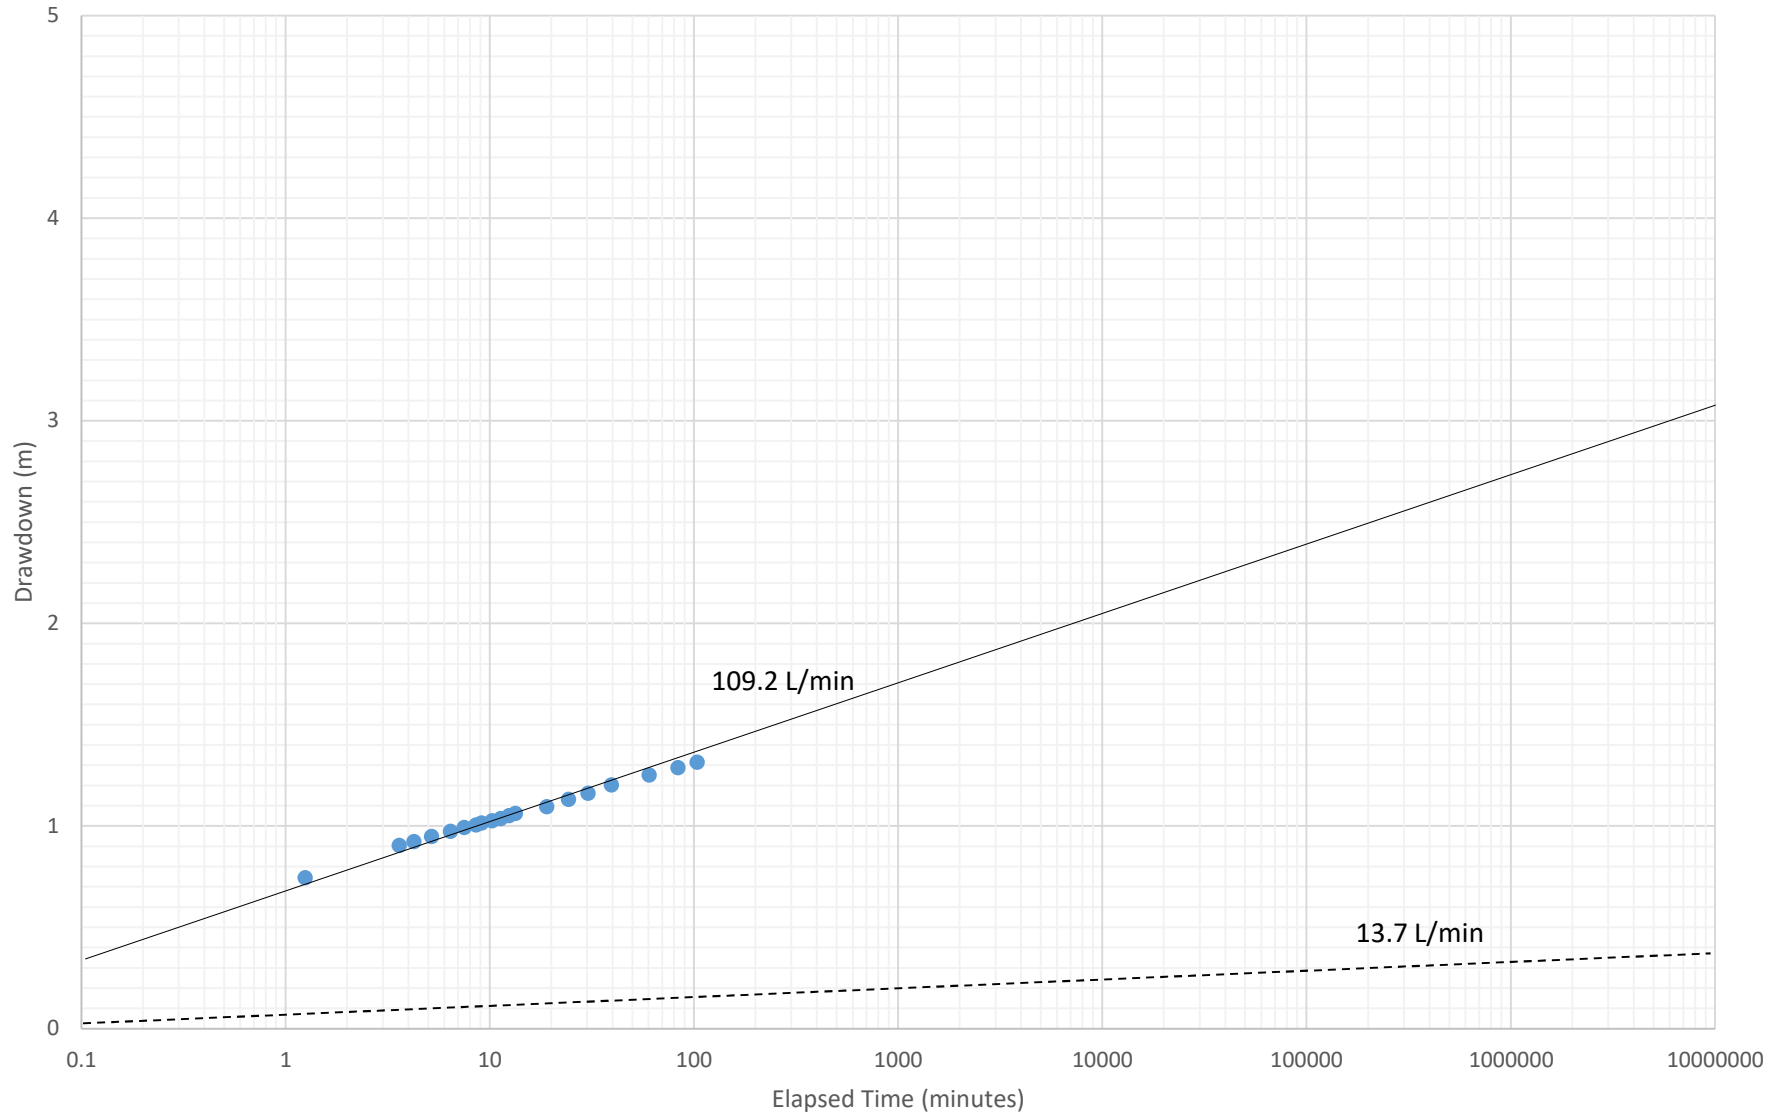
Drawdown vs Log Time
TW4 Pumping Test (Long-Term), December 21, 2020
Gardiner Shore, Beckwith ON

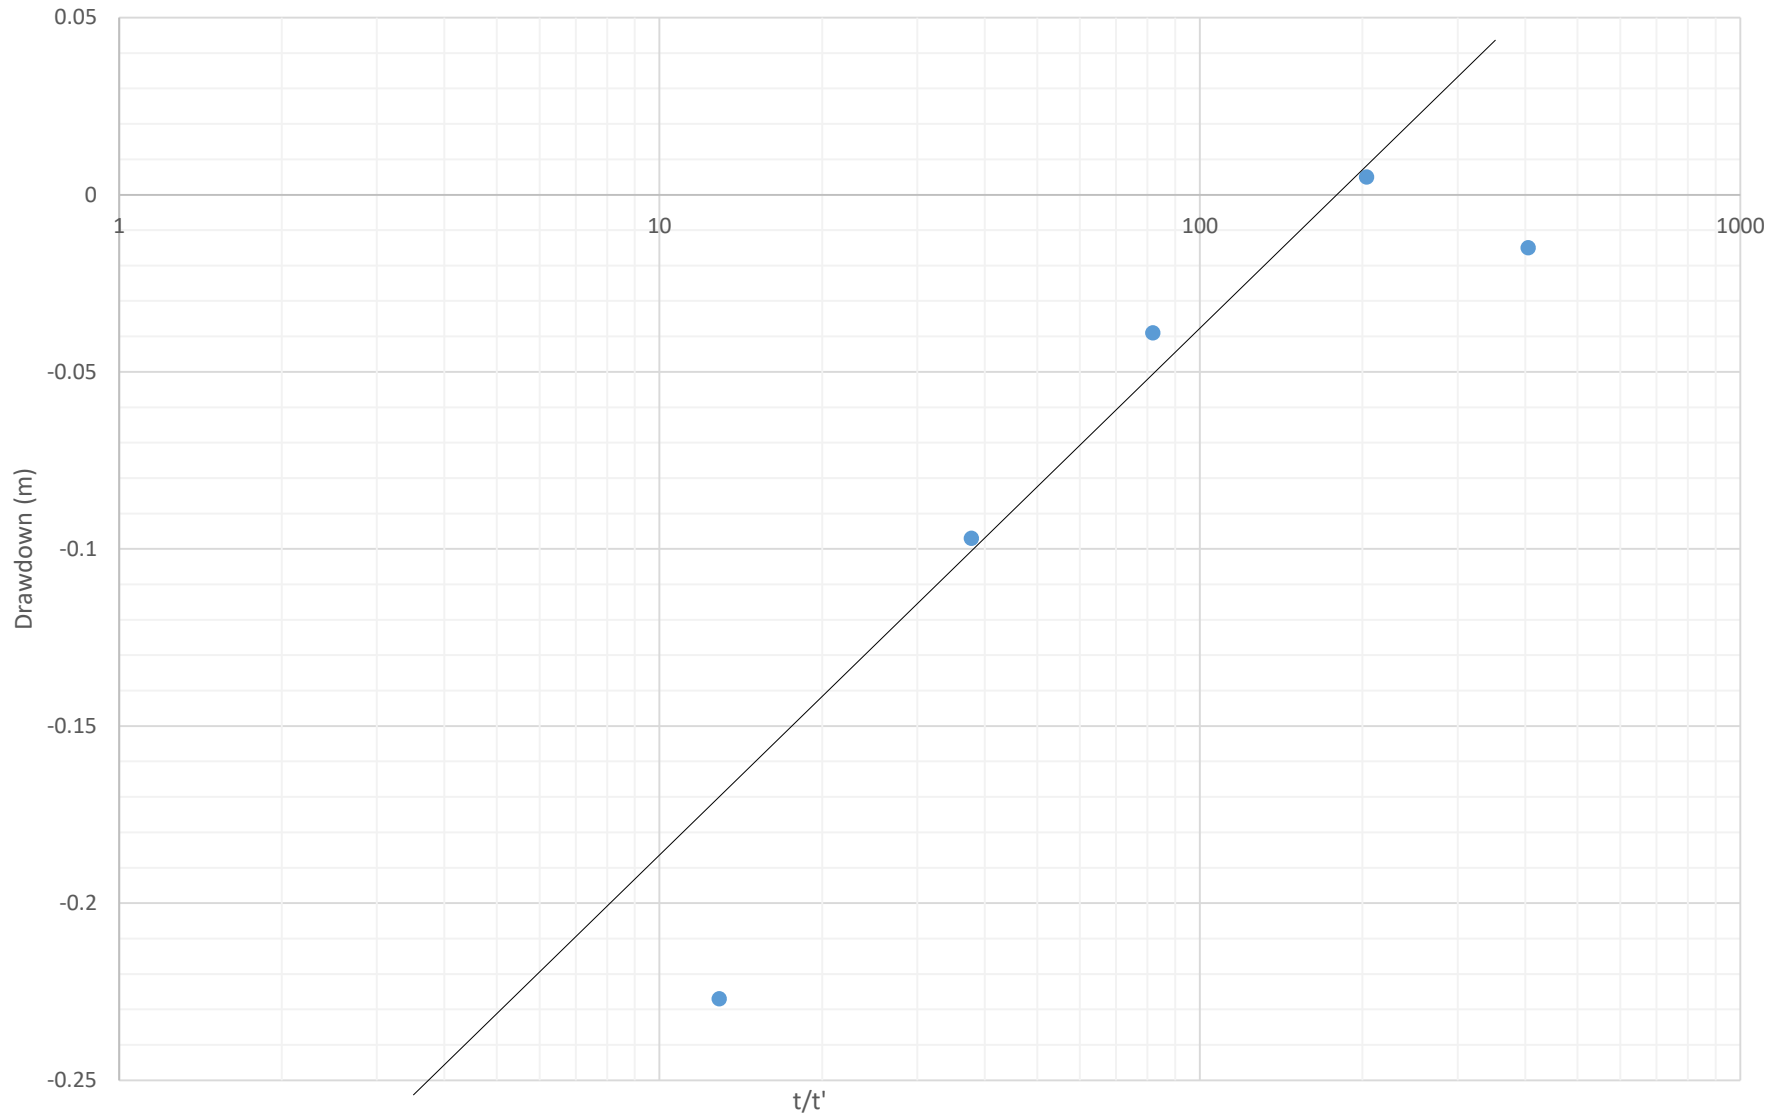
Drawdown vs Log Time
TW4 Pumping Test (Recovery), December 21, 2020
Gardiner Shore, Beckwith ON

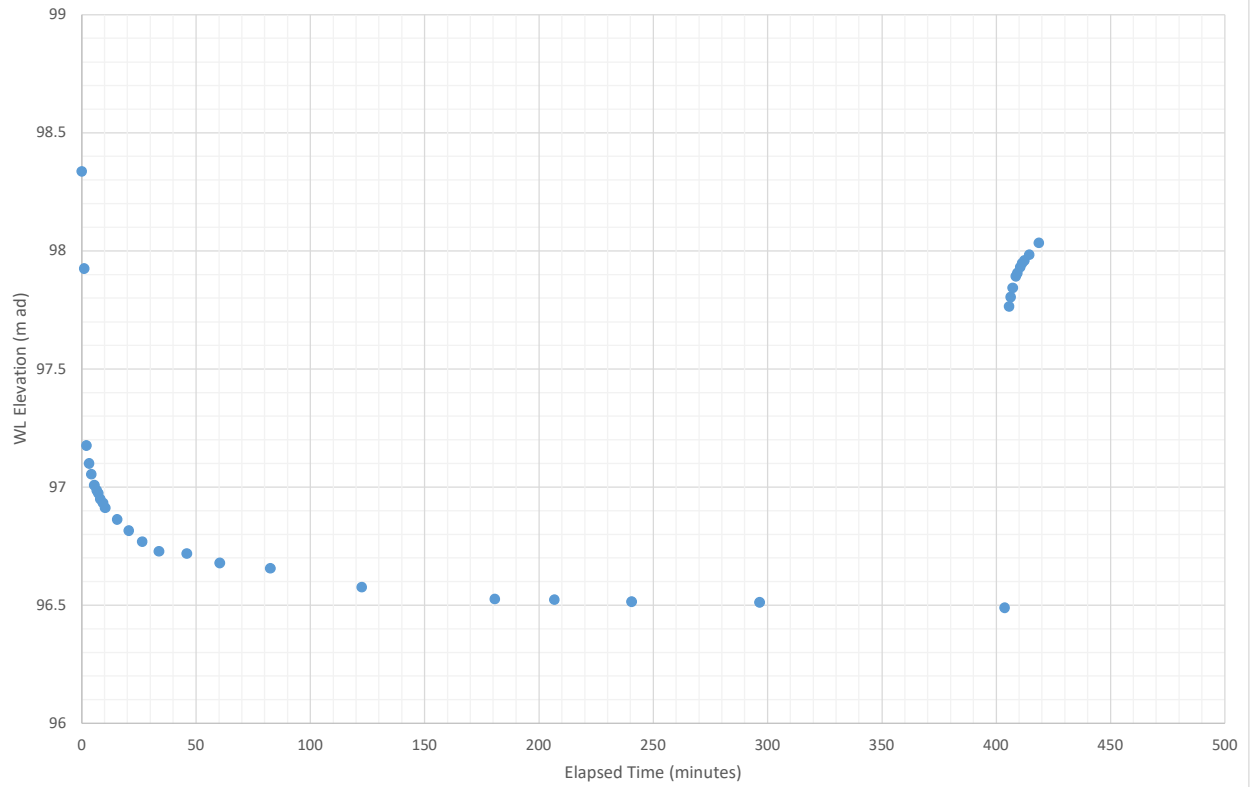
Drawdown vs Time
TW5 Pumping Test (Drawdown), January 6, 2021
Gardiner Shore, Beckwith ON

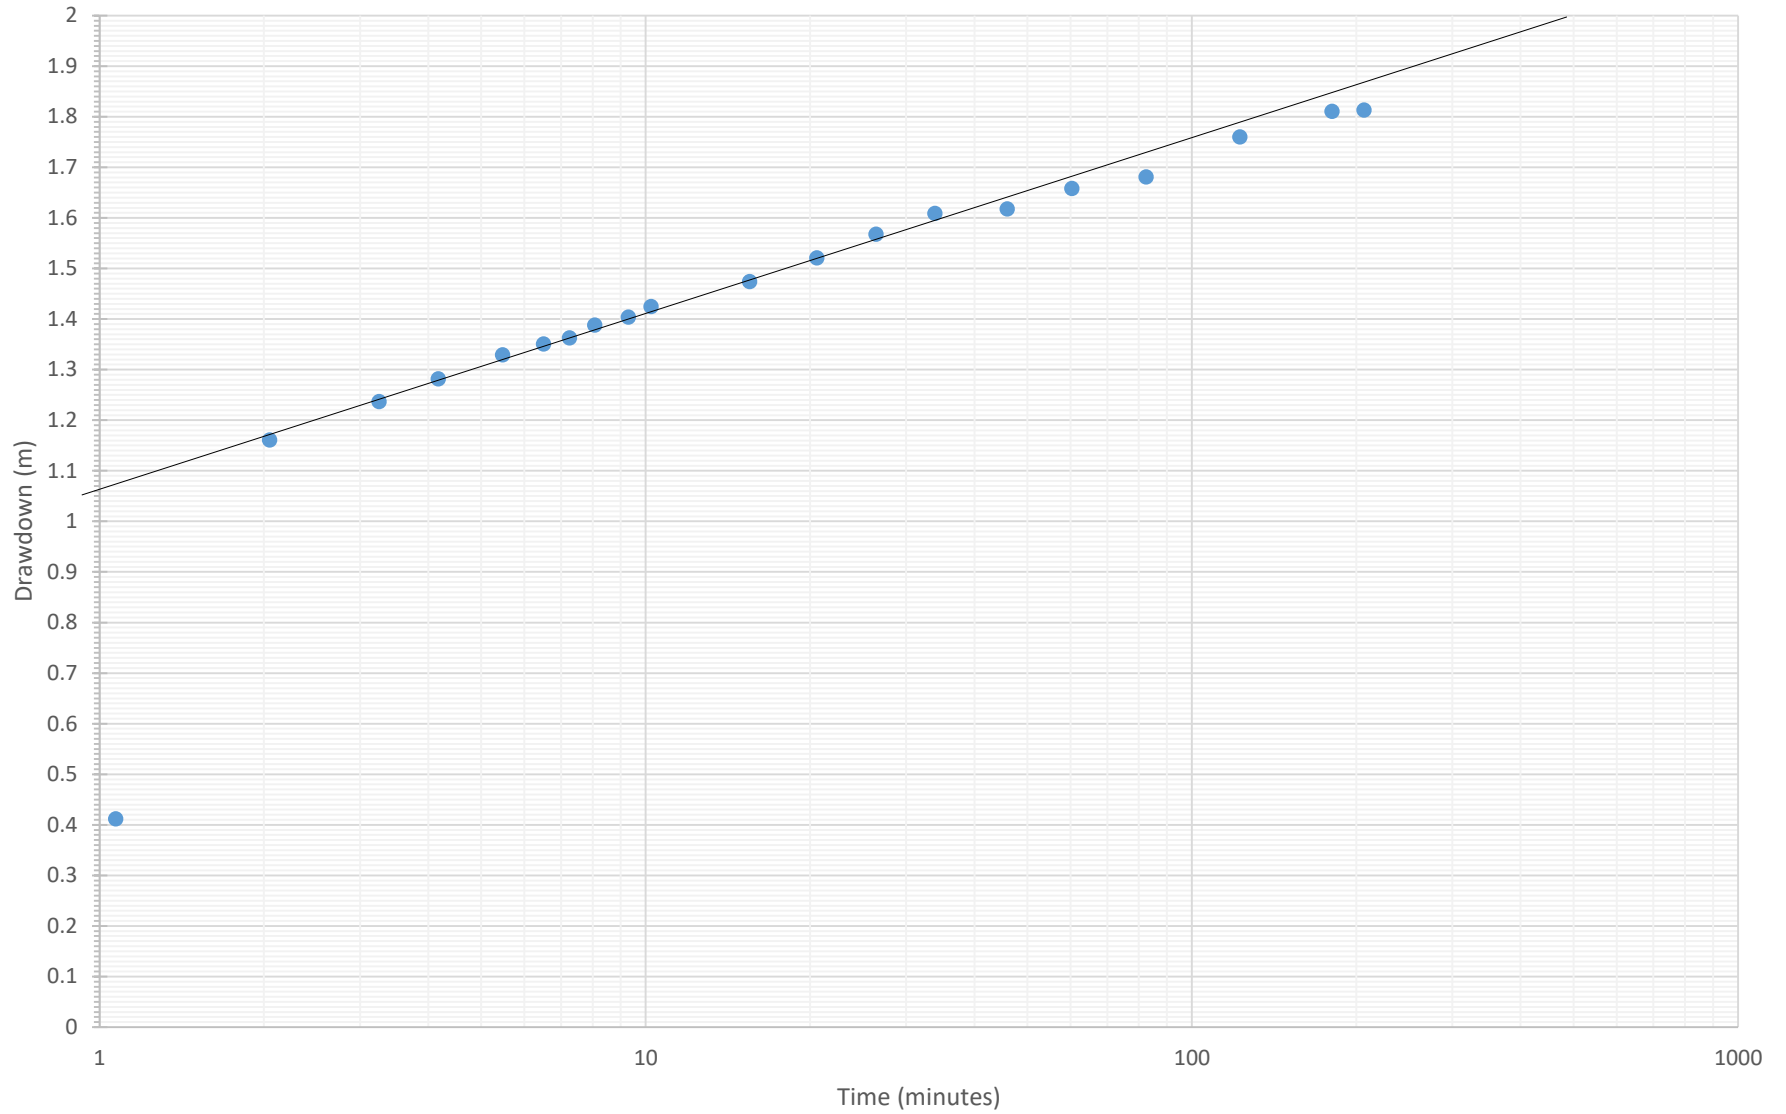
Drawdown vs Log Time
TW5 Pumping Test (Drawdown), January 6, 2021
Gardiner Shore, Beckwith ON

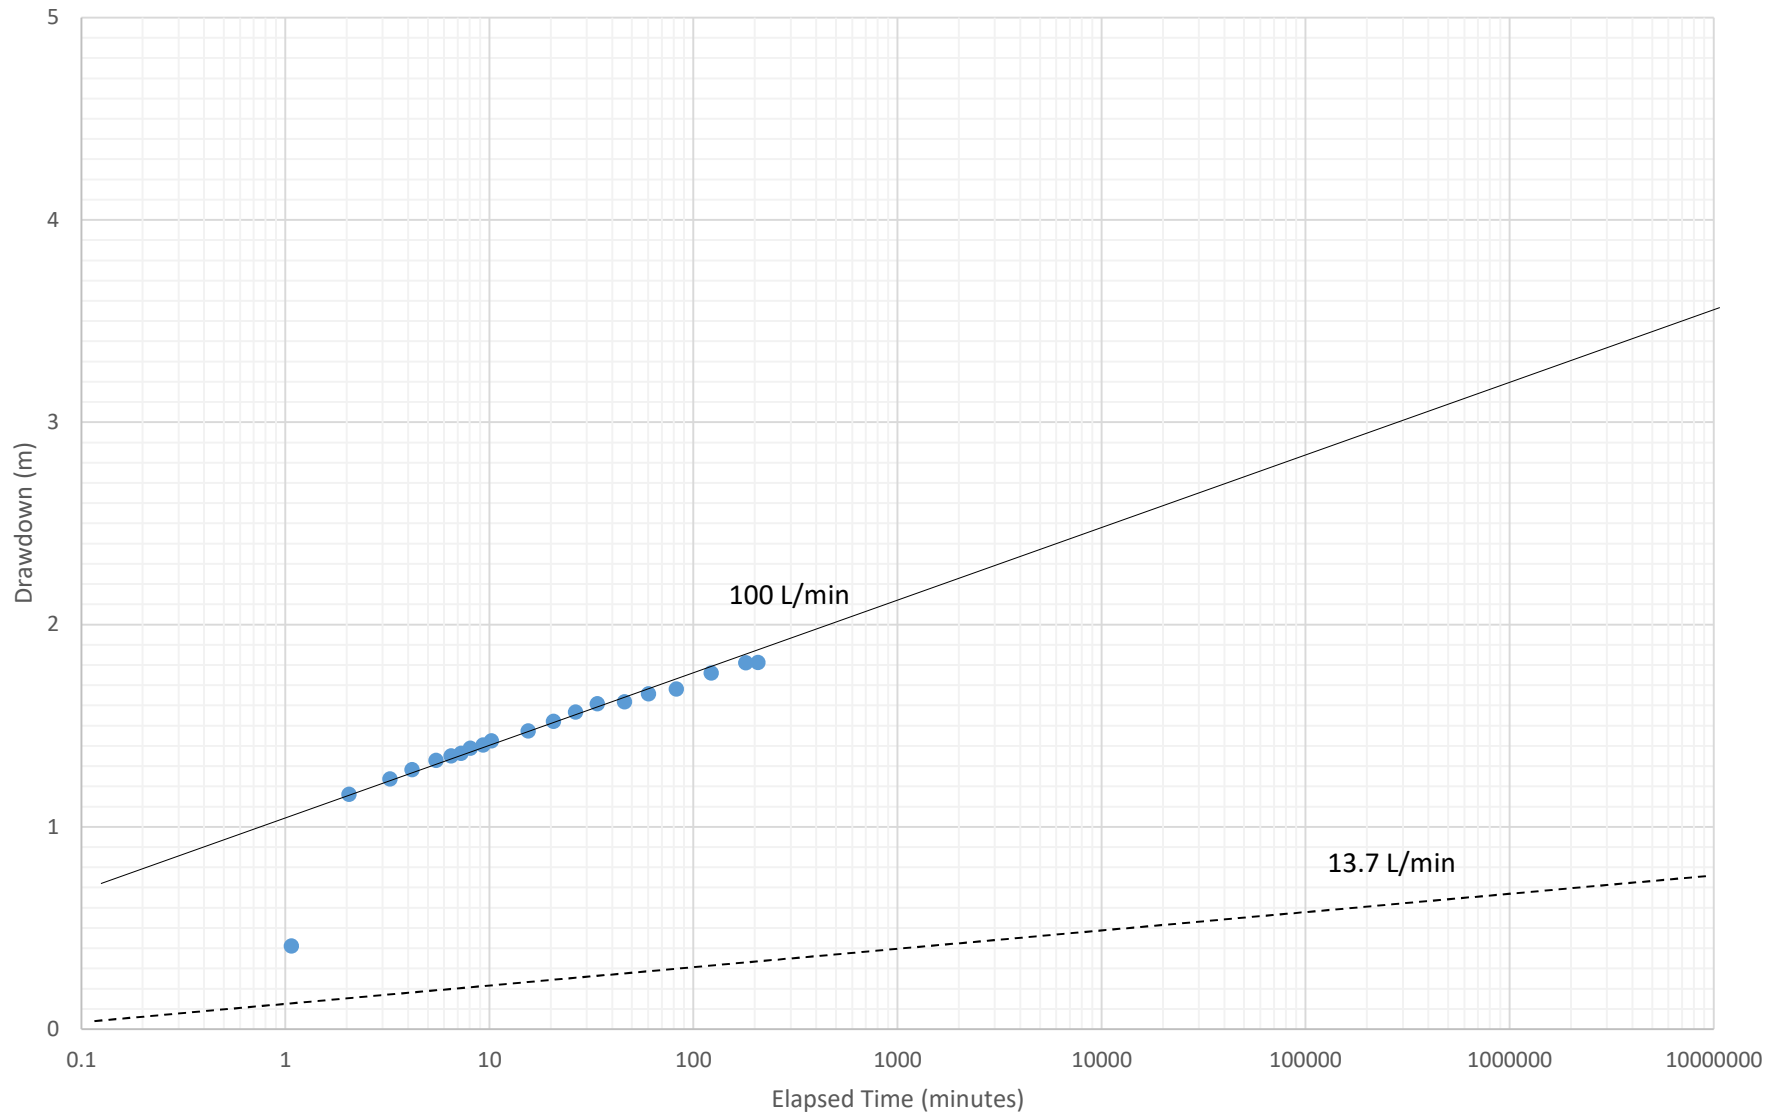
Drawdown vs Log Time
TW5 Pumping Test (Long-Term), January 6, 2021
Gardiner Shore, Beckwith ON

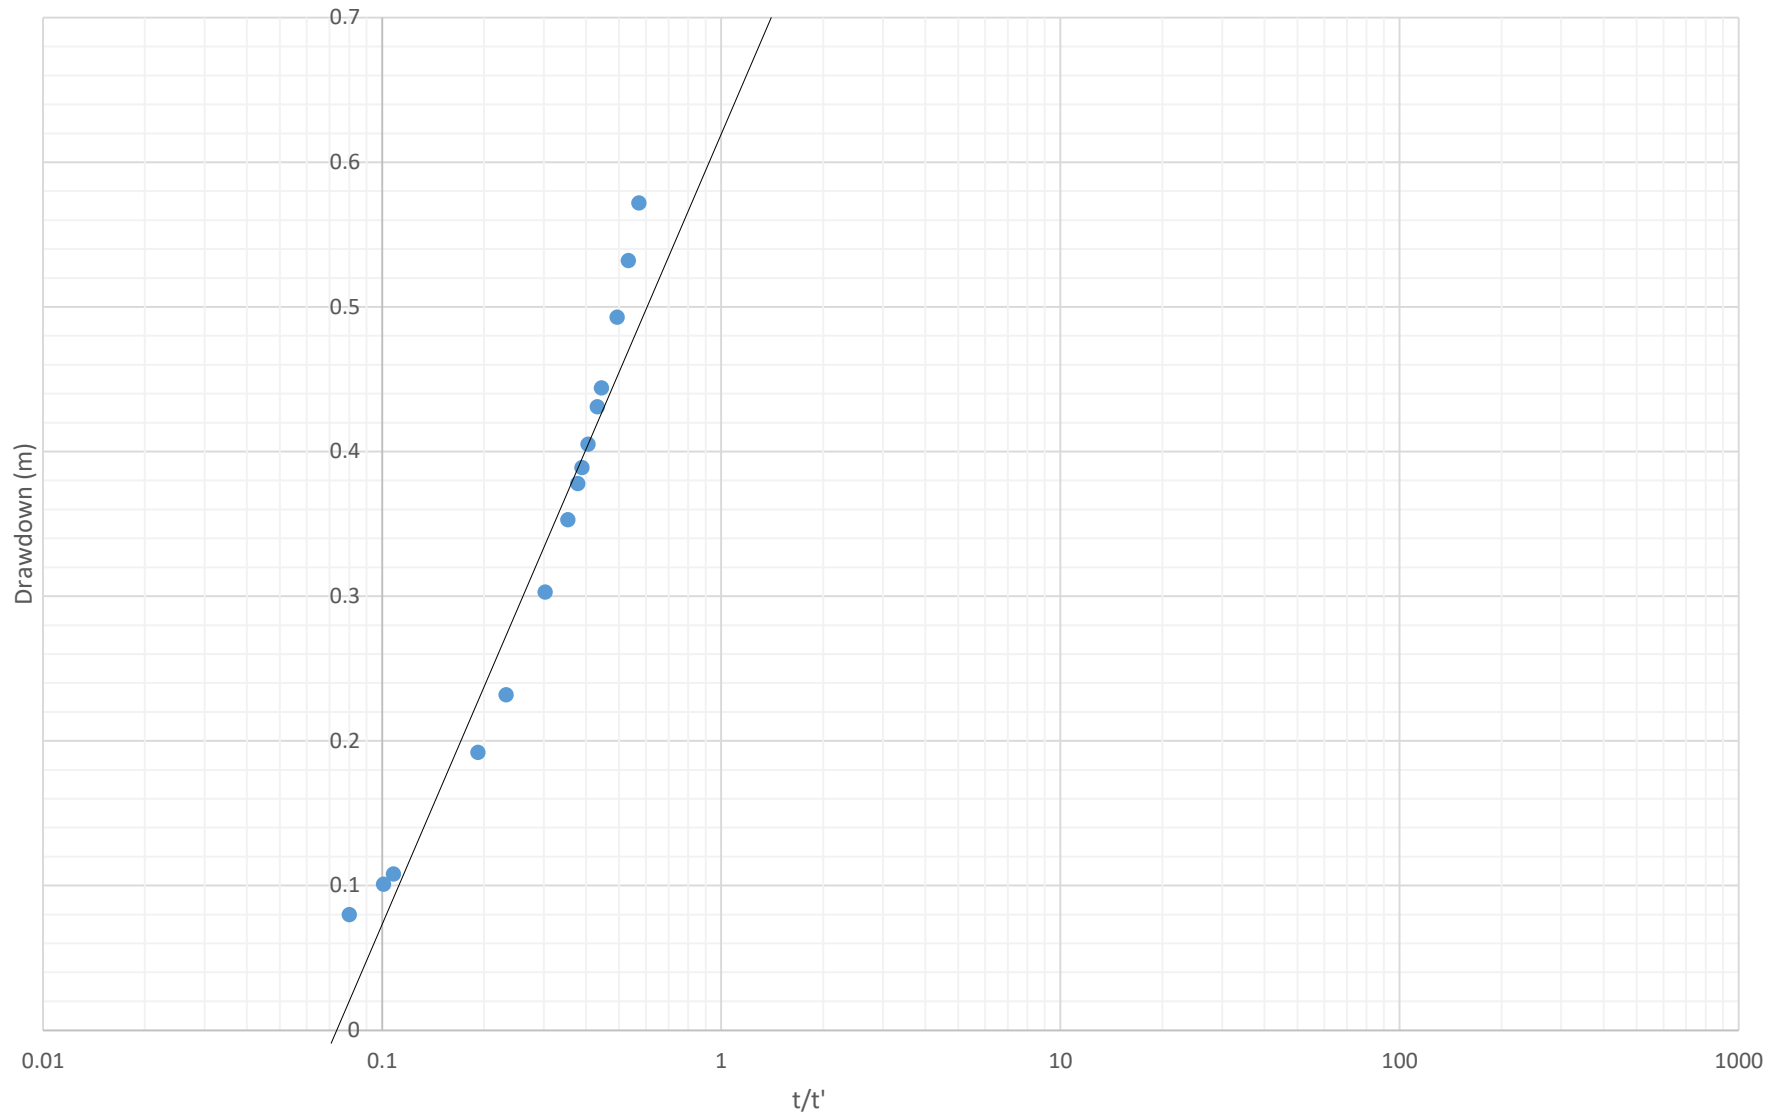
Drawdown vs Log Time
TW5 Pumping Test (Recovery), January 6, 2021
Gardiner Shore, Beckwith ON

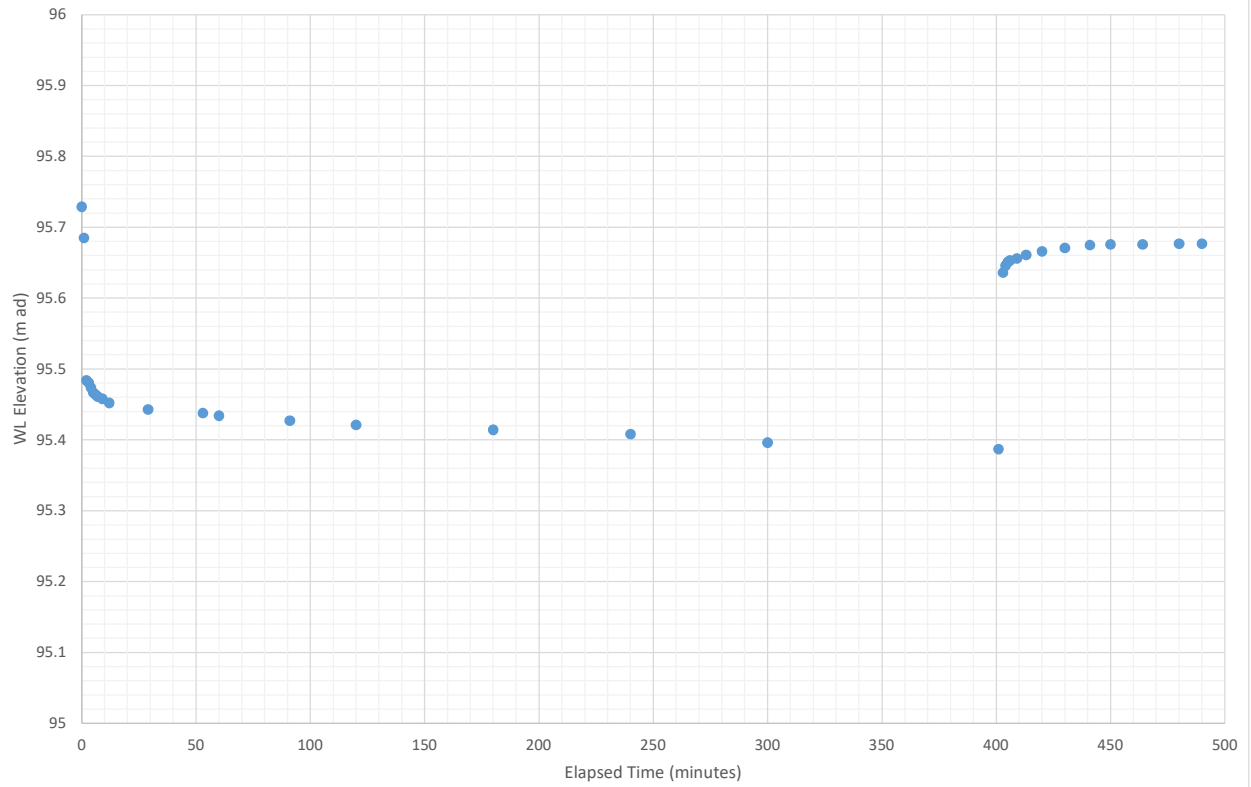
Drawdown vs Time
TW6 Pumping Test (Drawdown), January 7, 2021
Gardiner Shore, Beckwith ON

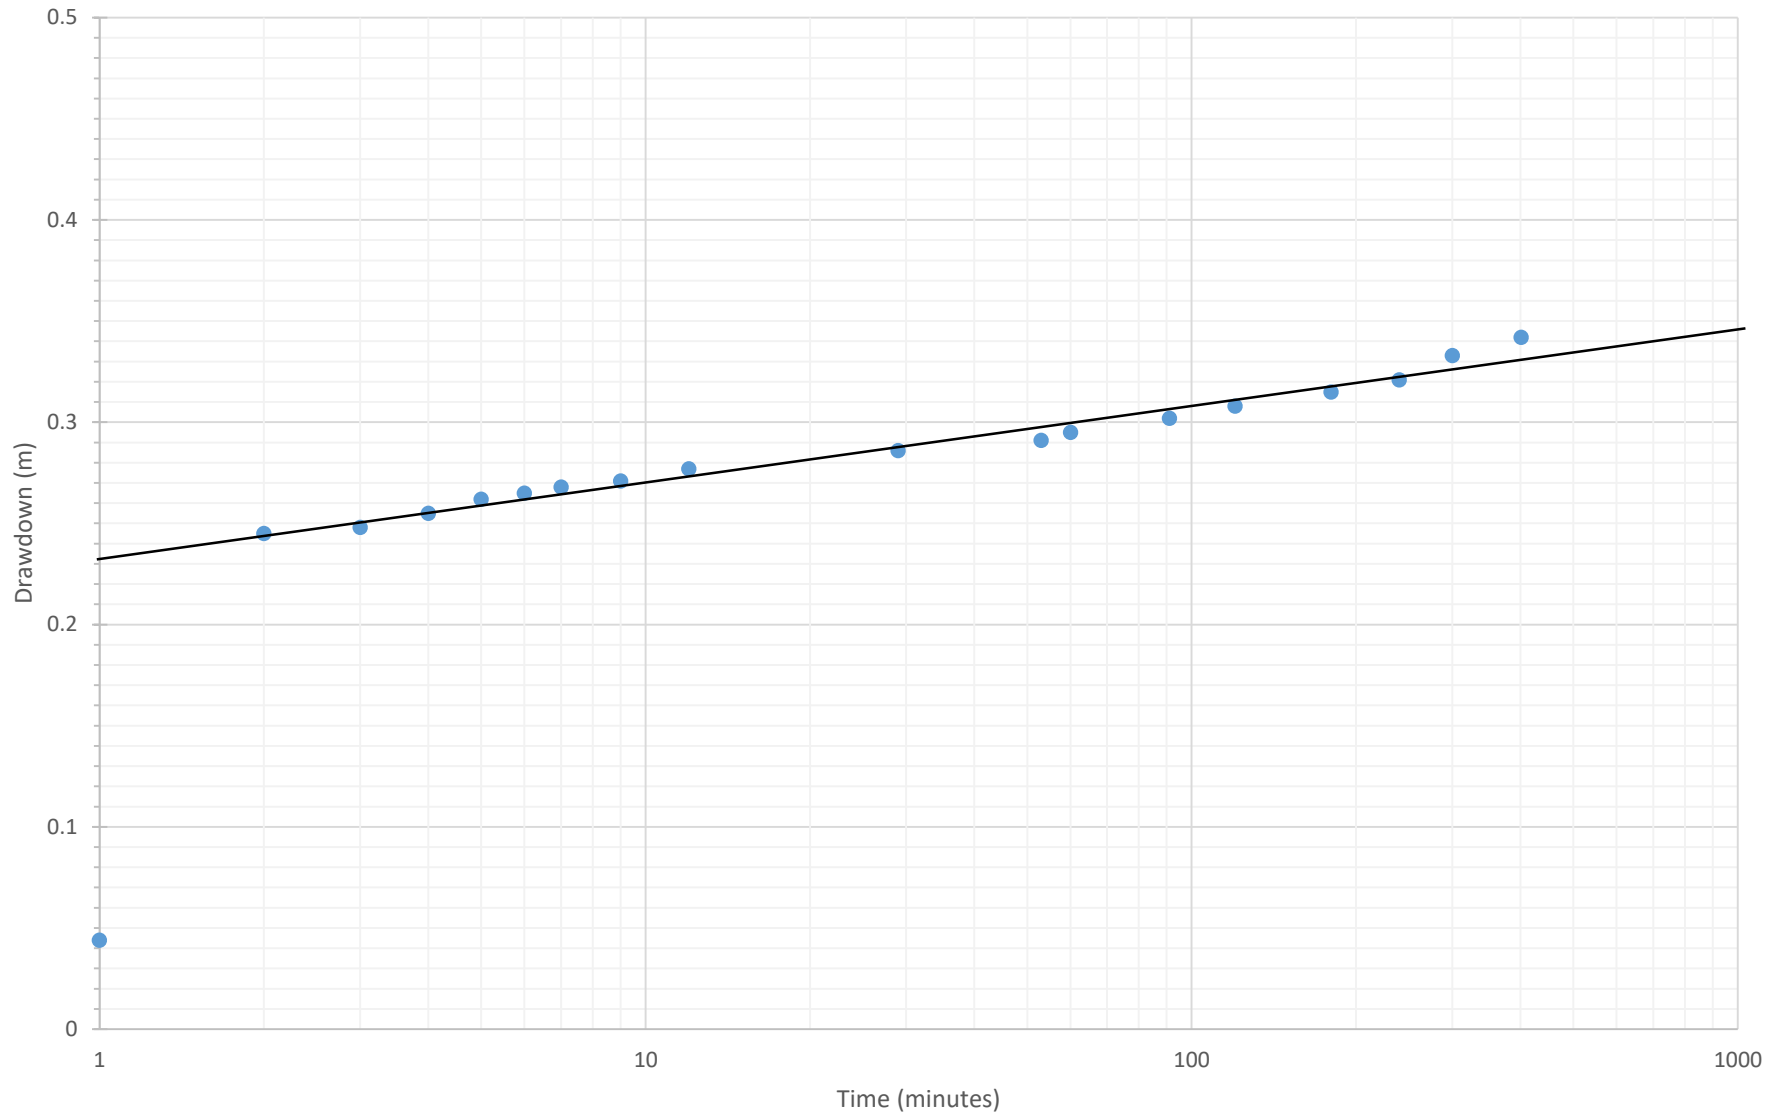
Drawdown vs Log Time
TW6 Pumping Test (Drawdown), January 7, 2021
Gardiner Shore, Beckwith ON
