HYDROGEOLOGICAL ASSESSMENT GARDINERS SHORE SUBDIVISION, BECKWITH ON

Project No.: CCO-20-0203

McIntosh Perry Consulting Engineers Ltd.
115 Walgreen Road
Carp, Ontario
K0A 1L0

June 6, 2021

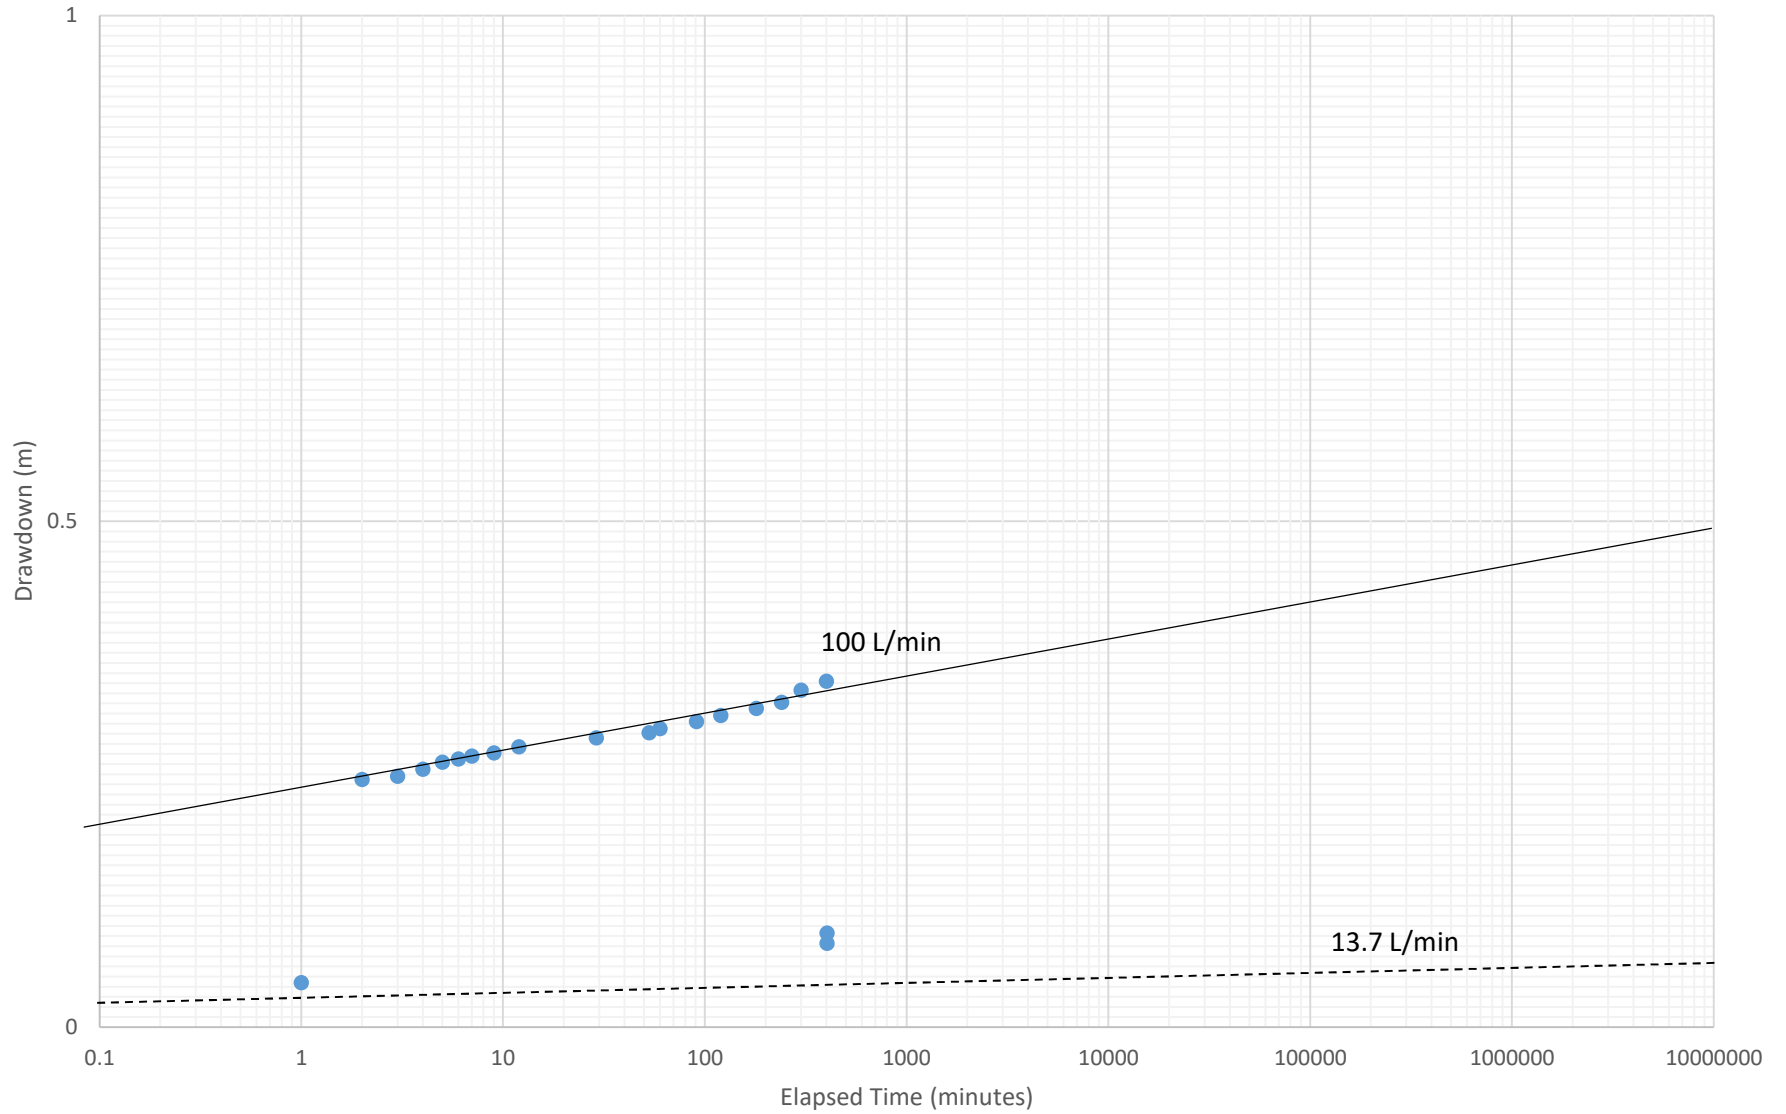
Drawdown vs Log Time
TW6 Pumping Test (Long-Term), January 7, 2021
Gardiner Shore, Beckwith ON

It should be noted that long-term projections of drawdown using the Cooper-Jacob method indicate that all test wells can sustain a constant pumping at rates exceeding 13.7 L/min if pumped constantly for 20 years (see Appendix D). The calculated maximum drawdown for all wells when theoretically pumped at a rate of 13.7 L/min was below 0.75 m, with the exception of TW2 which would be expected to have a drawdown of approximately 1.3 m.

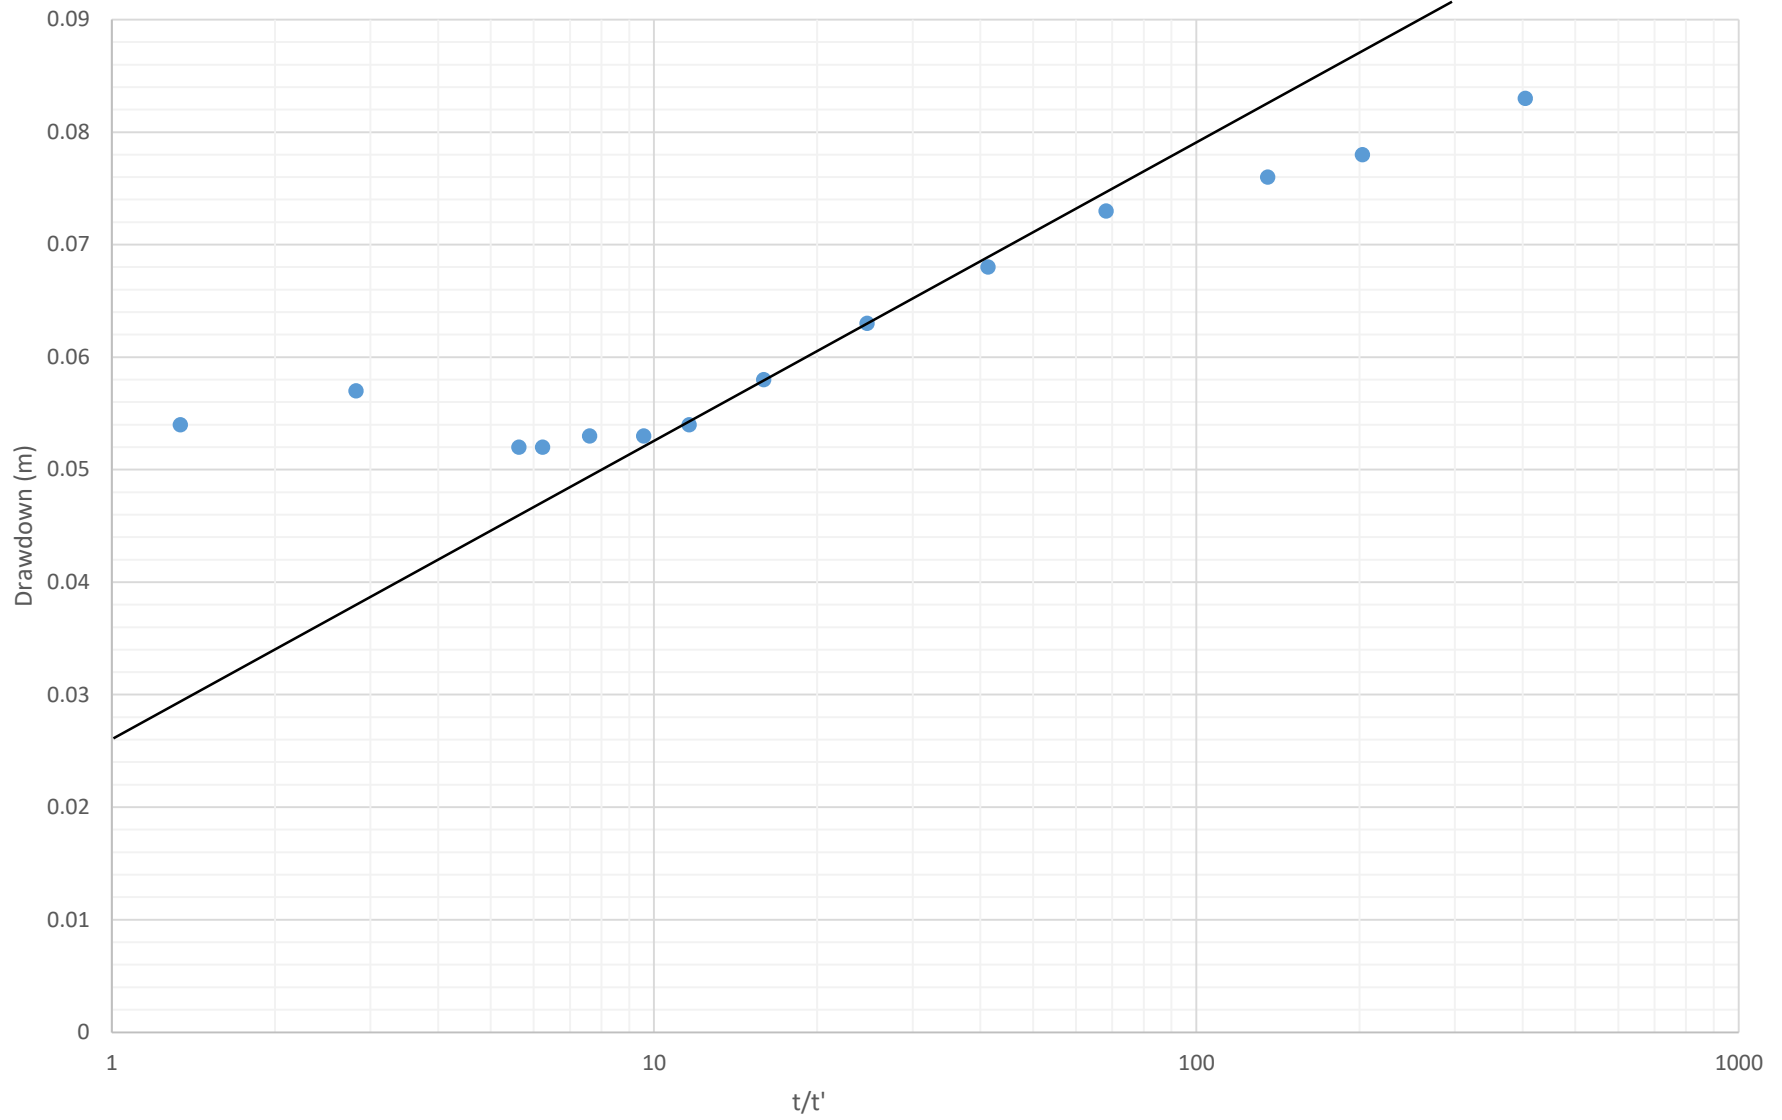
Drawdown vs Log Time
TW6 Pumping Test (Recovery), January 7, 2021
Gardiner Shore, Beckwith ON

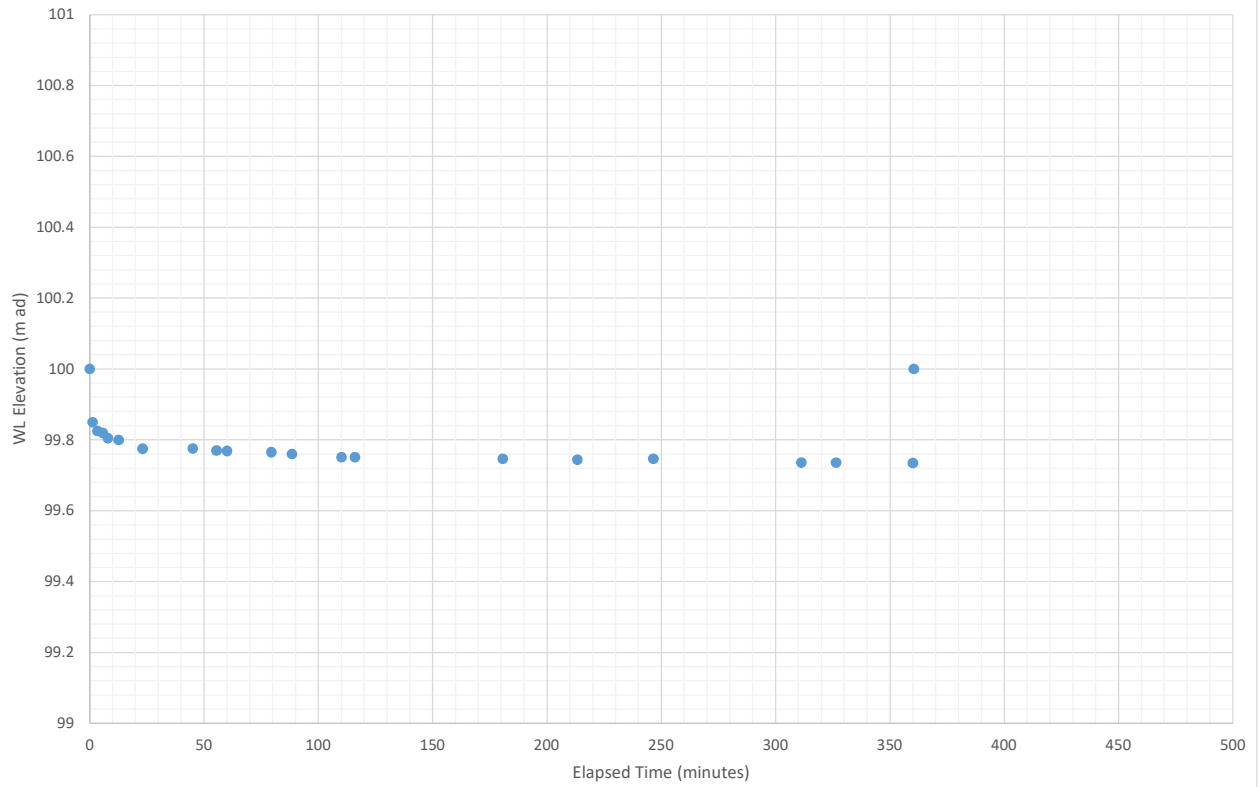
Drawdown vs Time
TW7 Pumping Test (Drawdown), December 21, 2020
Gardiner Shore, Beckwith ON

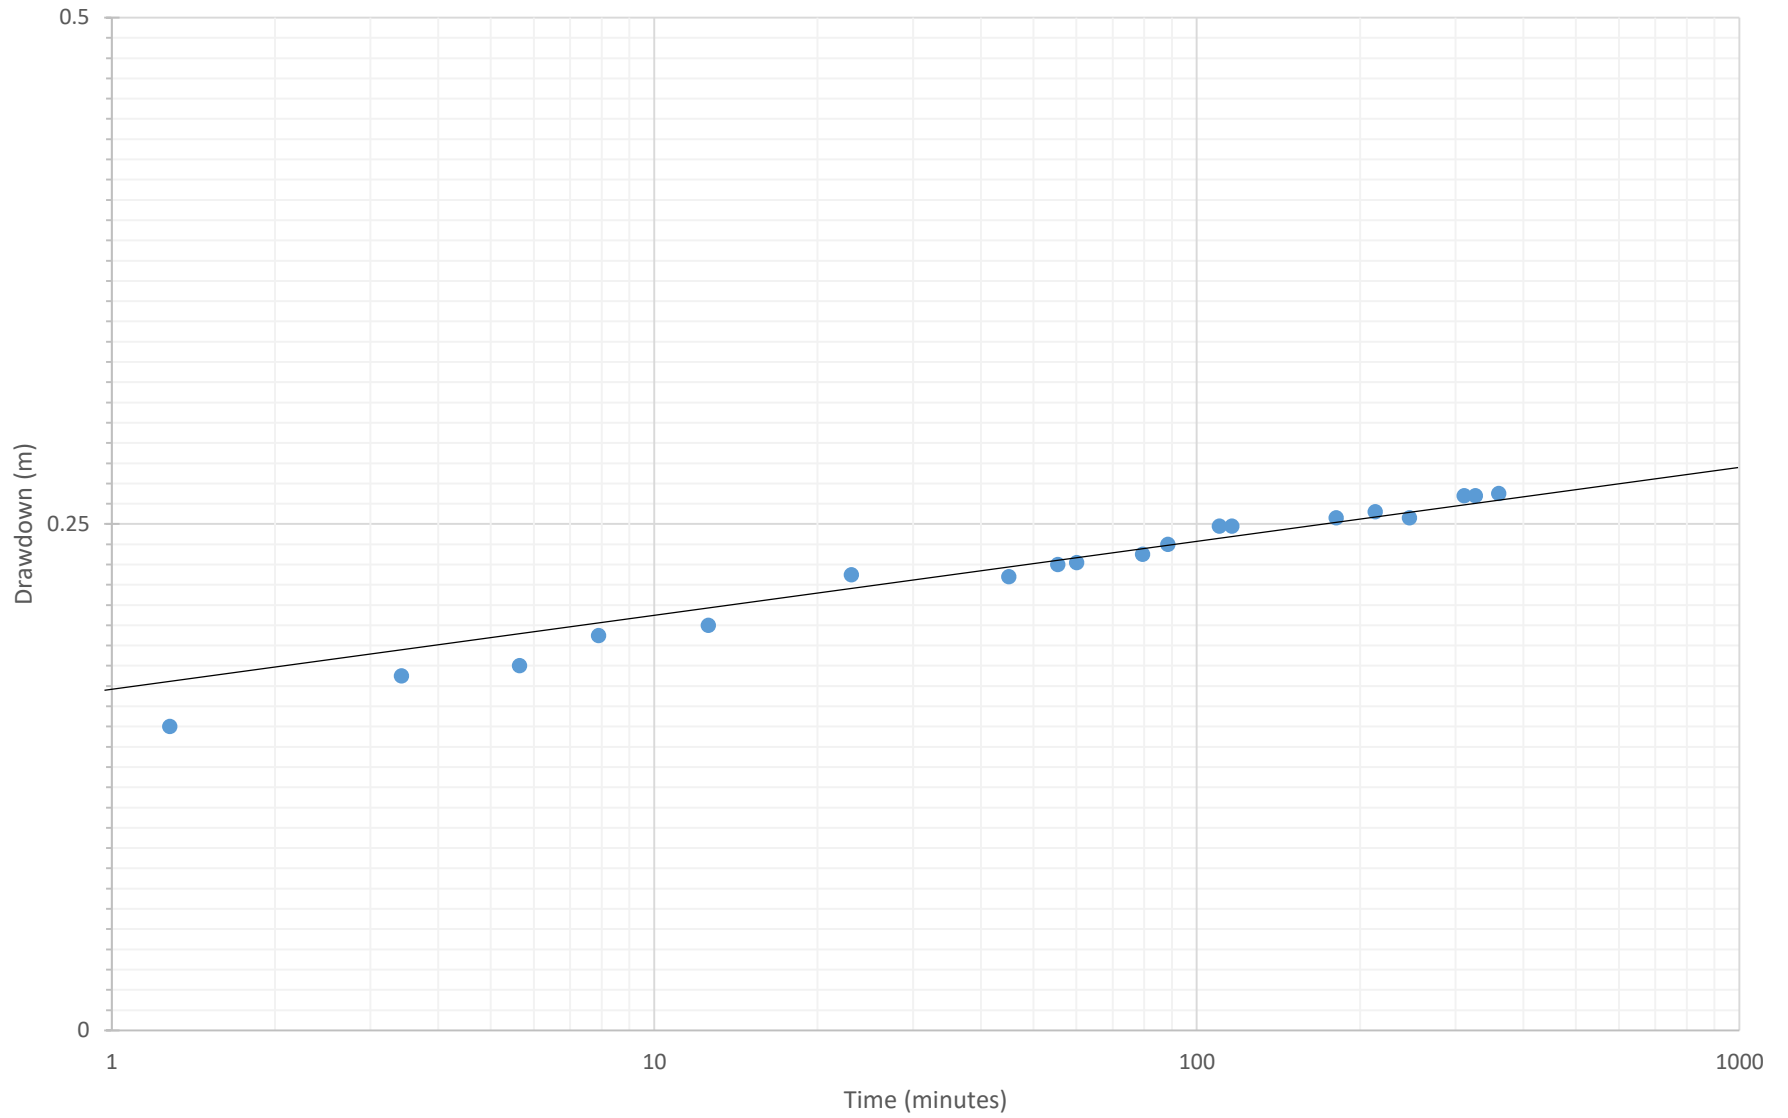
Drawdown vs Log Time
TW7 Pumping Test (Drawdown), December 21, 2020
Gardiner Shore, Beckwith ON

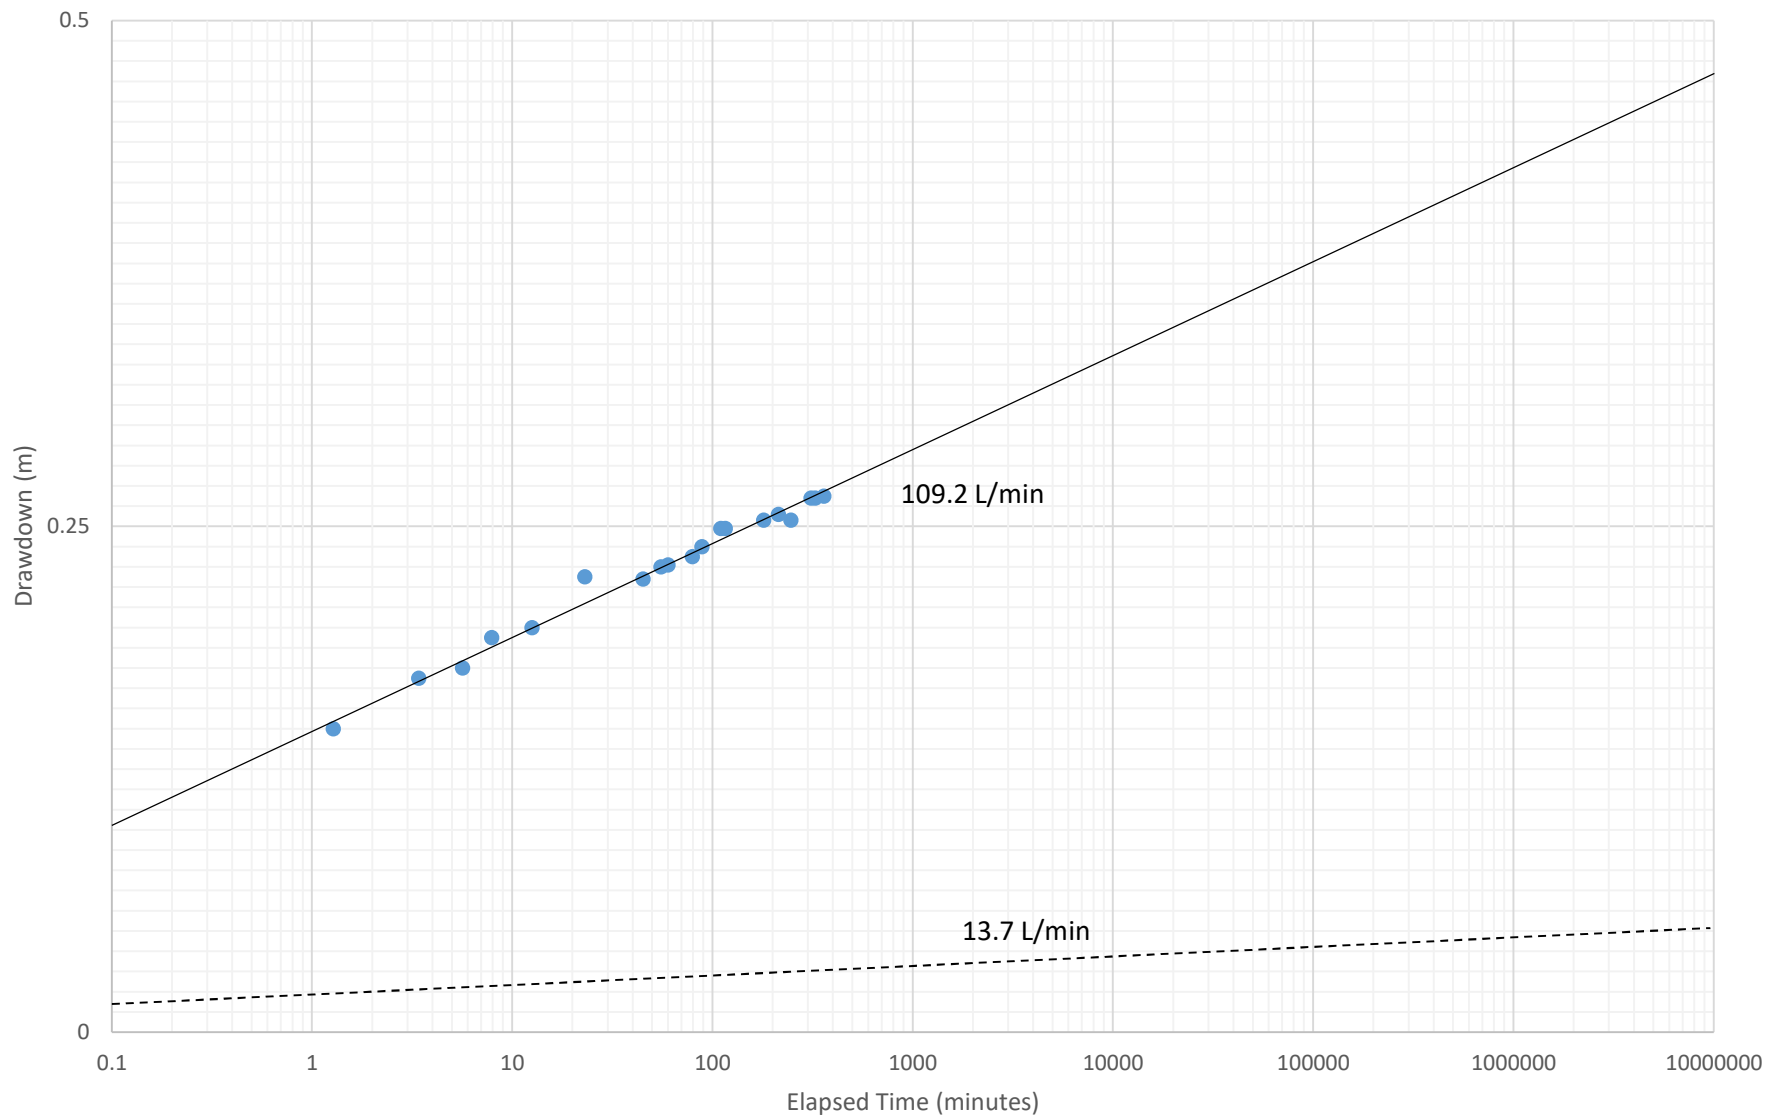
Drawdown vs Log Time
TW7 Pumping Test (Long-Term), December 21, 2020
Gardiner Shore, Beckwith ON
