HYDROGEOLOGICAL ASSESSMENT AND TERRAIN ANALYSIS

GRIZZLY HOMES SUBDIVISION, BECKWITH, ON

Project No.: CCO-22-0256

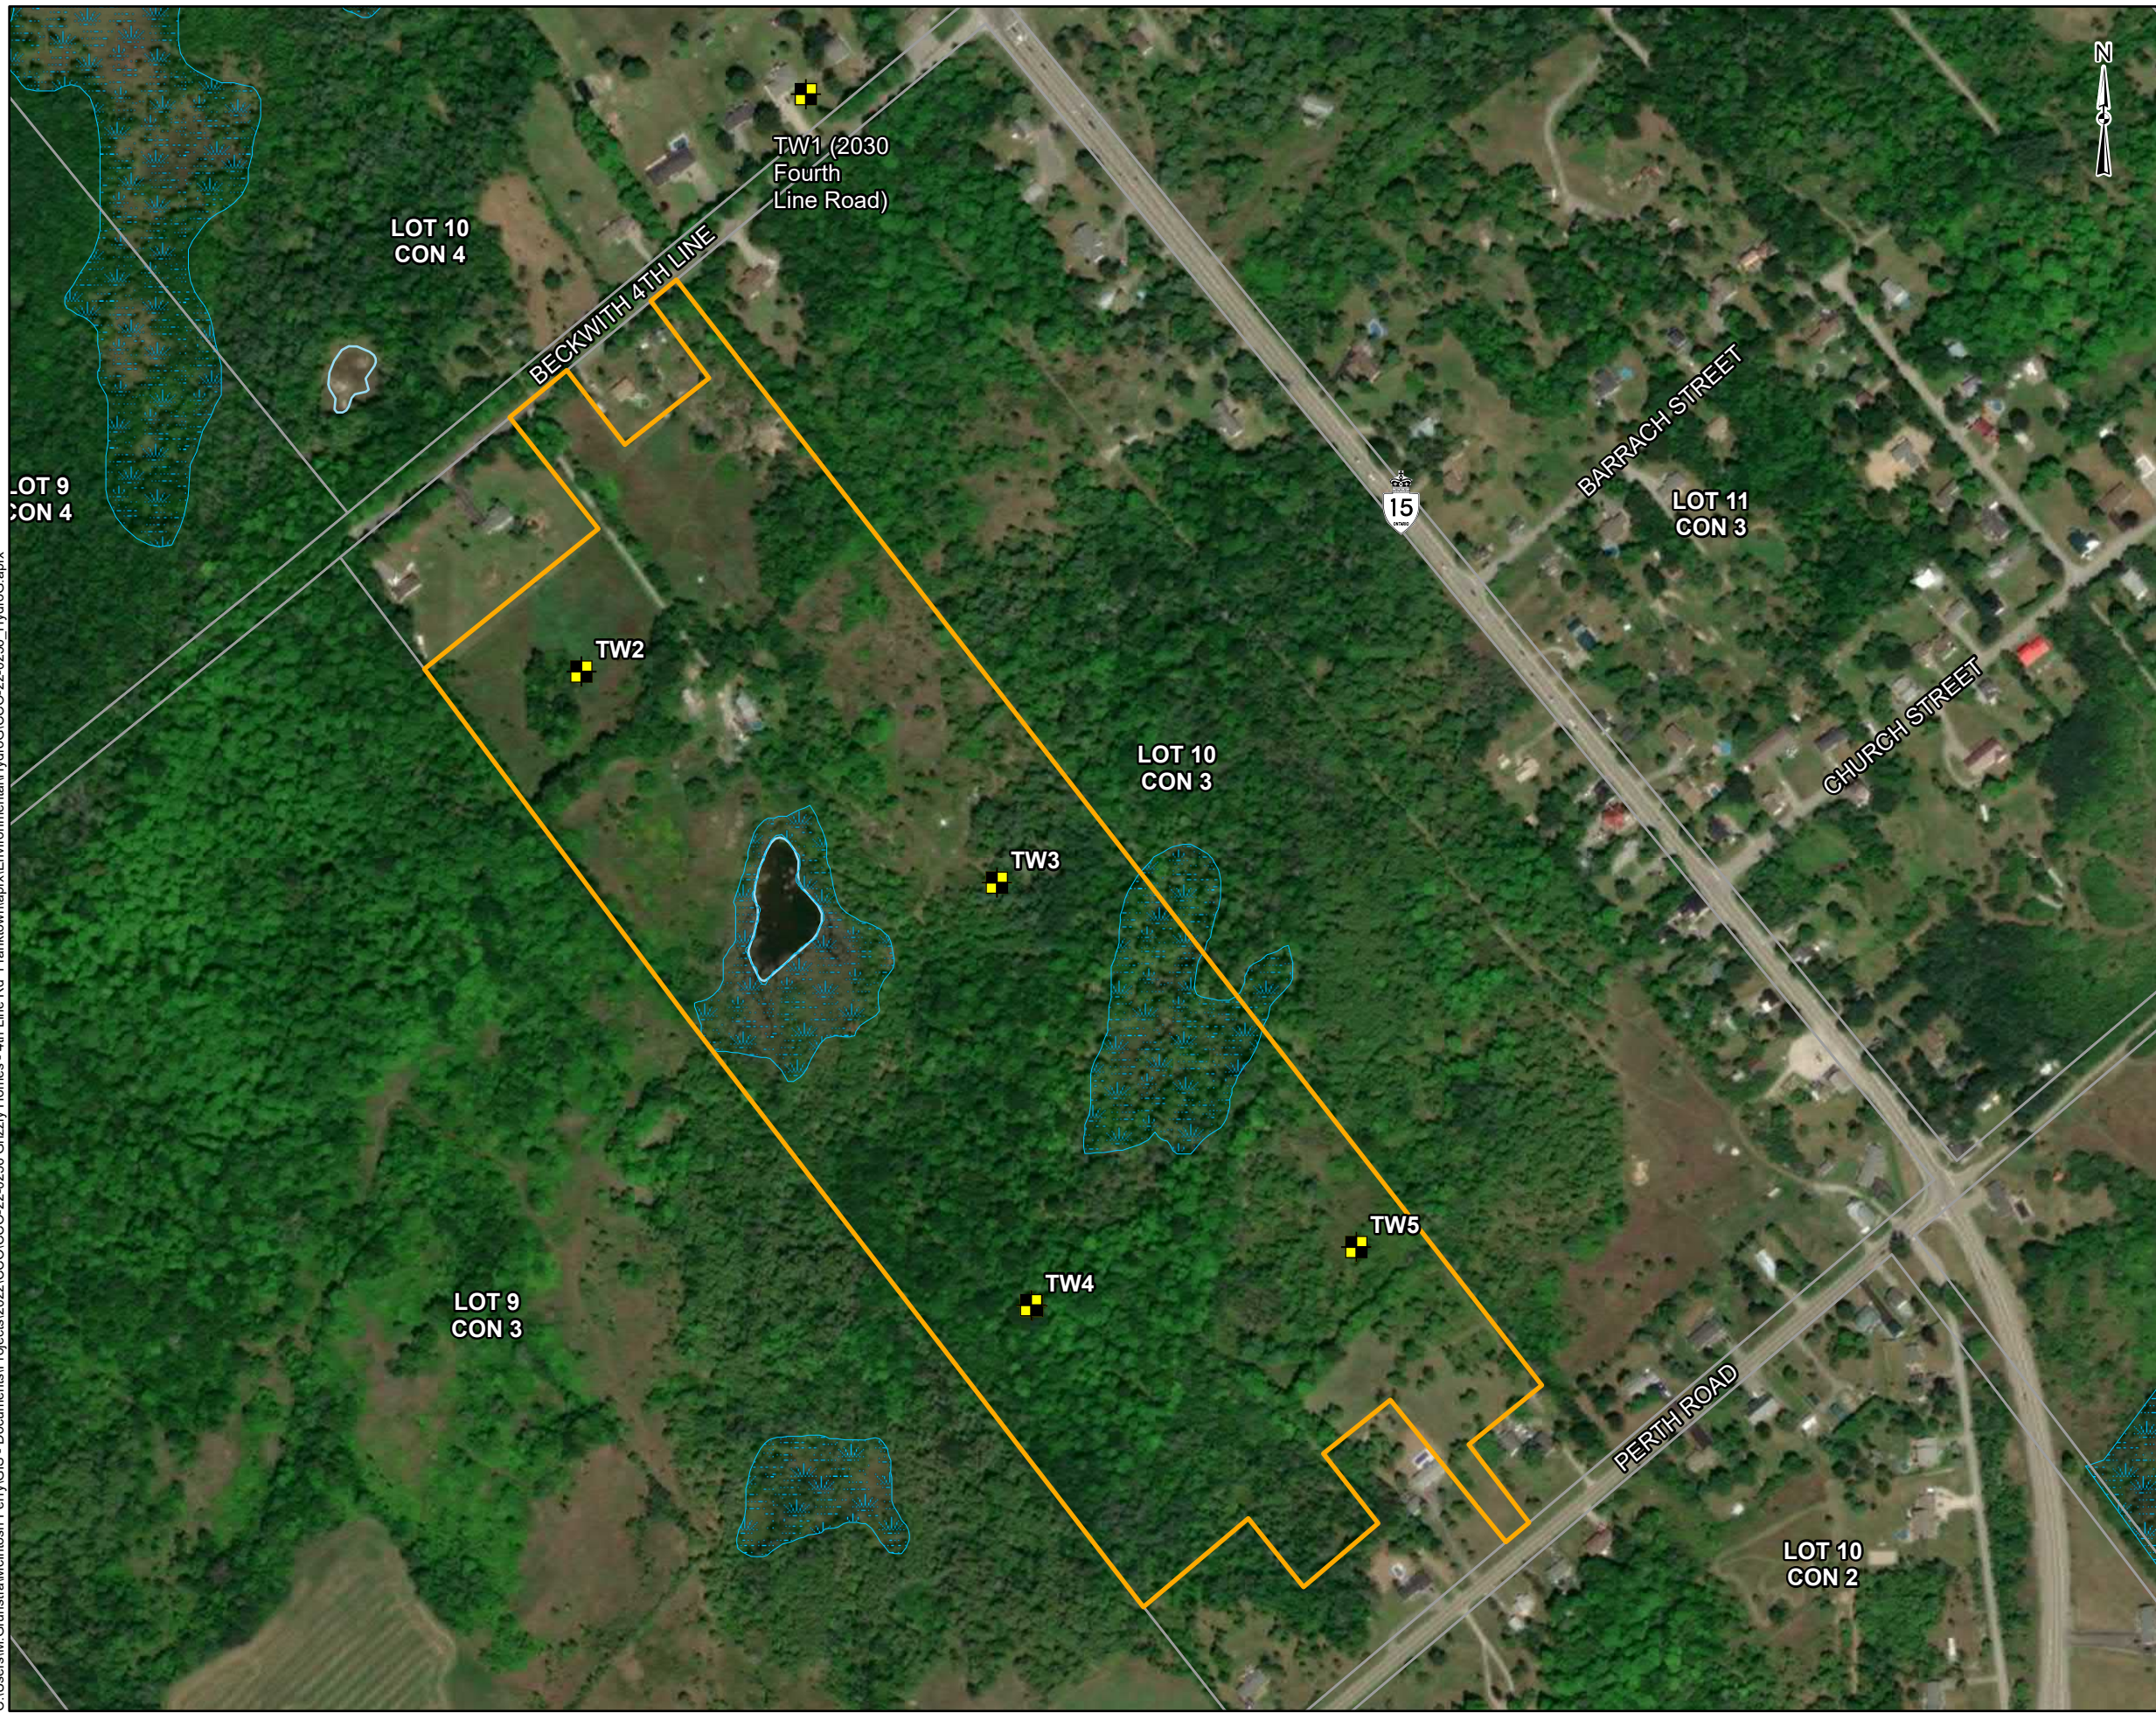
McIntosh Perry supervised the installation of four on-site water wells, as well as the excavation of fifteen on-site test pits. Wells were used for groundwater quality and quantity testing, and all test well locations were selected for eventual domestic use when the Site is developed. Test pit data were collected for purposes of soil classification and overburden thickness. A summary of the test wells and test pit locations is illustrated on Figure 2.

Air Rock Drilling Ltd. (Air Rock; Well Contractor’s Licence No.1119) was retained by Cavanagh Construction to drill four water wells at the Site for testing purposes and eventual domestic use when the property is developed. The drilling was conducted by licensed employees of Air Rock, and McIntosh Perry personnel observed the grouting of each well per O. Reg. 903 (Wells), as amended. The driller also provided and installed a pump for the pumping test activities at the drilled test wells (TW2, TW3, TW4, TW5). A summary of the test well construction based on driller-provided well records is presented in Table 1. The location of all on-site wells is noted on Figure 2.

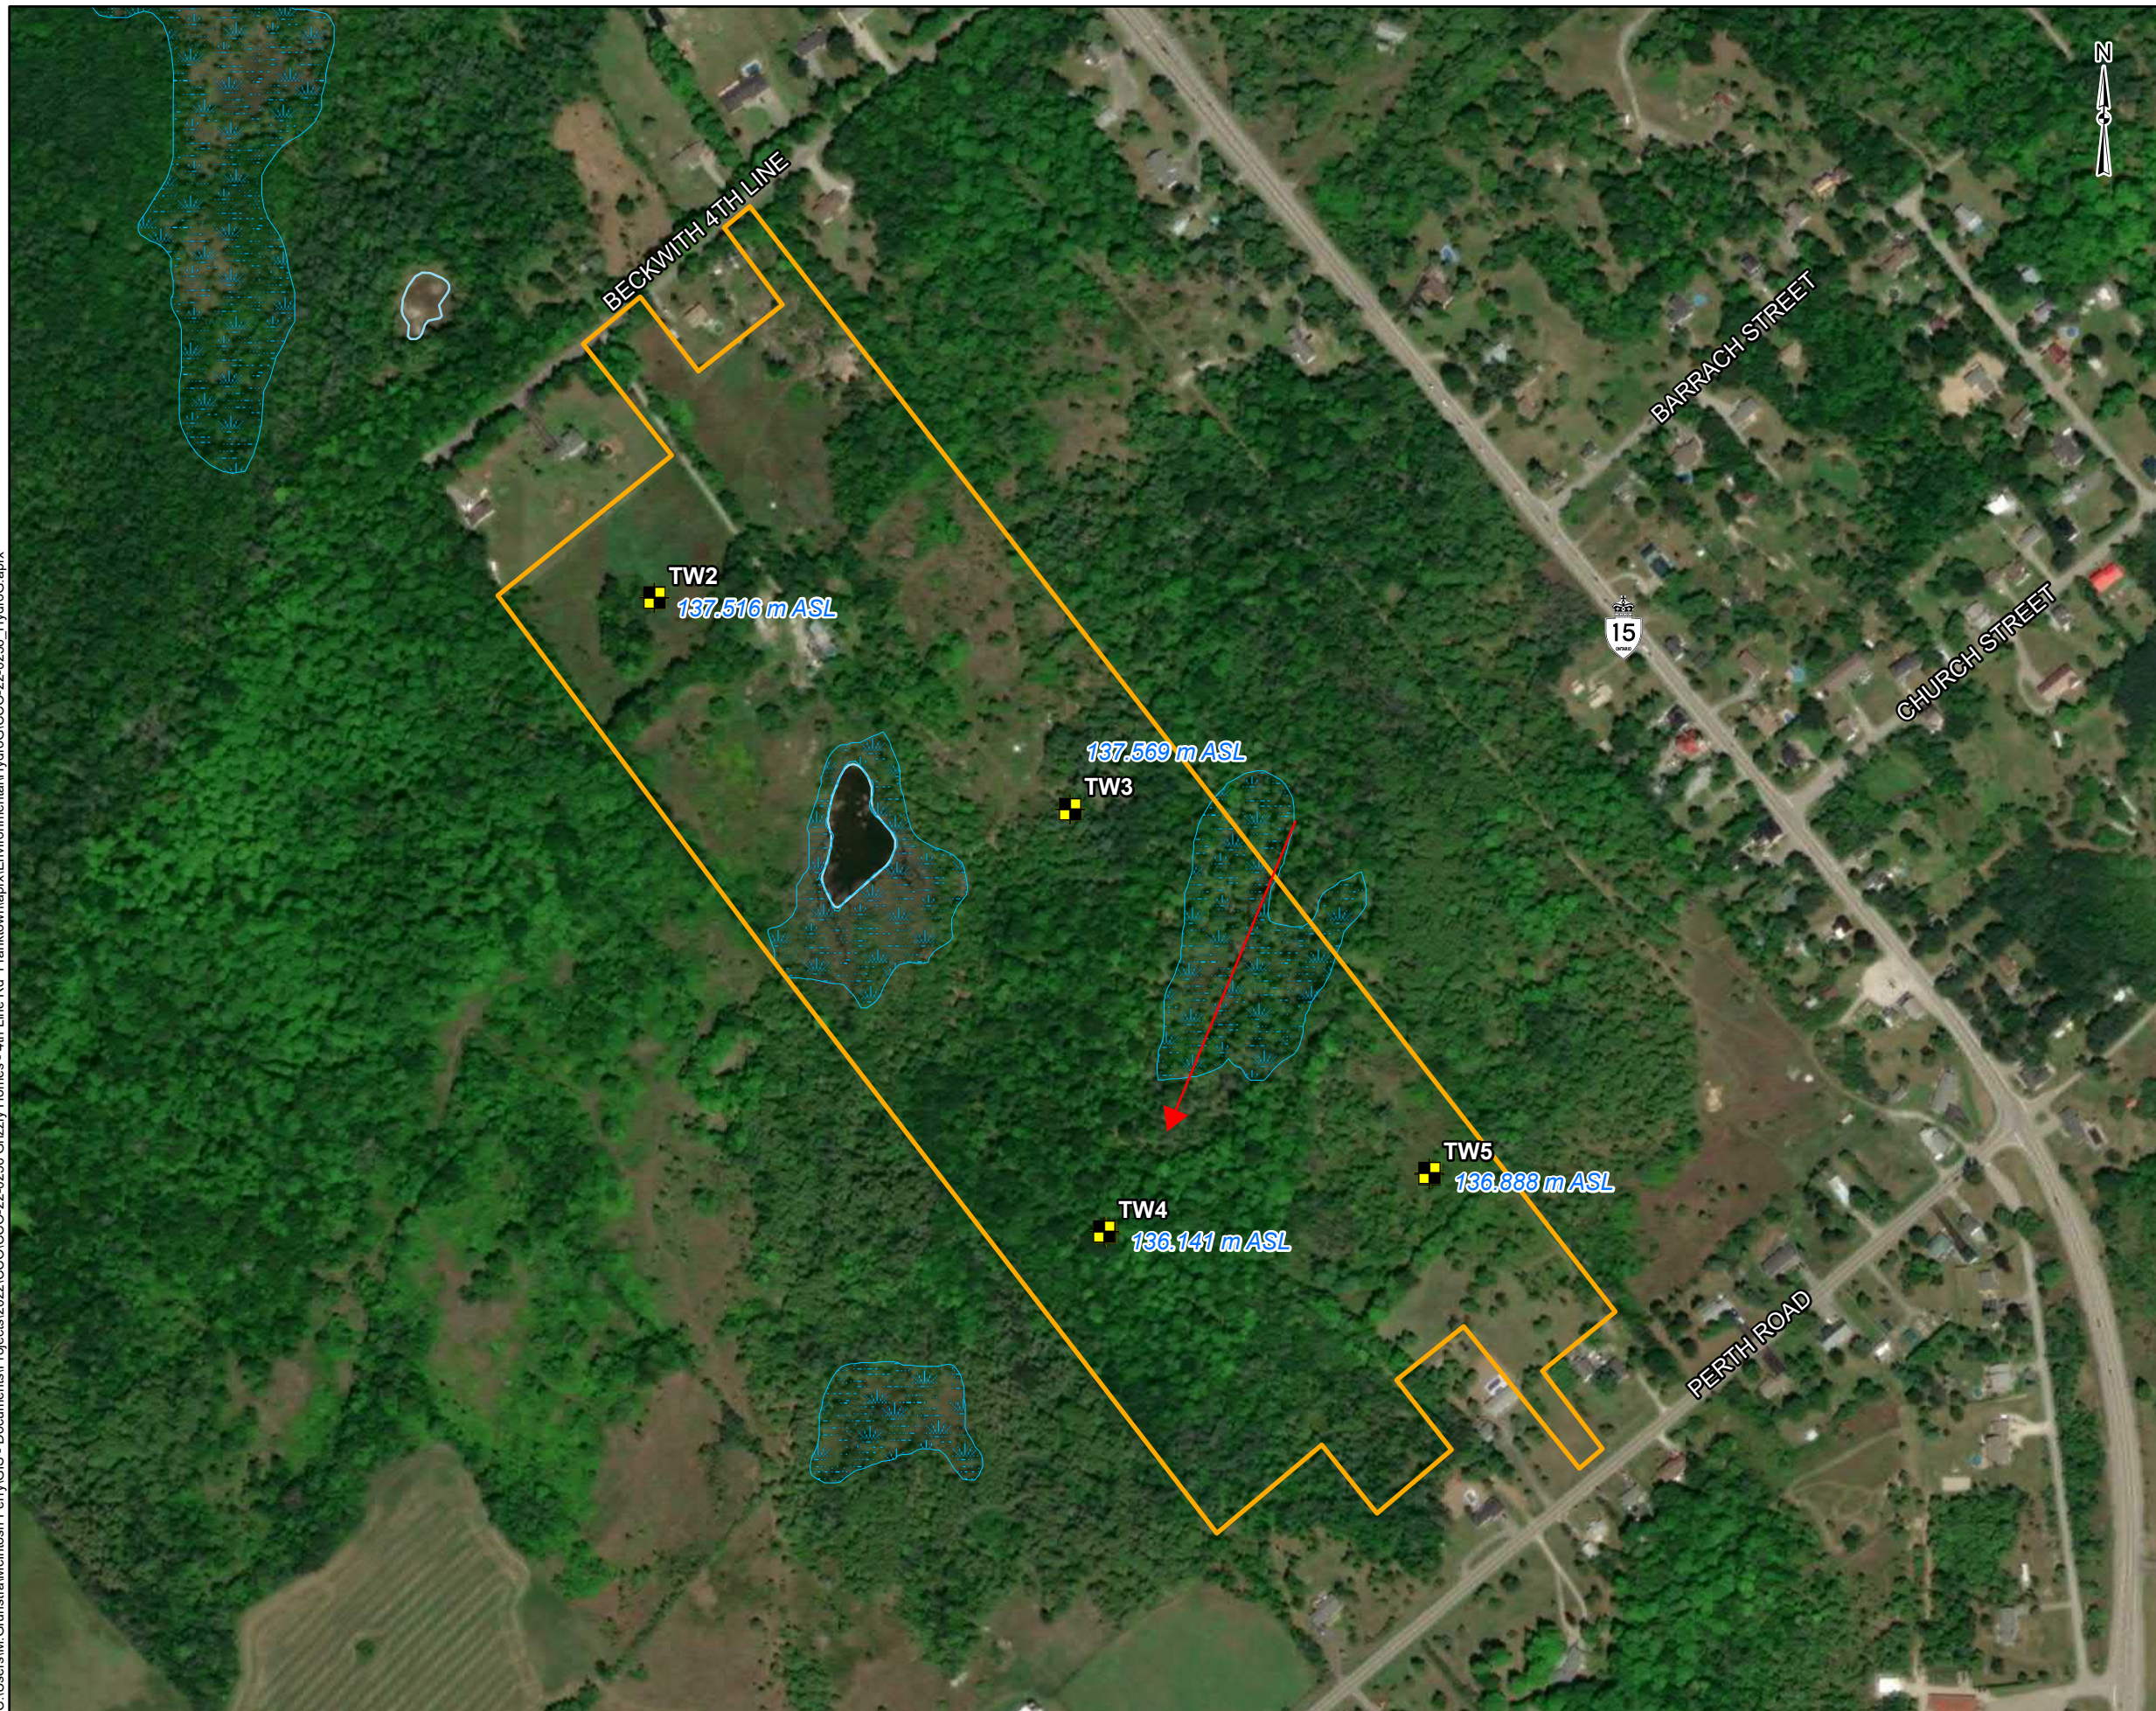
Prior to the initiation of pumping, water levels were measured in the seven test wells (Table 2, below). The static groundwater elevation ranged between 136.141 – 137.569 m asl at the time of the pumping tests (Figure 4). Static groundwater elevations suggest that on-site bedrock groundwater flow has a southwestern component, toward Mississippi Lake. On-site wells were completed in a similar geologic unit (listed by the driller as “sandstone”). Well depths are noted in Table 2, below.

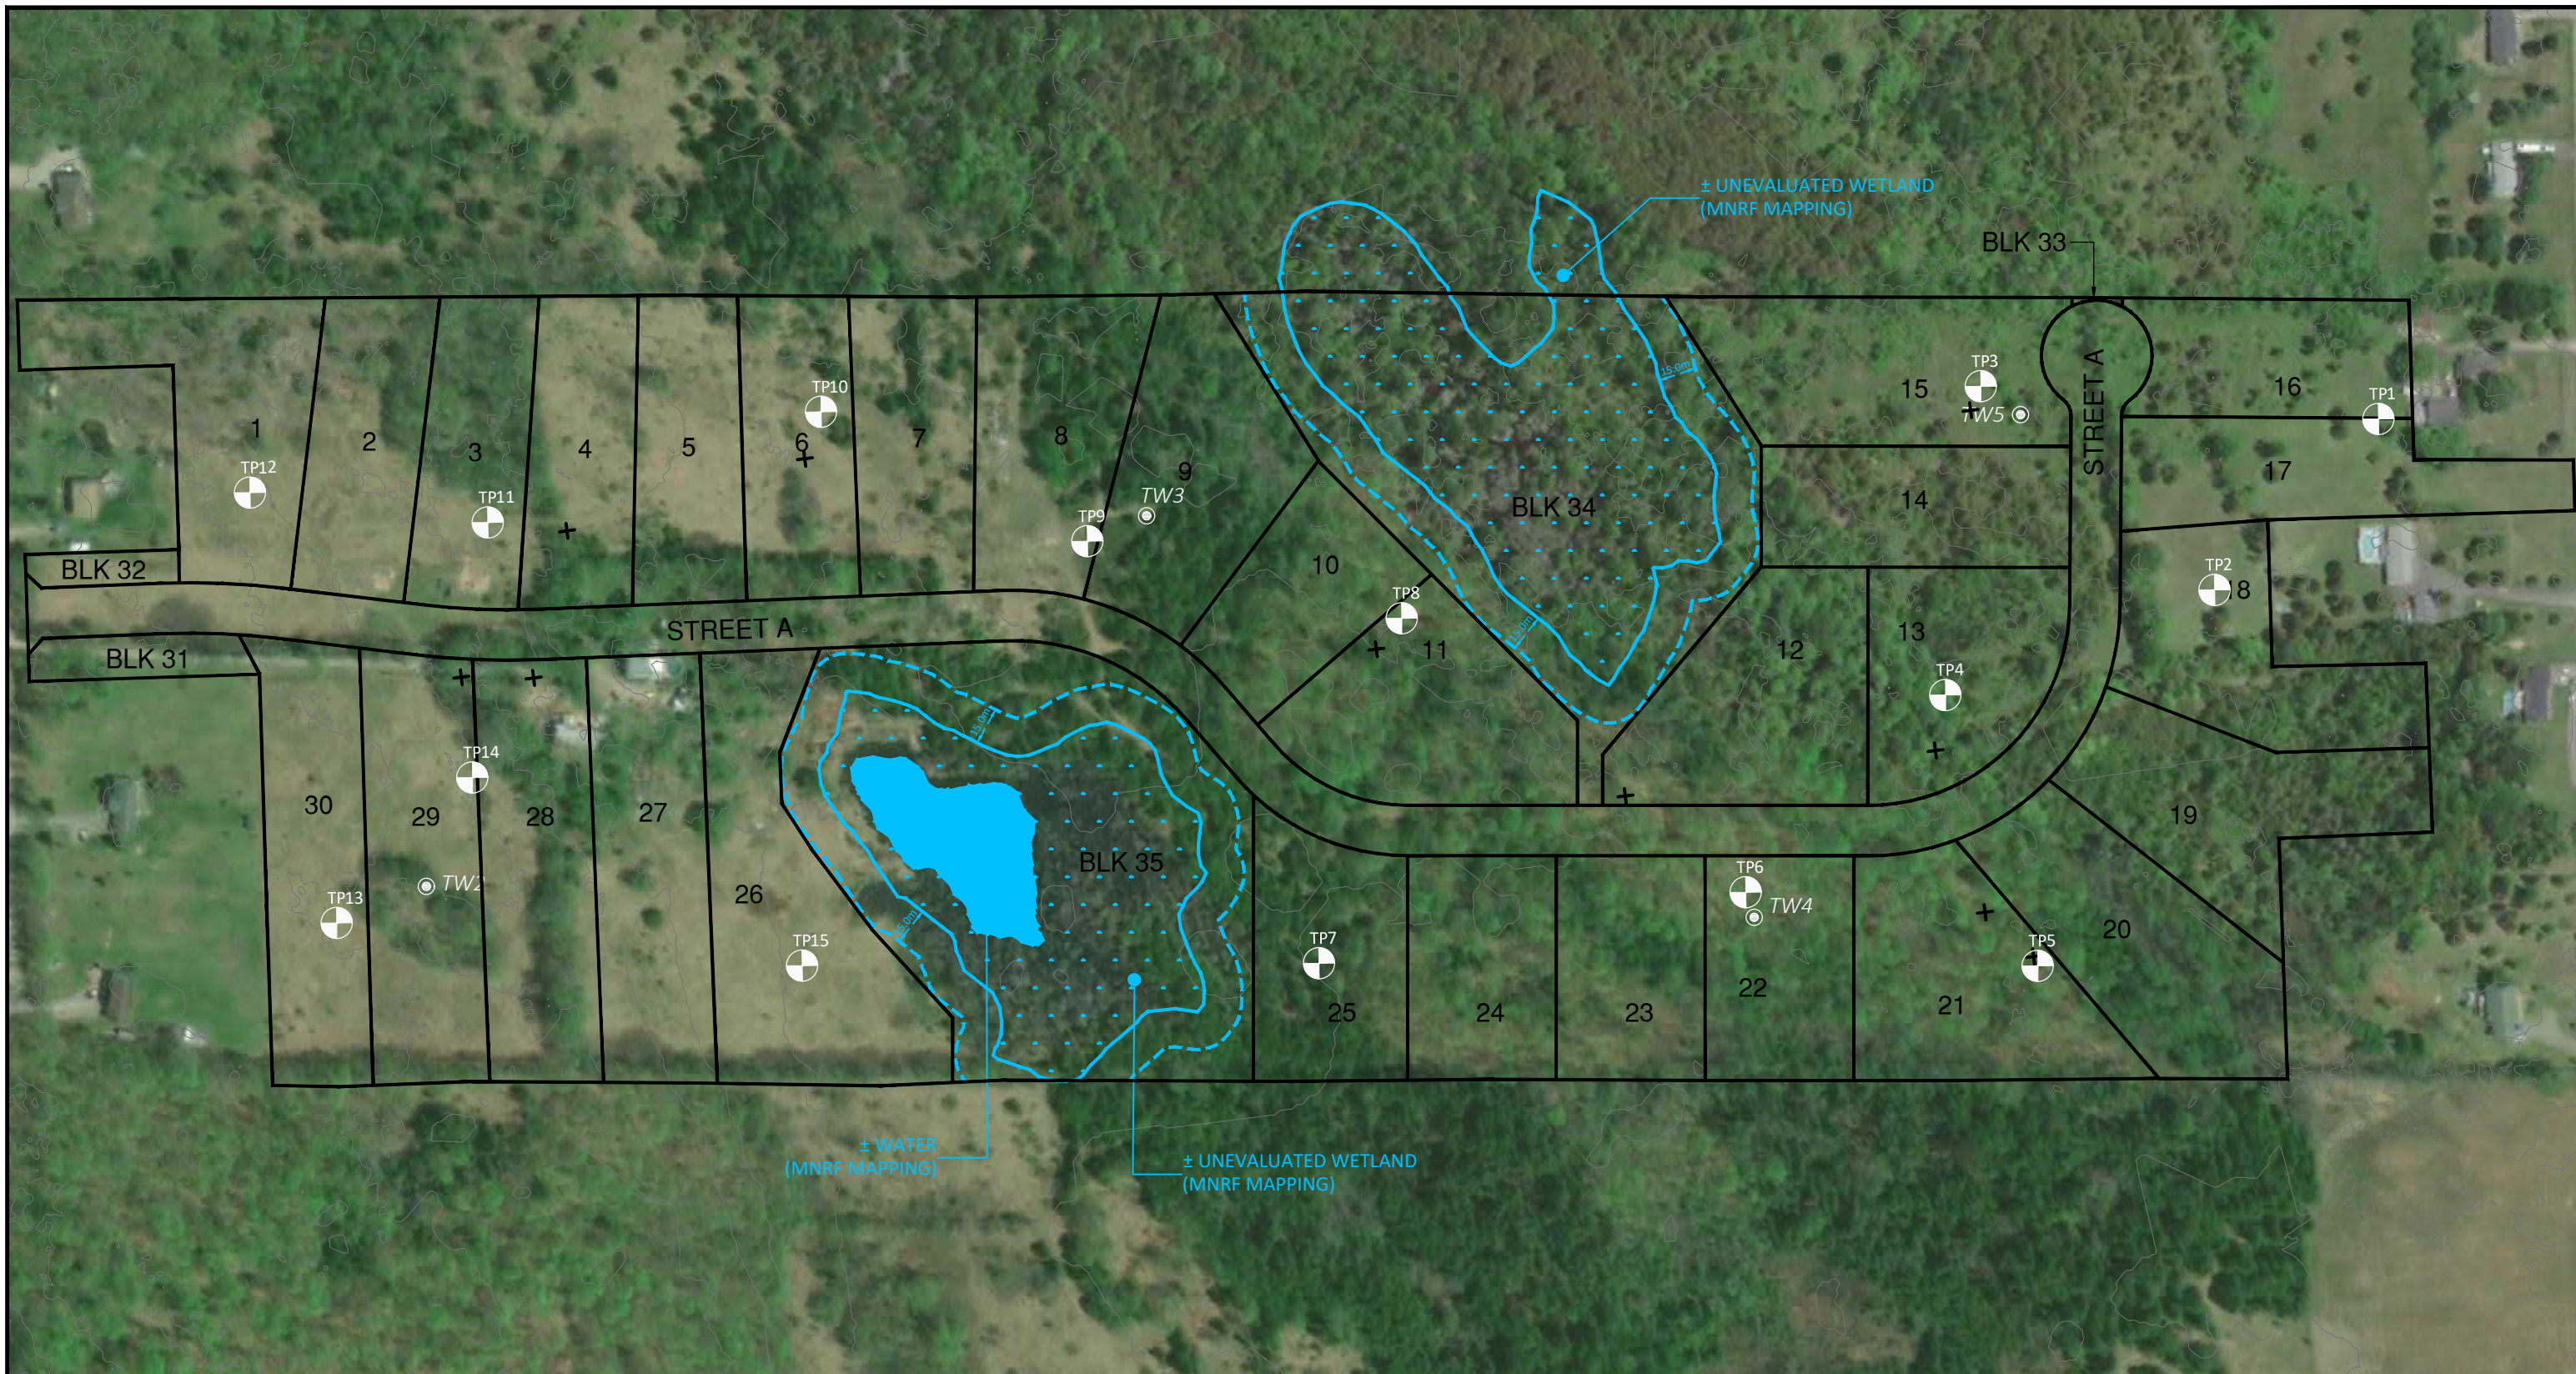
Soil and shallow groundwater conditions for each of the 15 test pits are summarized in Appendix H. Test pit locations are outlined in Figure 7. Soil characterization is summarized in Figure 8.
