Jp2g Ref No. 18-7048A

June 25, 2019
(Revised December 4, 2019 and May 19, 2020)

**Re: Environmental Impact Study (EIS) – Young Subdivision
Part Lot 3, Concession 8, Township of Beckwith, County of Lanark.
Our File No. 18-7048A.**

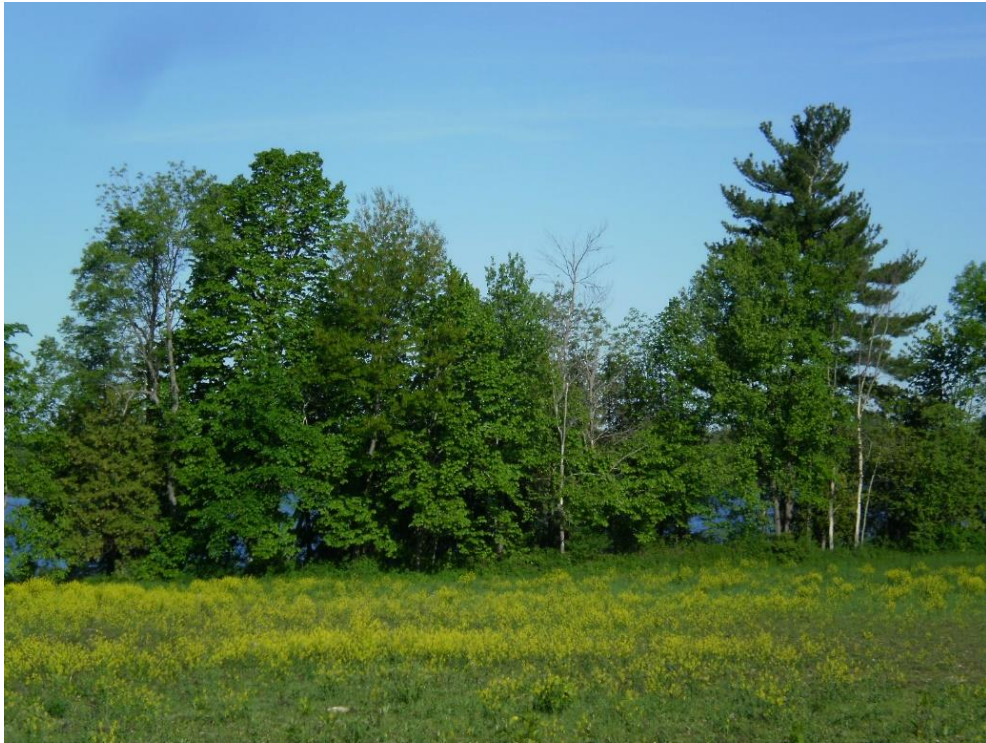
Photo 1 - Middle field looking west to deciduous hedgerow adjacent to the shoreline of Mississippi Lake
(June 6, 2019)

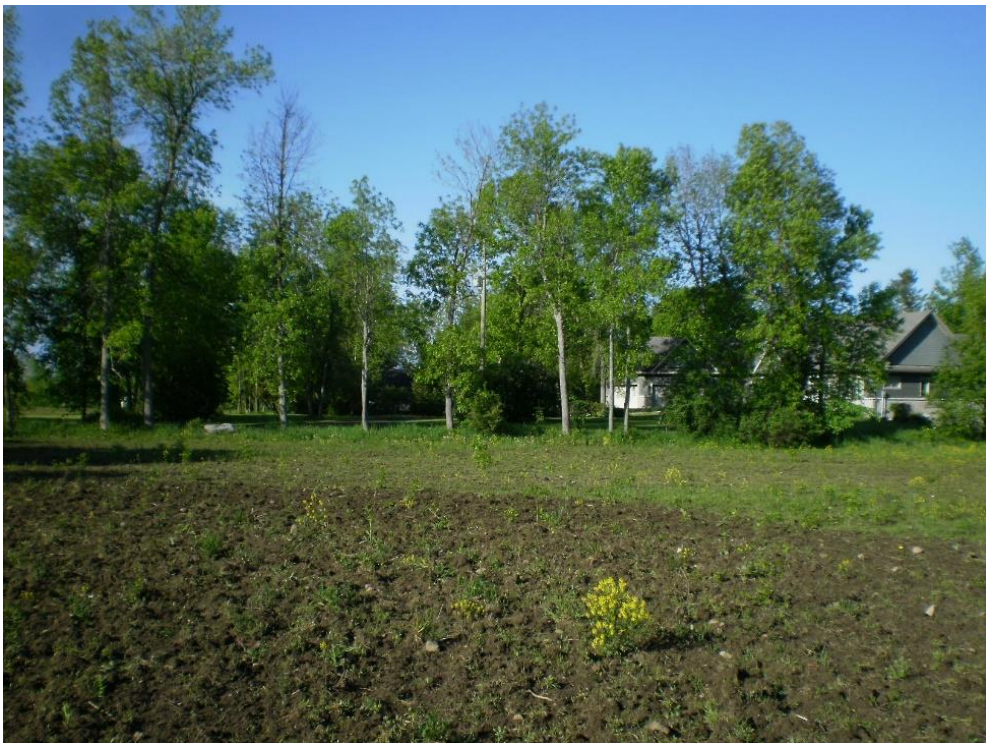
Photo 2 - Middle field looking south to existing severance from point count 1 in the middle of the field
(June 6, 2019)

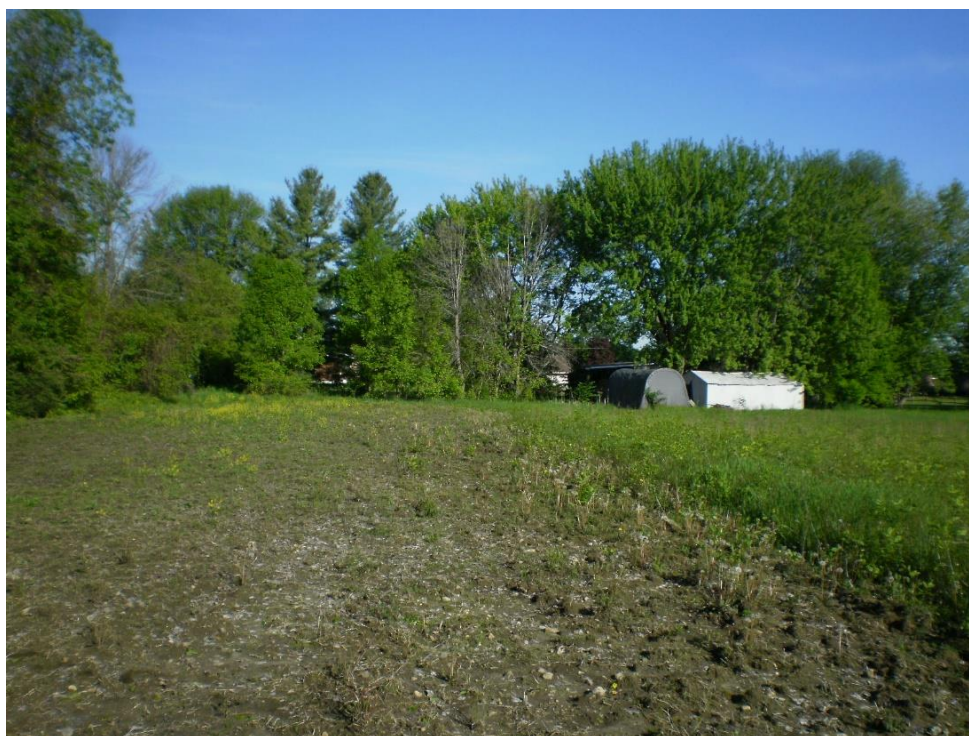
Photo 3 - North field looking west from point count 2 along the north edge of the property (June 6, 2019)

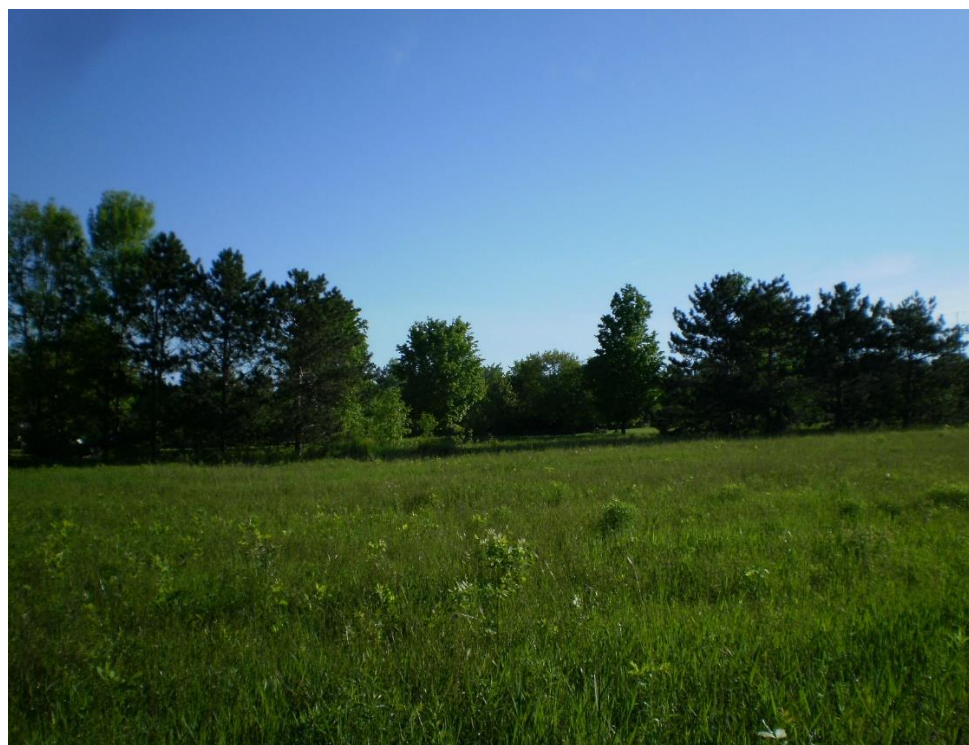
Photo 4 - Meadow to the north of the north site edge and point count 2. View looking north (June 13, 2019)

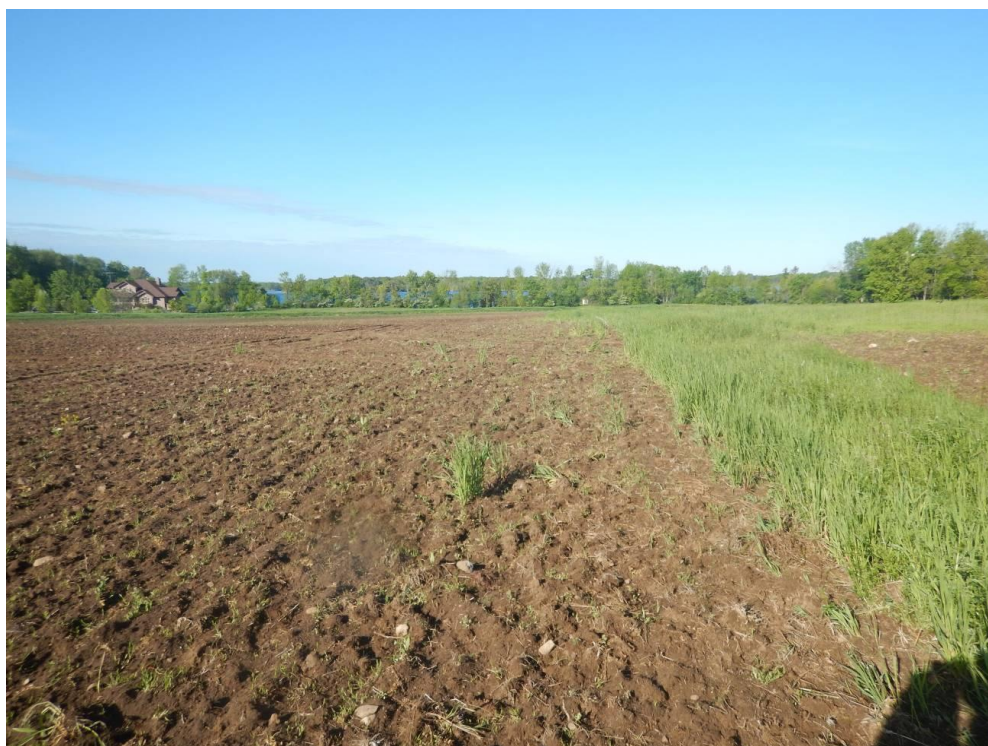
Photo 5 - South field looking west from point count 3 in the middle of the field
(June 6, 2019)

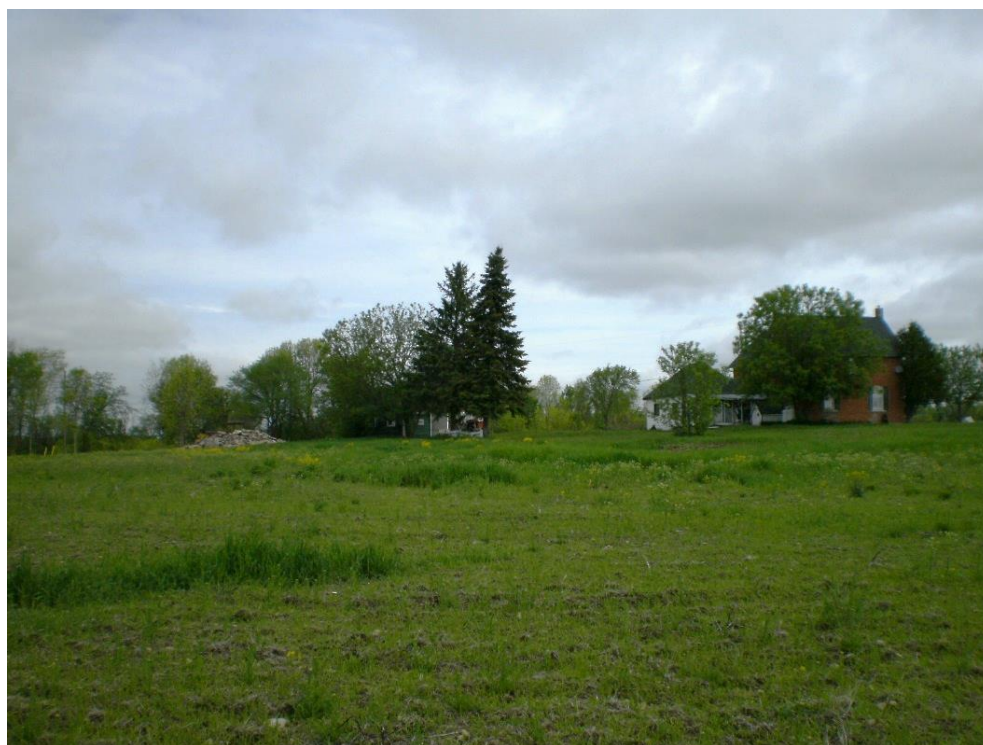
Photo 6 - South field looking north to farmhouse from point count 3
(May 29, 2019)

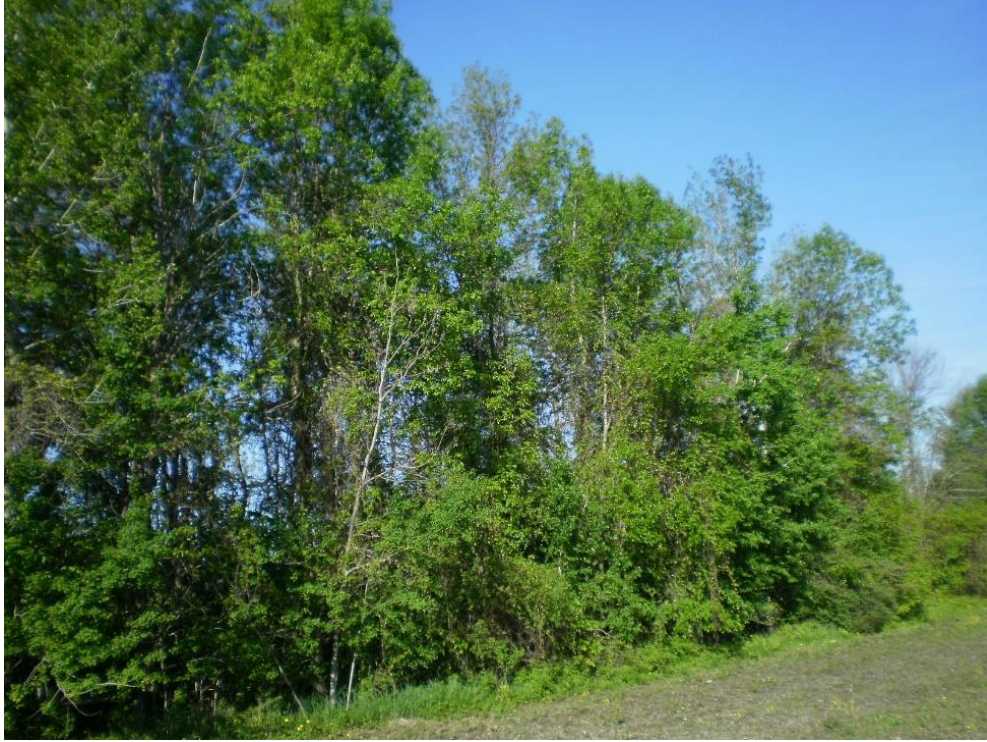
Deciduous hedgerows (Photos 7-9) are present along the laneways and shoreline on the subject lands. White ash and trembling aspen are dominant, with Manitoba maple, white elm, basswood, sugar maple, green ash, and black cherry well represented in areas. Many of the ash trees are damaged by emerald ash borer and had greatly reduced leaf-out. Many of the white elm also showed reduced leaf-out. Most trees are in the 25cm to 35cm diameter at breast height (dbh) range with a 50cm Manitoba maple at the east end of the laneway west of Ninth Line and white ash up to 55cm dbh to the southwest along the laneway. The hedgerows along the shoreline have a greater conifer component including two mature white pine trees (65cm and 70cm dbh, Photo 9) and white cedar trees up to 38cm dbh.

Photo 7 - Deciduous hedgerow along the south edge of the north field.
View looking northwest (June 6, 2019)

2. A 30.0 metre wide buffer area is to be maintained along the shoreline of Mississippi Lake. This buffer area should be maintained substantially in a natural vegetated state, with the exception of a pathway constructed of permeable surface materials leading to the Lake as well as the limbing of trees to provide for a view of the Lake and the removal of dead or diseased trees. Woody vegetation regeneration is to be encouraged in current open areas of the setback;

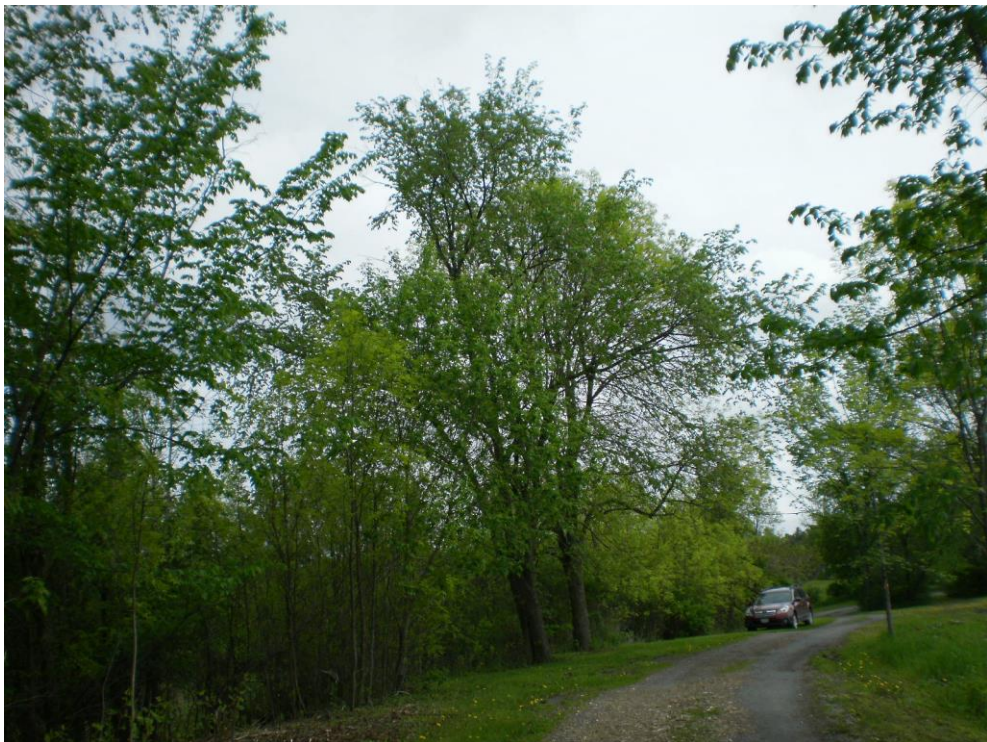
Photo 8 - White elm in deciduous hedgerow along laneway off Ninth Line in the north-central portion of the site.
View looking north (May 29, 2019)

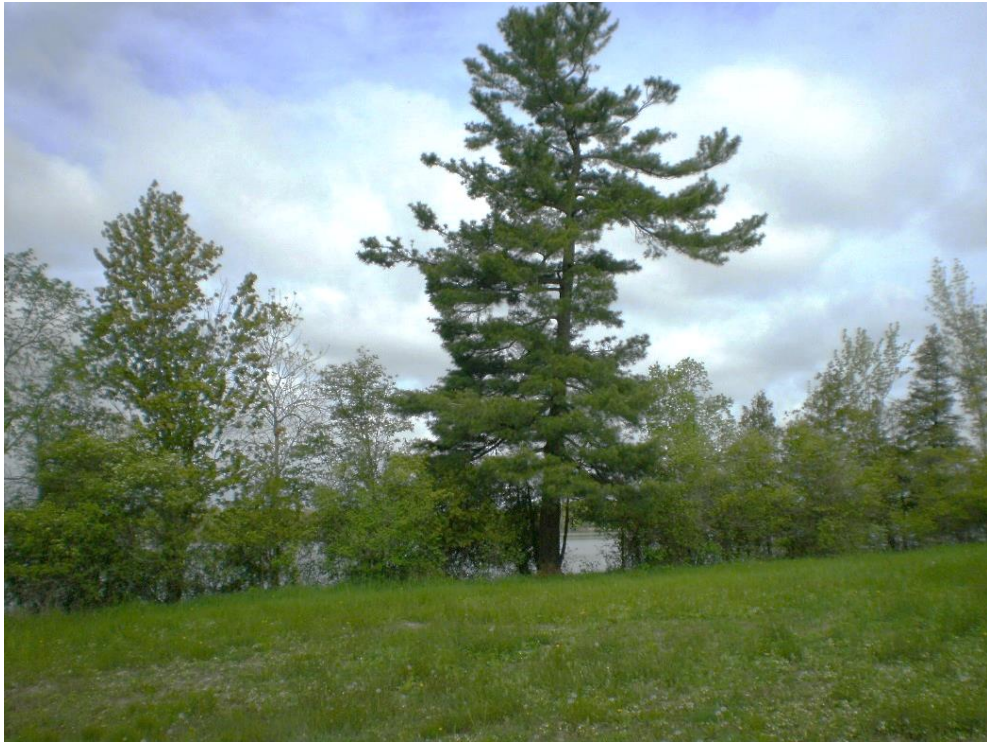
Stone piles were noted adjacent to the shoreline at the west edge of the north fields within the shoreline setback and potential wildlife cavities were present in one of the mature white pines along the shoreline, also within the shoreline setback.

Acoustic surveys for bats were not carried out at the subdivision lands as they were not considered to contain suitable high potential maternity roost habitat for bats, due to the lack of cavity trees/snags greater than 25 cm in diameter on the subdivision lands. Potential wildlife cavities were only present in one of the mature white pines along the shoreline (within setback).

Photo 9 - Mature white pine along Mississippi Lake shoreline to the west of the south field.
View looking northwest (May 29, 2019)

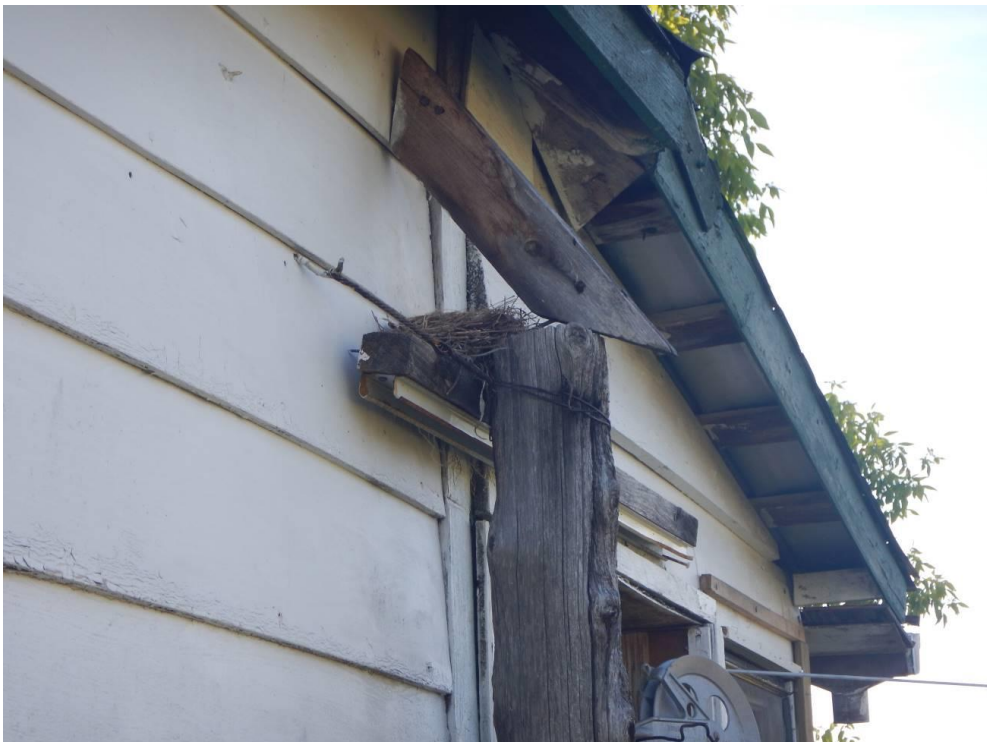
Two American robin nests were seen on the farmhouse (Photo 10), and one on the outside eaves of the large shed adjacent to the farmhouse. An active eastern phoebe nest was also seen behind the eavestrough on the large shed (Photo 11).

Photo 10 - Robin's nest on west side of farmhouse
(June 6, 2019)

1. Nests and eggs of many bird species are protected under federal and/or provincial legislation such as the Migratory Birds Convention Act and the Fish and Wildlife Conservation Act. To protect breeding birds, no tree or shrub removal should occur between May 15th and July 31st, unless a breeding bird survey completed by a qualified biologist within five days of the woody vegetation removal identifies no nesting activity. A similar restriction applies to the removal of the on-site structures, which the owner advises will be demolished in September;

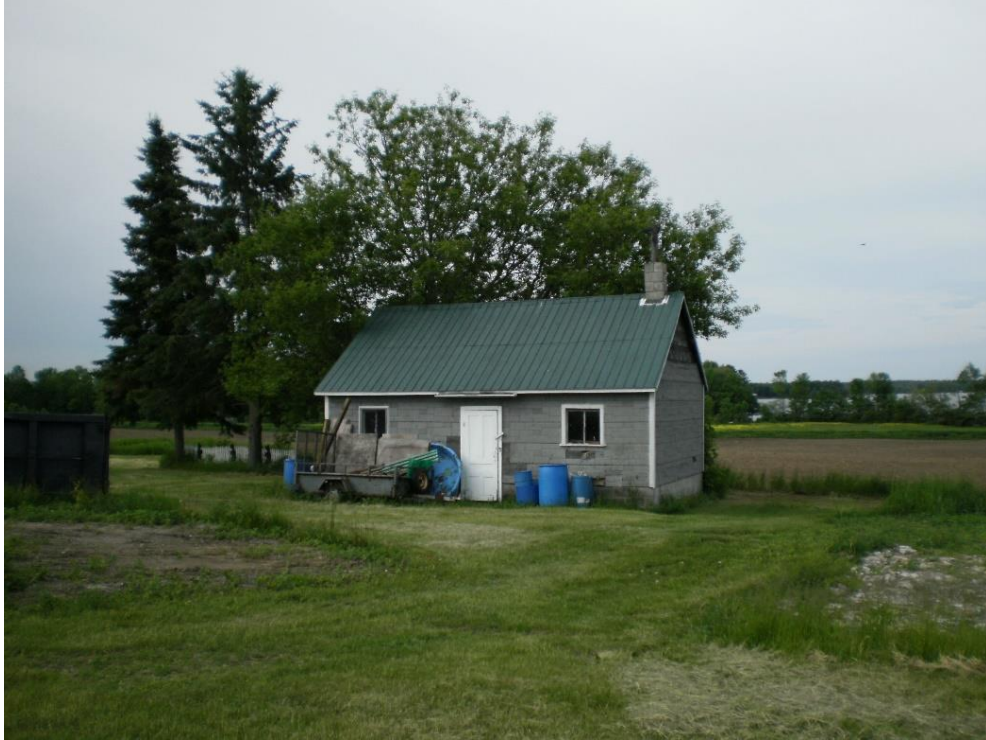
The subdivision lands contain two structures. Although no access to the interior was possible, some external rafters could be suitable barn swallow nesting habitat. No barn swallows were observed during the three morning spring site visits carried out at the property.

Photo 11- Large shed to the northeast of the farmhouse.
View looking north (June 13, 2019)
