**Hydrogeological Investigation &
Terrain Analysis
Proposed Residential Subdivision
Lot 3, Concession 8
Beckwith Township, Ontario**

March 11, 2020
Project: 60215.11

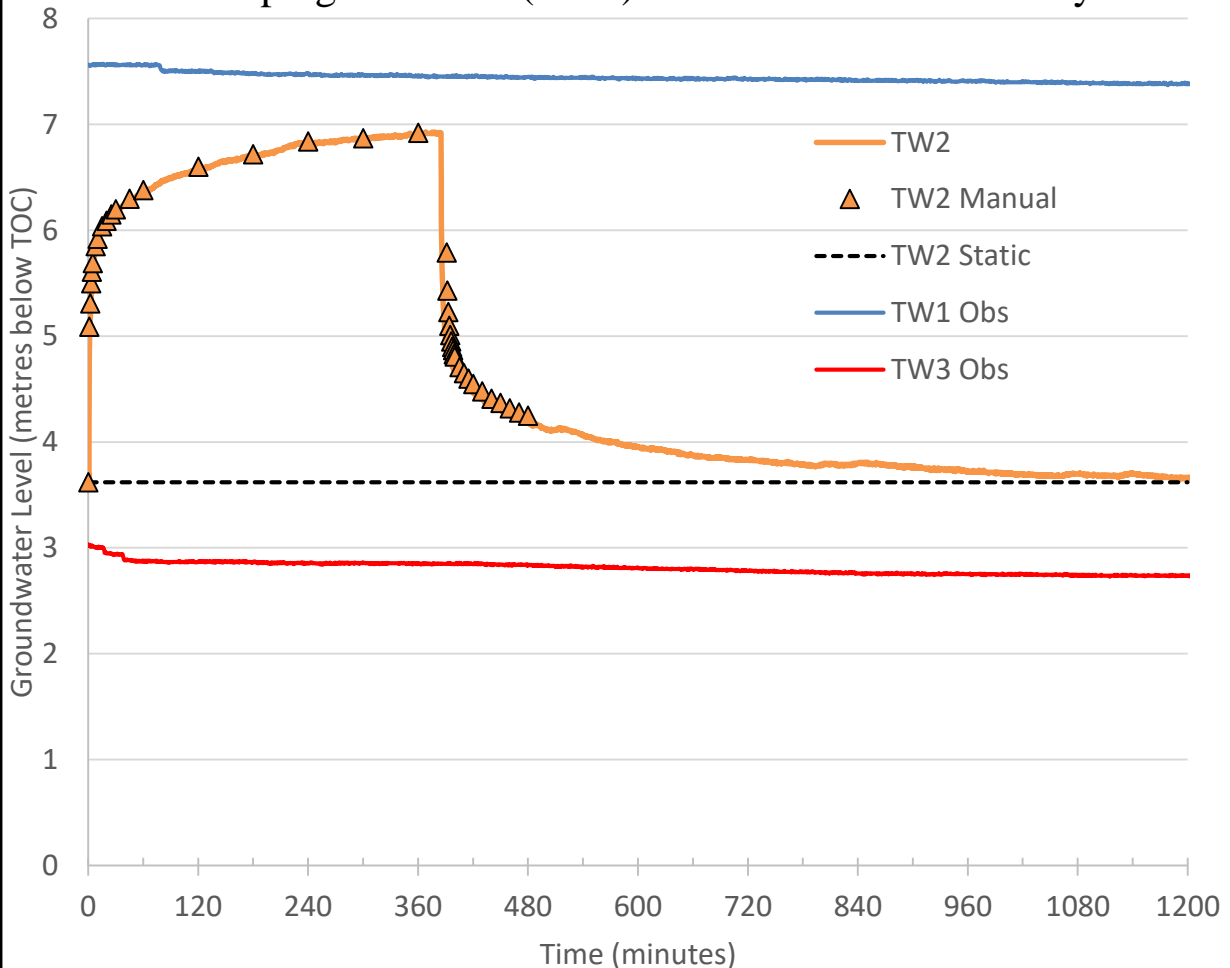
Pumping Test Data (TW2): Drawdown and Recovery

Note: Diver Datalogger recording at 15-second intervals; compensated with on-site barometer.

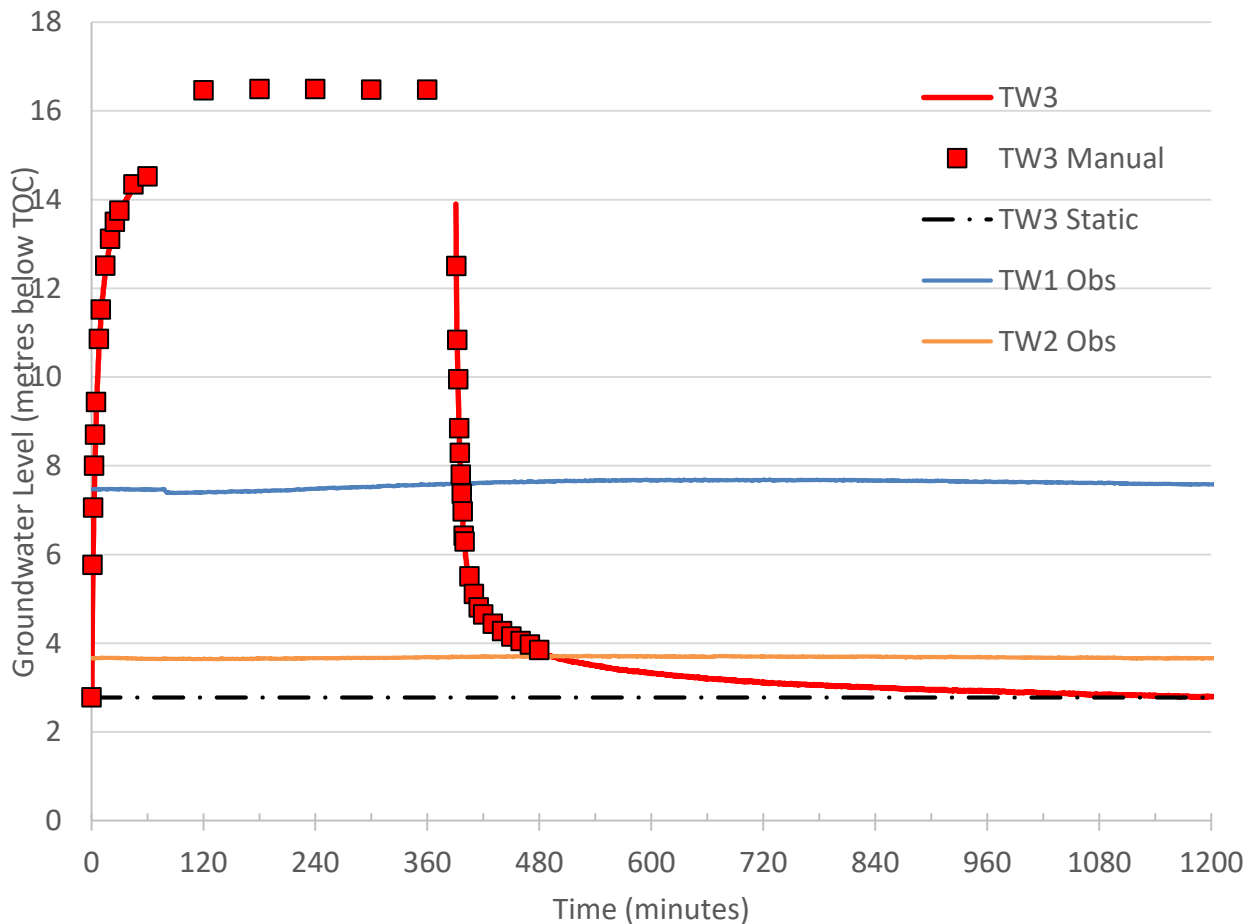
Pumping Test Data (TW3): Drawdown and Recovery

Note: Diver Datalogger recording at 15-second intervals; compensated with on-site barometer.

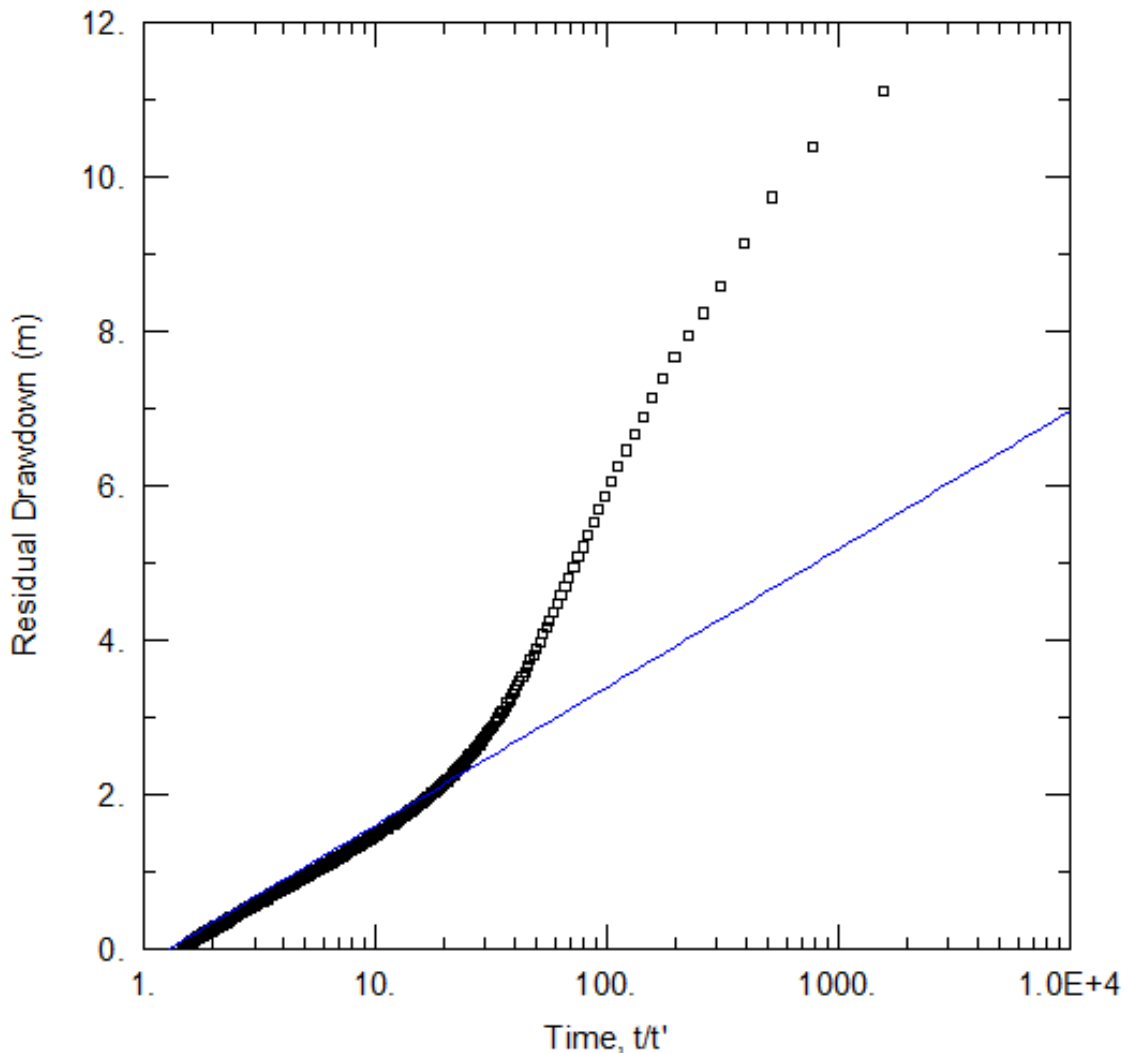
Pumping Test Analysis – Theis Recovery (TW3)

Aquifer Model: Confined

Estimated Transmissivity: 5.8 m²/day
