Muncaster
Environmental
Planning Inc.

**RE: Mill Valley Estates, Southeast Almonte
Environmental Impact Assessment**

NATURAL ENVIRONMENT FEATURES

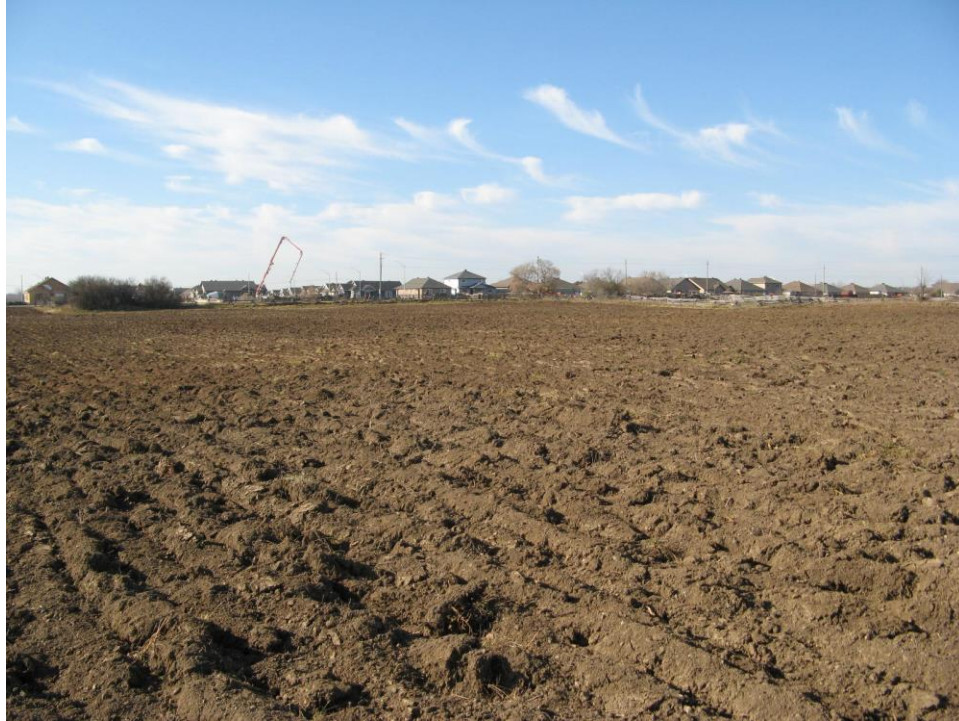
Photo 1 – Agricultural field in the southwest portion of the site. View looking west

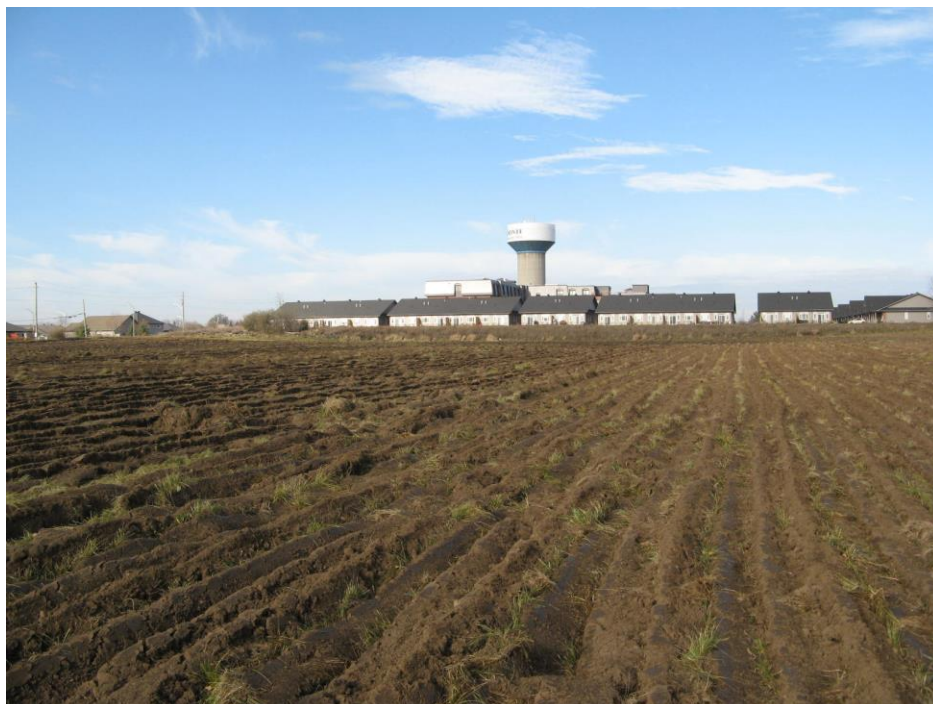
Photo 2 – Agricultural field in the northwest portion of the site. View looking north

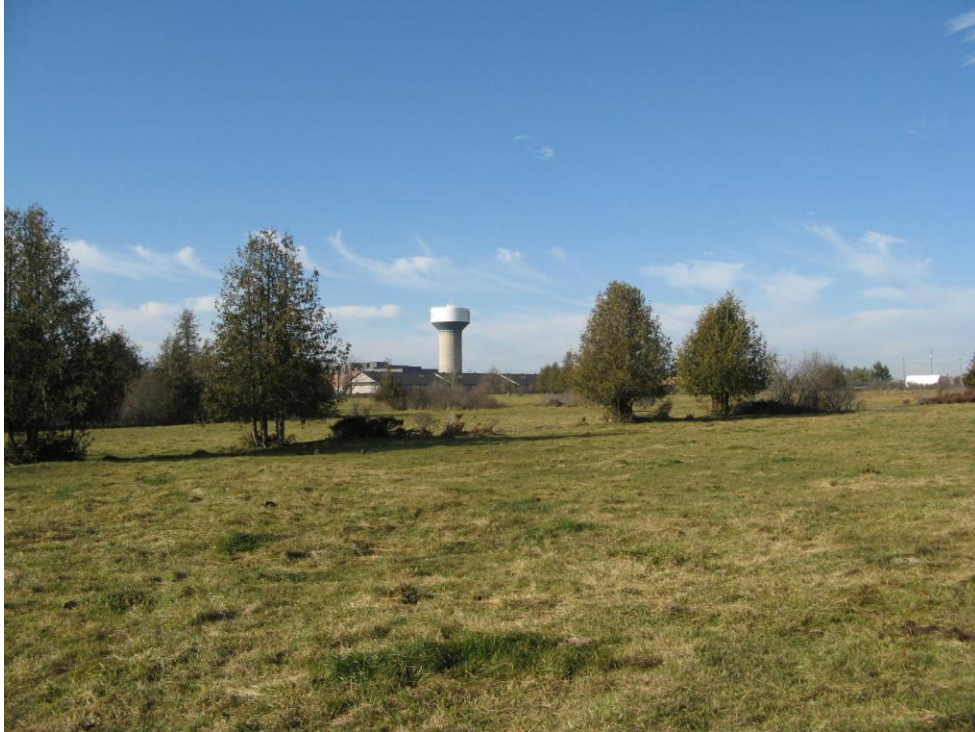
Photo 3 - Pasture habitat in the north-central portion of the site. View looking northwest

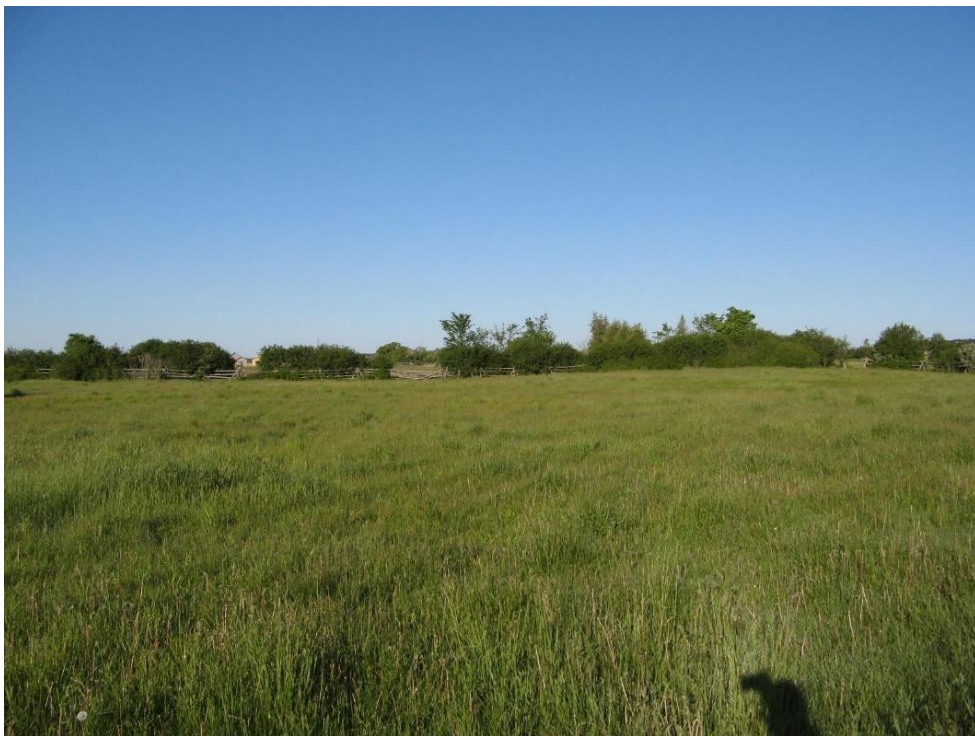
*Photo 4 - Pasture habitat in the south-central portion of the site.
View looking west to intermittent deciduous hedgerow*

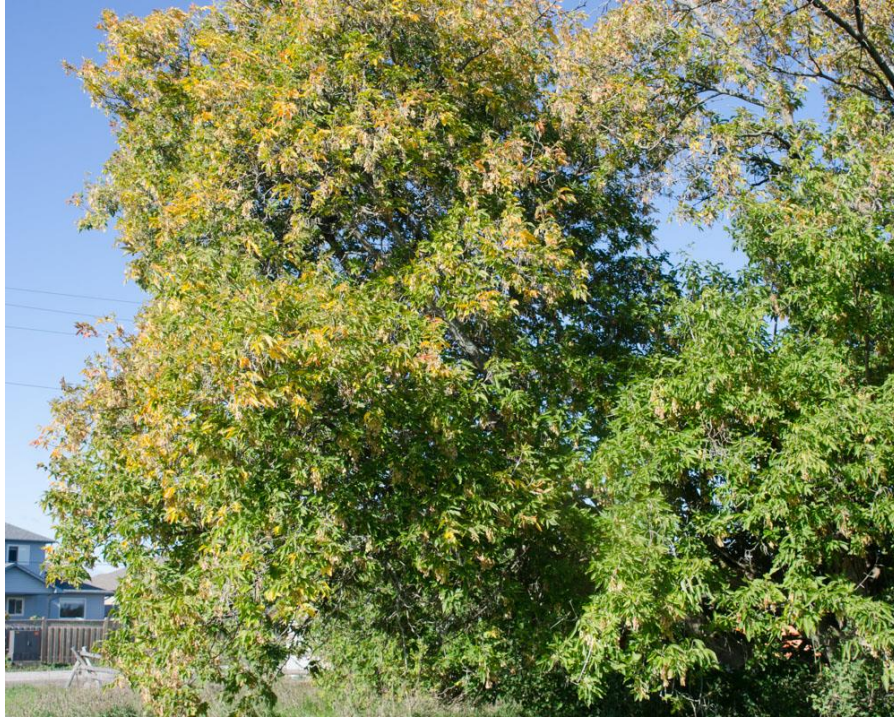
*Photo 5 – Manitoba maples are common along the south-central site edge.
View looking south*

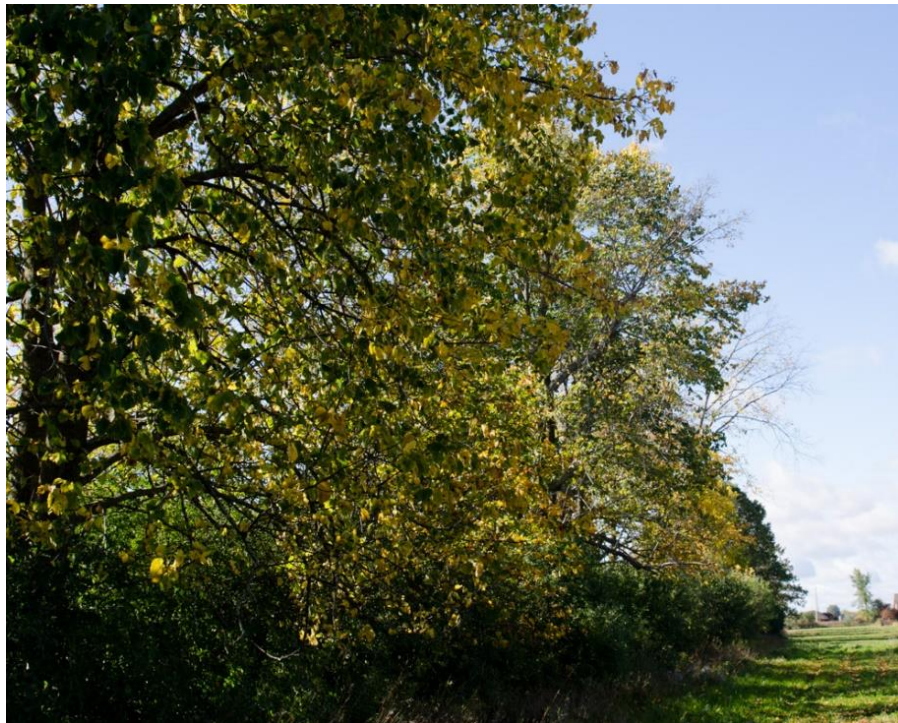
Several areas of deciduous hedgerows are between the agricultural fields (Photo 6). Bur oak, basswood, green ash, white ash, Manitoba maple, white cedar, sugar maple, white spruce, and white elm are the common trees in the hedgerows (Photos 5 and 7), with tartarian honeysuckle, prickly ash, common buckthorn, red raspberry, blackberry, hawthorn, and apple shrubs among the hedgerow trees. Regenerating basswood, white elm, Manitoba maple, and ash are also among the hedgerow trees. The larger trees include basswoods in the northwest portion of the site up to 60cm dbh, and a twin-stem bur oak, with individual stems up to 58cm dbh and a 45cm dbh sugar maple on the west site edge. Leaf-out was poor on many of the ash and elm trees and thicket creeper and wild grape coverage is common on some lower tree branches. Other than along the west portion of the south site boundary, the deciduous hedgerows are intermittent.

*Photo 6 – Deciduous hedgerow along the south site boundary.
View looking west*

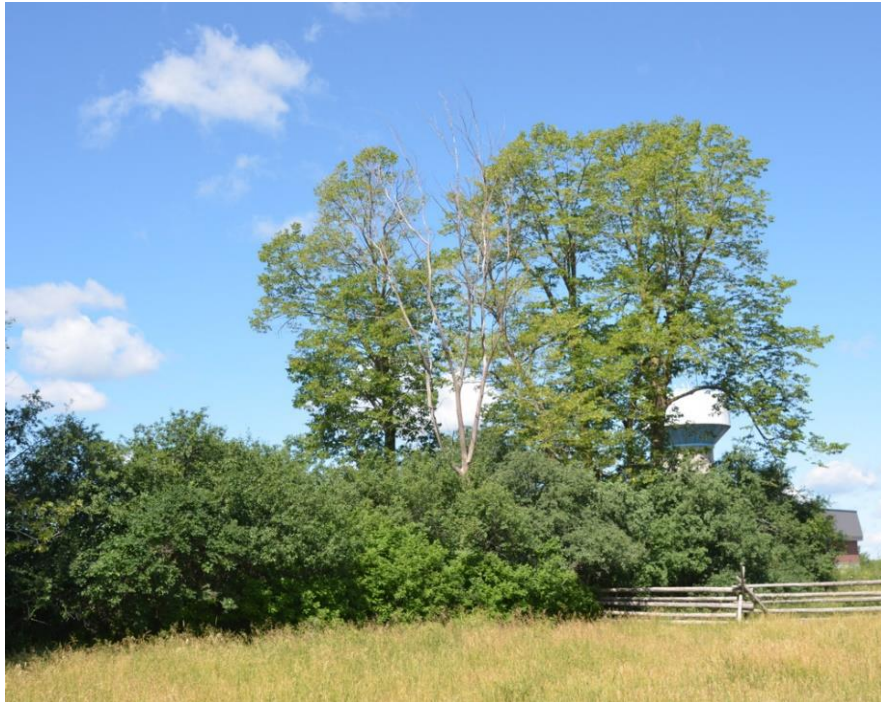
*Photo 7 – Basswood in the intermittent deciduous hedgerow in the northwest portion of the site.
View looking northwest*

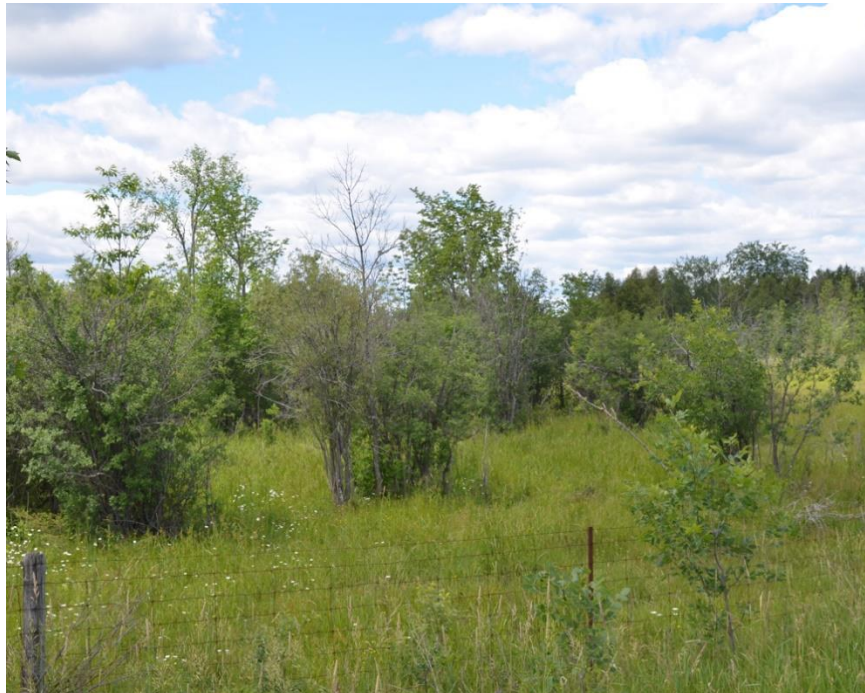
Where there is more woody vegetation cover, cultural thicket habitat is mapped in the central and east portions of the site (Photo 8). Common buckthorn shrubs are dominant in much of the thicket habitats, with prickly ash very common in others. Common juniper, slender willow, Bebb's willow, tartarian honeysuckle, black currant, red-osier dogwood, and barberry shrubs are

*Photo 8 – Cultural thicket in the northeast portion of the site,
with view looking west from Appleton Side Road*

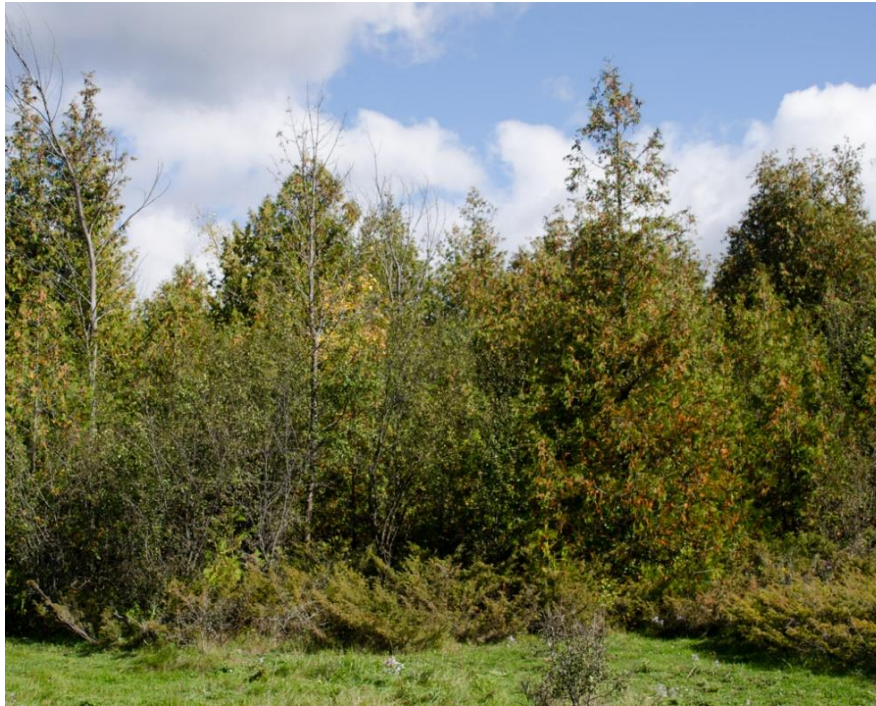
Several pockets of upland coniferous forests are in the east portion of the site, west of Appleton Side Road (Photos 9 and 10). The small forests are heavily dominated by white cedars. There is a high density of cedars, with the largest stems in the 25cm dbh range. Due to the cedar density, there is limited understory and ground vegetation in the coniferous forests. A few deciduous trees, up to 30cm dbh, are in the coniferous forests, including white ash, green ash, and white elm. Most of the ash trees are dead and many of the elm had reduced leaf-out.

*Photo 9 – Upland cedar coniferous forest representation in the northeast portion of the site.
View looking east*

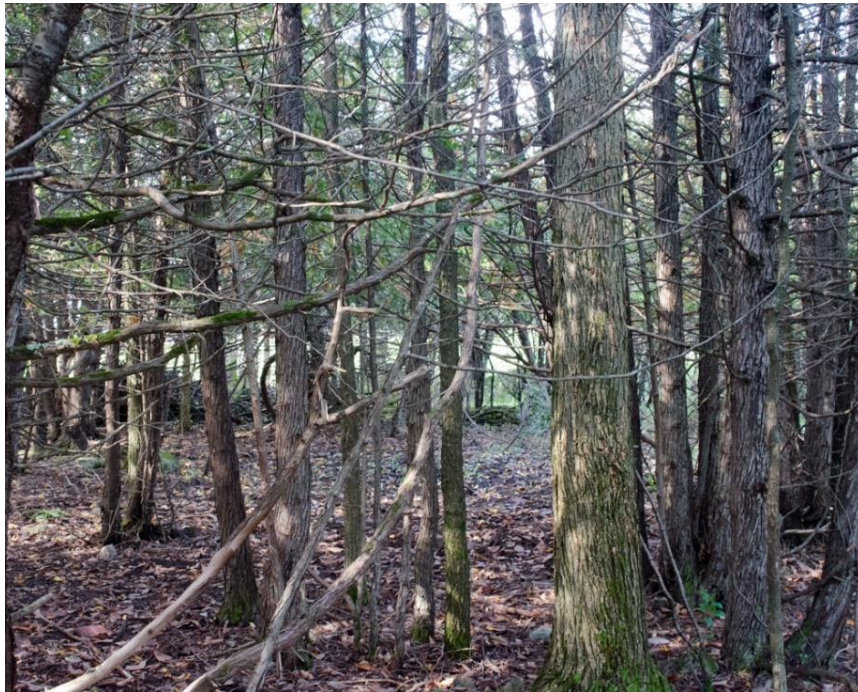
*Photo 10 – Typical cedar size in the coniferous forests in the northeast portion of the site.
View looking north*

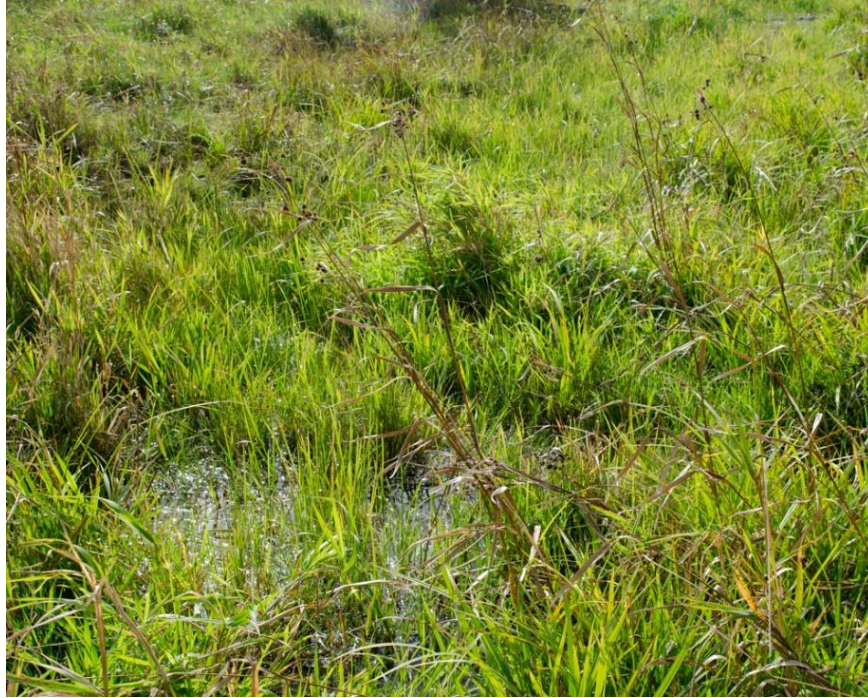
A 3.5 metres wide dug drainage feature is in the southeast corner of the site, beginning at Appleton Side Road, going straight west before a 90 degree plus angle to the south site boundary approximately 190 metres west of the road. Standing water up to 15cm in depth was observed in the feature several times, including the October 1st, 2020 and June, 2021 surveys, but the water was not flowing (Photo 11). No low flow channel is present within the 3.5 metres bankfull width and no forage fish were observed though only visual observations were made. Algae was extensive, with water plantain, reed canary grass, hard-stemmed bulrush, lake sedge, purple loosestrife, and red-osier dogwood also present. There is no canopy cover for the feature and there is no connecting channel on the east side of Appleton Side Road other than the roadside ditch on the east side of the road. Downstream of the site, the culvert under Old Almonte Road is perched at the downstream end (Photo 12). This will prevent any fish migration upstream towards the site from the Mississippi River. Algae growth was already extensive in the channel downstream of Old Almonte Road on June 23rd (Photo 12). Any fish habitat in the dug channel is noticeably minimized in sensitivity due to a lack of connection with larger, natural watercourses and the lack of flow and artificial nature of the channel with potential fish habitat structure limited to aquatic vegetation.

Photo 11 – Dug channel in the southeast corner of the site has standing water in places but no flowing water observed in June, 2021 or the other field surveys. View looking southeast

- All necessary permits are to be obtained from MVCA and DFO for the realignment;
- Although the potential for fish habitat in the realigned channel are minimal, the new channel alignment is should include some features to promote habitat including a defined low flow channel, transplanting plus of aquatic vegetation, and placement of cobble and other coarse material;

- The new channel is to be created well before the flows are redirected to permit the vegetation along the new channel to germinate and take hold;
- All in-water work is to be completed preferably during low flow periods and must be completed outside of the more sensitive March 15th to June 30th period. The summer period is recommended due to generally reduced flow, decreased potential for sediment input, and the greater growing season afforded for re-vegetation of disturbed areas. If the proposed timing of the work is to take place between October 15th and March 15th, it may be necessary to have all exposed areas along the banks covered with erosion control blankets to keep the soil in place and prevent erosion from occurring during the following spring freshet;

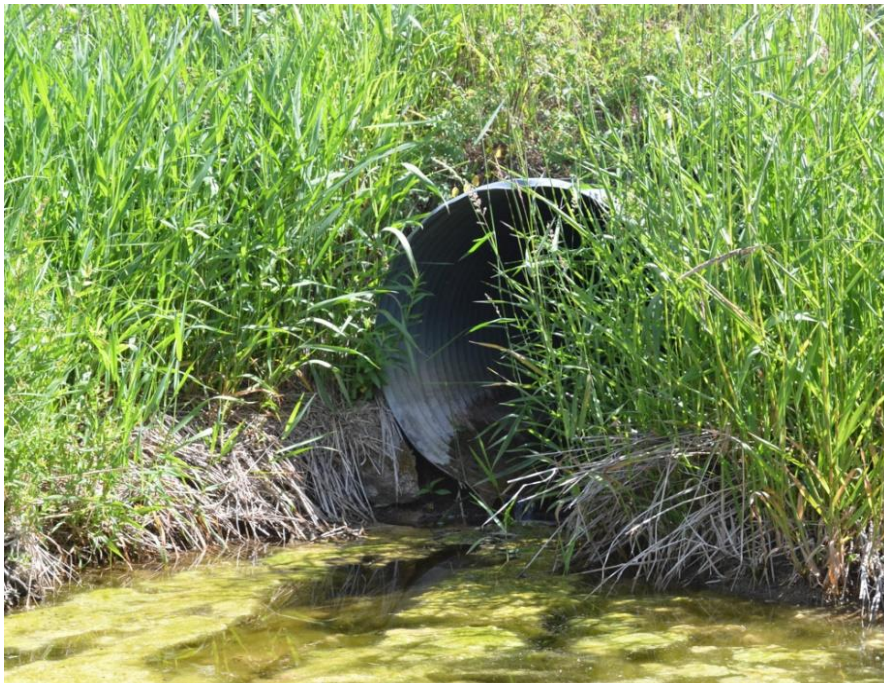
Photo 12 – South of the site, the culvert under Old Almonte Road is perched at the downstream (west) end. View looking east

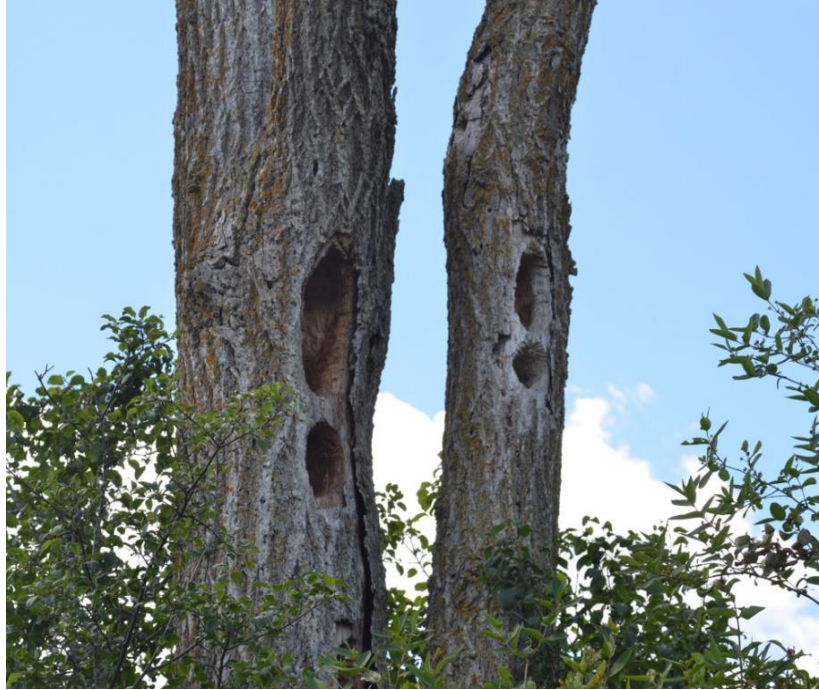
Potential wildlife cavities were observed in a large white elm in the central-south thicket (Photo 13) though no evidence of wildlife activity was observed during the field surveys. No fissures in the exposed bedrock, stone fences, or evidence of raptor nesting were observed.

*Photo 13 – Potential wildlife cavity tree in the south-central portion of the site.
View looking south*

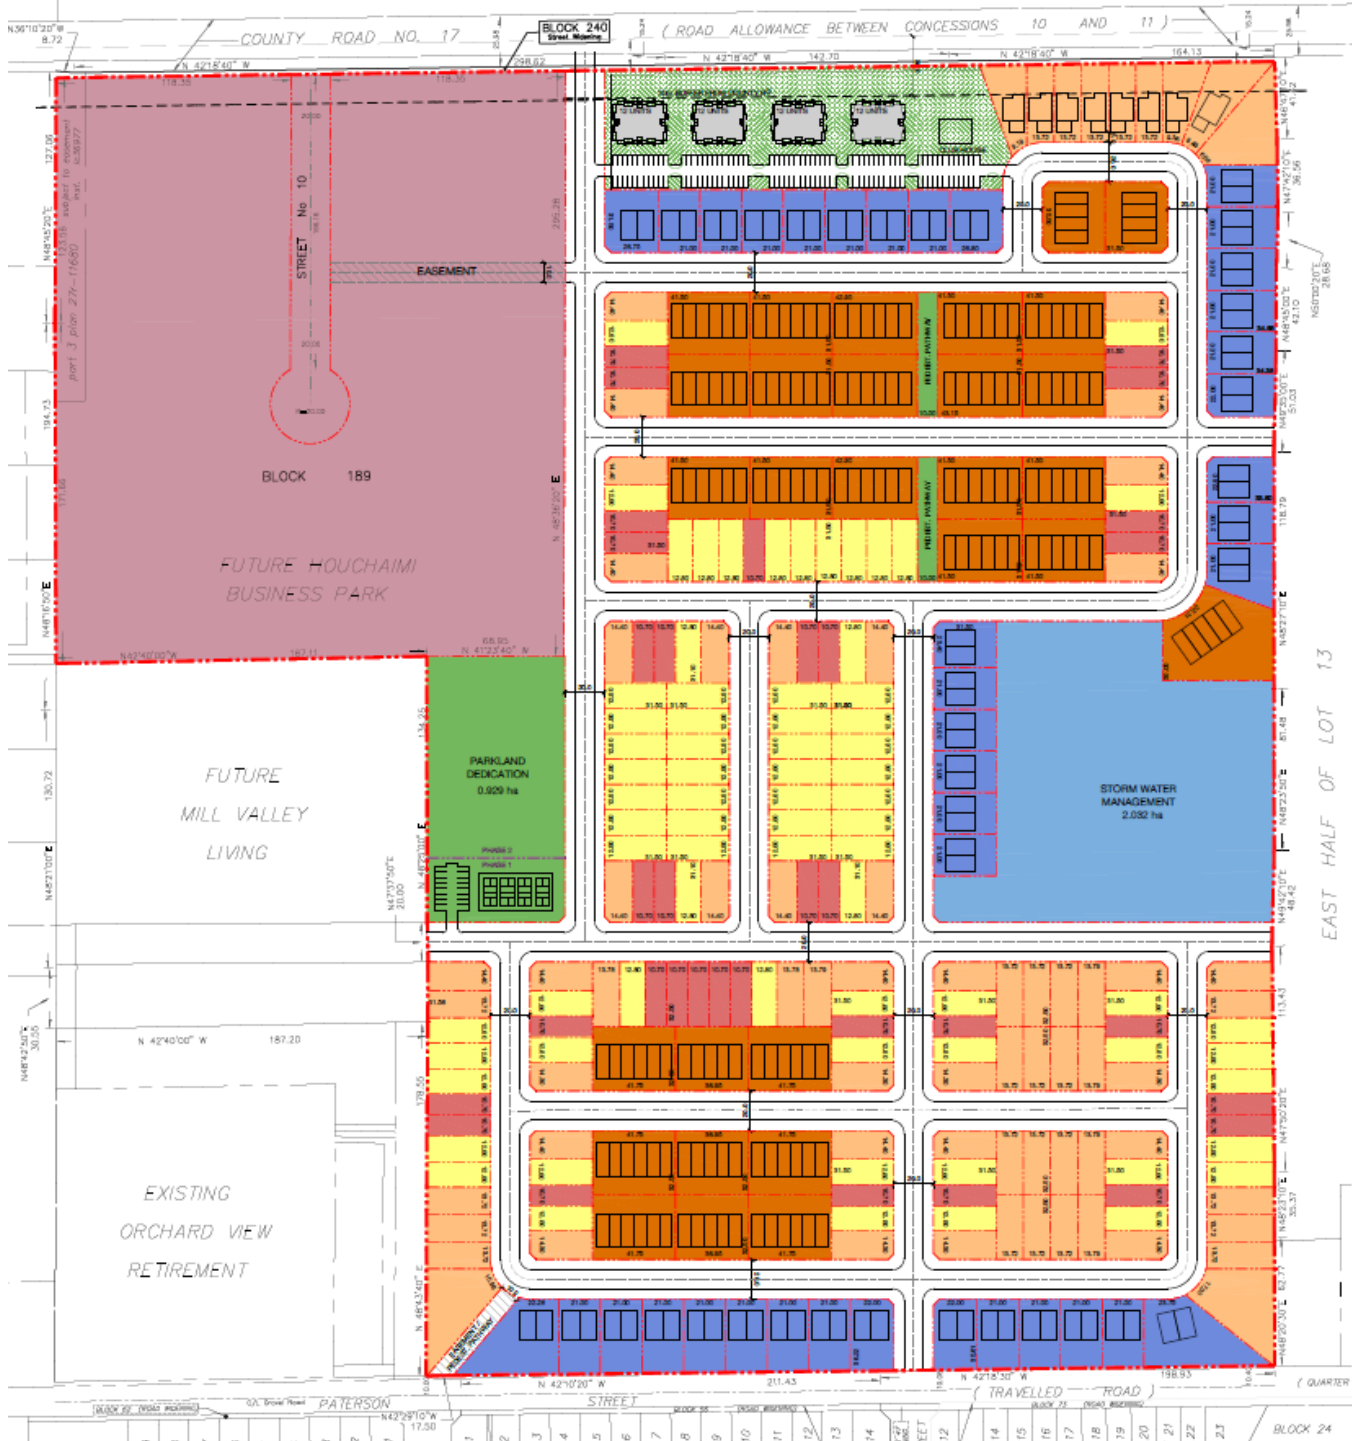
FIGURE 2 – SUBDIVISION PLAN

Four hundred and seventy-one residential units are proposed for the subdivision, with 257 single detached and semi-detached residences, 166 townhomes, and 48 apartment units (Figure 2). The development will be accessed with a new road each off Old Almonte Road and Appleton Side Road, leading to an internal road network. A 0.93 hectare park is proposed for the north-central portion of the site. The residential development will be on full municipal services. The stormwater management approach being proposed is installation of storm sewers, which will
