LANARK COUNTY SCOP - OFFICIAL PLAN AMENDMENT APPLICATION FORM

OFFICIAL PLAN AMENDMENT  
APPLICATION FORM

Name of Owner: Thomas Cavanagh Construction Limited  
Address: 9094 Cavanagh Road, Ashton, ON

Lot: 5 Concession: 10  
Registered Plan No.: \_\_\_\_\_ Lot or Block No.: \_\_\_\_\_  
Other: Dalhousie Township, Township of Lanark Highlands  
Abutting Roads Highland Line, Anderson Lane

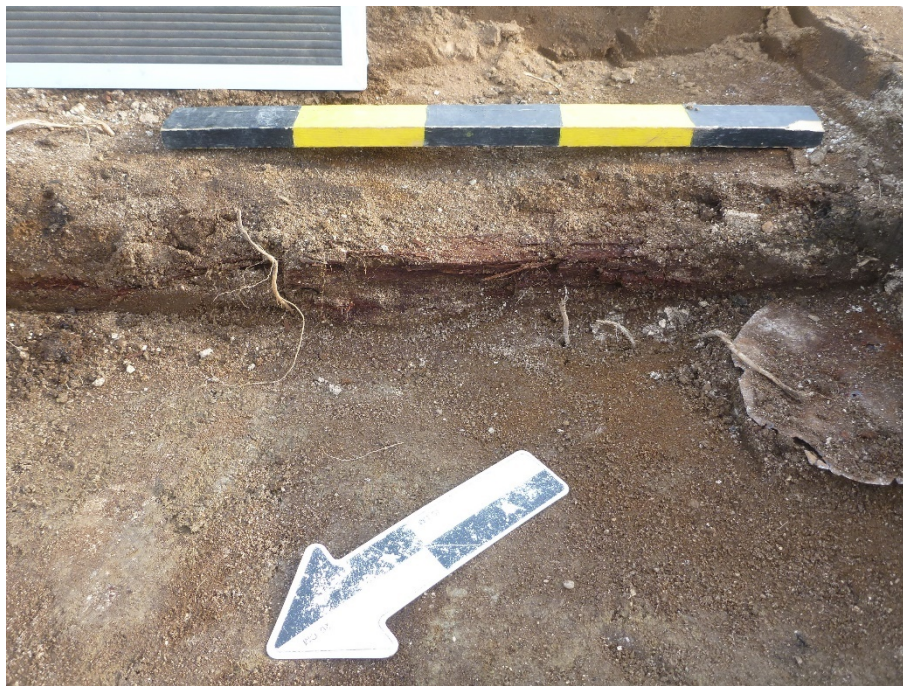
Image 20: Closeup of the remains of a wood frame used in the construction of Feature 1, view southwest.

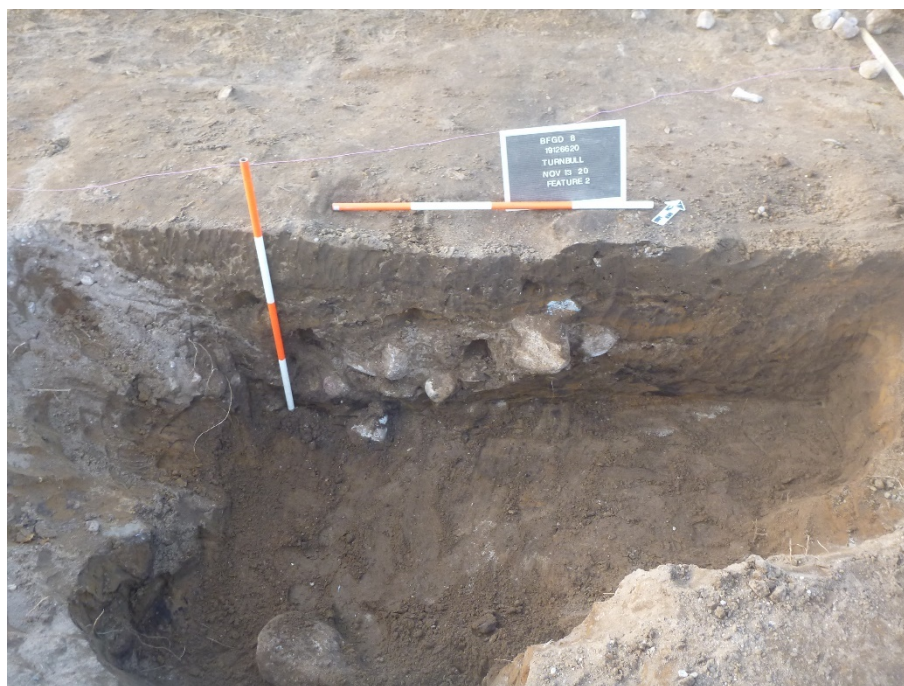
Image 28: Photo of north profile of Feature 2, view northwest.

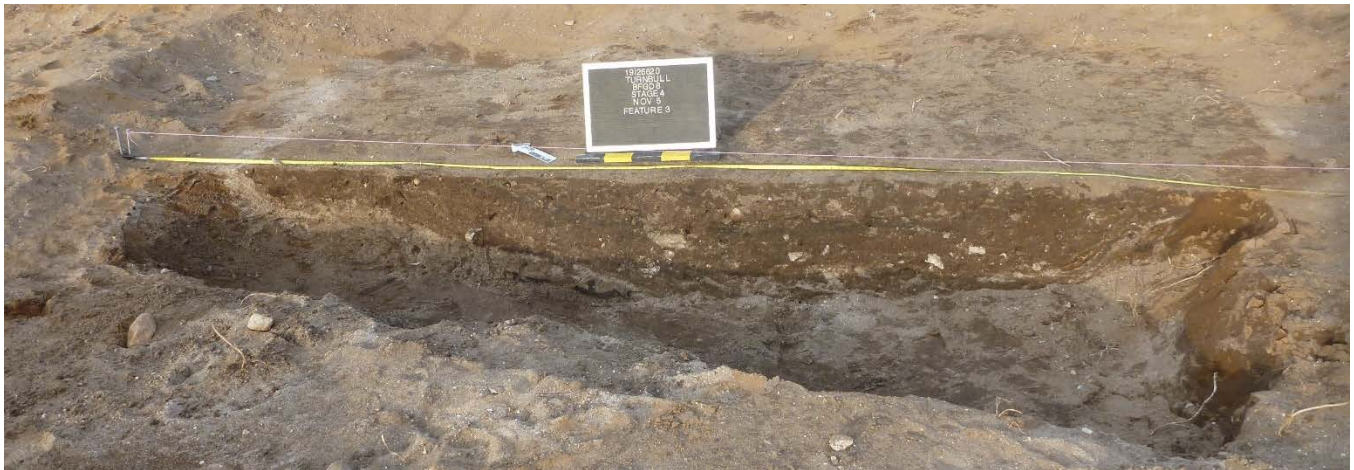
Image 36: East Profile of Feature 3, view northeast.

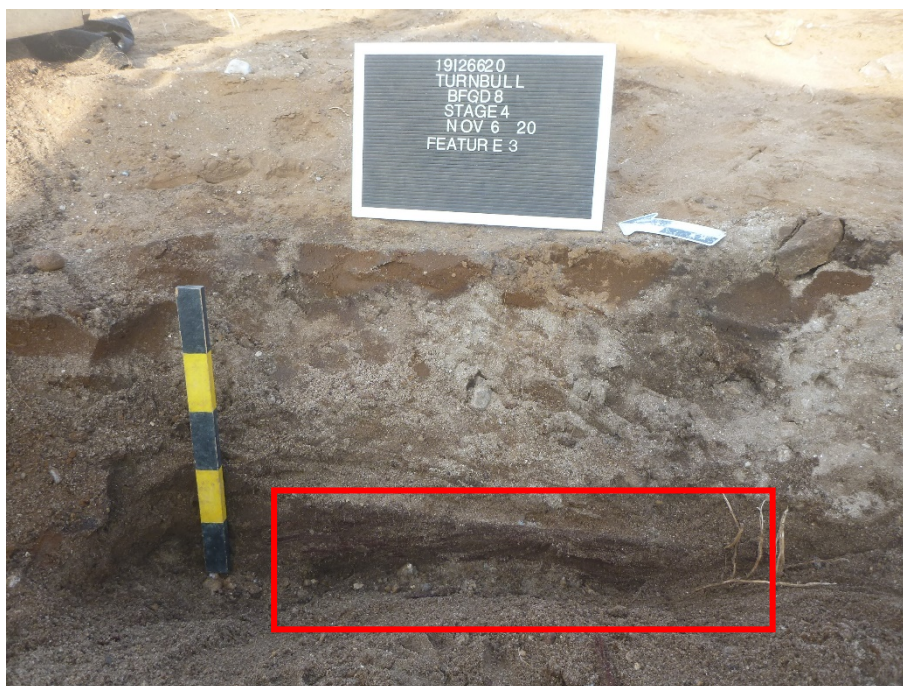
Image 38: Location of a fragmentary wooden board (Lot 16) along the wall of Feature 3. The location of the board is highlighted by the red rectangle.

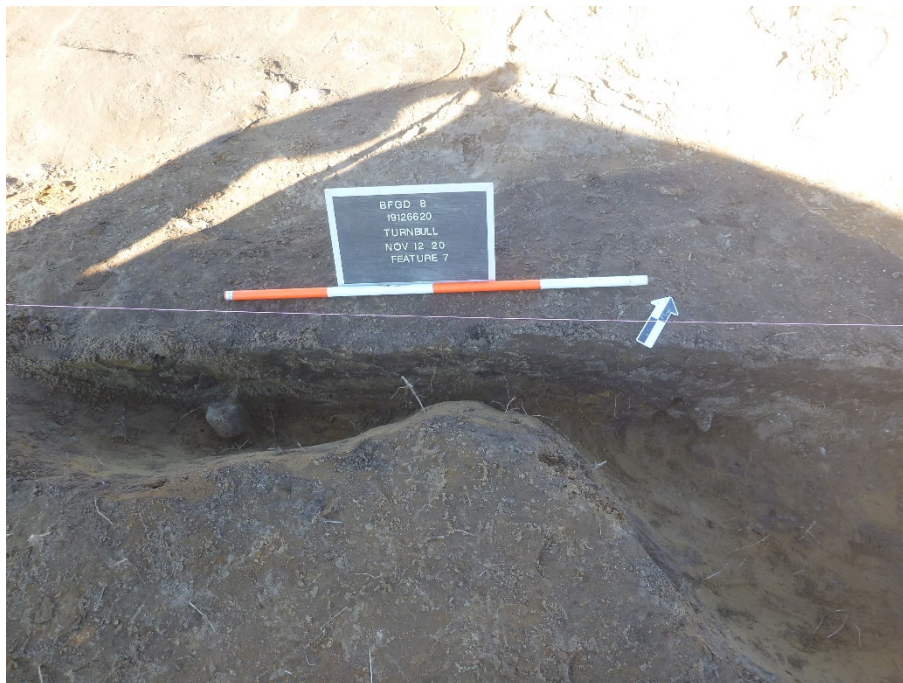
Image 52: North profile of Feature 7, view north.

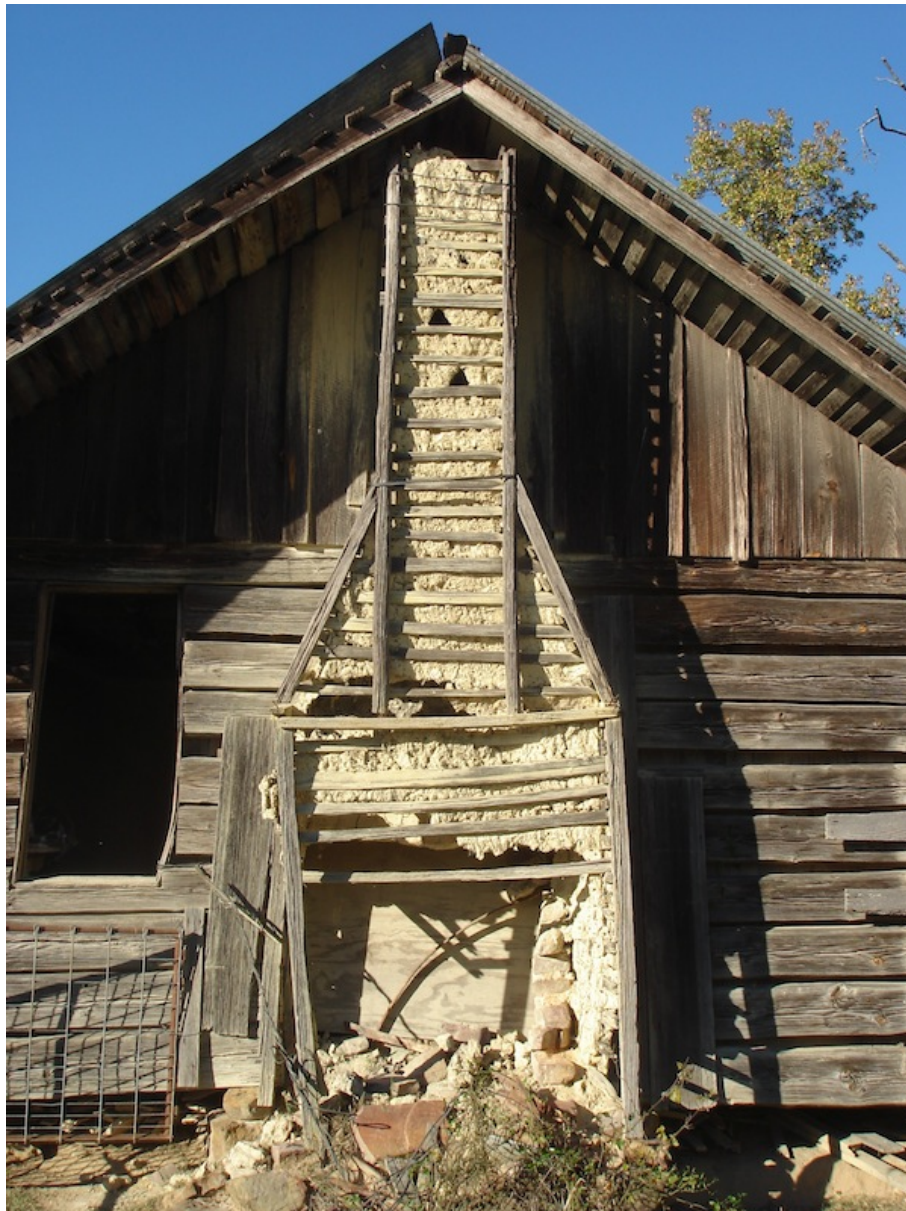
Image 59: Photo of a stick and mud chimney from a historic log house (Caddo Heritage Productions 2013). Note the field stones used in the construction of the base.

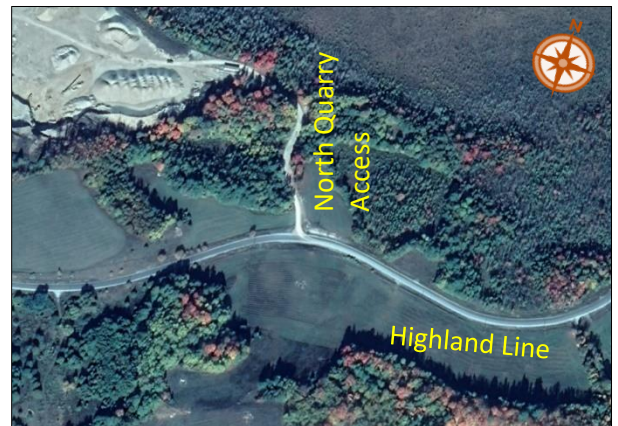
Exhibit 2-4: Highland Line and North Quarry Access

- Exhibit 2-4 illustrates the 3-leg Highland Line / North Quarry Access;
- It is a 3-way uncontrolled “T”-intersection;
- For the purposes of the traffic analysis, the minor north leg (Quarry Access) is assumed to be yield-controlled;
- Each approach of the intersection provides for one lane of shared through-turn movement and no auxiliary lanes;
- In the operational conditions, the intersection will effectively become a 4-leg intersection with the site access located on the south leg of the intersection.

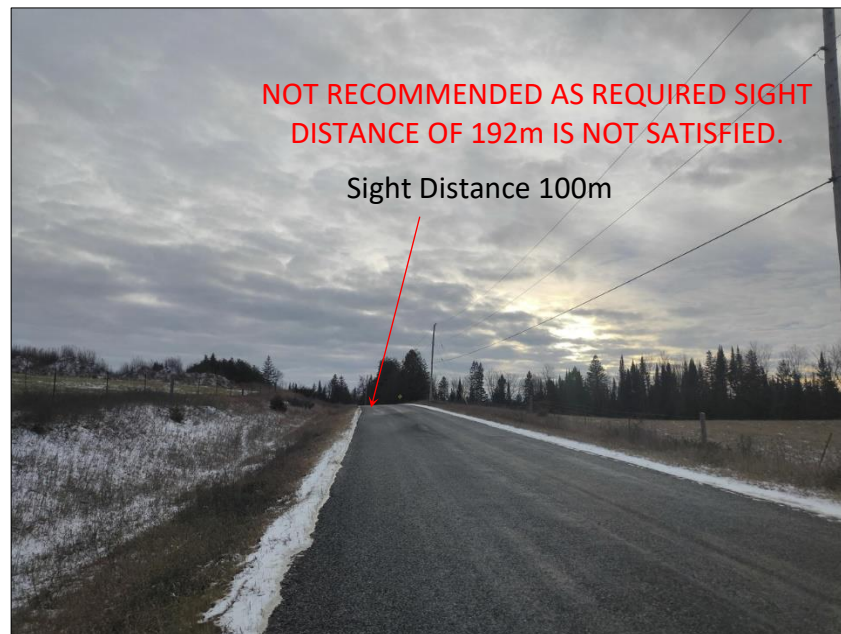
**Exhibit 5-3: Access 1 (EA1) Looking West (100m SD)**

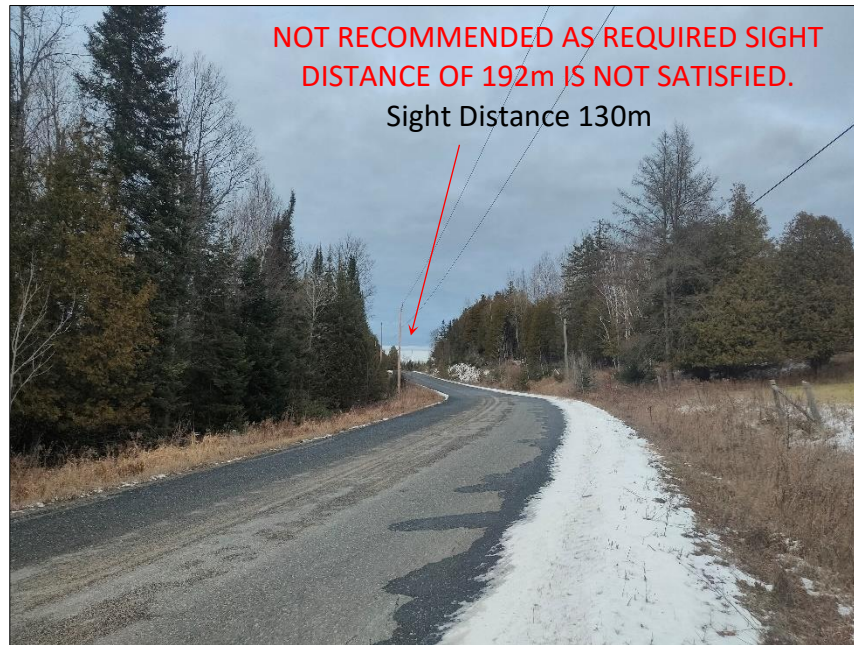
Exhibit 5-4: Access 2 (EA1) Looking East (130m SD)

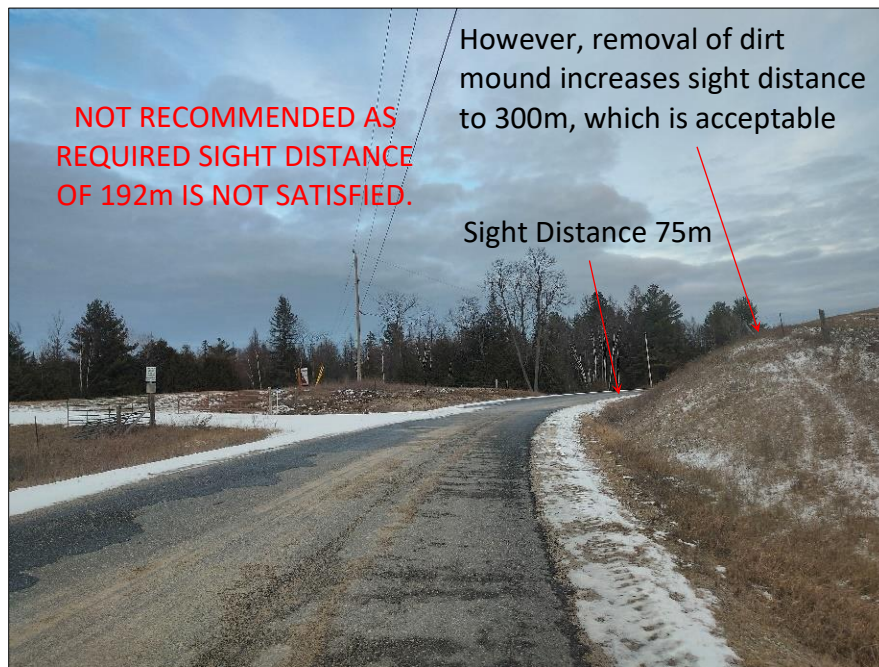
**Exhibit 5-6: Access 1 (EA2) Looking East (75m SD)**

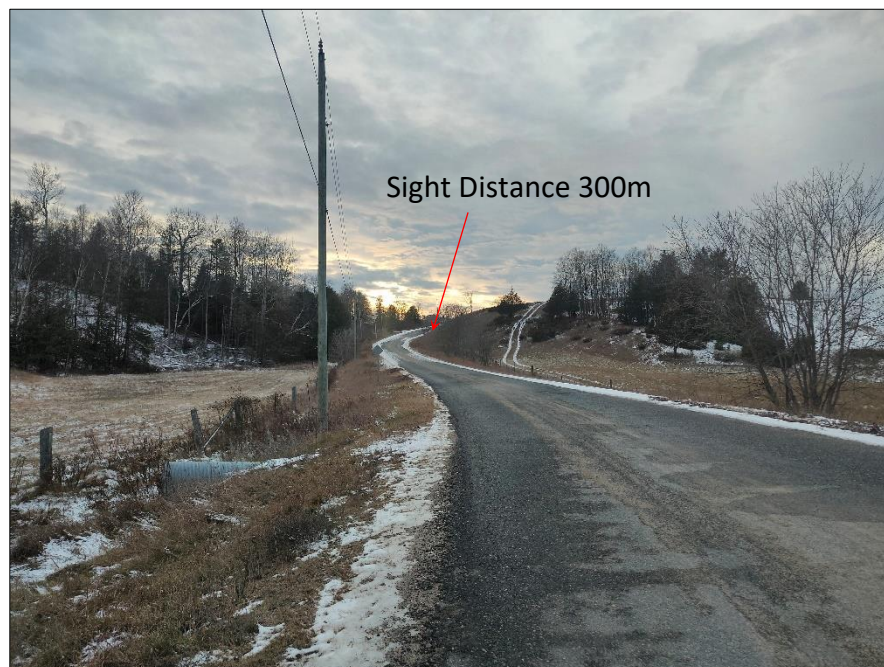
**Exhibit 5-7: Access 1 (EA2) Looking West (300m SD)**

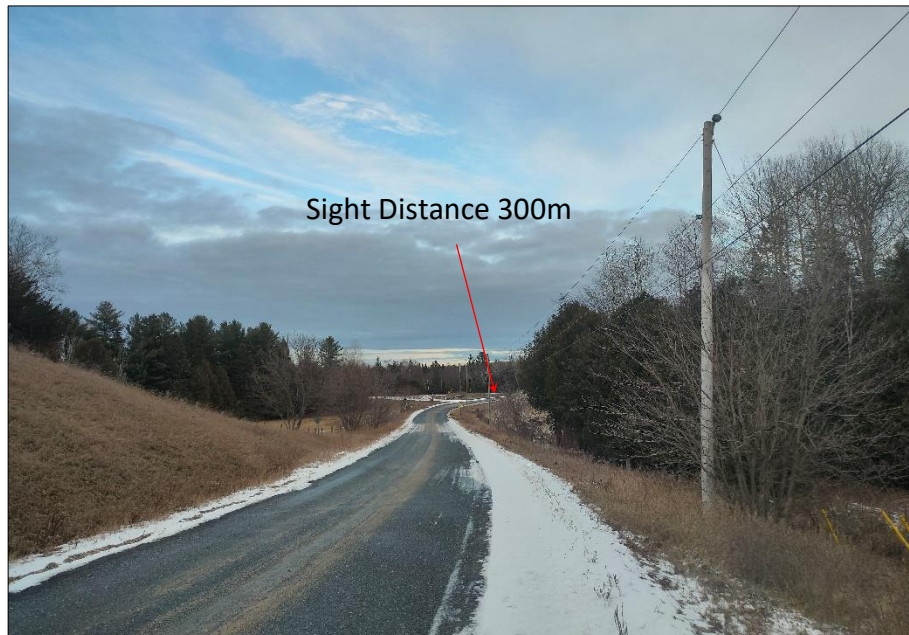
**Exhibit 5-8: Access 2 (EA2) Looking East (300 SD)**

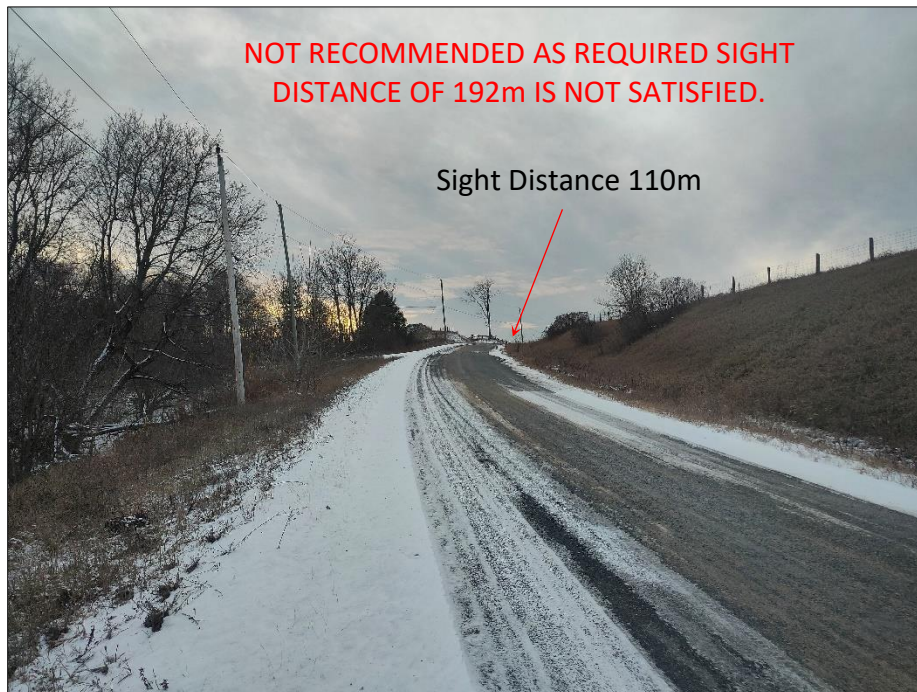
**Exhibit 5-9: Access 2 (EA2) Looking West (110m SD)**

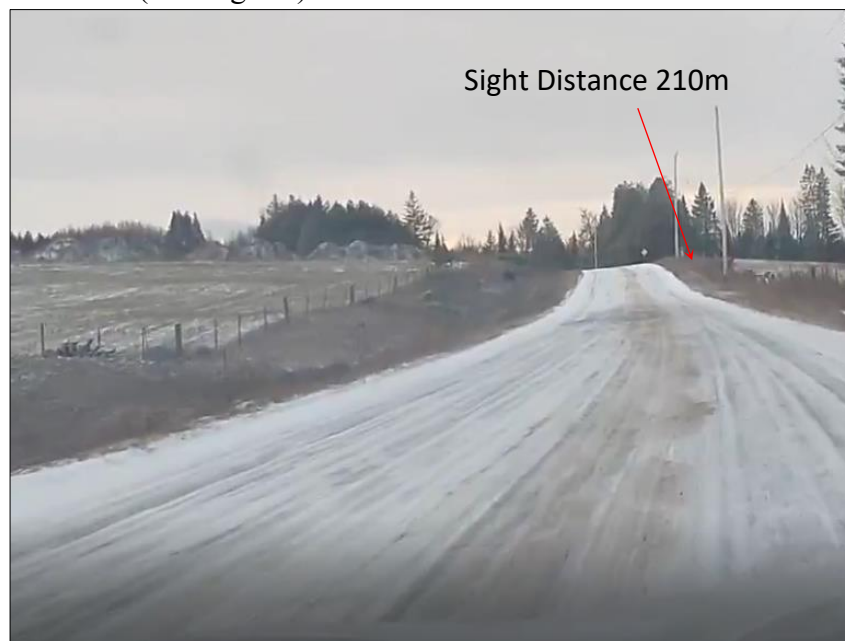
**Exhibit 5-11: Alternative Access 1 (EA1) Looking West (210m SD)**
