Hydrogeology, Terrain Analysis and Impact Assessment Report

Derry Side Road, Township of Beckwith, Ontario

OTT-00236288-A0

September 18, 2020

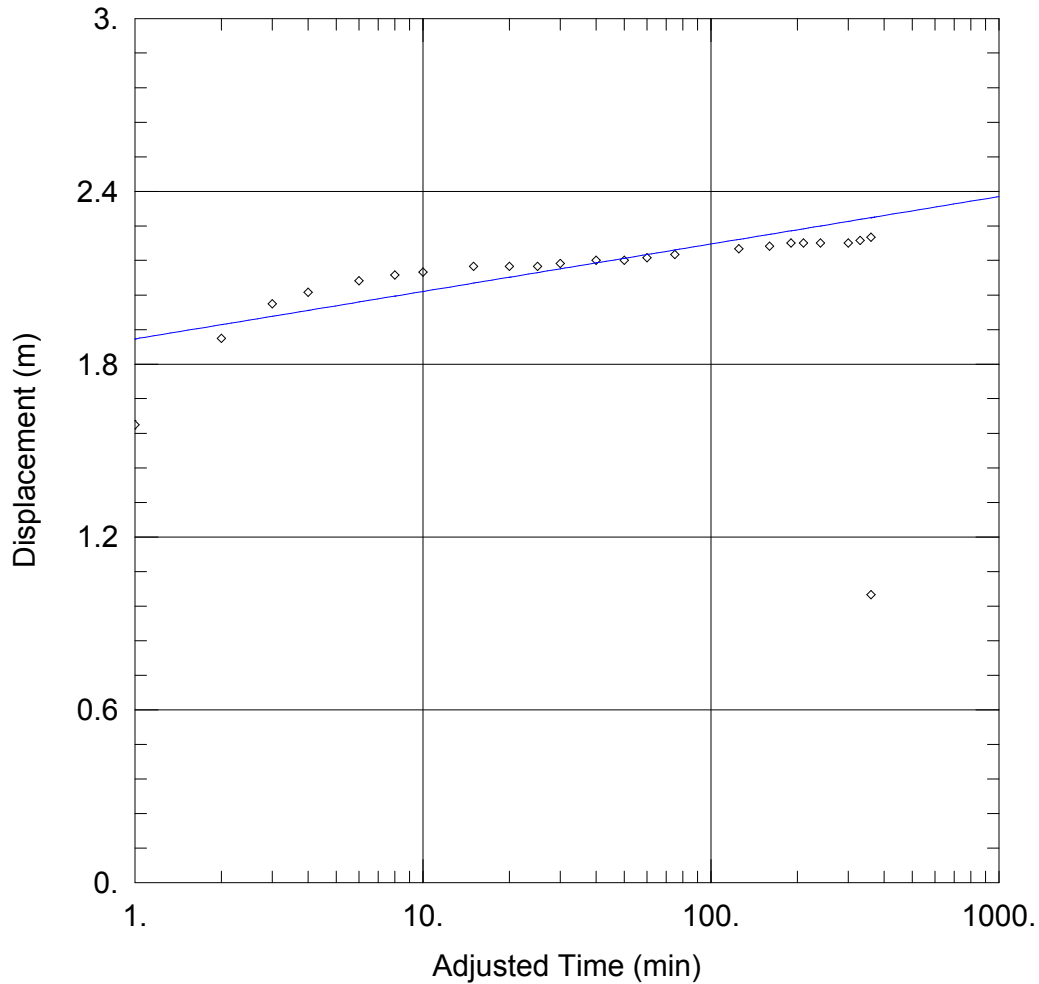
Data Set: P:\...\Well 4.aqt
 Date: 04/21/17

WELL TEST ANALYSIS

Test Well #4 was pumped at a constant rate of 75 L/min for 6 hours on April 3, 2017. Drawdown at the end of the test was 2.24 m, which represents less than 5 % of the total available drawdown based on a static water level of 2.63 m. Following the 6-hr pump test, the well recovered to within 95% of the observed drawdown within 25 minutes of the end of the pump test. The well recovered within 10 min of the end of the pumping test with 95% of the recovery occurring within the first two minutes.

Based on the observed drawdown/recovery relationships from the test well, the long-term yield of Test Well #4 is at or in excess of the tested rate of 75 L/min, and more than sufficient to supply the needs of a single-family home. This rate exceeds the MECP minimum yield of 18.75 L for a 4-bedroom dwelling to supply a single-family residence.
