# ANDREWSVILLE BRIDGE

## SUMMARY OF EVENTS FROM 2005 TO 2022

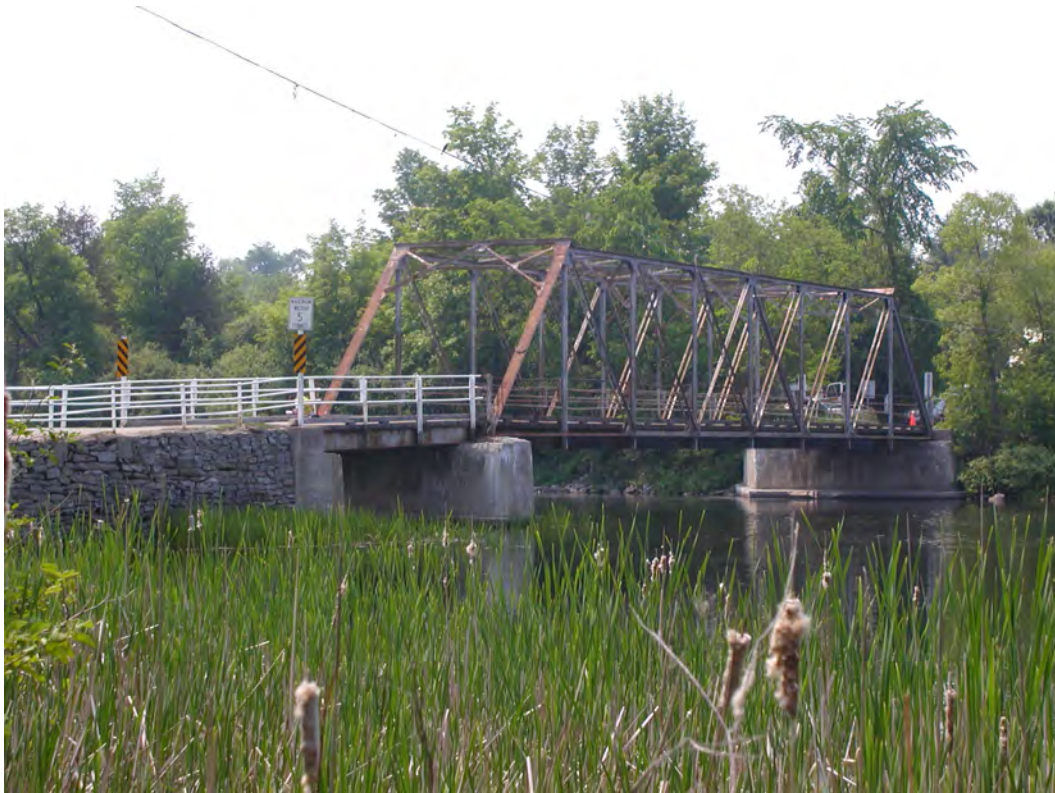
Photograph 1: North elevation of Andrewsville Bridge.

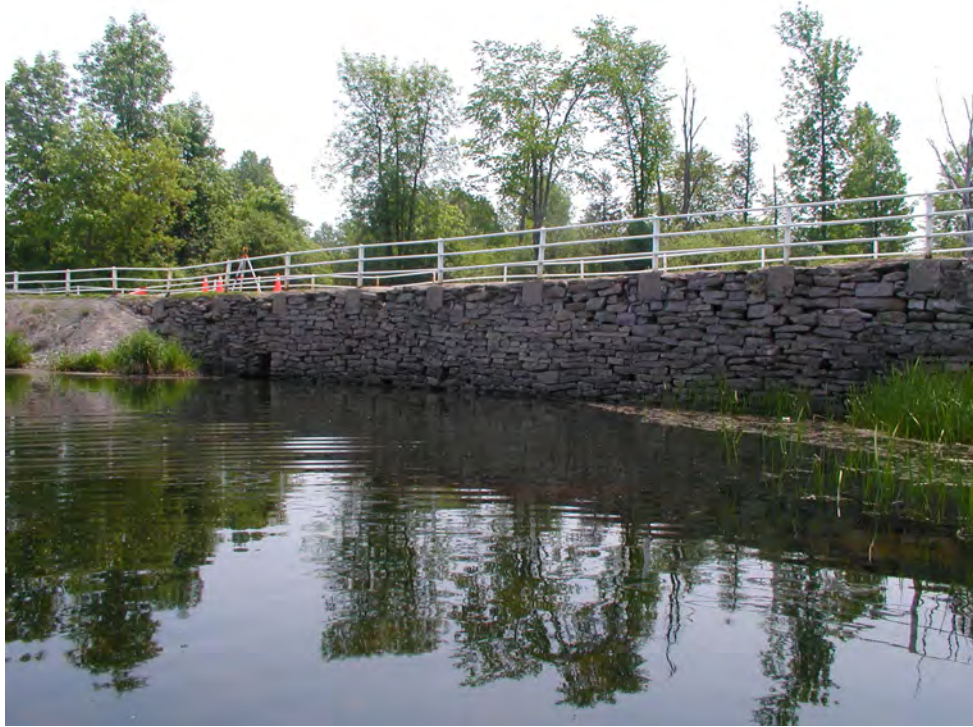
Photograph 3: North elevation of east stone retaining wall.

The fills in the east approach are retained by an ungrouted masonry retaining wall (photograph 3). The wall is in fair to poor condition. The wall has settled on the south side, which has deformed the guiderail (Photograph 34).

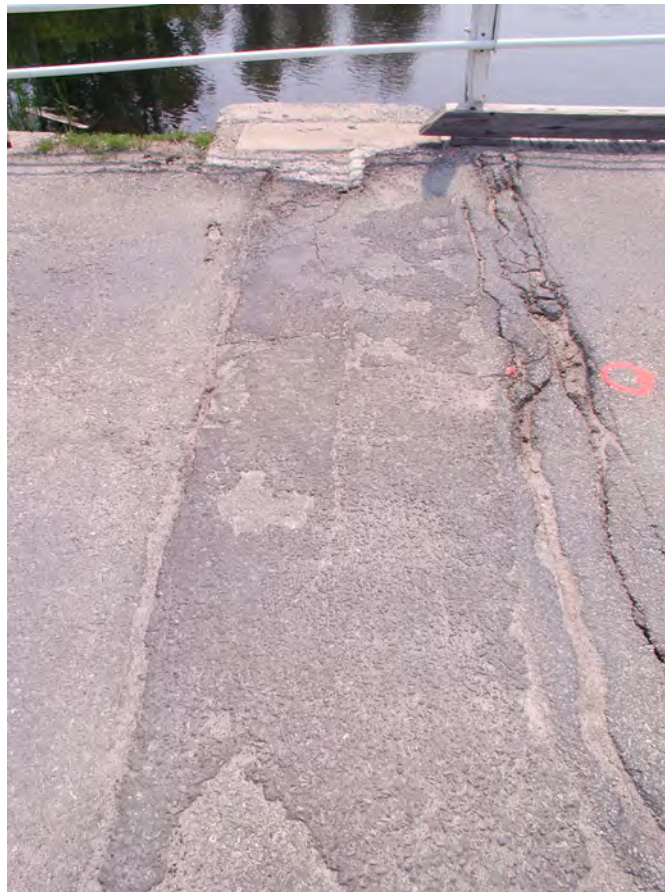
The timber deck is in fair to poor condition. The timbers are connected to the stringers with steel clip angles (Photograph 18). At many of these clip angles, the timbers have separated (Photograph 9), permitting runoff through the timbers. The runoff has removed the protective creosote in these locations, and there is evidence of brown and white rot in the timbers (Photographs 10, 11, 12). The asphalt wearing surface has also failed in these locations (Photographs 7 and 8). The deck has separated from the steel stringers in several locations and the timbers were observed to deflect upwards under traffic loads. There is evidence of numerous previous repairs to the asphalt over the expansion joints (Photograph 6).

Photograph 6: East expansion joint, looking south.

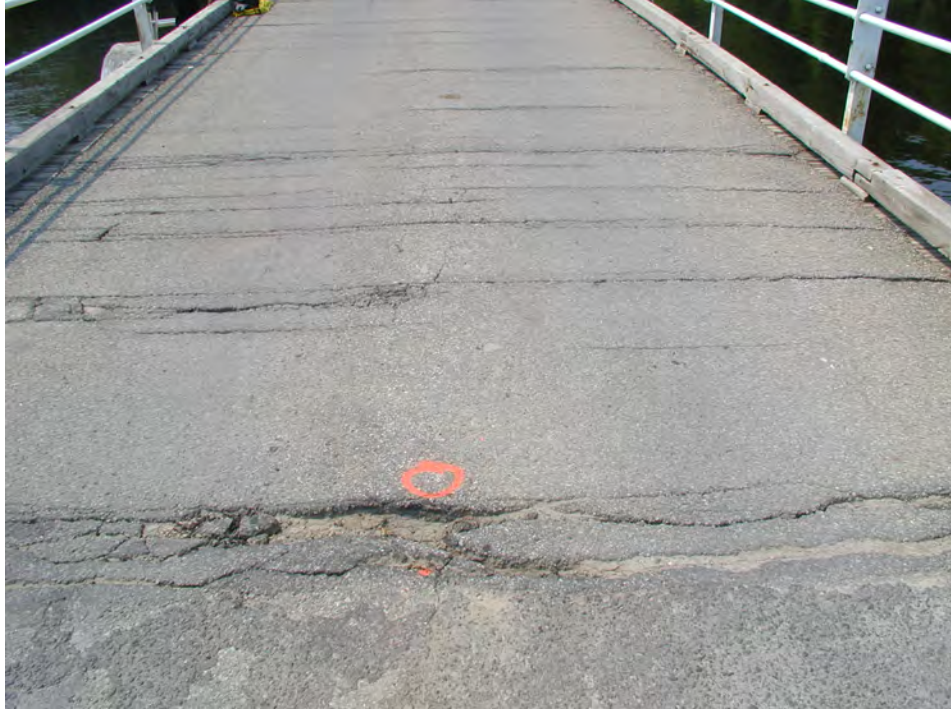
Photograph 7: View of west expansion joint, looking east.

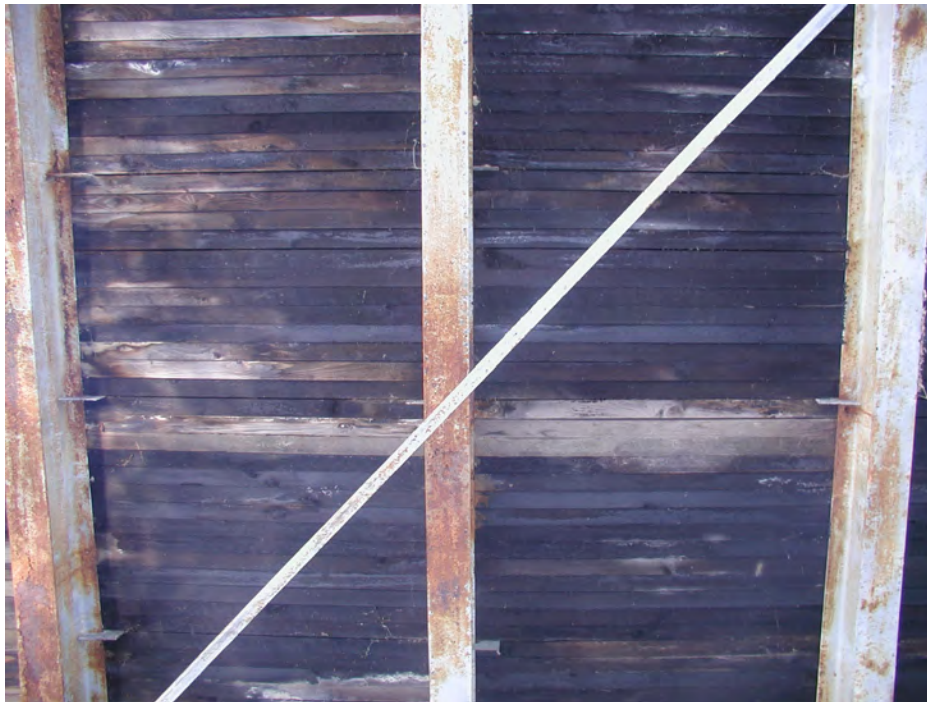
Photograph 10: Typical condition of underside of deck.

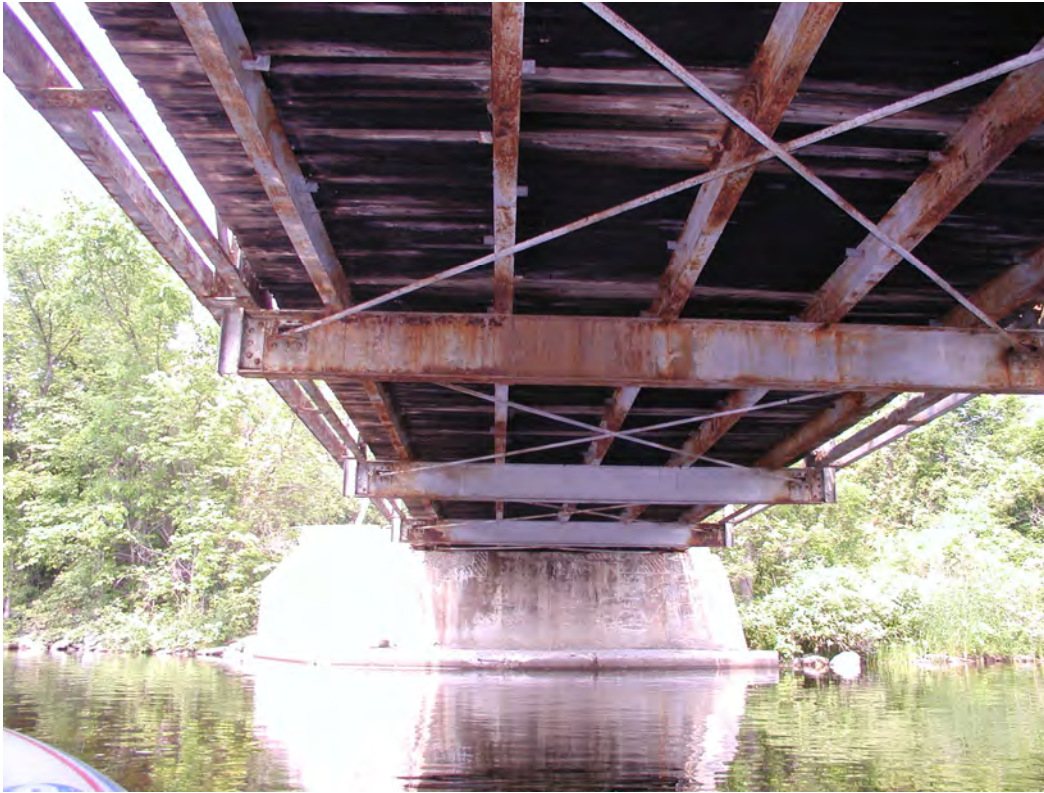
Photograph 13: Configuration of below-deck structural steel in truss span.

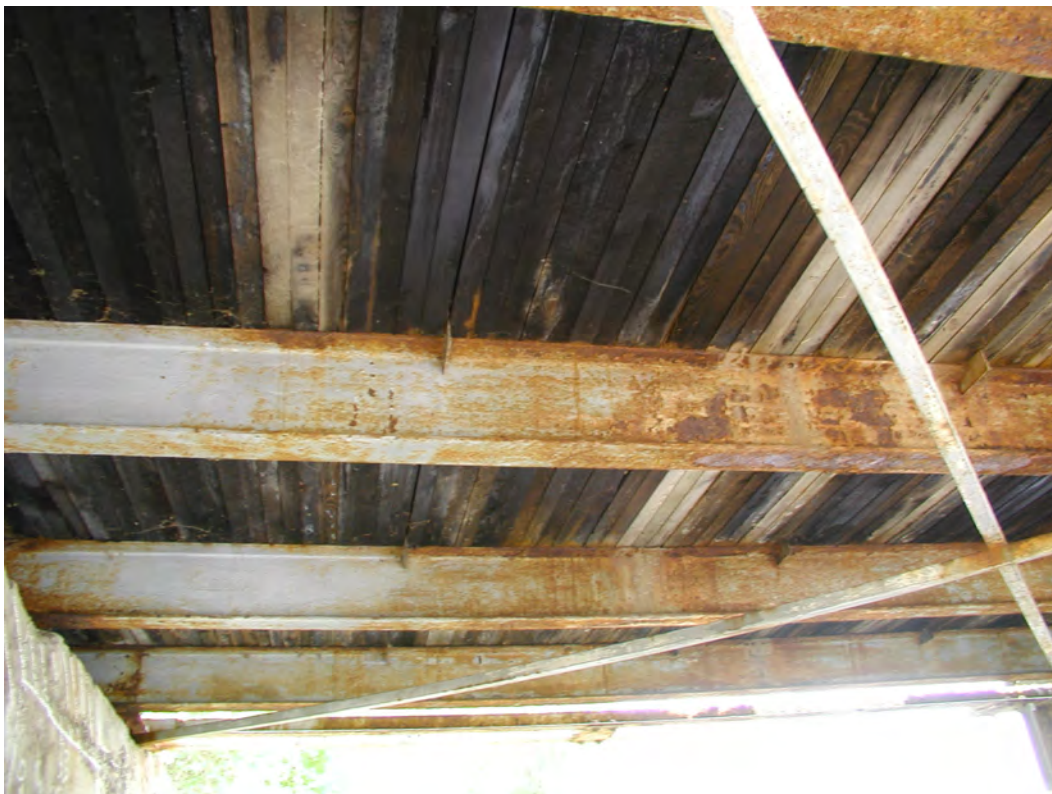
Photograph 14: View of longitudinal stringers and deck just west of pier.

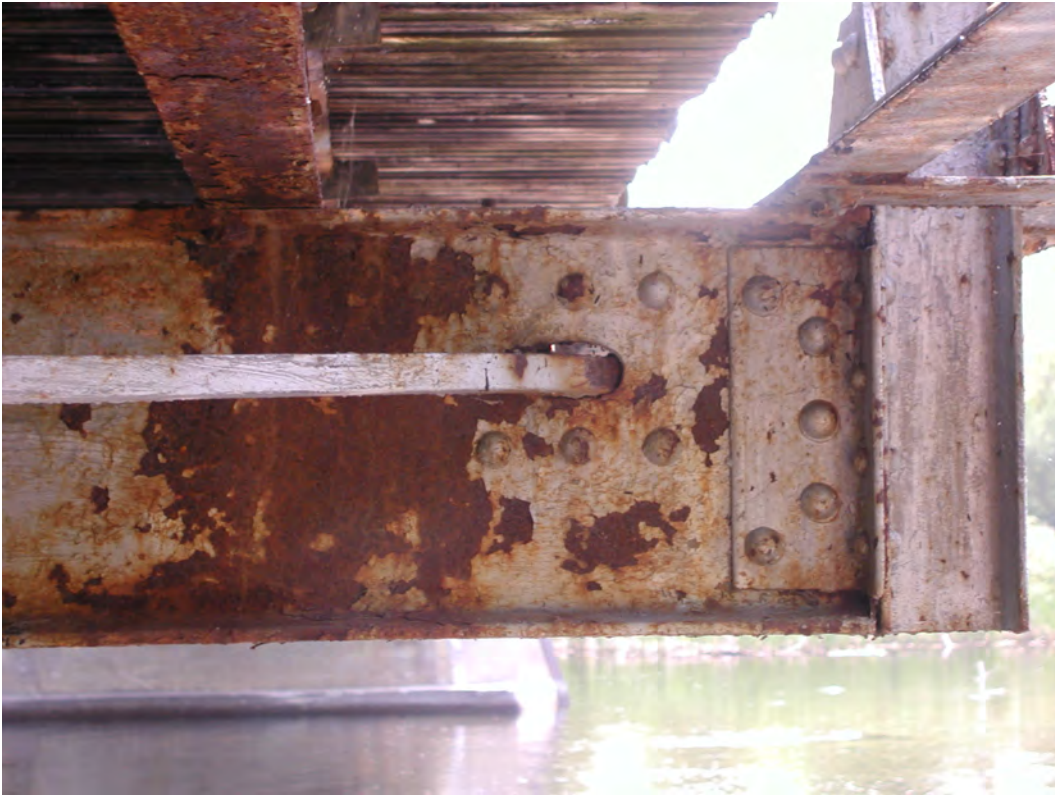
Lateral bracing for the steel floor system is provided by square iron bars that are anchored to, and pass through, the floorbeams (Photographs 15 and 16). The bracing is in fair to poor condition.

Photograph 15: Detail of cross-bracing as it passes through the web of the floorbeam.

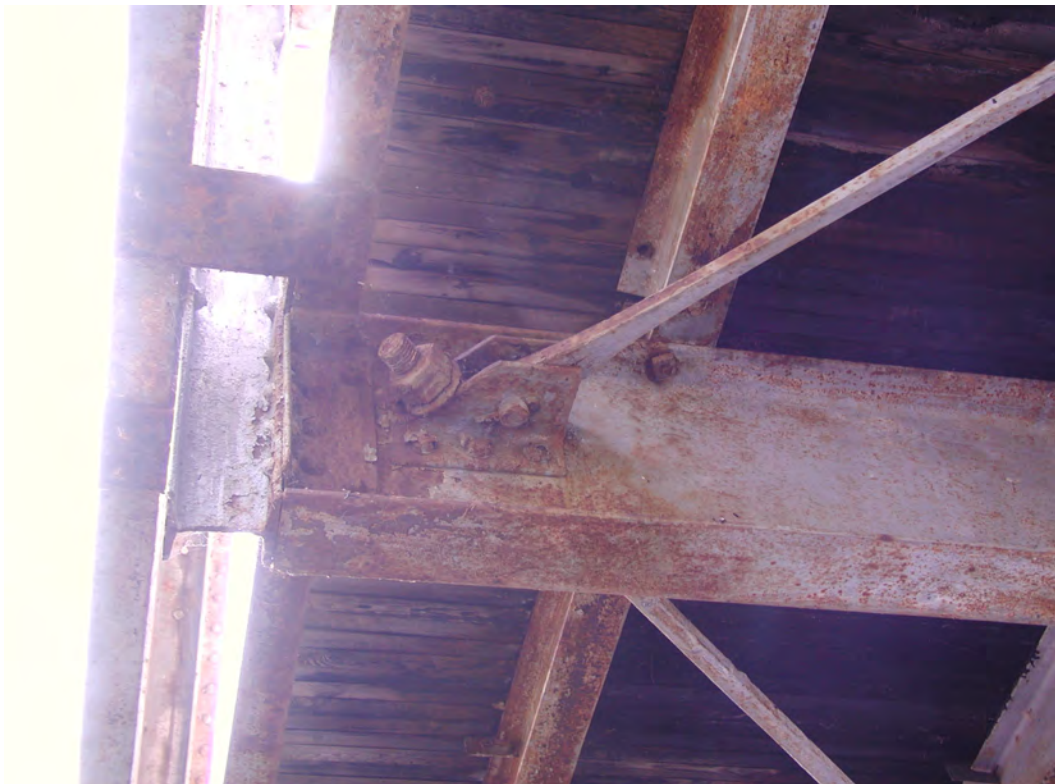
Photograph 16: Detail of cross-bracing connection at floorbeam.

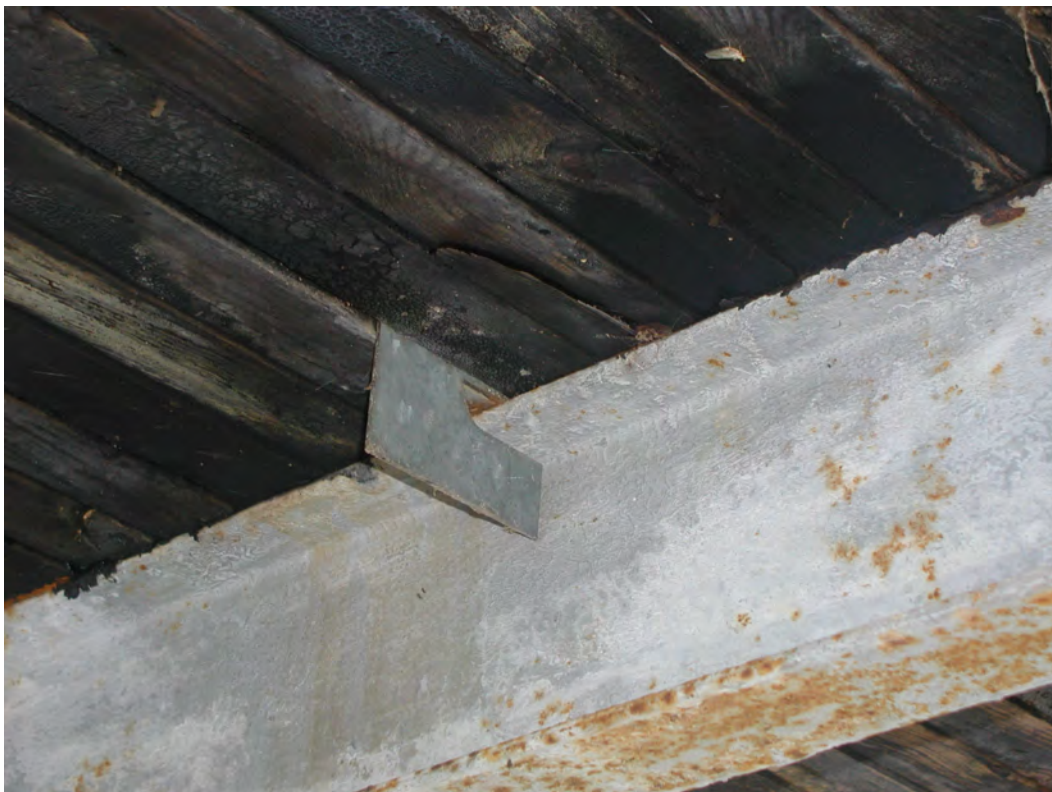
Photograph 18: Detail of clip attaching deck to stringer,

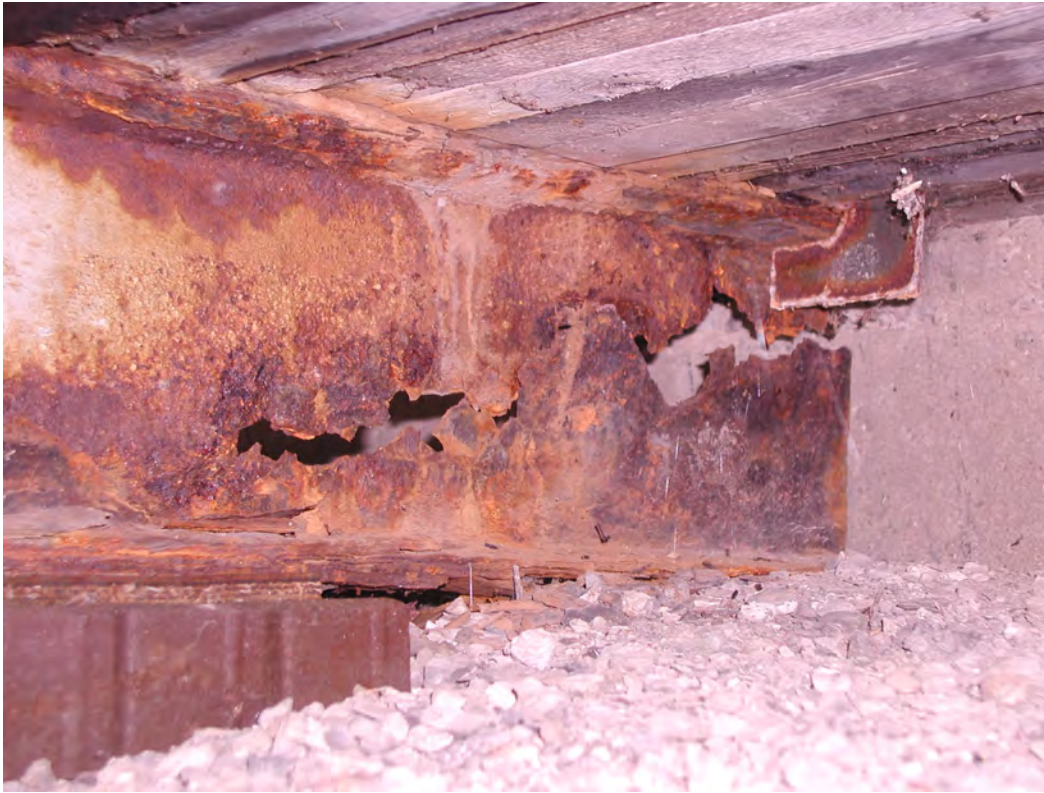
The steel truss is in fair condition, with widespread light corrosion and minor section loss throughout. The structural steel in the truss is typically in better condition above deck than below deck. The below deck steel floor system consists of longitudinal stringers and transverse floorbeams, which are suspended below the bottom chord in the truss span (Photograph 13) and tie into the exterior girder in the short span (Photograph 17). The steel floor systems are generally in fair condition, with the exception of the stringers at the West Abutment, which exhibit very severe section loss (Photographs 19 and 20).

Photograph 19: Very severe section loss in web of middle stringer, West Abutment.

It is recommended that the webs of three of the stringers in the truss span at the West Abutment be strengthened by replacing a section of the deteriorated stringer. It is further recommended that this work be undertaken in the fall of 2005. The cost for this work is estimated to be \$7,000.00.

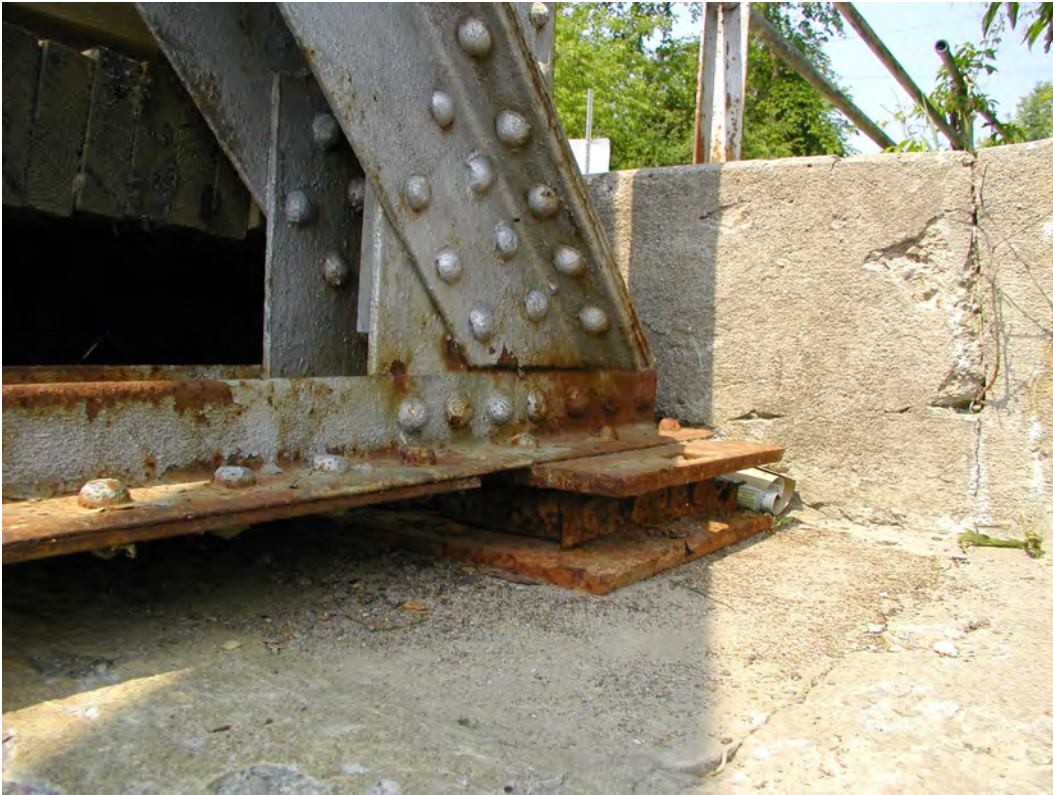
The truss bearings are fixed steel bearing plates at the pier and nested roller bearings at the West Abutment. The north roller bearing is in poor condition (Photographs 21 and 22), and the south roller bearing is in fair to good condition (Photograph 23). The longitudinal stringers on the truss do not tie into the transverse floorbeams at the bearings, but are individually supported on brick bearing pads (Photograph 24). The short span is fixed at both ends.

Photograph 21: Bearing configuration at West Abutment.

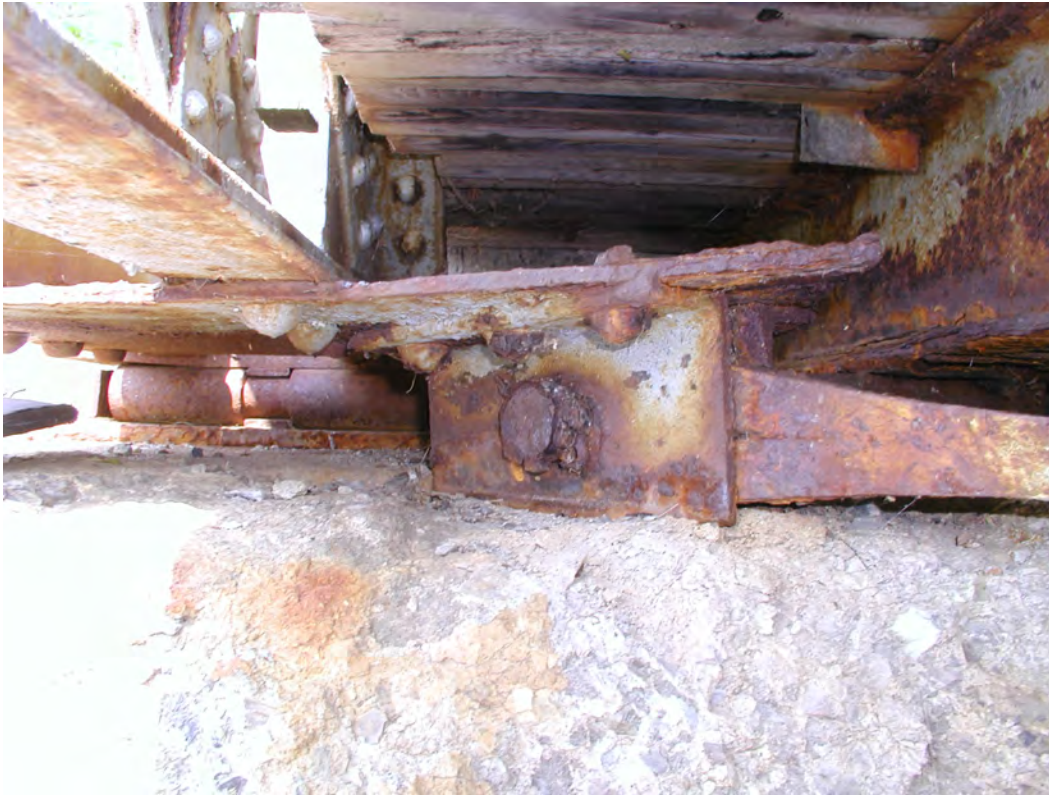
Photograph 23: Detail of south roller bearing at West Abutment.

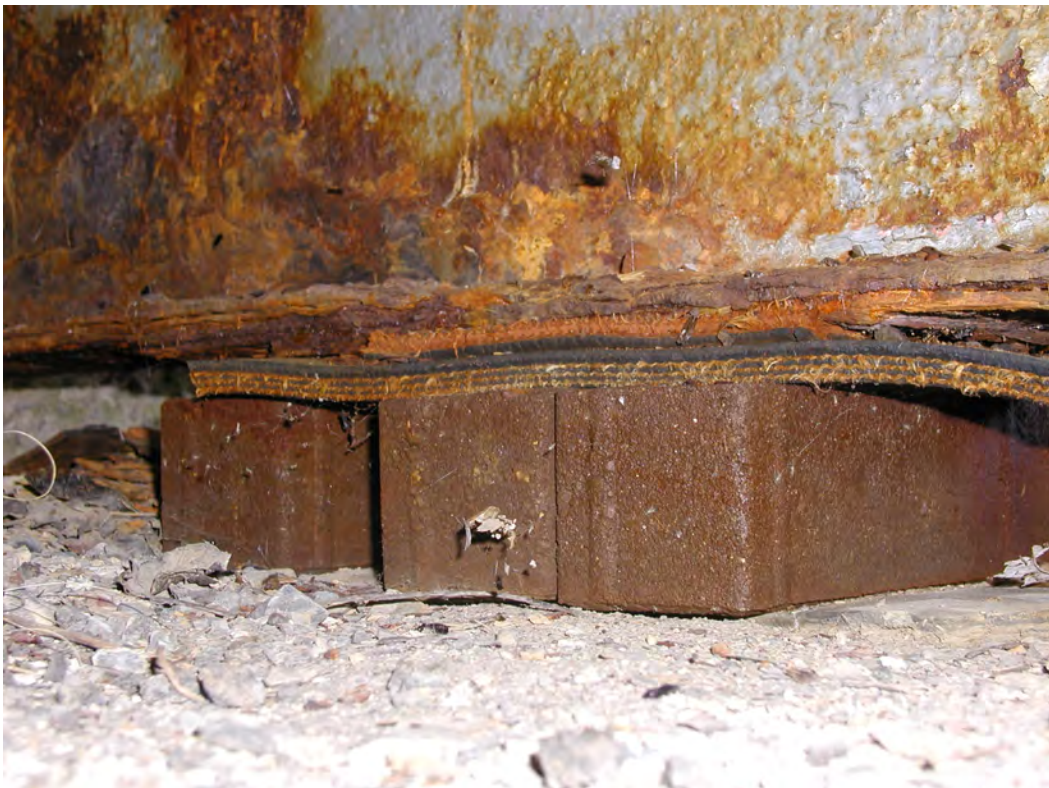
Photograph 24: Detail of bearing pads on interior girders, East and West Abutments.

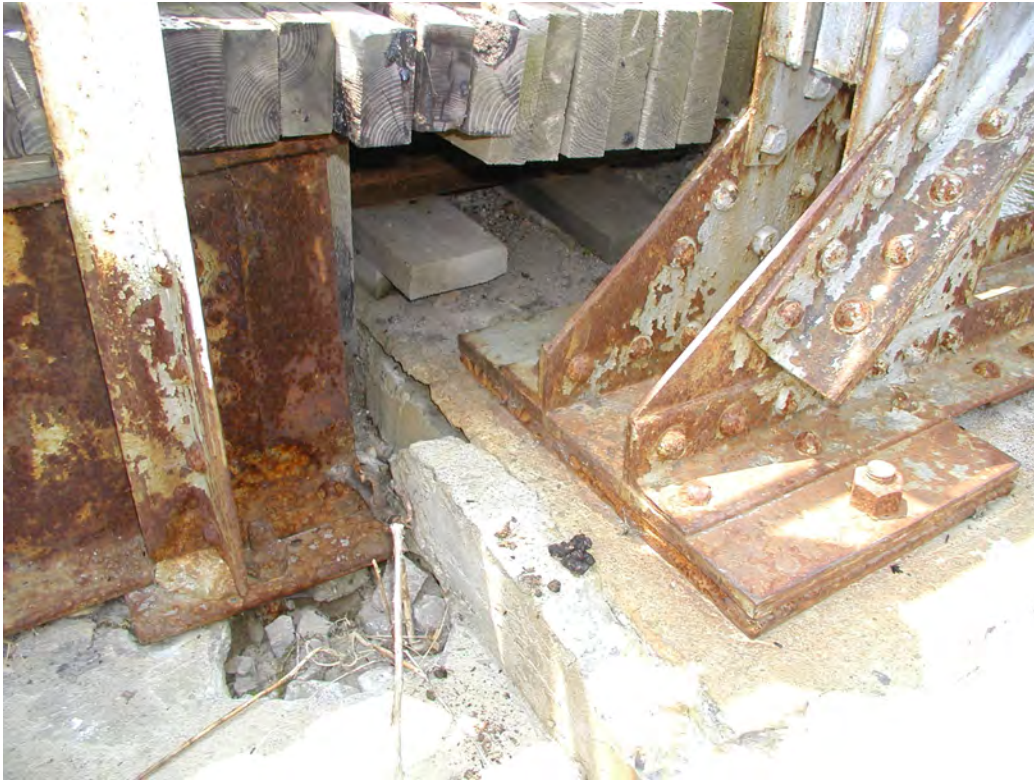
Photograph 25: North bearings at pier. Note undermining of east bearing.

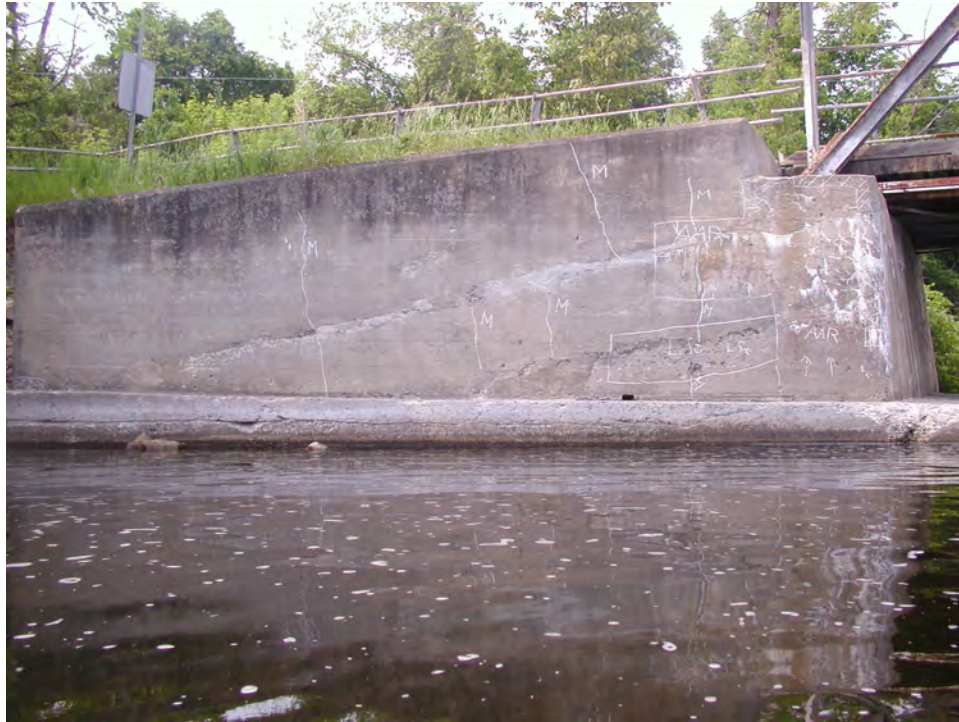
Photograph 27: Elevation of south wingwall at West Abutment.

The abutments and pier are in poor condition with extensive scaling, delaminations, spalls, deterioration, and alkali-aggregate reaction (Photographs 27, 26, 28, 29). The bearing seats are similarly delaminated, severely scaled and disintegrated at the pier and East Abutment (Photographs 31 and 32). The East Abutment ballast wall exhibits severe deterioration (photograph 30) and undermining of the north bearing plate (Photograph 25). Based on field observations, it appears that the existing substructure, likely masonry, has been encased in concrete (Photograph 32). However, further investigation would be required to confirm visual observations. The top of the footings were exposed and wide cracks, delamination, and spalls were noted throughout.

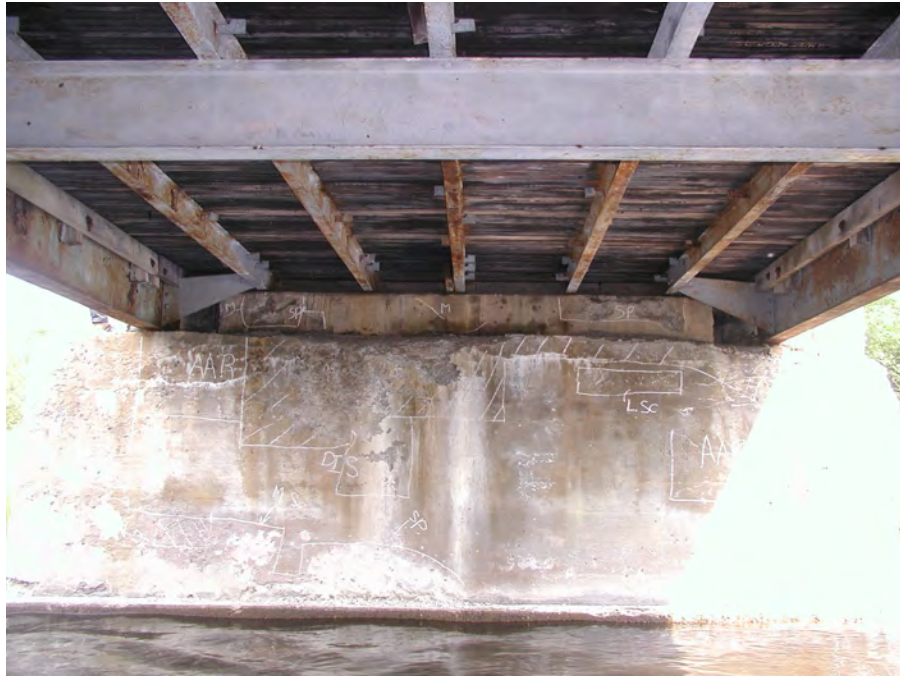
Photograph 29: Condition of east face of pier. Condition of west face is similar.

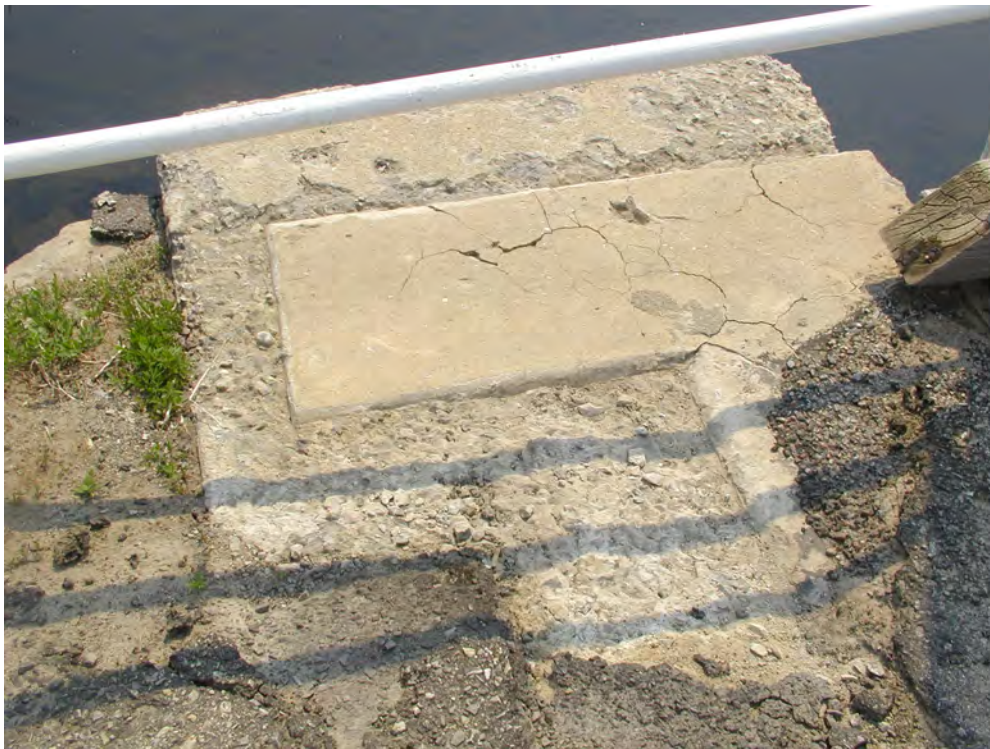
The severe deterioration of the substructure components is consistent with the deterioration typical when masonry structures are encased in concrete. It is therefore likely that the existing substructure was constructed of masonry shafts with concrete bearing seats and ballast walls (see Photographs 31 and 32).

Photograph 32: Detail of top of East Abutment, showing concrete encasement. West Abutment similar.

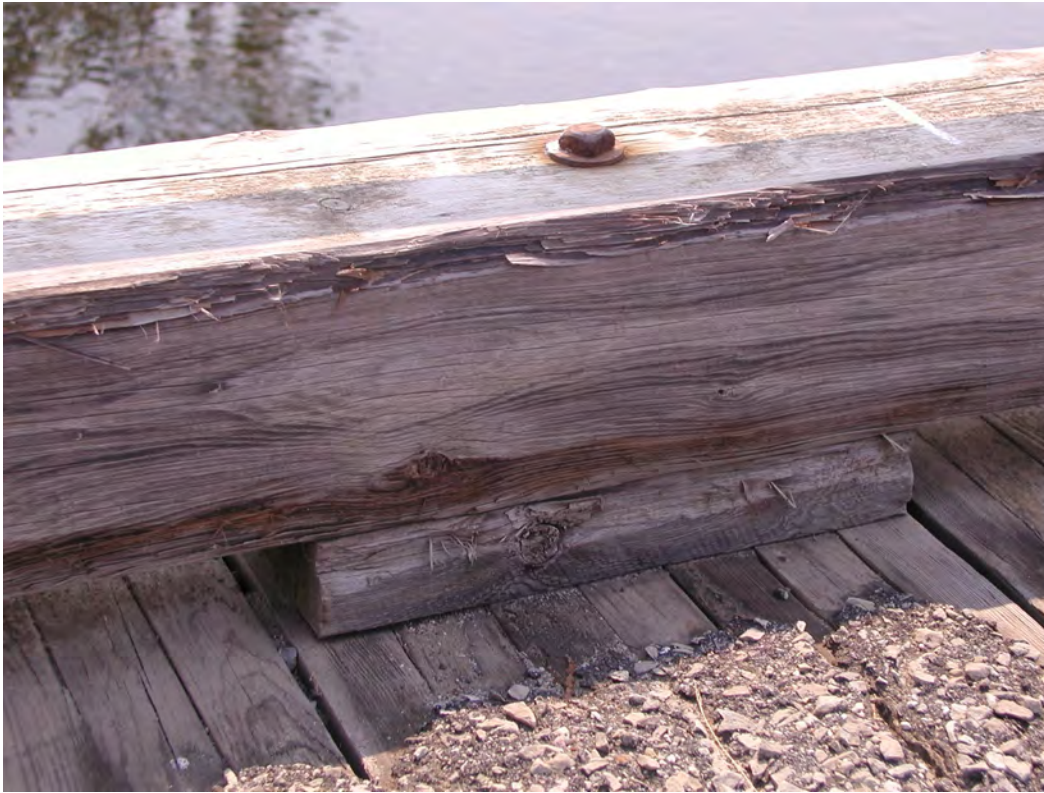
The curb on the deck consists of 152 mm x 152 mm timbers (Photograph 33), and is in fair to good condition.

Photograph 33: Detail of curb on timber deck.

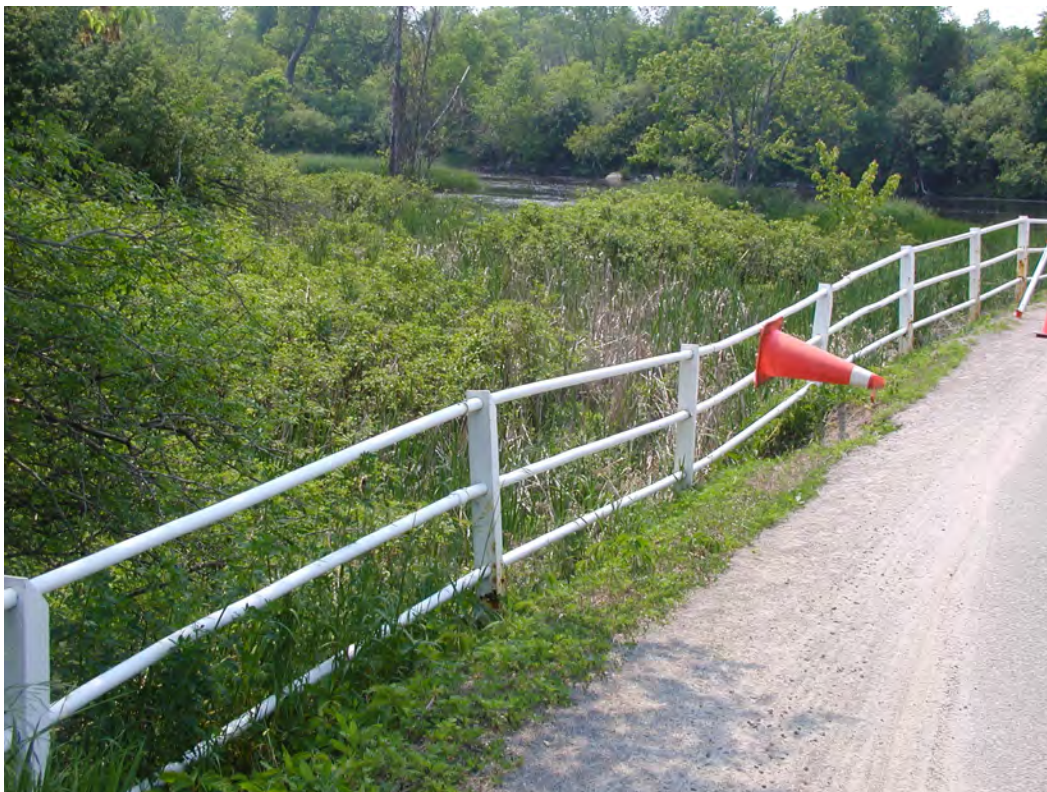
Photograph 34: Deformed railing on south side of east approach retaining wall as a result of slope erosion undermining posts.

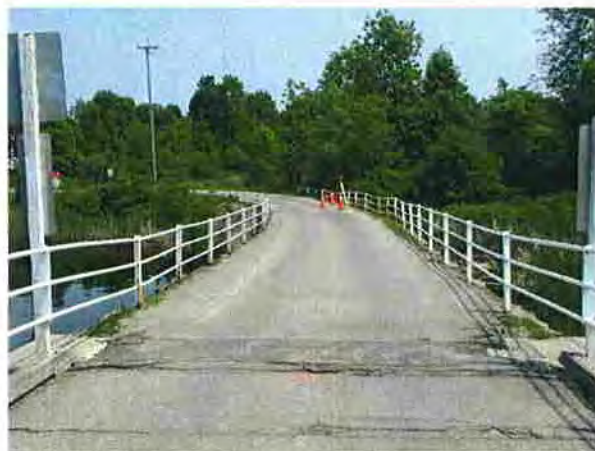
Photograph 3: View of single lane east approach on dry stone retaining walls, looking east.

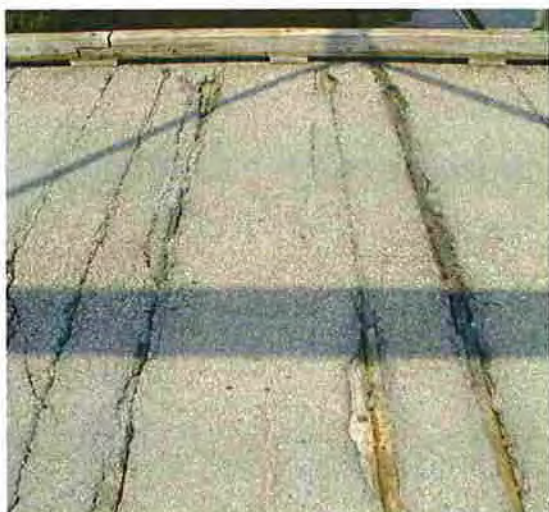
The timber deck is in fair to poor condition. The timbers have separated in numerous locations, permitting runoff through the timbers and removing the protective creosote (Photographs 4 and 5). Timber rot was also observed in a few areas where the creosote was missing. The deck has separated from the steel stringers in several locations and the timbers were observed to deflect upwards under traffic loads. The asphalt wearing surface has also failed in these locations. There is evidence of numerous previous repairs to the asphalt over the expansion joints.

Photograph 4: Deterioration of the asphalt and separation of the deck timbers.

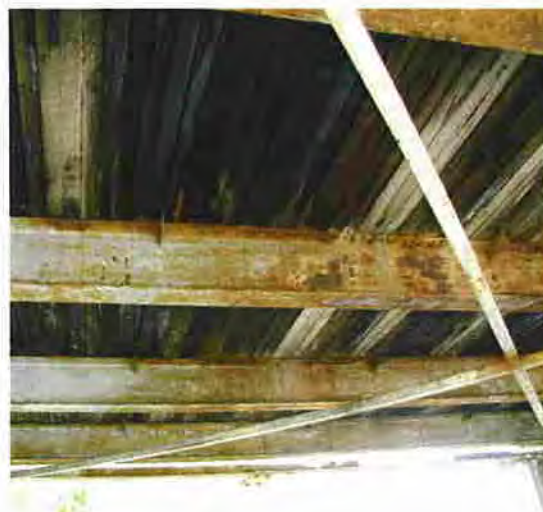
Photograph 5: Deterioration of the timber deck due to loss of creosote protection. Note the widespread light corrosion of the below-deck steel floor system.

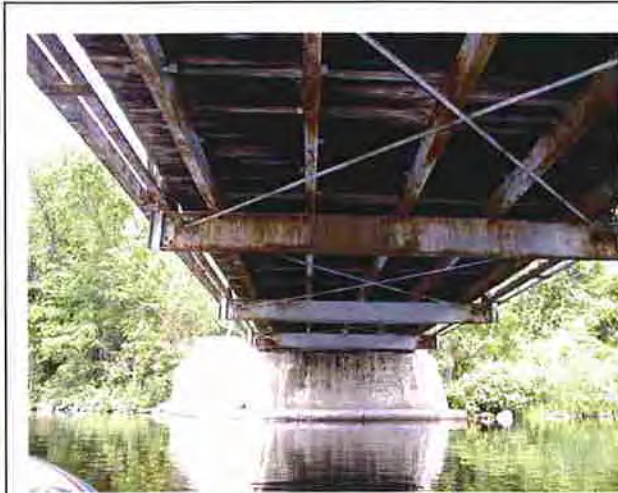
The steel truss is in fair condition, with widespread light corrosion and minor section loss throughout (Photograph 6). The structural steel in the truss is typically in better condition above deck than below deck. The steel floor systems are generally in fair condition, with the exception of the stringers at the West Abutment. During the June 2005 inspection, it was noted that the stringers at the West Abutment exhibited very severe section loss and perforations. The October 2005 report recommended that these stringers be retrofit, which had been done by the time of the February 2007 inspection (Photograph 7).

Photograph 6: Typical condition of below-deck structural steel in truss.

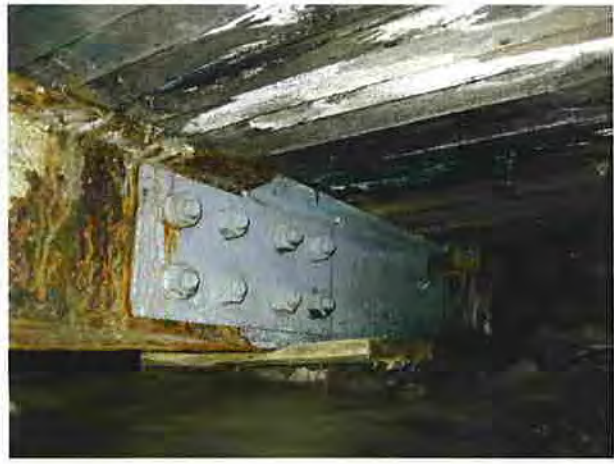
Photograph 7: Detail of repaired stringer at the West Abutment.

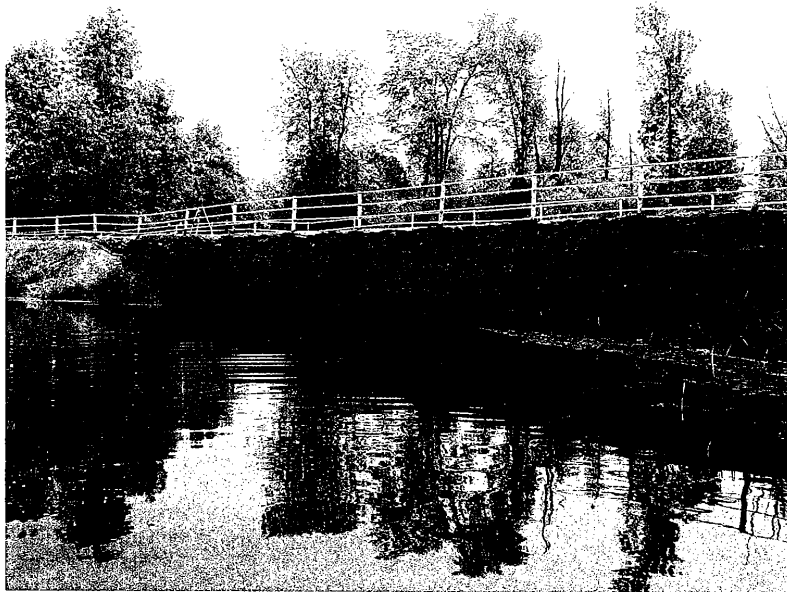
Photograph 5: Dry stone retaining wall on east approach.

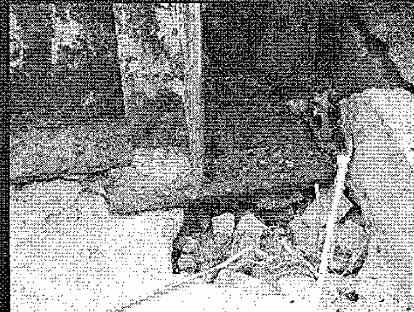
Undermining of south pier bearing

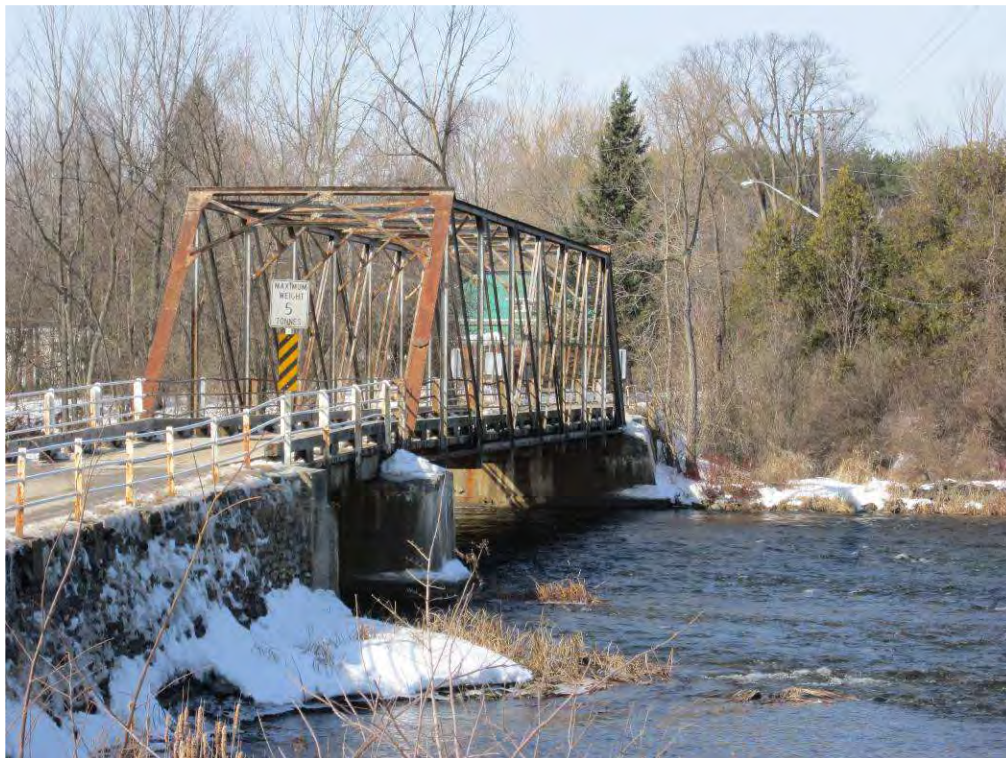
*Photograph 1: East elevation, looking northwest.*

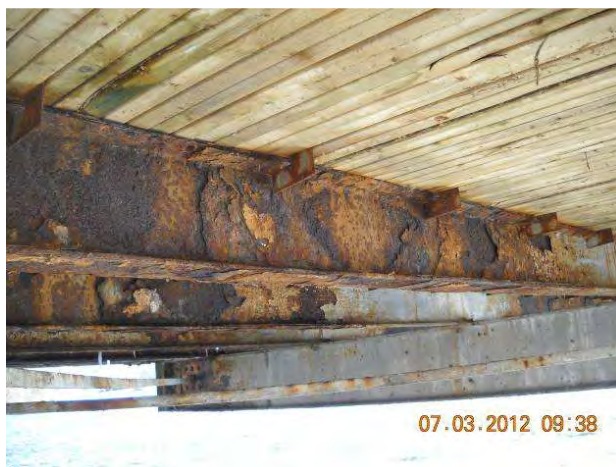
The steel superstructure is in fair condition with widespread surface corrosion. The structural steel is generally in better condition above deck than below deck. The stringers in the end bays of the truss span have widespread surface corrosion with moderate section loss in the web and both flanges (Photograph 2). The section loss has been measured at several locations and was calculated to be up to 30% of the flange area. For the purposes of the inspection and structural evaluation, truss joints are numbered as shown in Figure 1 below.

*Photograph 2: Typical stringer corrosion in end bay of truss span.*

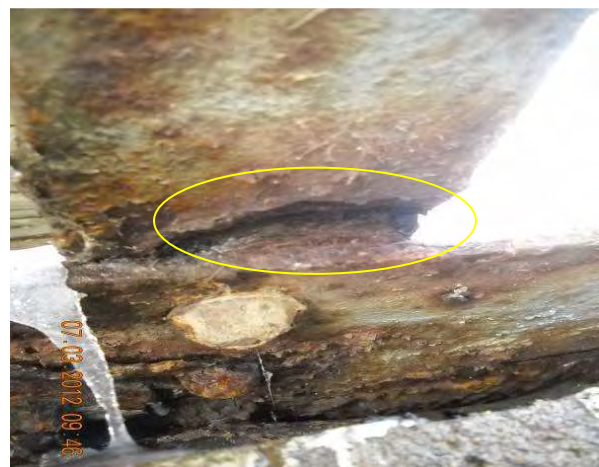
Severe section loss was observed in both the east and west bottom chords of the north end bay between L0L1 (see Figure 1 for truss joint numbering used in this report). The horizontal legs of the double angle section near the lateral bracing connection plate at L0 have near complete loss of section (Photograph 3). The vertical legs of the angles exhibit moderate pitting (Photograph 4). The corresponding section loss for the two members has been estimated at 60% (east) and 50% (west). The lateral bracing connection plates at these locations are also severely corroded with perforations (Photograph 5).

*Photograph 3: Severe pitting of horizontal leg of bottom chord L0L1.*

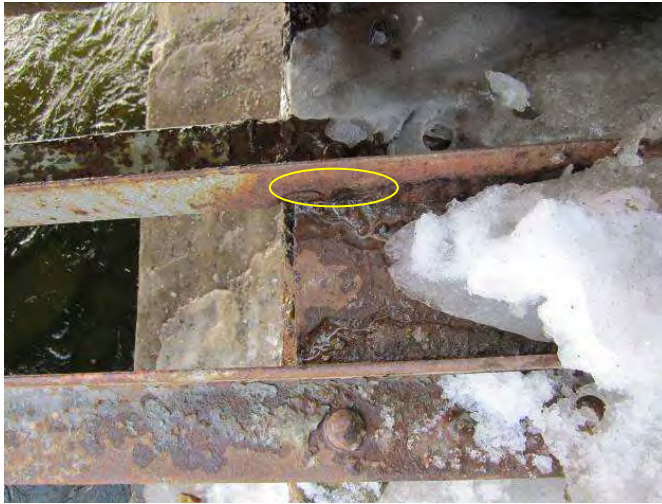
*Photograph 4: Moderate pitting vertical leg of bottom chord L0L1*

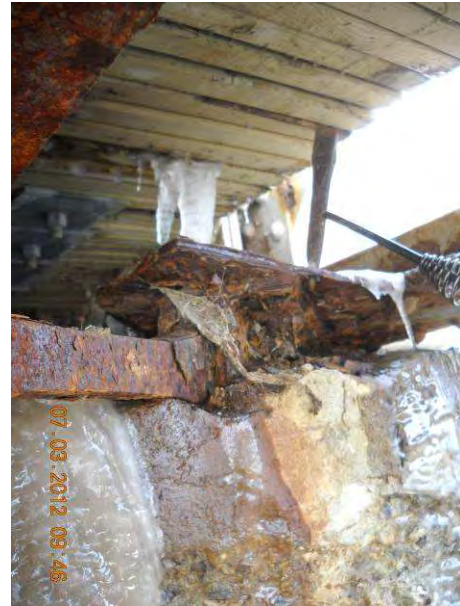
*Photograph 5: Severely corroded bottom lateral connection plate at L0*

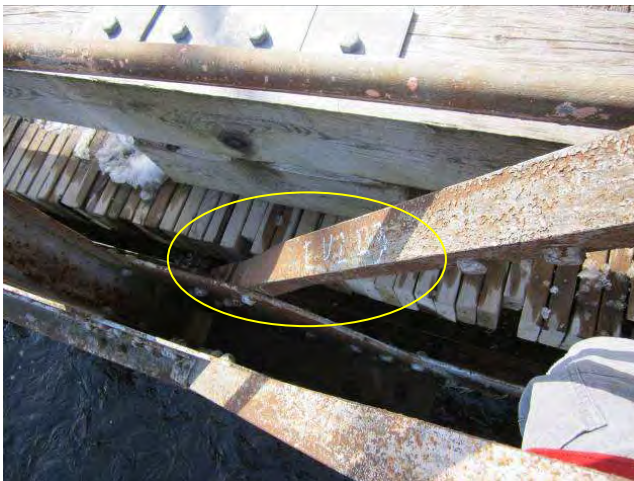
The truss diagonals U2L3 and U4L3' exhibit signs of buckling. The angle section U2L3 has twisted noticeably near L3, suggesting lateral torsional buckling has taken place (Photograph 6). At U4L3' the angles of the double angle section have bent and are nearly touching at mid-height, indicating global buckling (Photograph 7).

*Photograph 6: Twisting of U2L3 (east truss) near L3.*

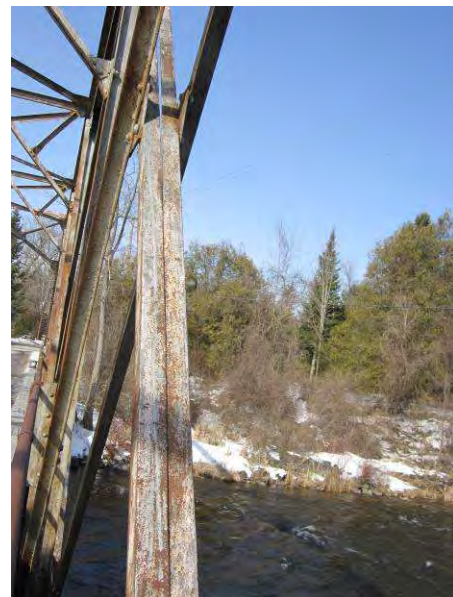
*Photograph 7: Buckling of U4L3' (east truss) near mid-height.*

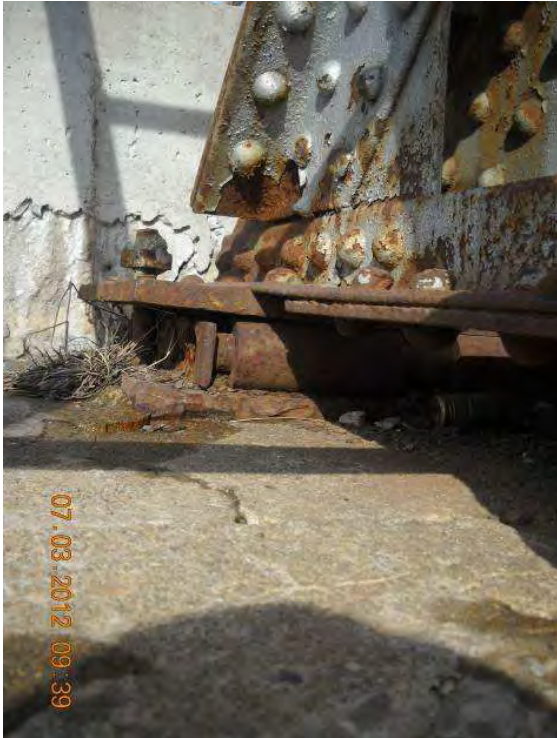
The bearings of the truss span are in poor condition and are unlikely to be functioning properly due to the advanced state of corrosion (Photograph 8). The timber blocking under the truss span stringer bearings is displaced at several locations causing excessive bending of the stringers due to lack of support (Photograph 9).

*Photograph 8: Condition of truss bearing. Southeast bearing shown.*
