# ANDREWSVILLE BRIDGE

## SUMMARY OF EVENTS FROM 2005 TO 2022

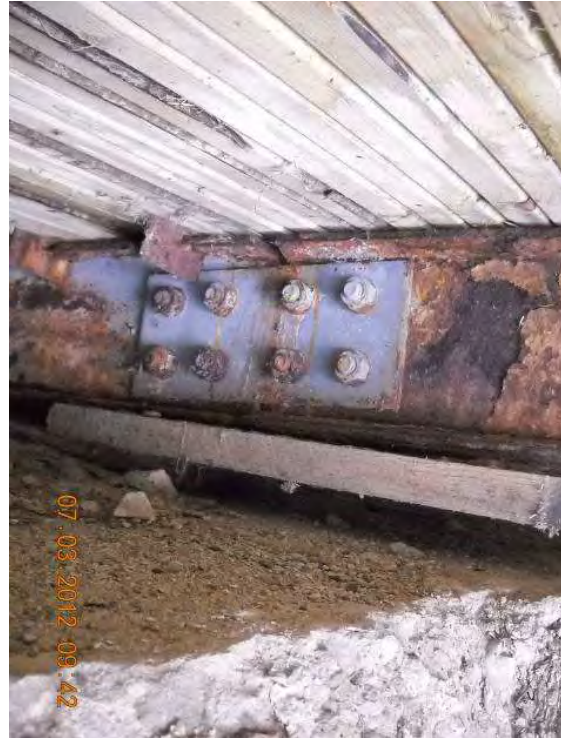
*Photograph 9: Displace timber blocking at stringer bearing. Note stringer web repair from 2009 rehabilitation.*

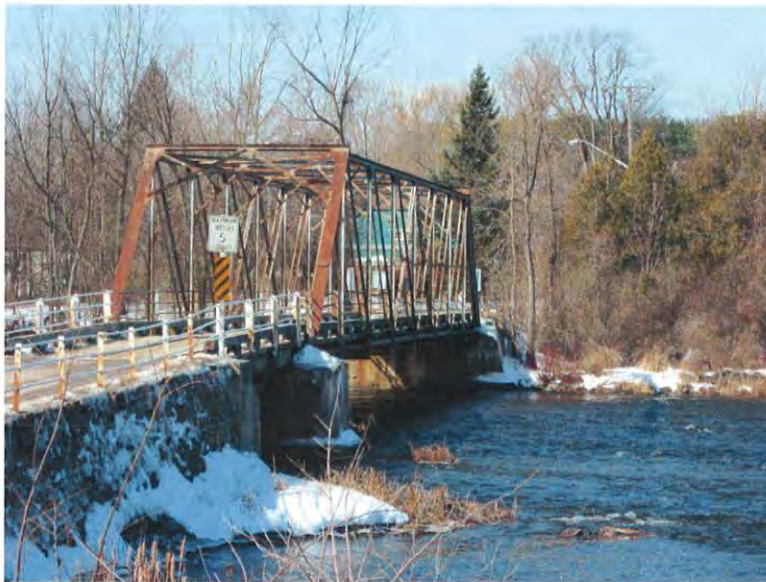
*Photograph 1: East elevation, looking northwest.*

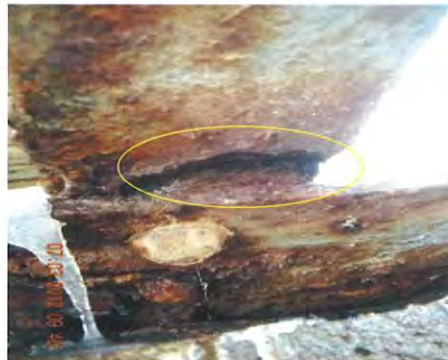
Severe section loss was observed in both the east and west bottom chords of the north end bay between L0L1 (see Figure 1 for truss joint numbering used in this report). The horizontal legs of the double angle section near the lateral bracing connection plate at L0 have near complete loss of section (Photograph 3). The vertical legs of the angles exhibit moderate pitting (Photograph 4). The corresponding section loss for the two members has been estimated at 60% (east) and 50% (west). The lateral bracing connection plates at these locations are also severely corroded with perforations (Photograph 5).

*Photograph 3: Severe pitting of horizontal leg of bottom chord L0L1.*

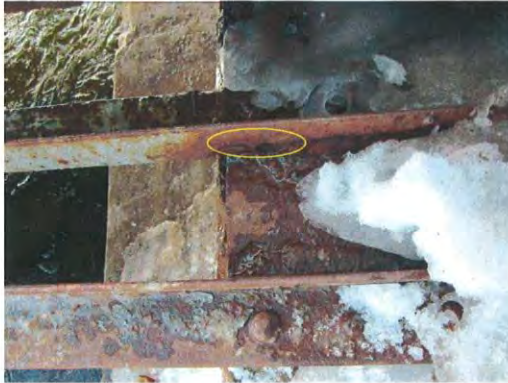
*Photograph 4: Moderate pitting vertical leg of bottom chord L0L1*

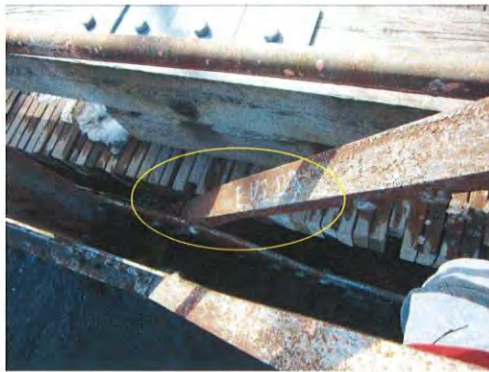
The truss diagonals U2L3 and U4L3' exhibit signs of buckling. The angle section U2L3 has twisted noticeably near L3, suggesting lateral torsional buckling has taken place (Photograph 6). At U4L3' the angles of the double angle section have bent and are nearly touching at mid-height, indicating global buckling (Photograph 7).

*Photograph 6: Twisting of U2L3 (east truss) near L3.*

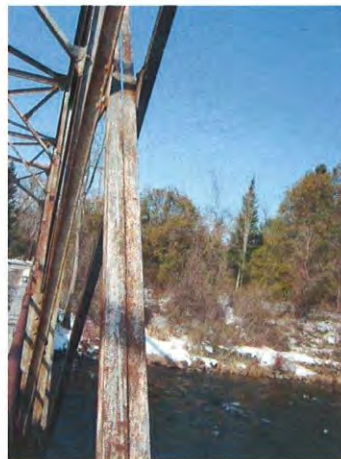
*Photograph 7: Buckling of U4L3' (east truss) near mid-height.*

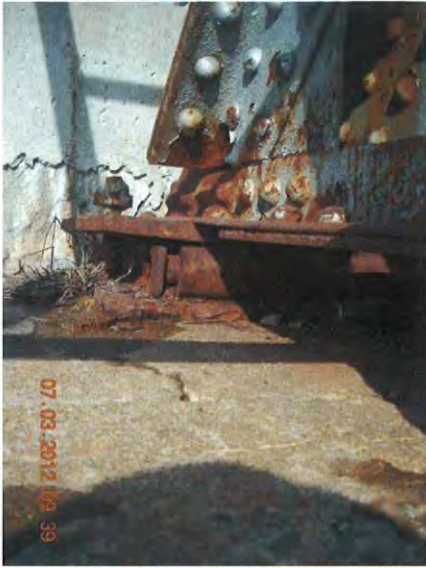
The bearings of the truss span are in poor condition and are unlikely to be functioning properly due to the advanced state of corrosion (Photograph 8). The timber blocking under the truss span stringer bearings is displaced at several locations causing excessive bending of the stringers due to lack of support (Photograph 9).

*Photograph 8: Condition of truss bearing. Southeast bearing shown.*

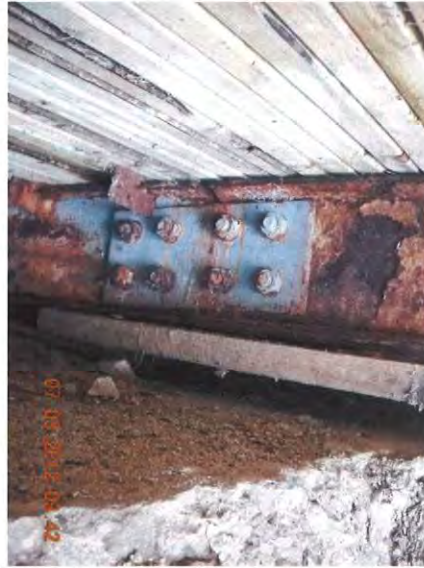
*Photograph 9: Displace timber blocking at stringer bearing. Note stringer web repair from 2009 rehabilitation.*

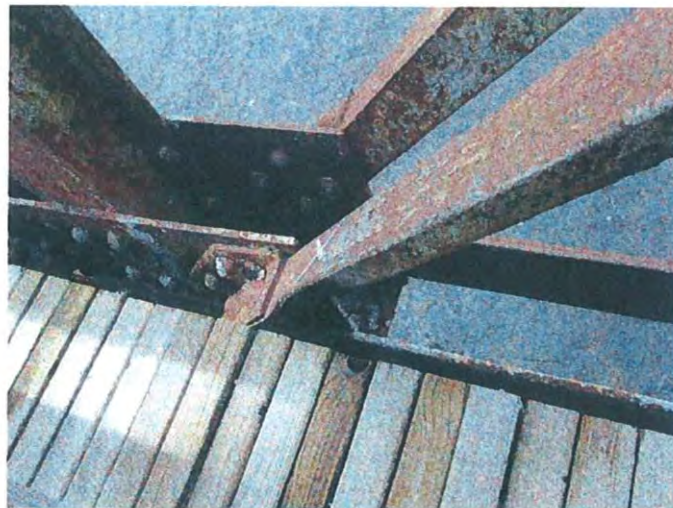
Photograph 2: Deformation in interior angle of U3L4, west truss.

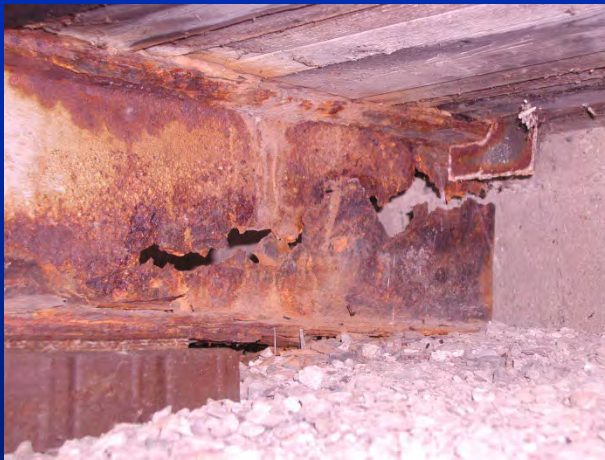
Condition of stringer, June 2005

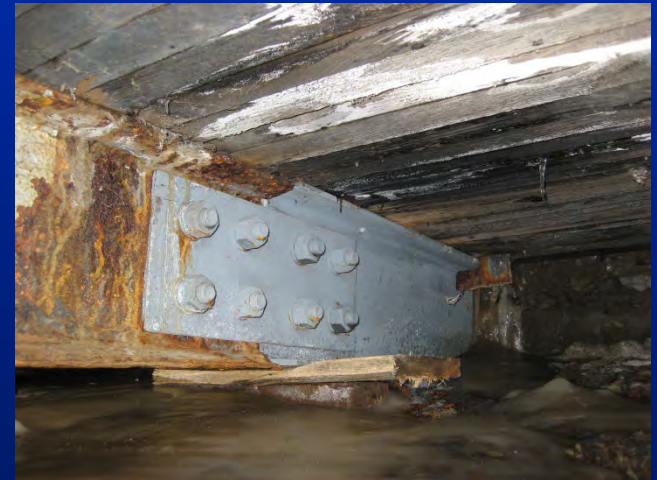
Repaired stringer, February 2006

In 2006, several stringers at the West Abutment were repaired to keep the bridge open to traffic.

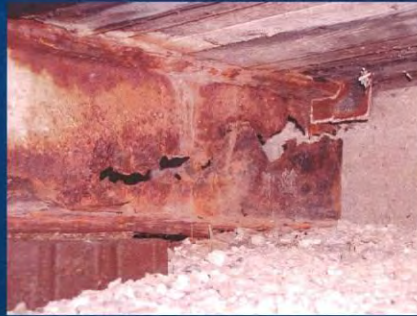
Condition of stringer, June 2005

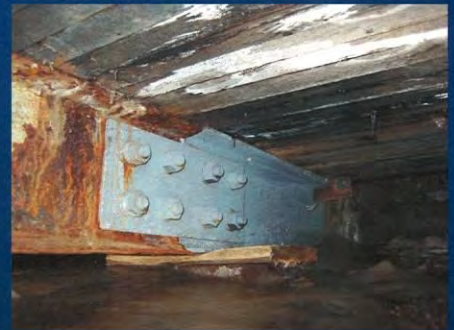
Repaired stringer, February 2006

In 2006, several stringers at the West Abutment were repaired to keep the bridge open to traffic.

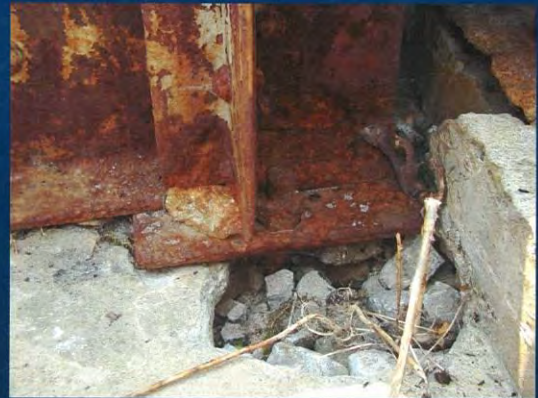
Undermining of south pier bearing

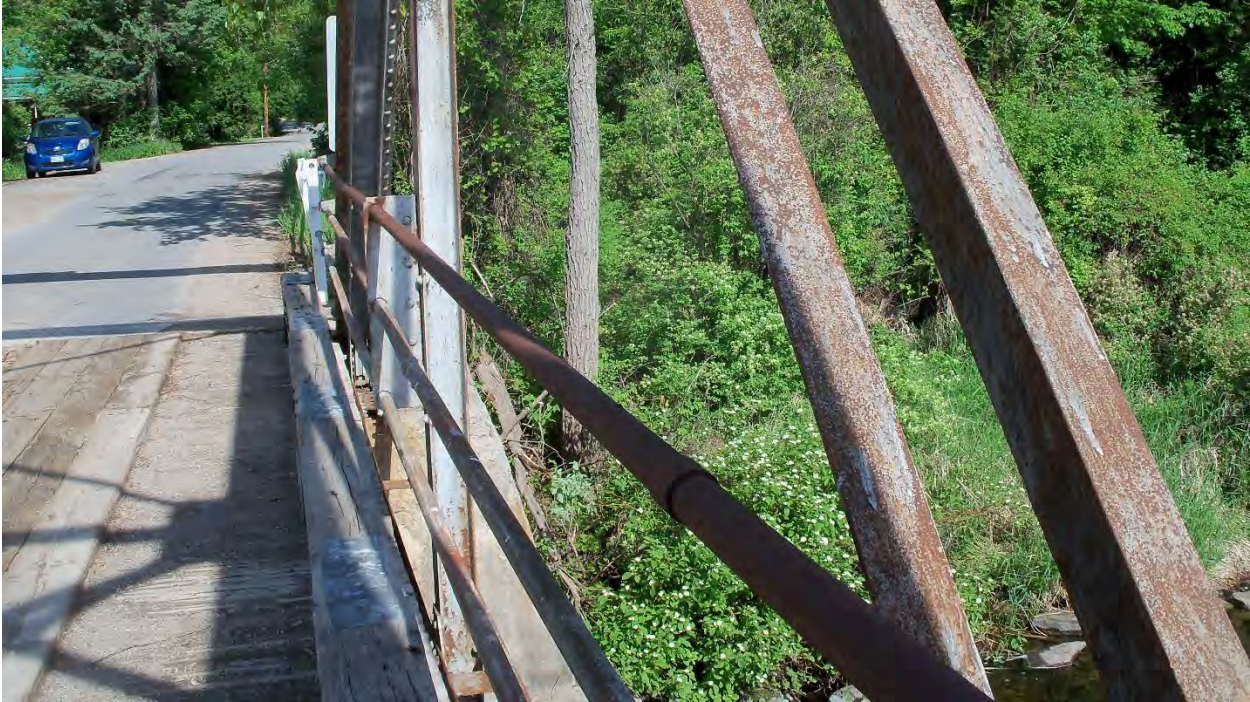
View of timber curb and railing system

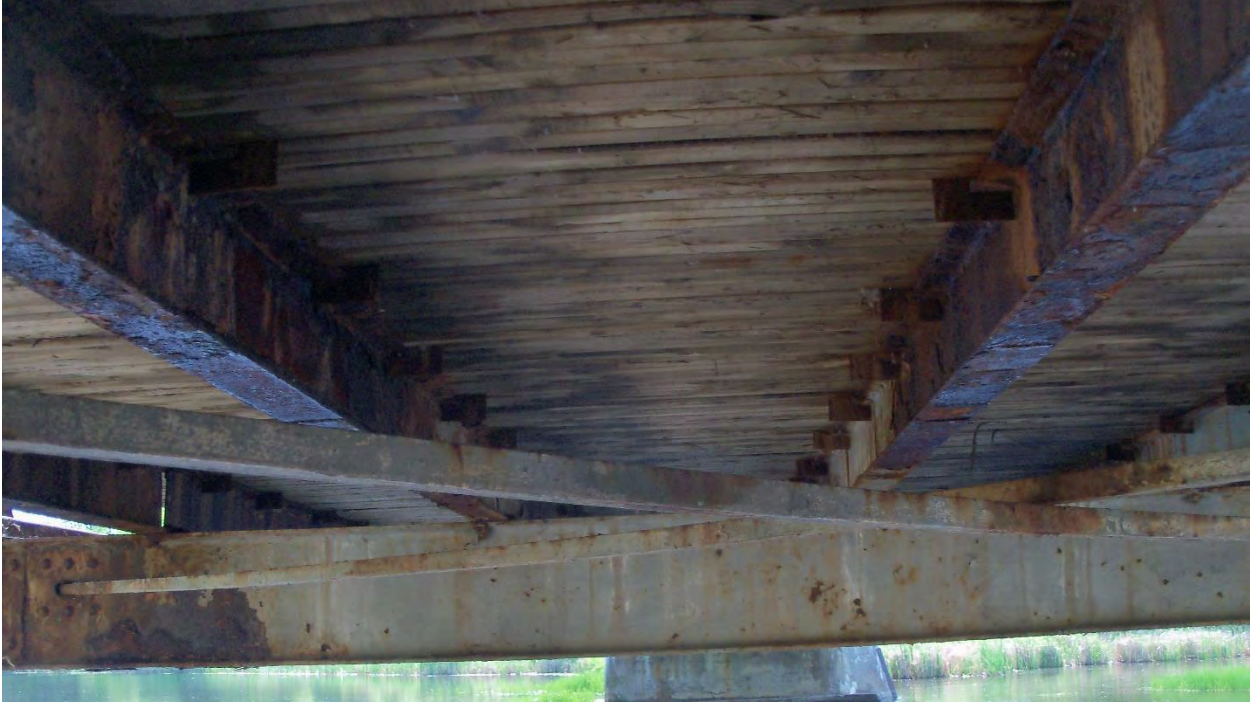
View of soffit and truss stringers and floor beams

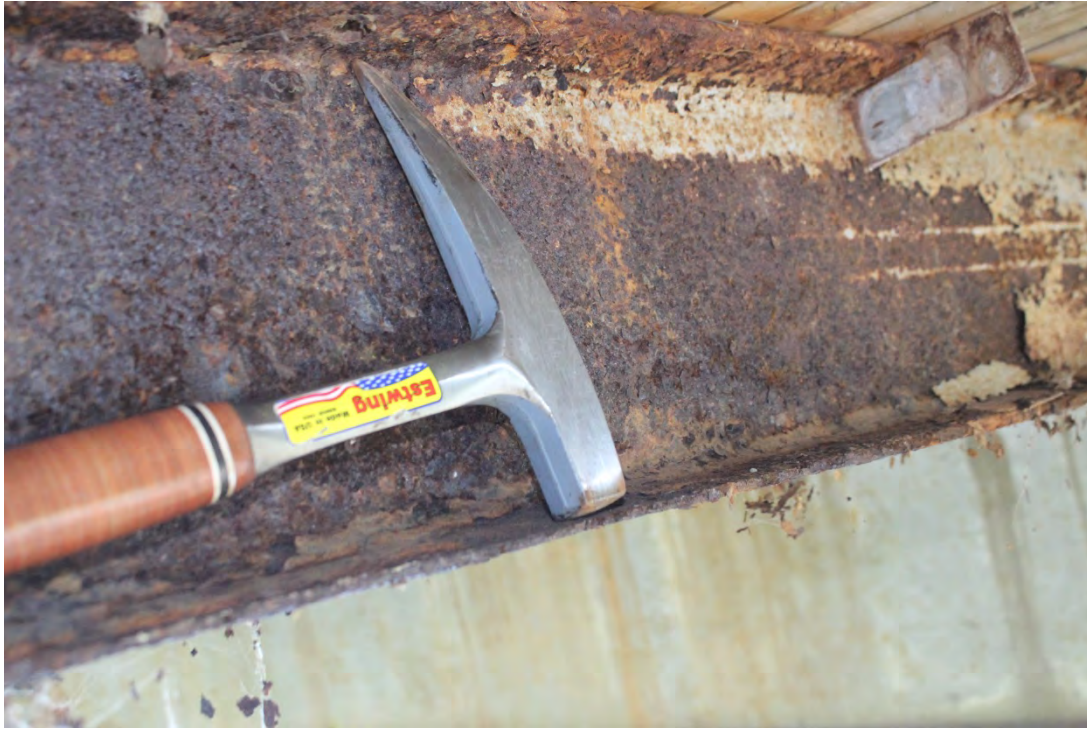
Image 1. Thinning of bottom flange of Stringer 2 in Bay 3

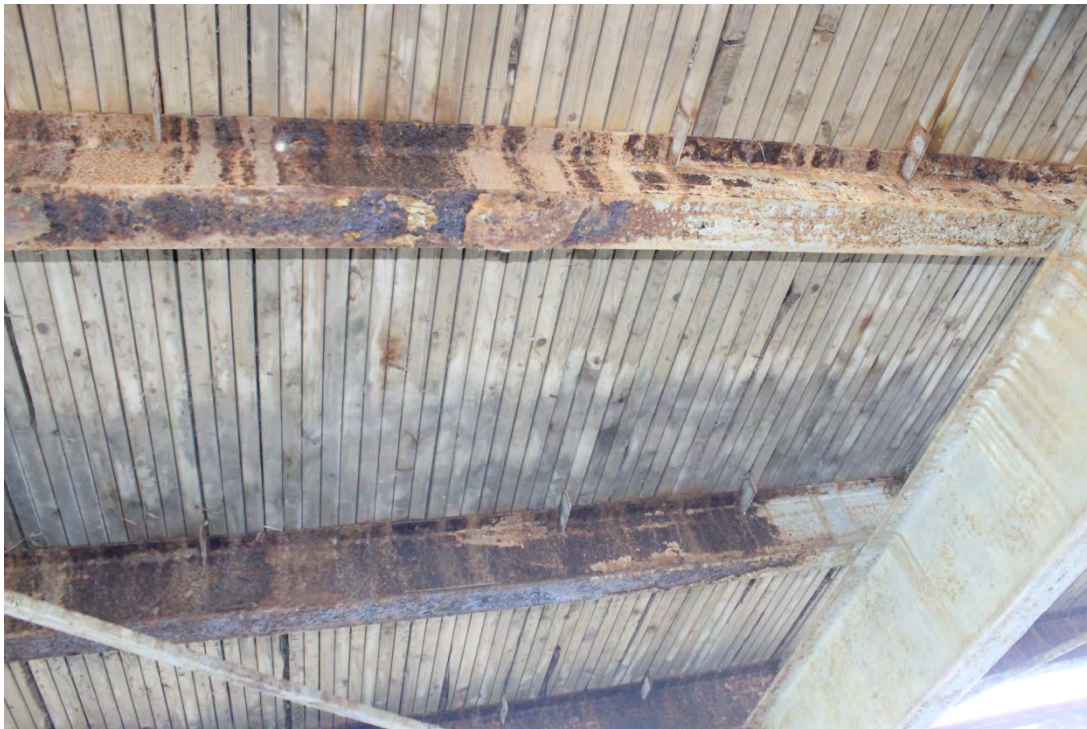
Image 2. Stringers 3 & 4 in Bay 3 looking downstream

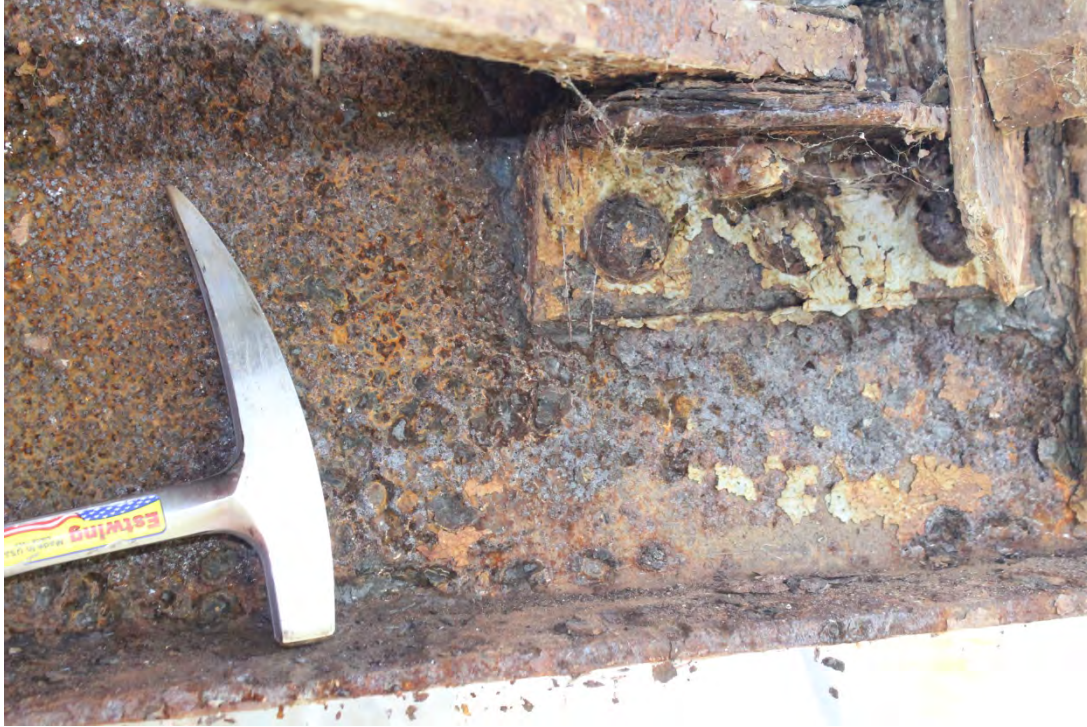
Image 3. South end of Floor Beam between Bays 1 & 2.

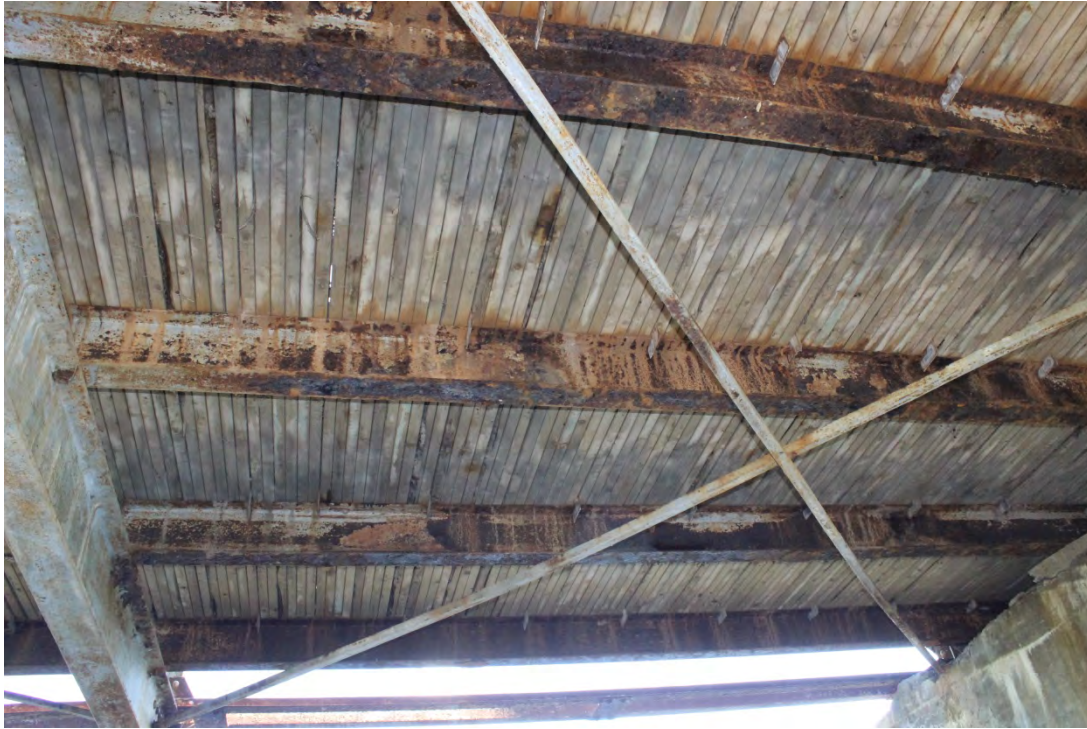
Image 5. Truss Bay 1 adjacent pier, looking downstream

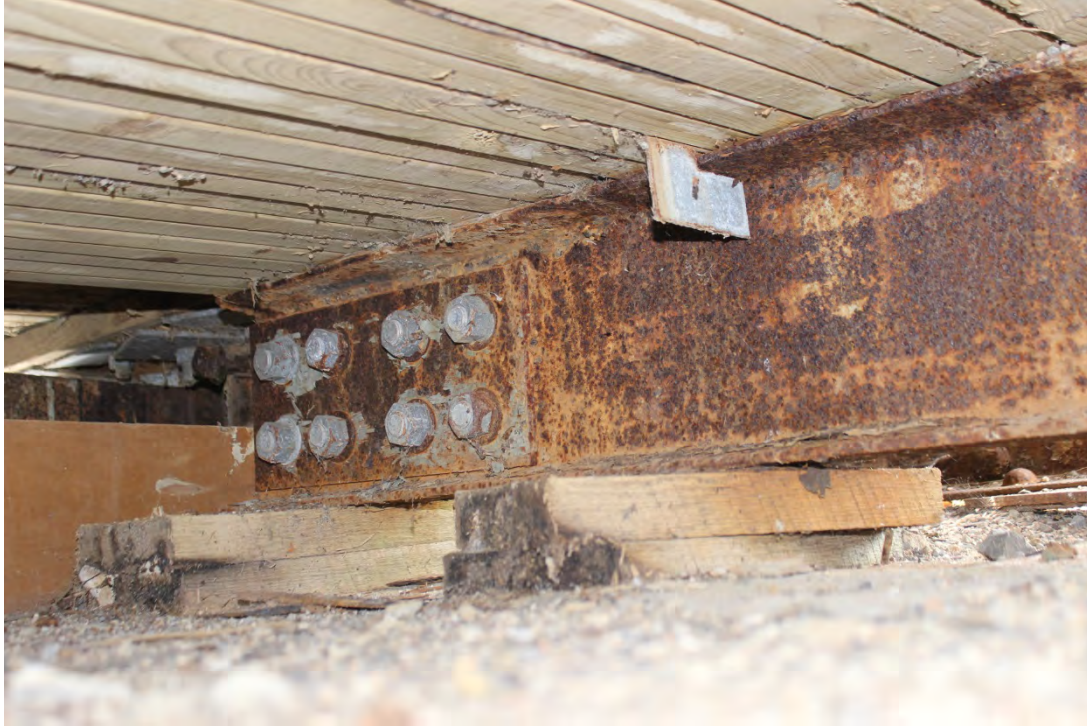
Image 7. Truss Stringer 1 at Pier Bearing

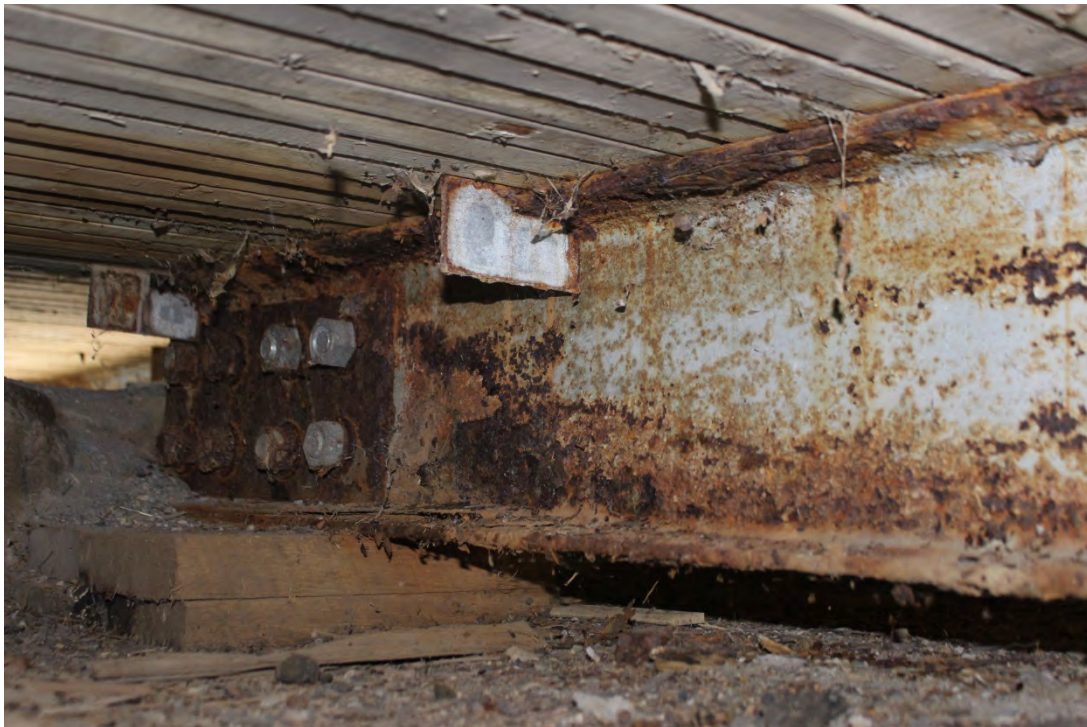
Image 8. Truss Stringer 2 at Pier Bearing

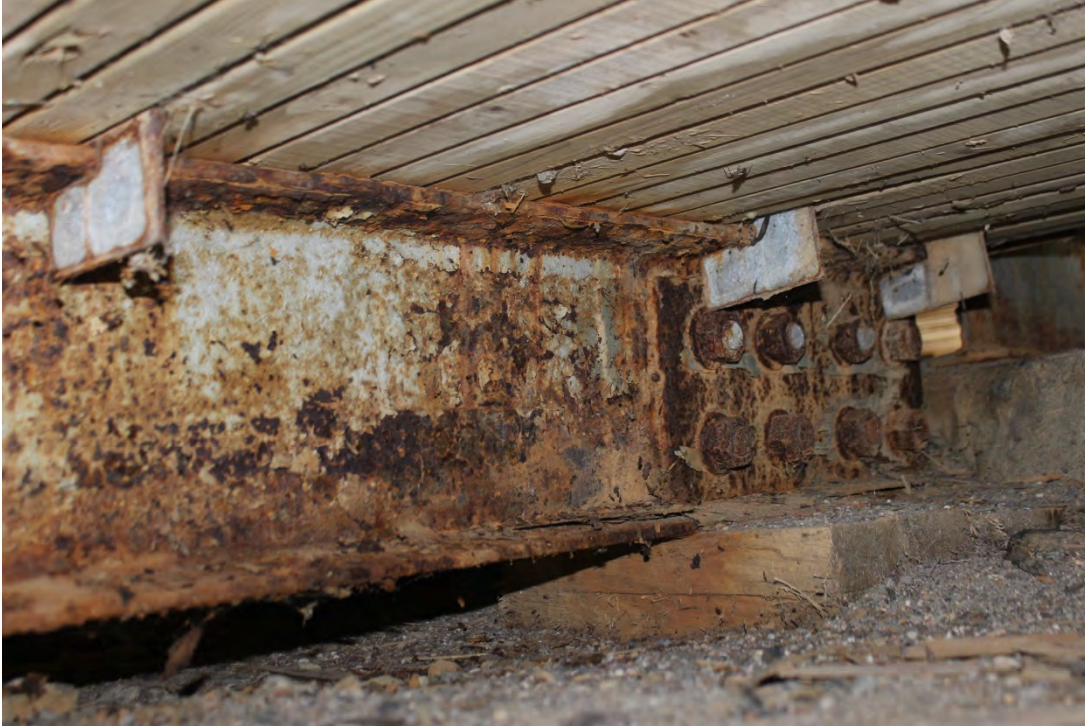
Image 9. Truss Stringer 3 at Pier Bearing

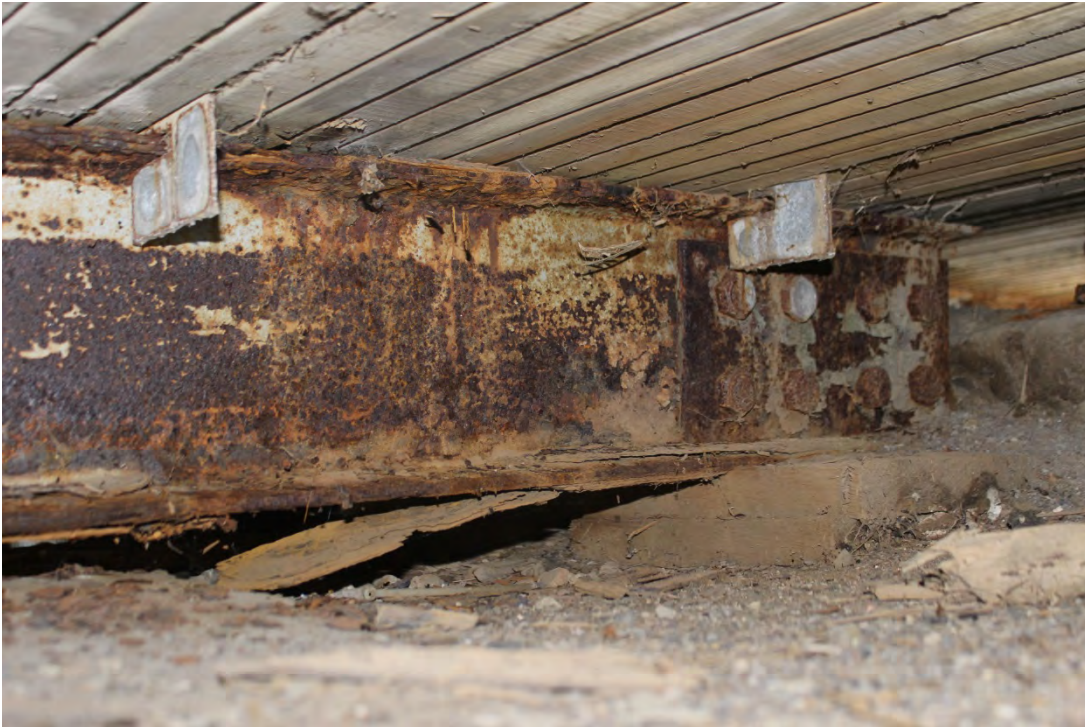
Image 10. Truss Stringer 4 at Pier Bearing

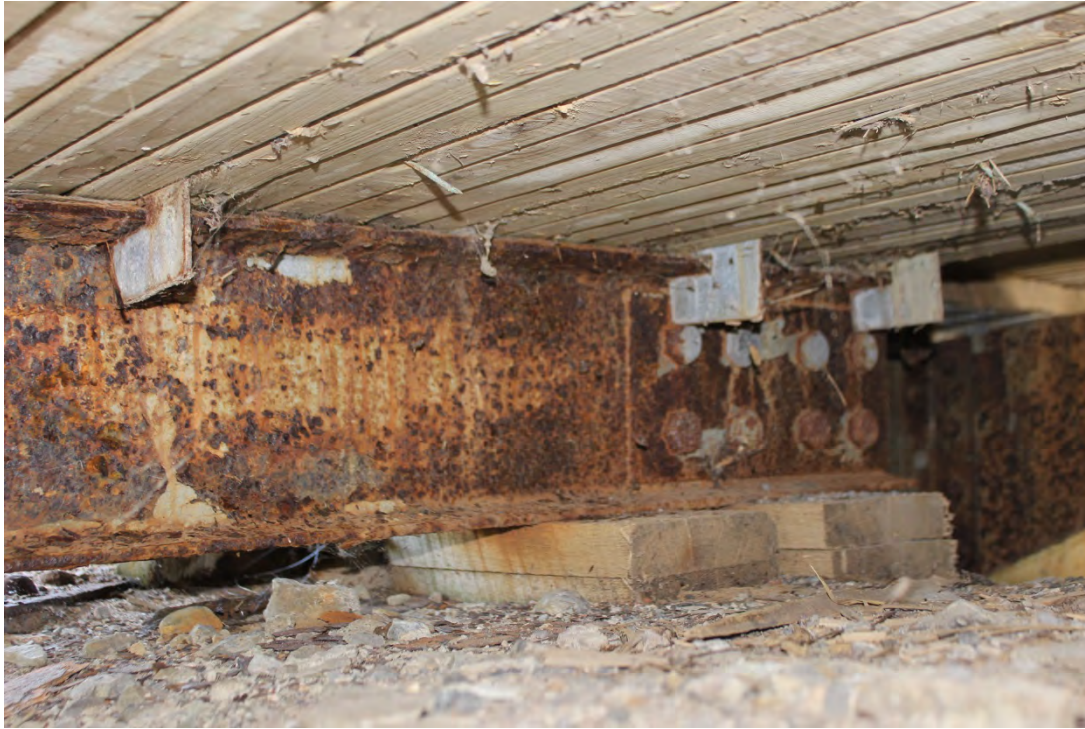
Image 11. Truss Stringer 5 at Pier Bearing

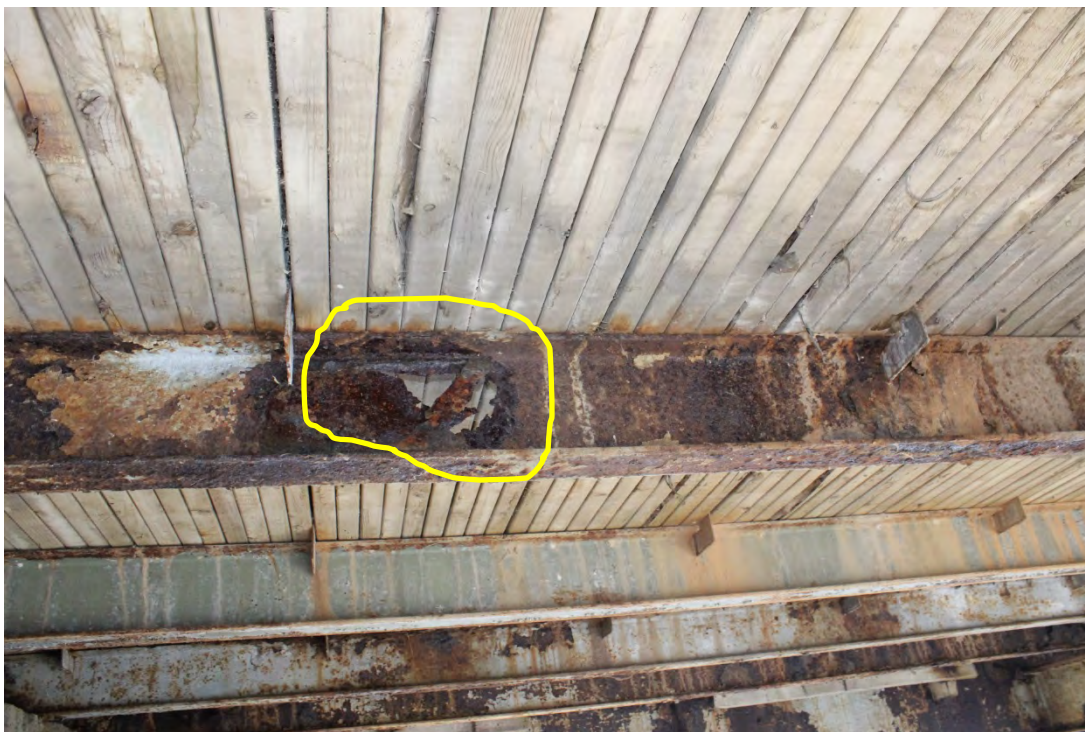
Image 12. Perforation of Approach Stringer 2 before probing

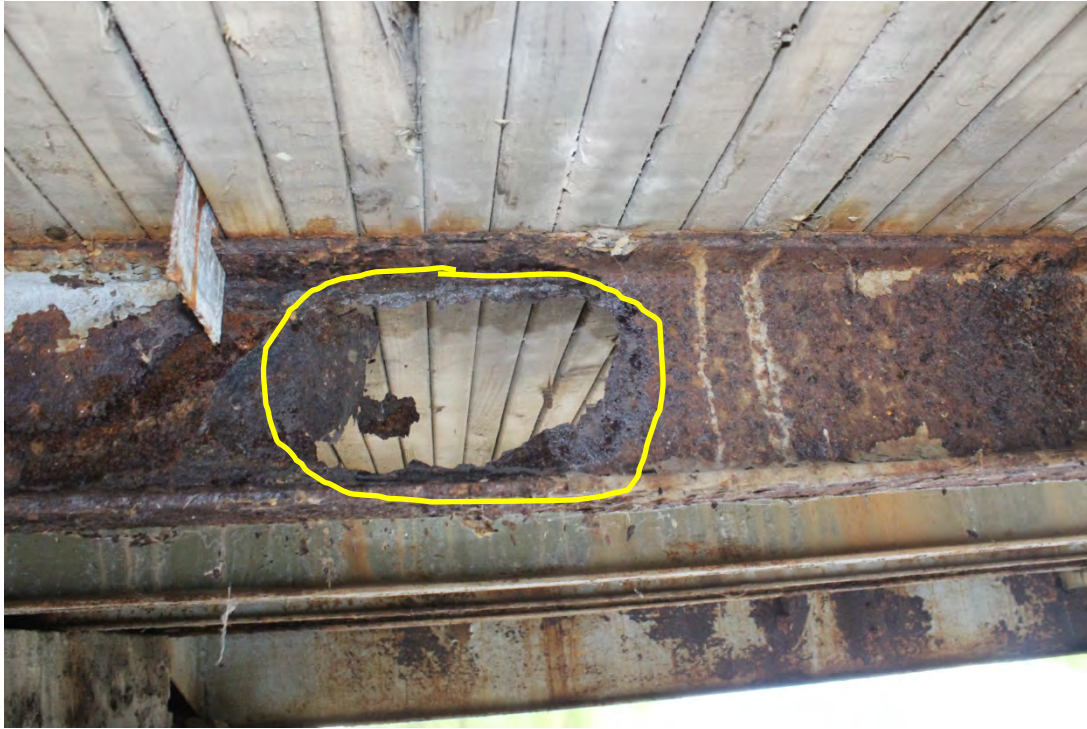
Image 13. Perforation of Approach Stringer 2 after probing

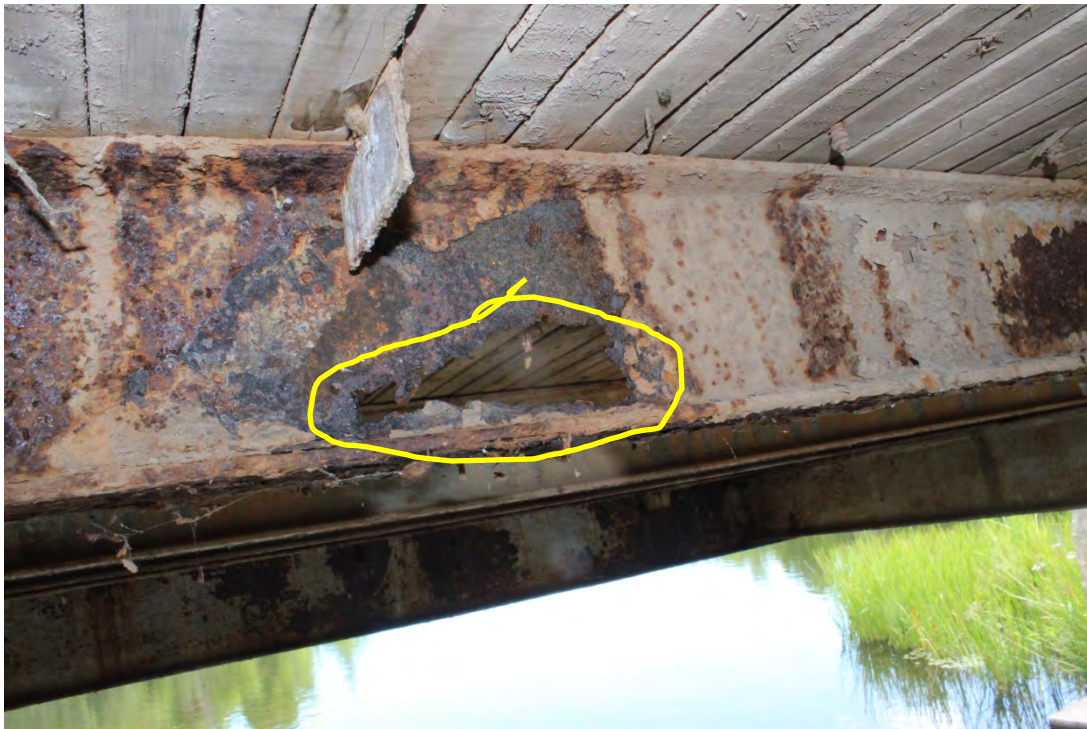
Image 14. Perforation near centre of Approach Stringer 2 west bay.

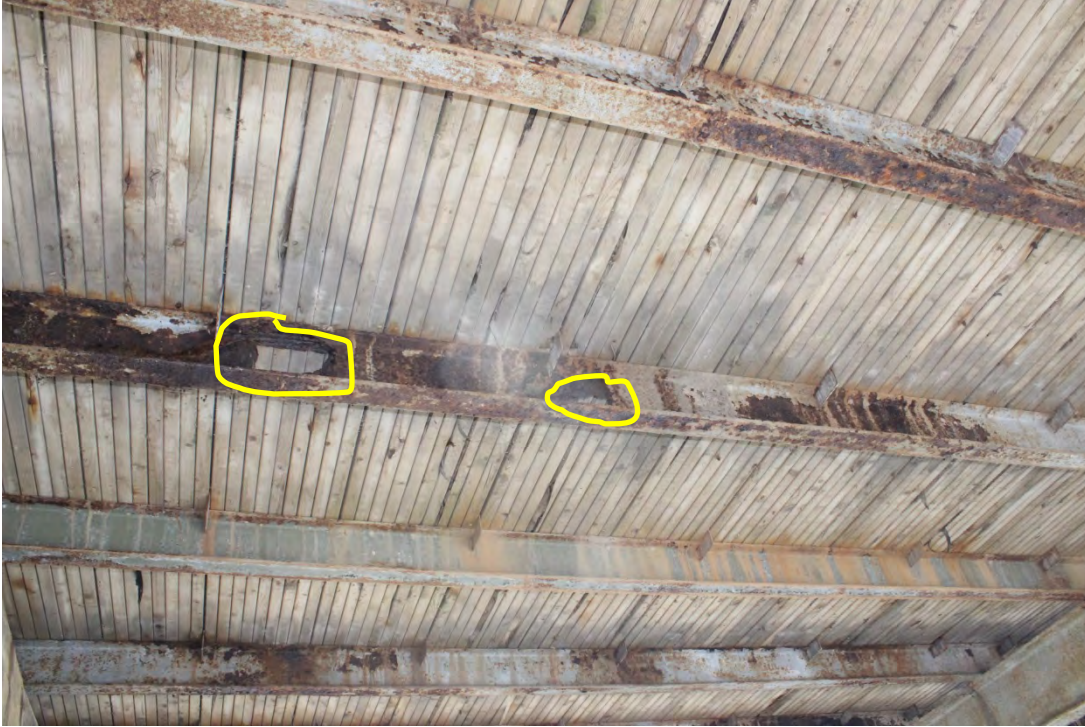
Image 15. General view of west bay of approach span looking downstream. Perforations circled.

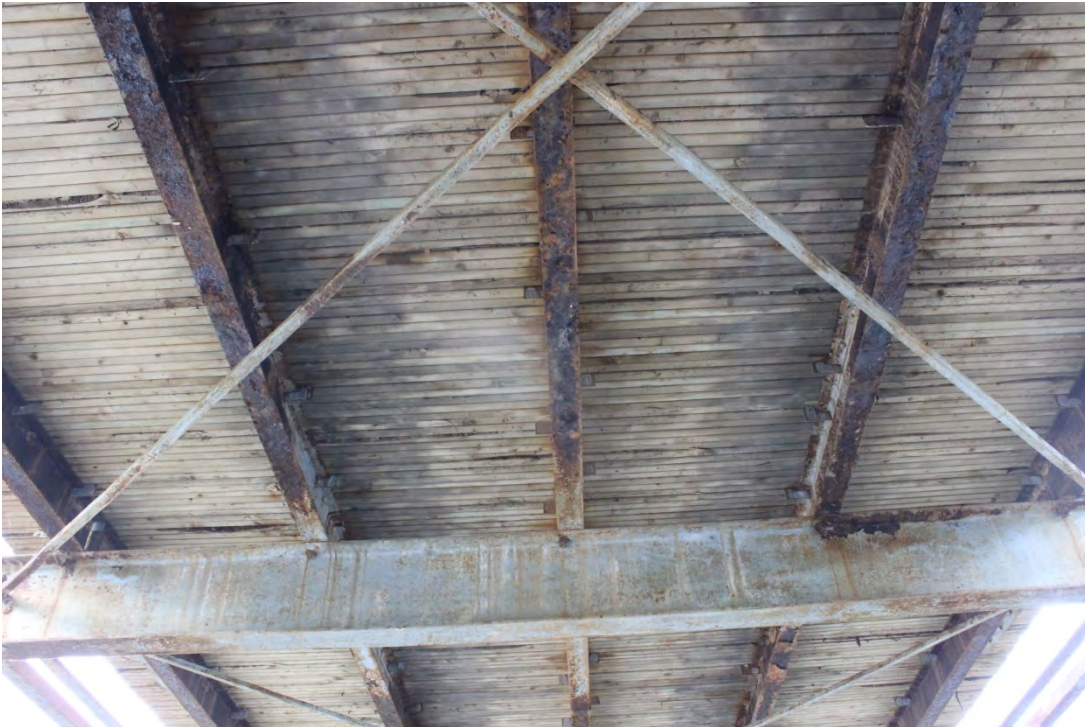
Image 16. Truss Bay 1 looking west

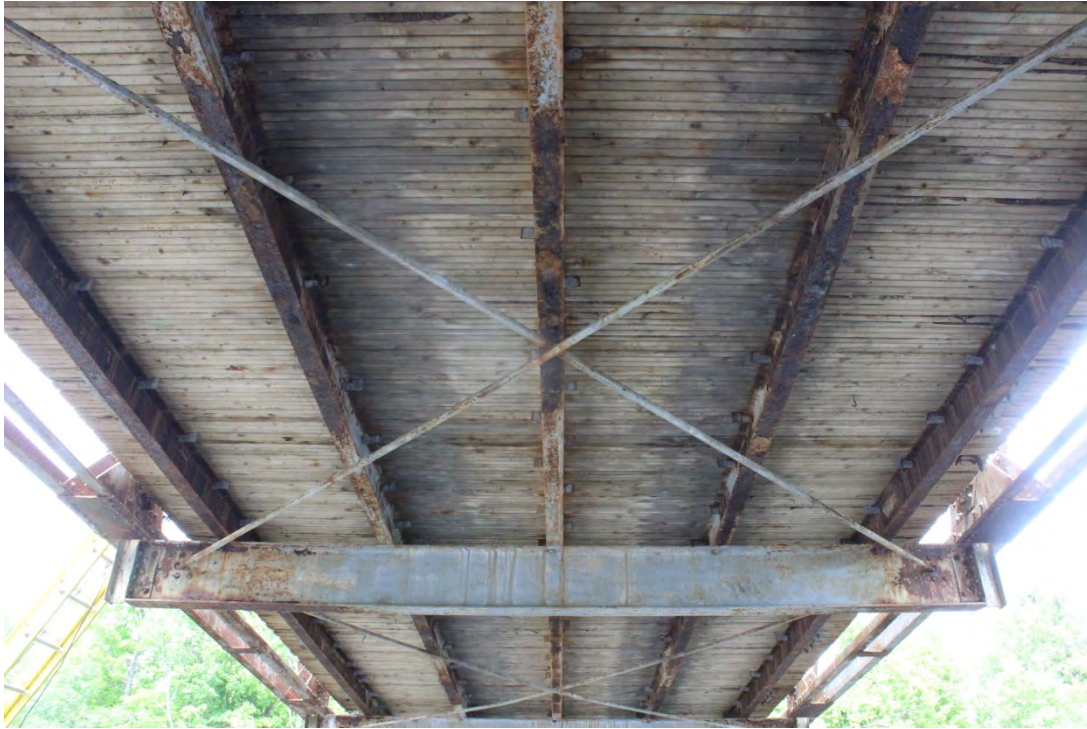
Image 17. Truss Bay 2 looking west

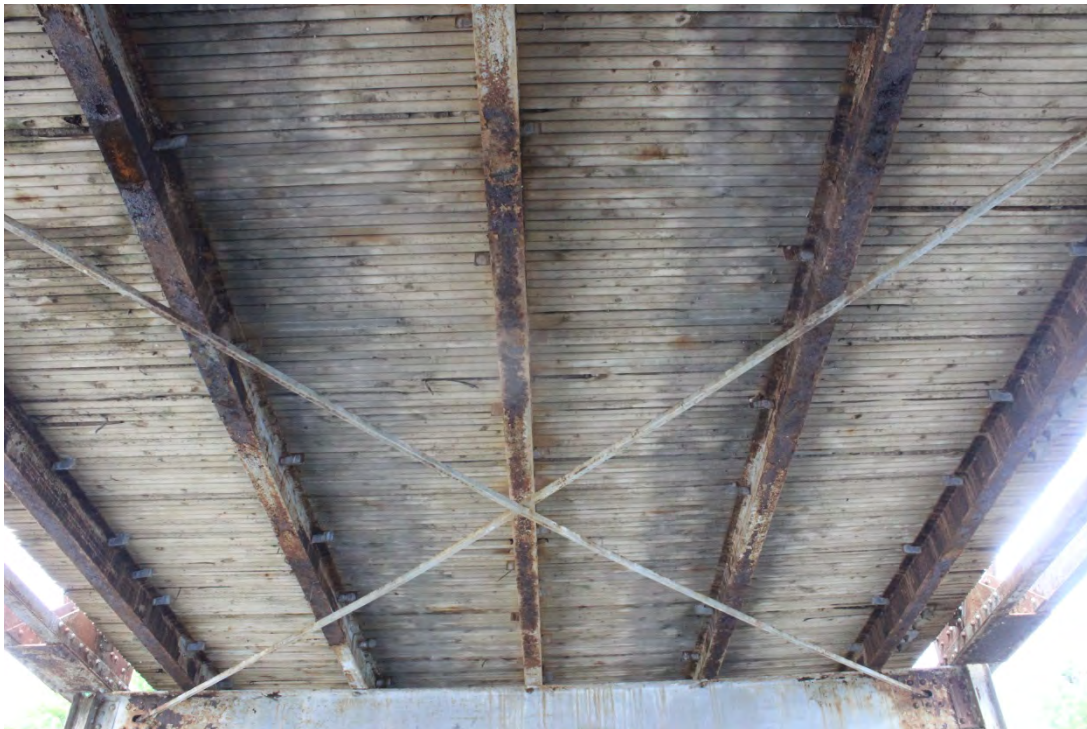
Image 18. Truss Bay 3 looking west

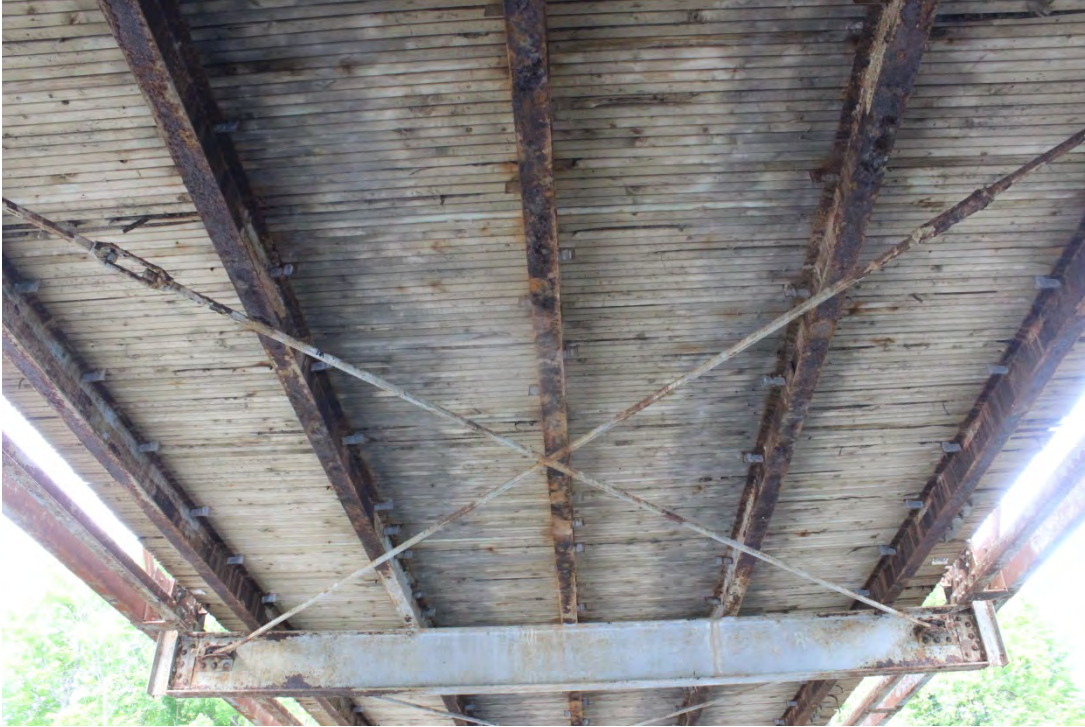
Image 19. Truss Bay 4 looking west

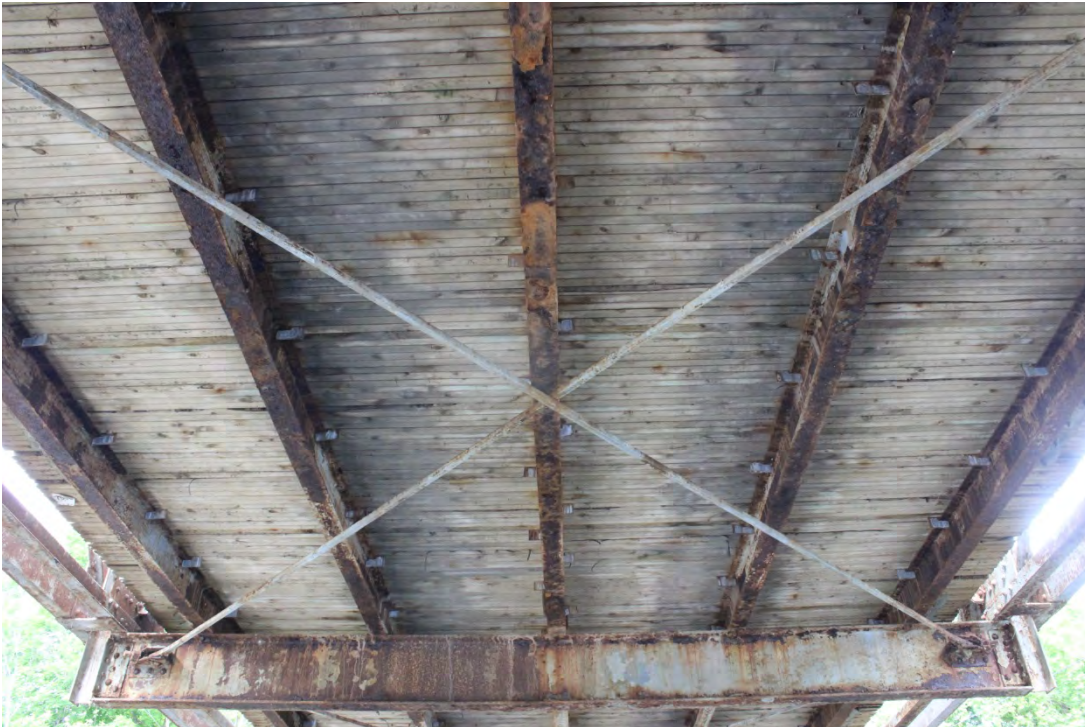
Image 20. Truss Bay 5 looking west

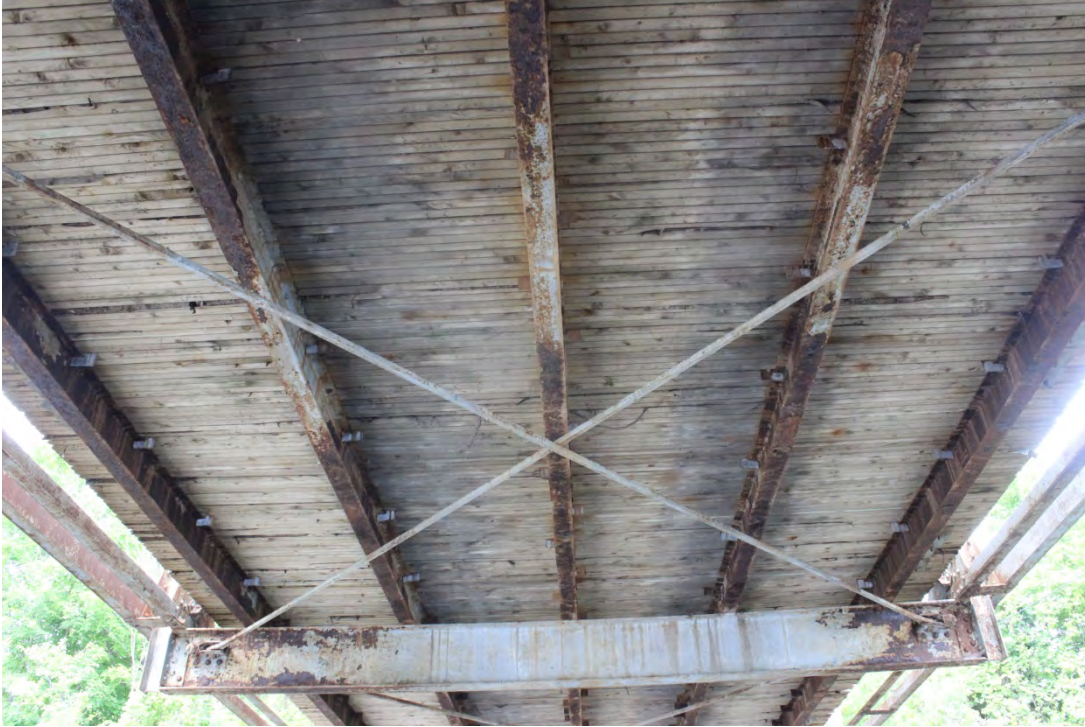
Image 21. Truss Bay 6 looking west

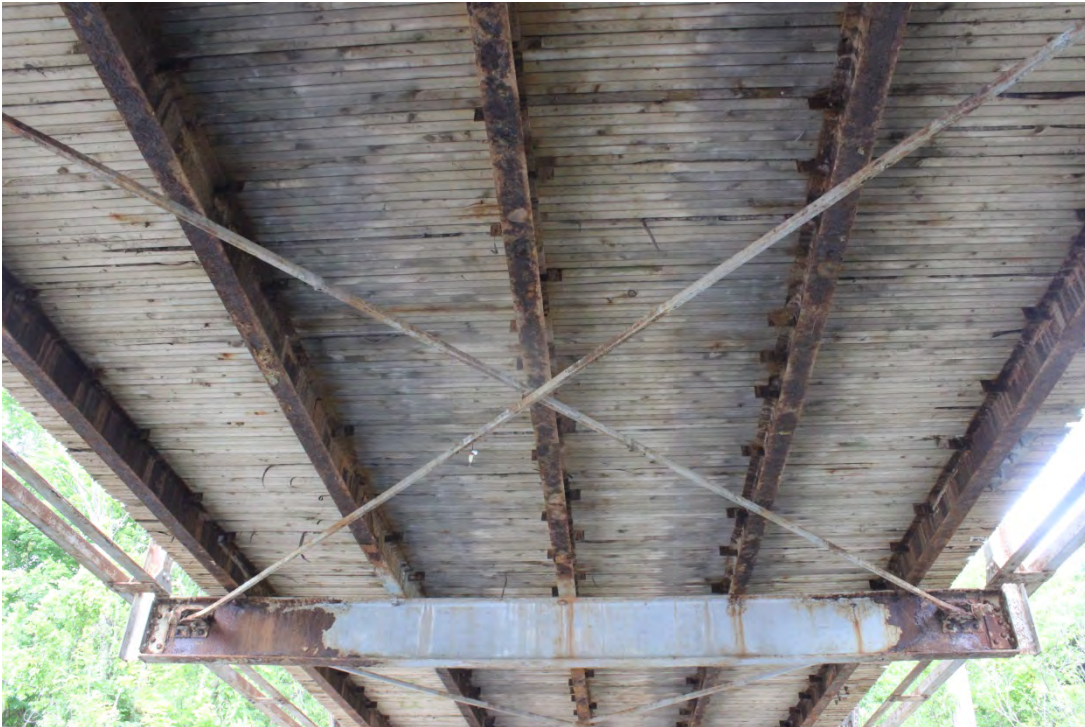
Image 22. Truss Bay 7 looking west

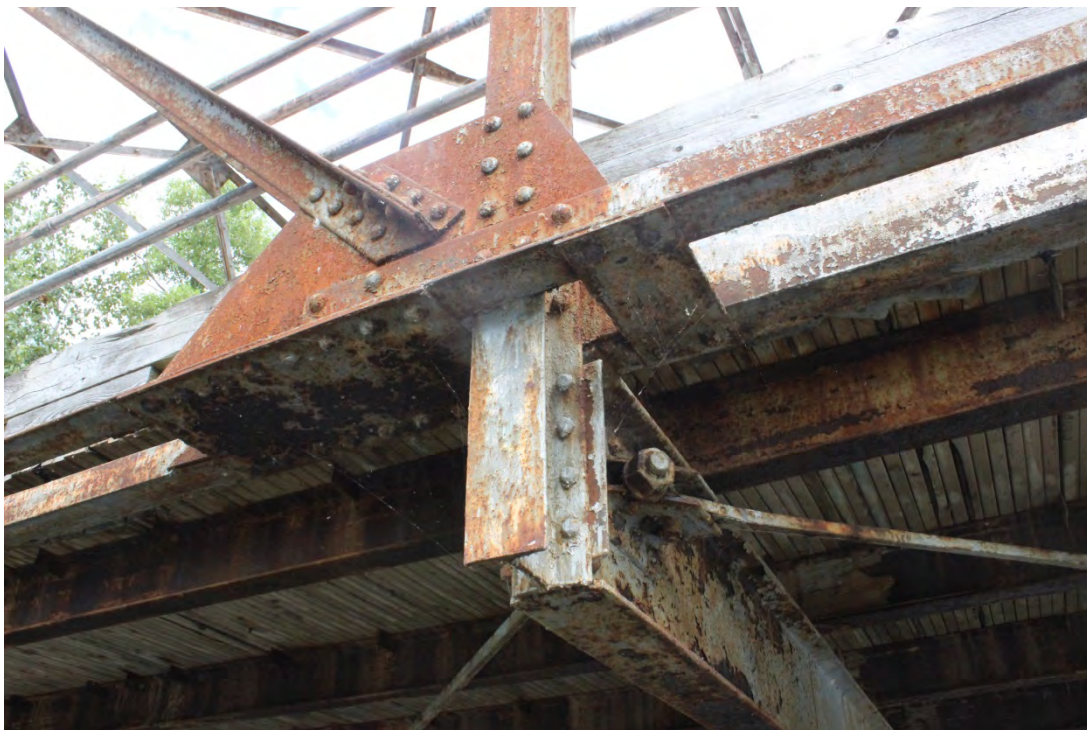
Image 24. South bottom chord between Bays 6 and 7. (Typical condition)
