# ANDREWSVILLE BRIDGE

## SUMMARY OF EVENTS FROM 2005 TO 2022

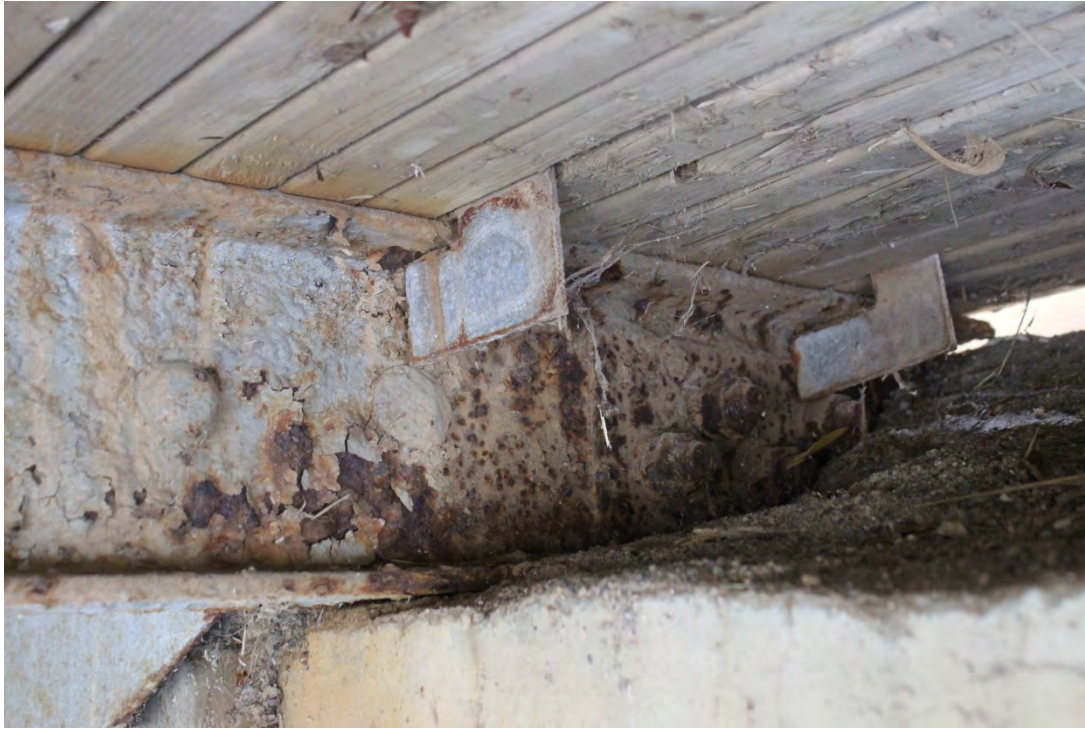
Image 25. Stringer 5 bearing area at east abutment

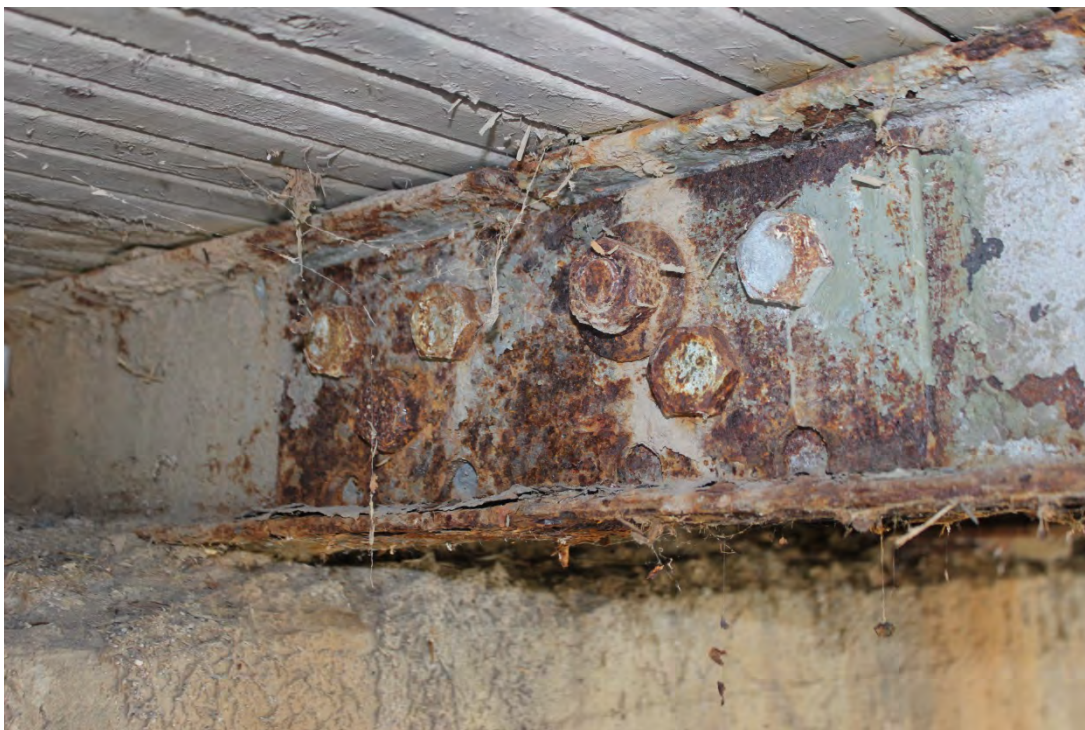
Image 26. Splice on Stringer 4 at east abutment

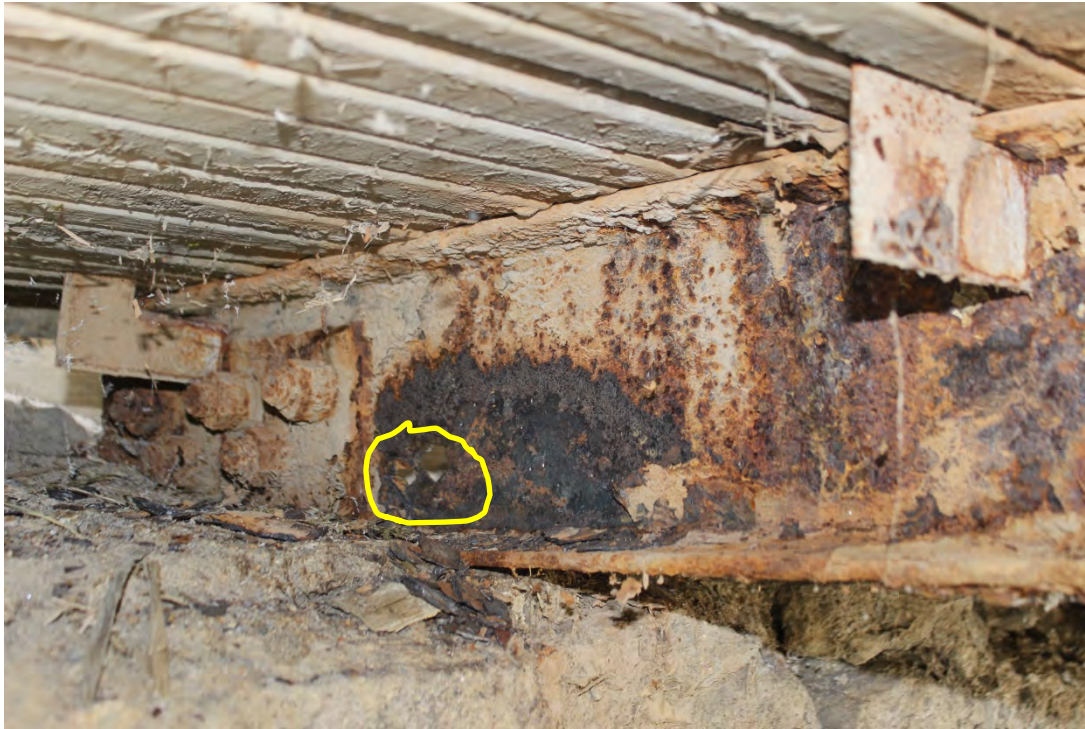
Image 27. Stringer 3 bearing area at east abutment

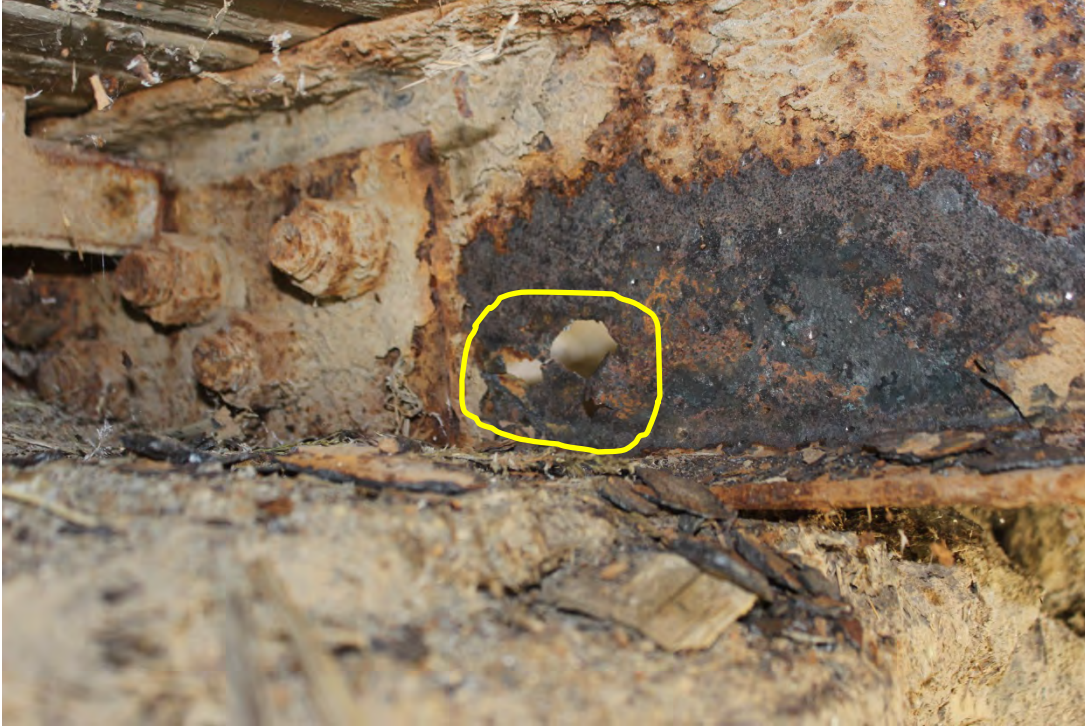
Image 28. Perforated Stringer 2 at east abutment bearing

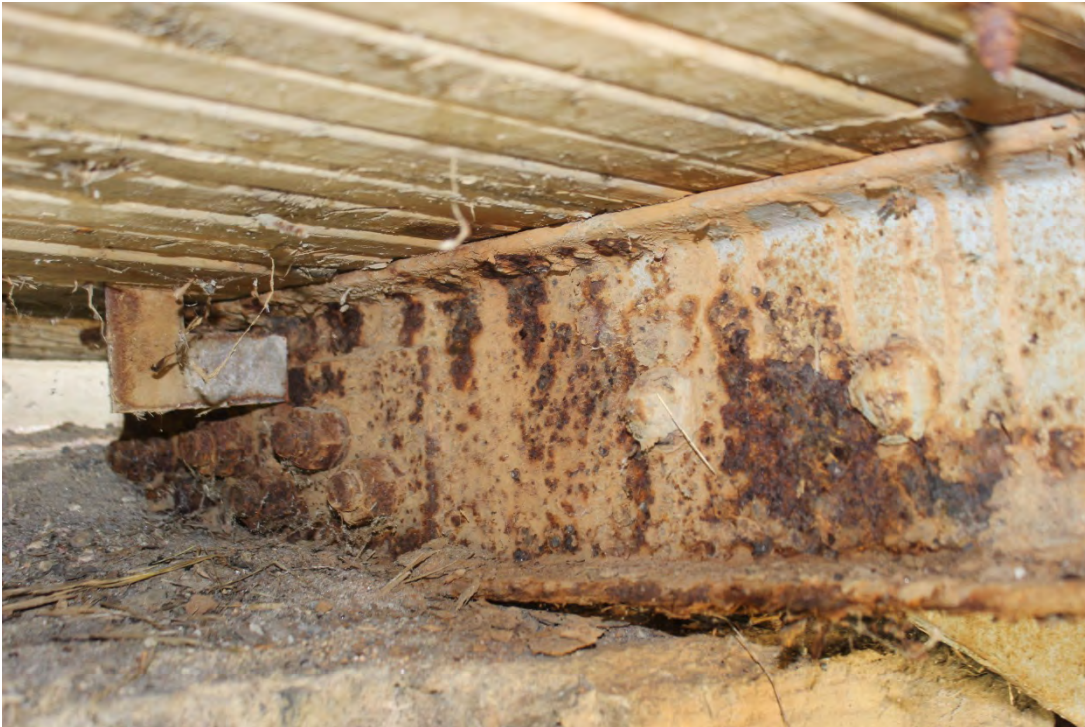
Image 29. Close up of perforated Stringer 2 at east abutment

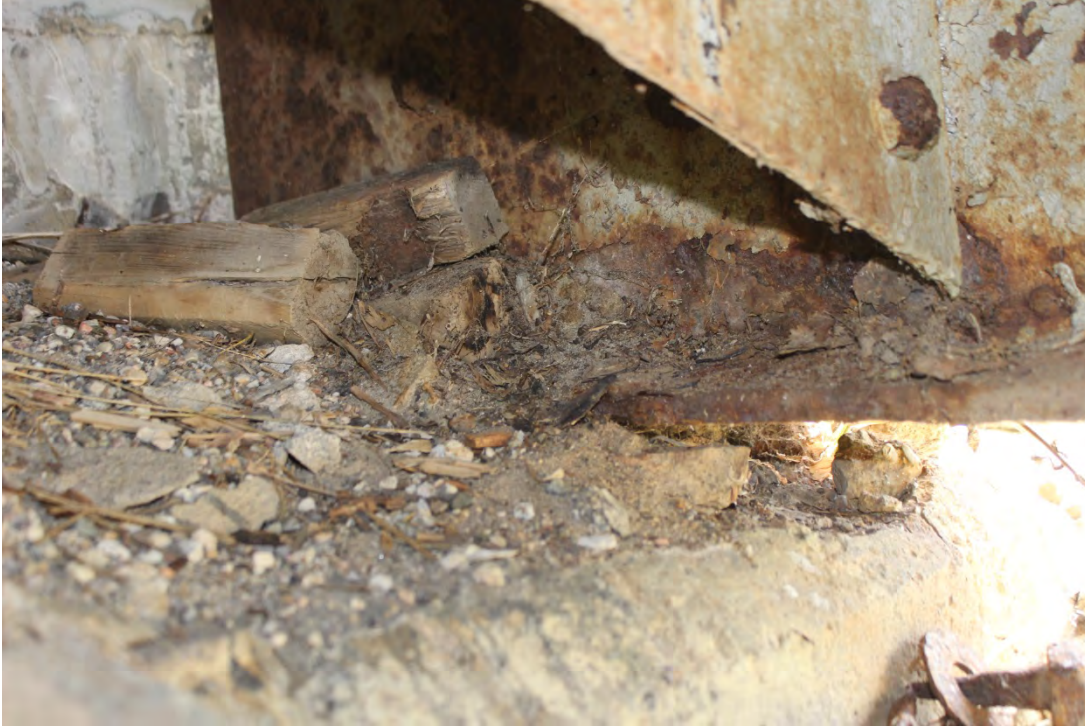
Image 30. Stringer 1 bearing area at east abutment

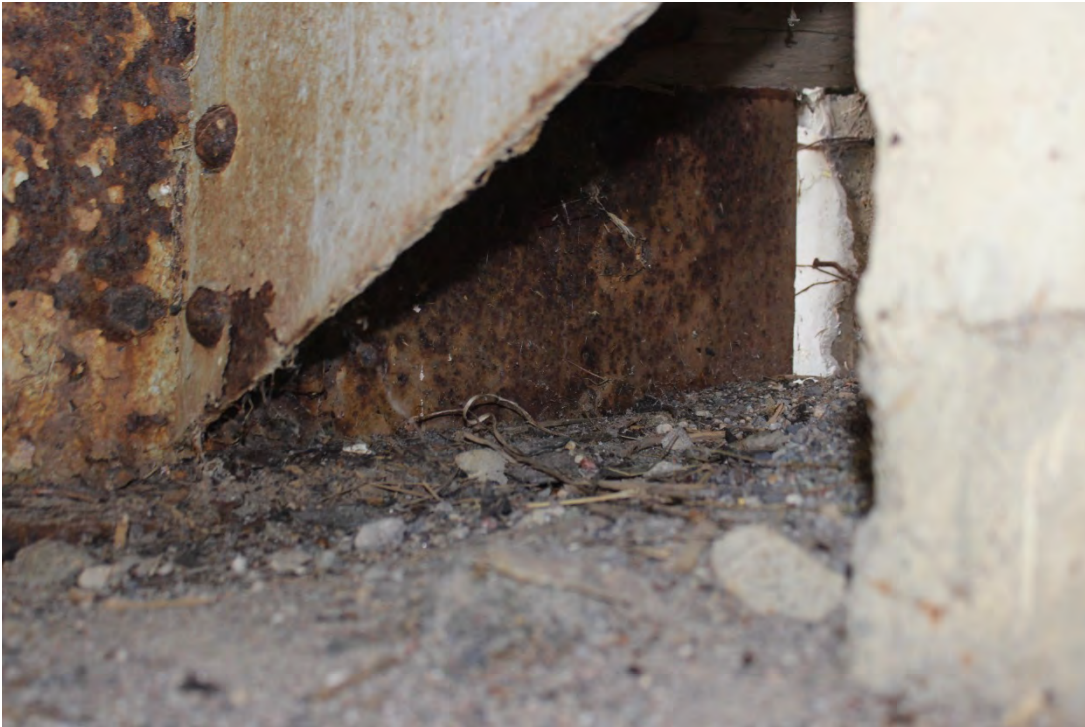
Image 31. South girder interior side bearing area at east abutment

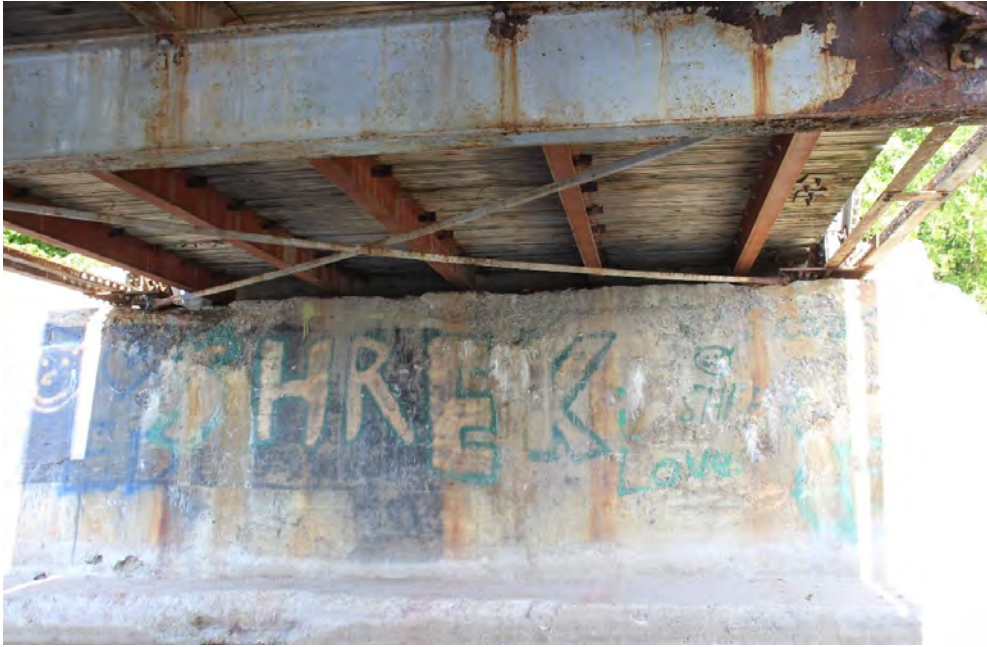
**Image 1. West abutment and replaced Bay 1 stringers, Floor Beam 1 in foreground.**

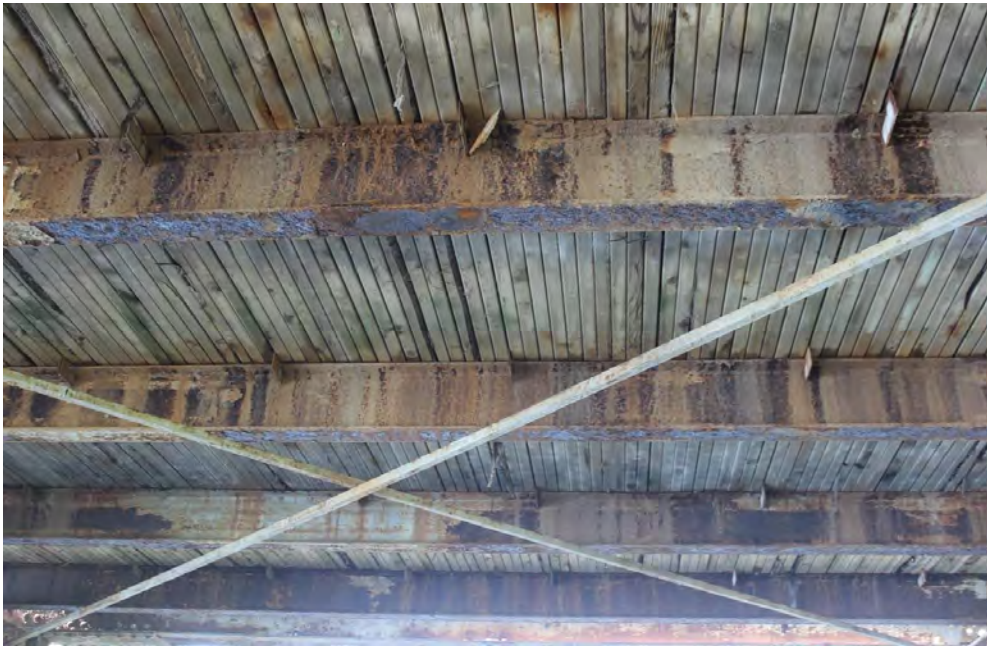
**Image 4. Bay 3 looking south, Stringers 4,3,2,1 visible**

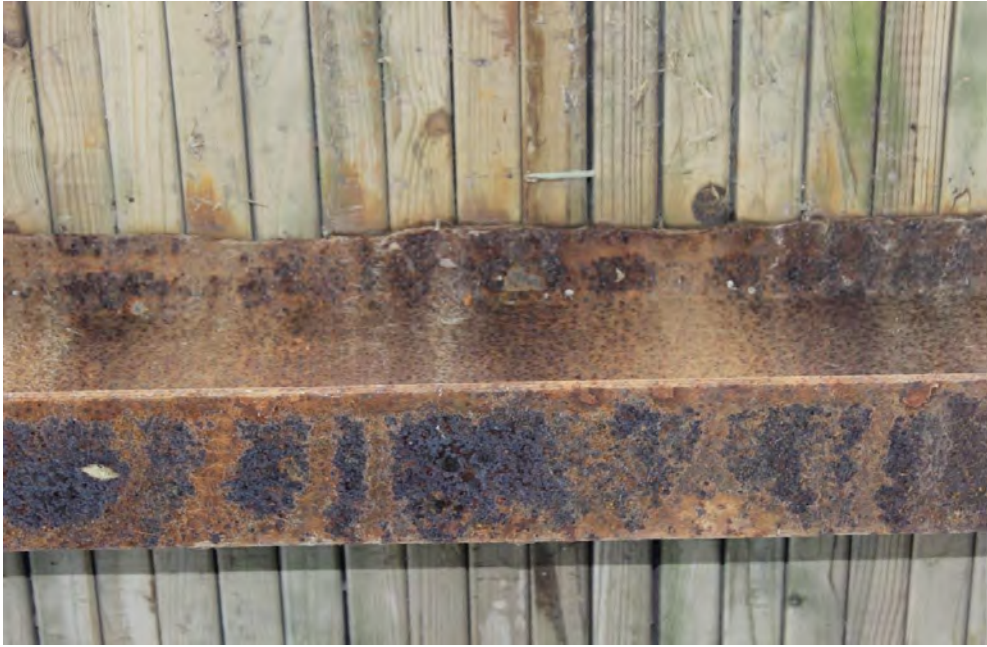
**Image 5. Stringer 5, Bay 3 with top flange thinning**

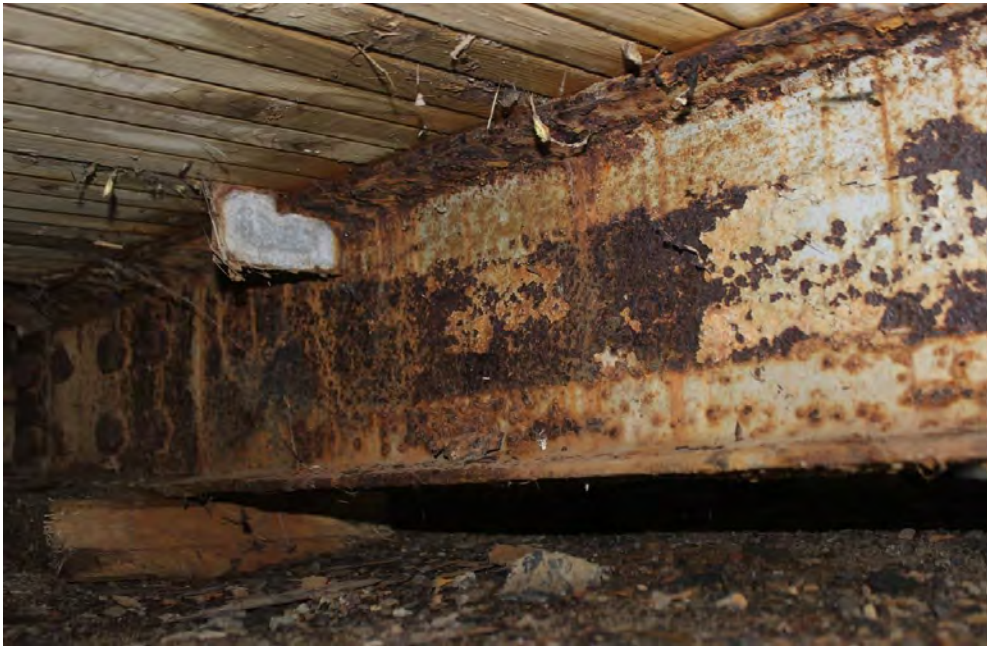
**Image 12.** North face of truss Stringer 3 at pier bearing

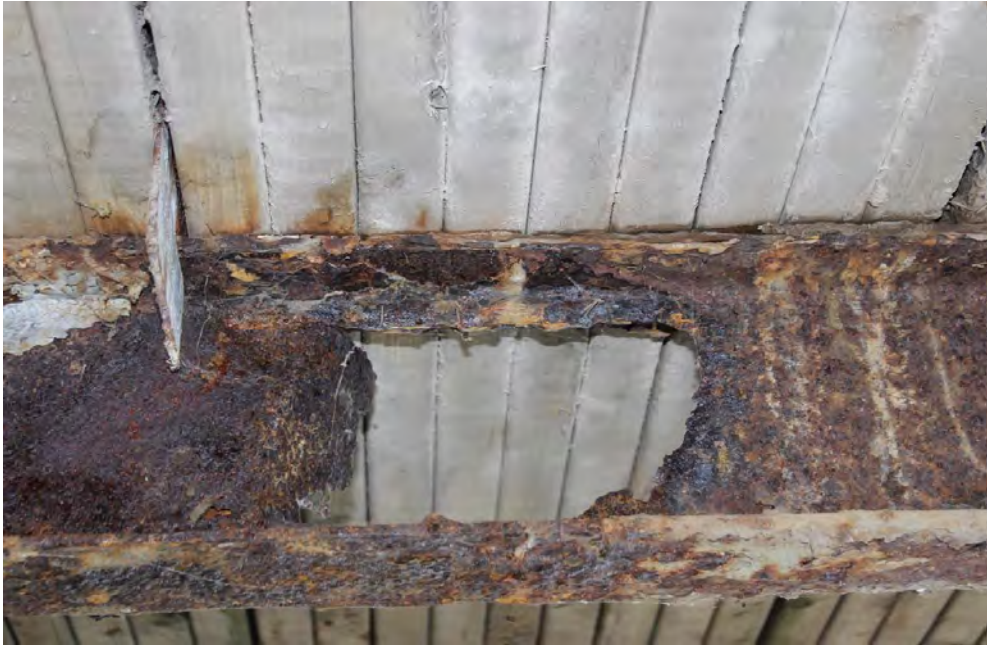
**Image 13. Perforated Stringer 2 west end approach span, looking north**

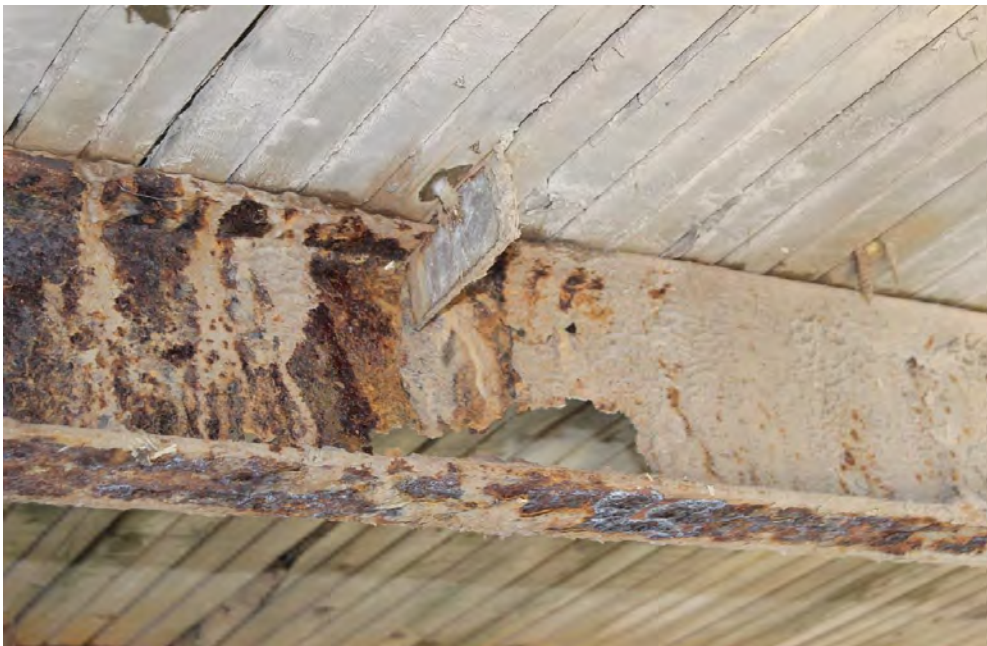
**Image 14. Perforated Stringer 2 west end approach span, looking north**

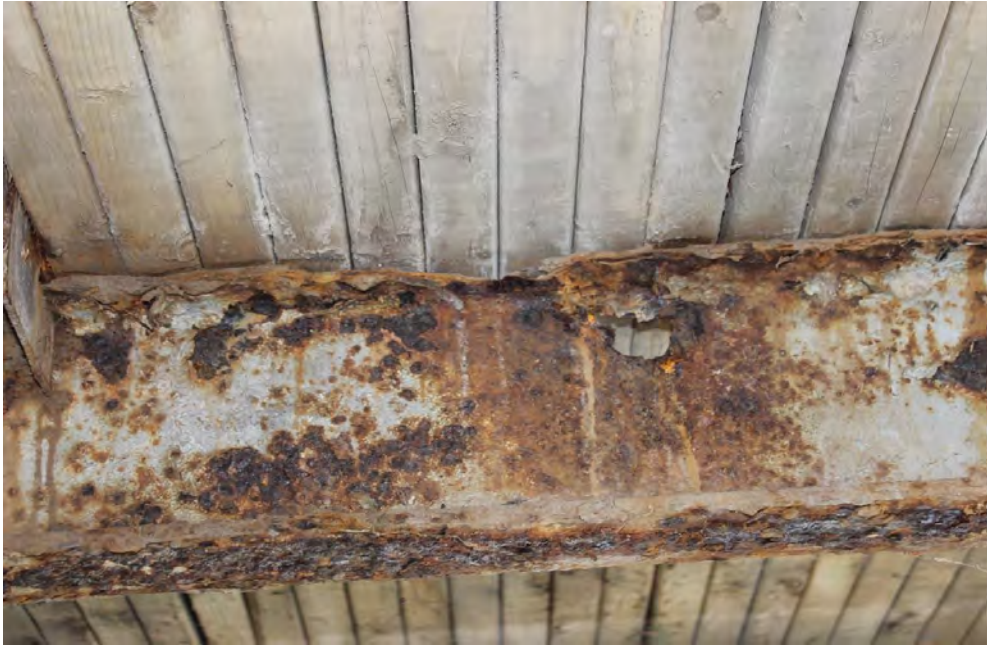
**Image 15. Perforated Stringer 4 west end approach span, looking north, severe flange thinning**

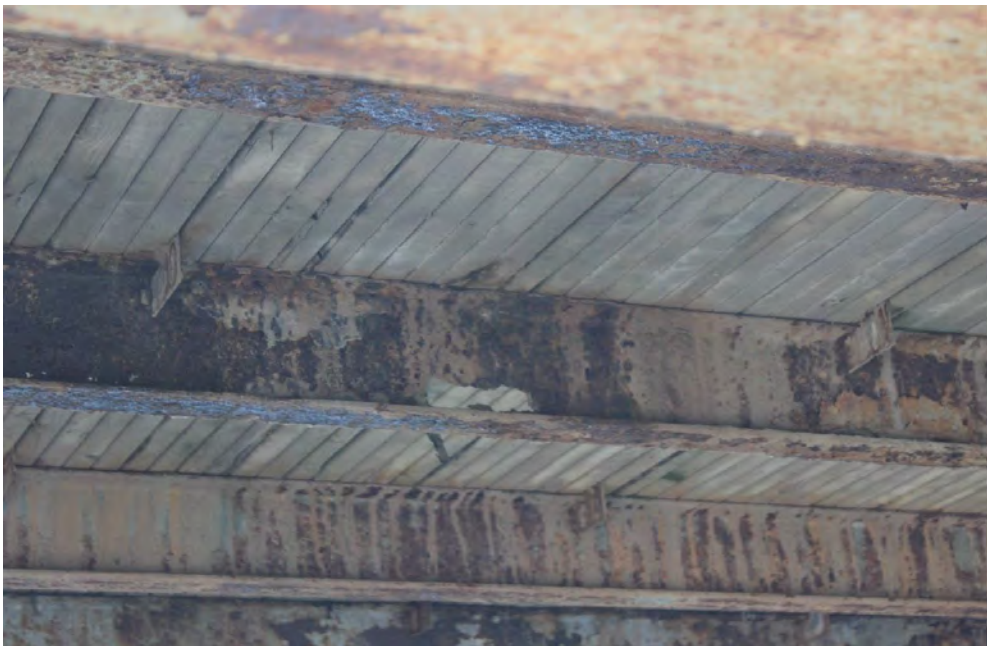
**Image 16. Perforated Stringer 2 east end approach span, looking north**

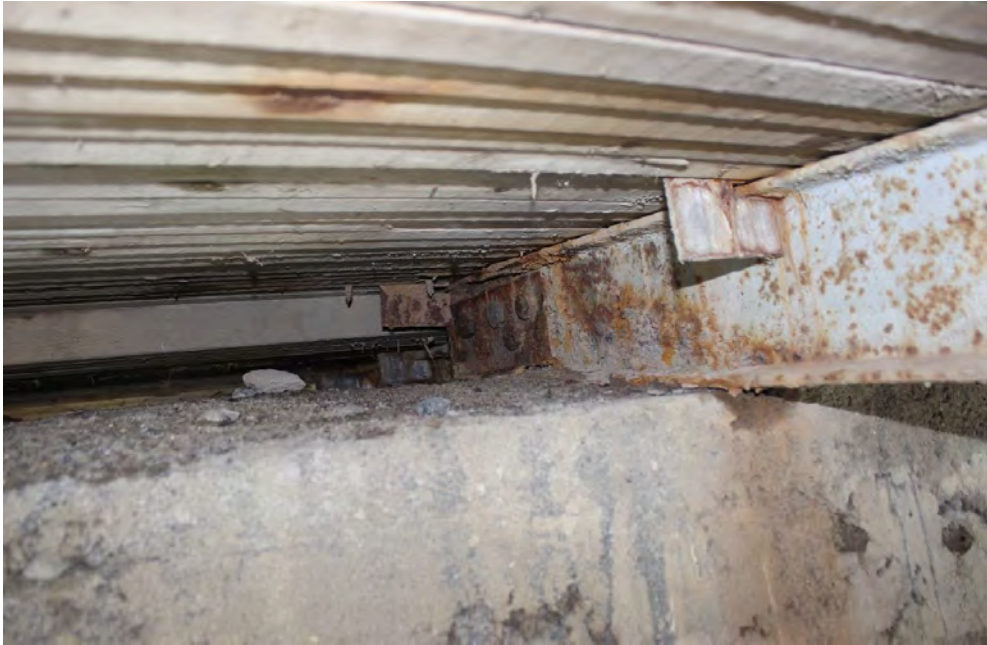
**Image 17. Approach span stringer resting on east abutment**

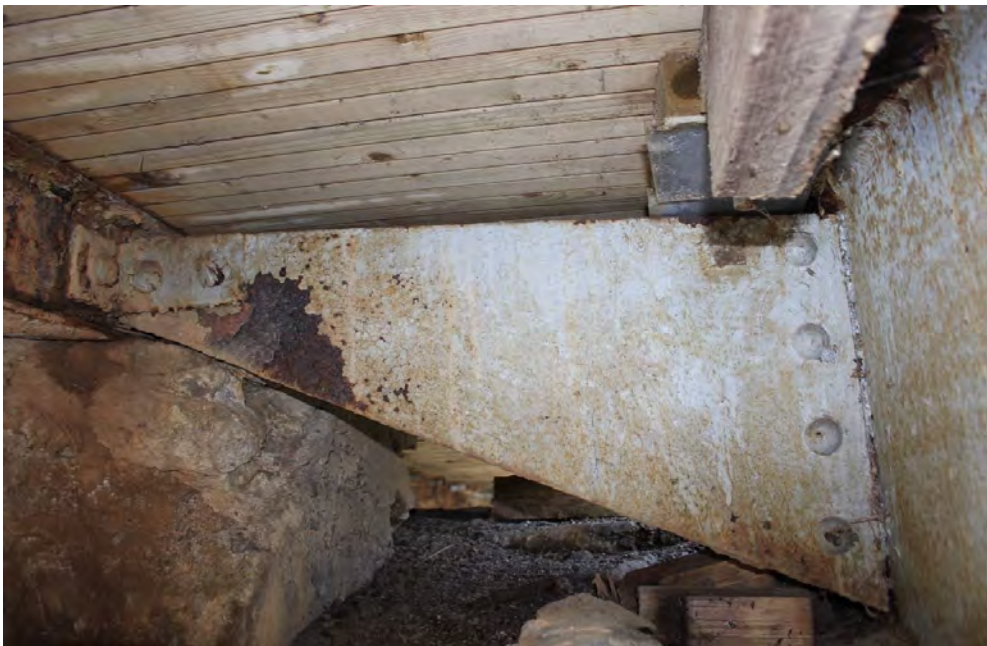
**Image 18. Outrigger attached to approach girder supporting Stringer 5 at pier**

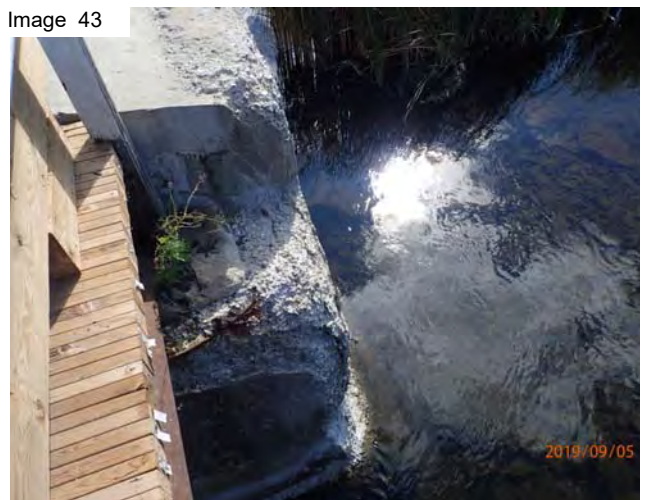
South abutment west corner disintegration

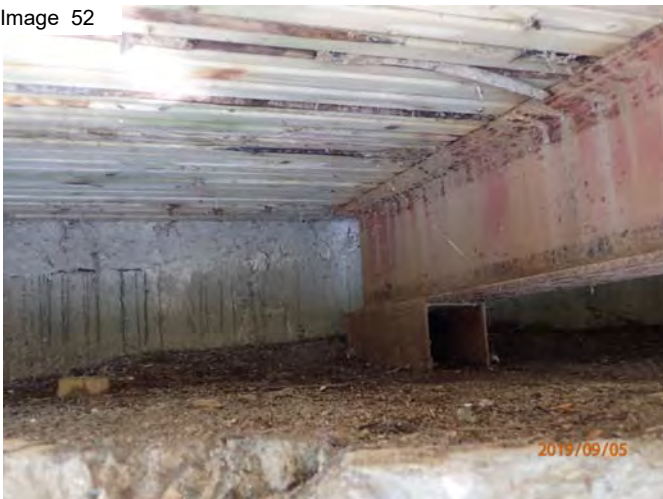
Image 52

NE bearing

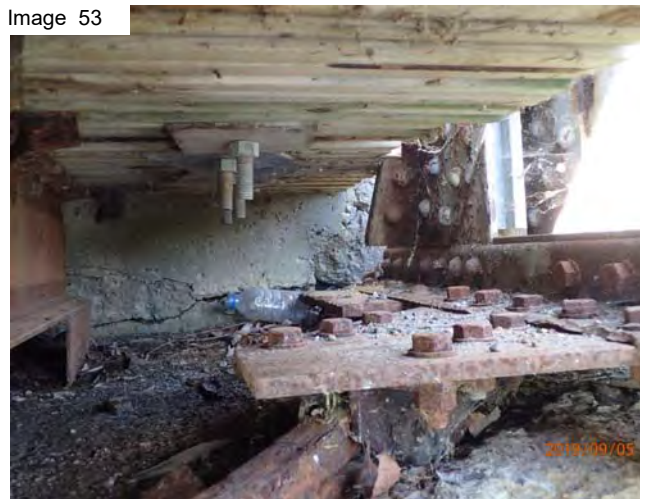
Image 53

West end ballast wall & stringer

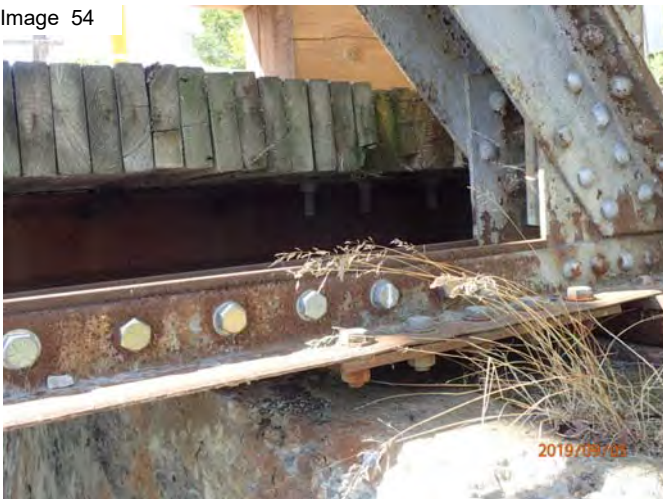
Image 54

NW corner bearing

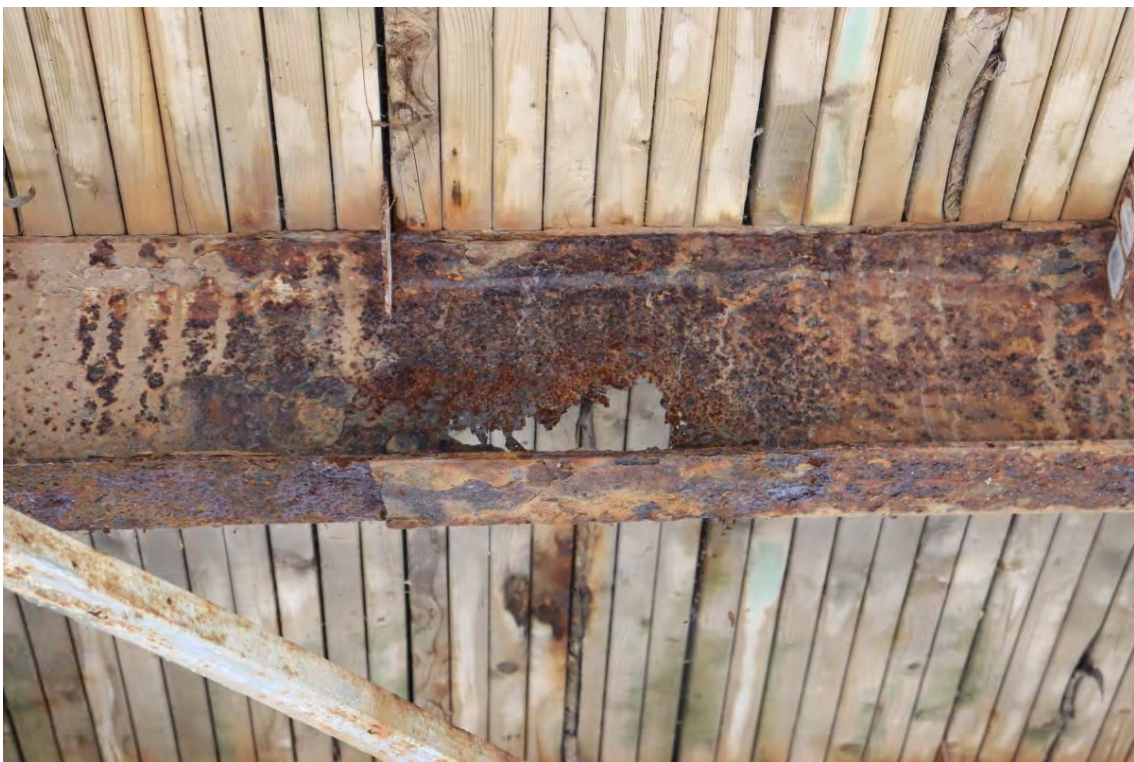
*Figure 10: Stringer 2 perforation in bay 8*

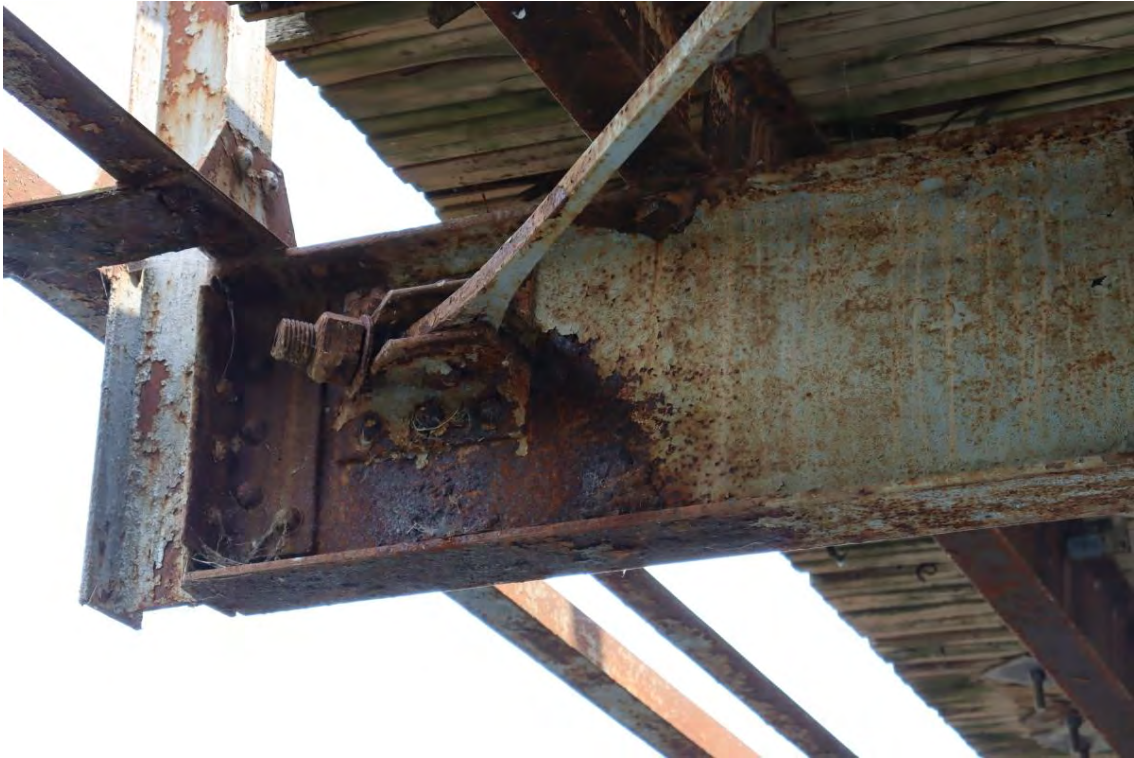
*Figure 11: Floor beam 7 north end*

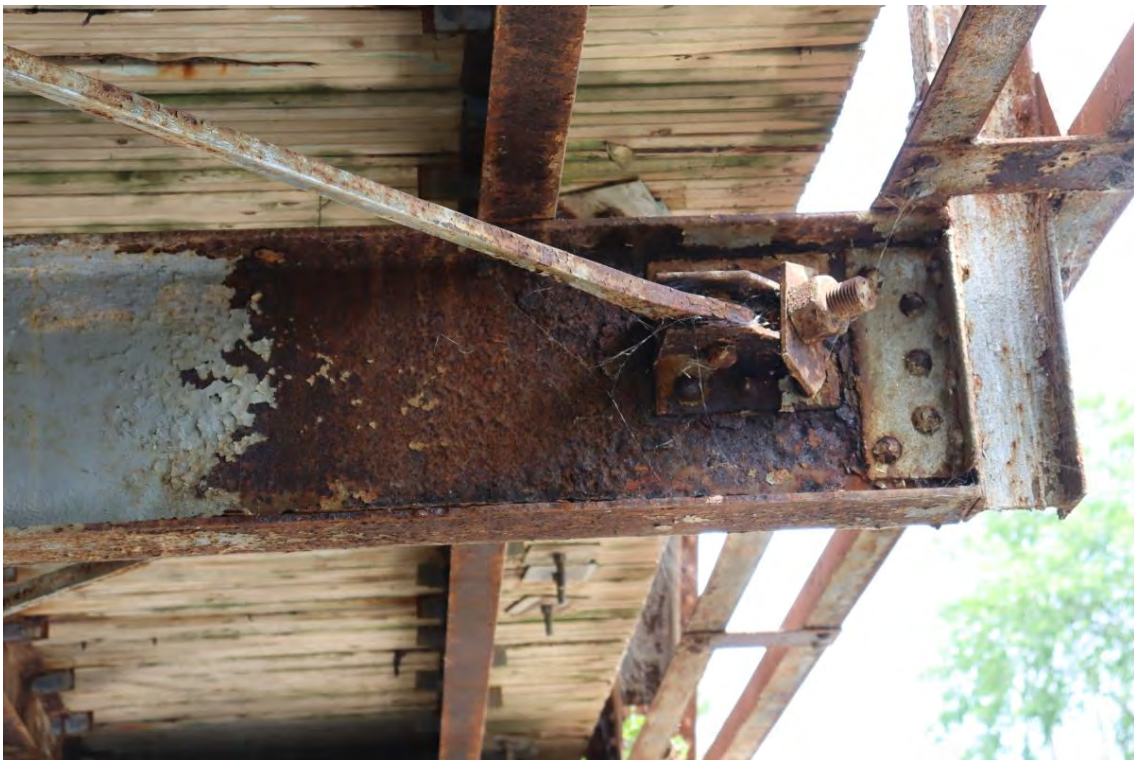
*Figure 12: Floor beam 7 south end*

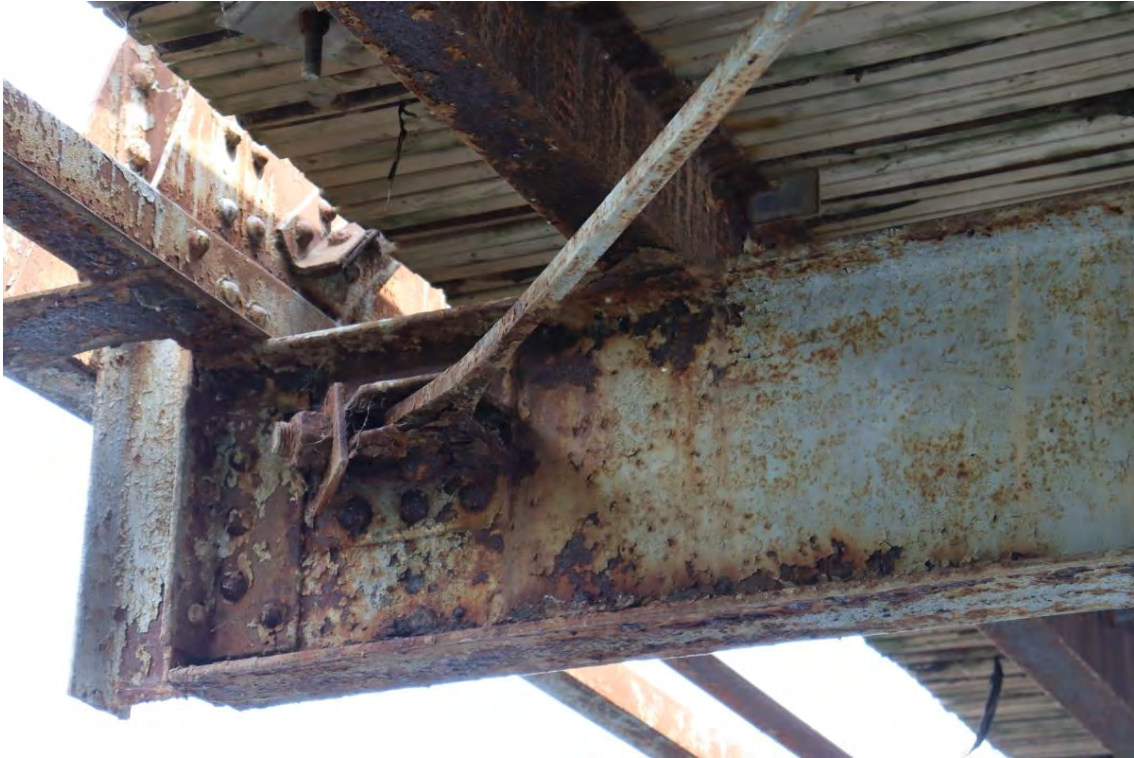
*Figure 13: Floor beam 6 north end*

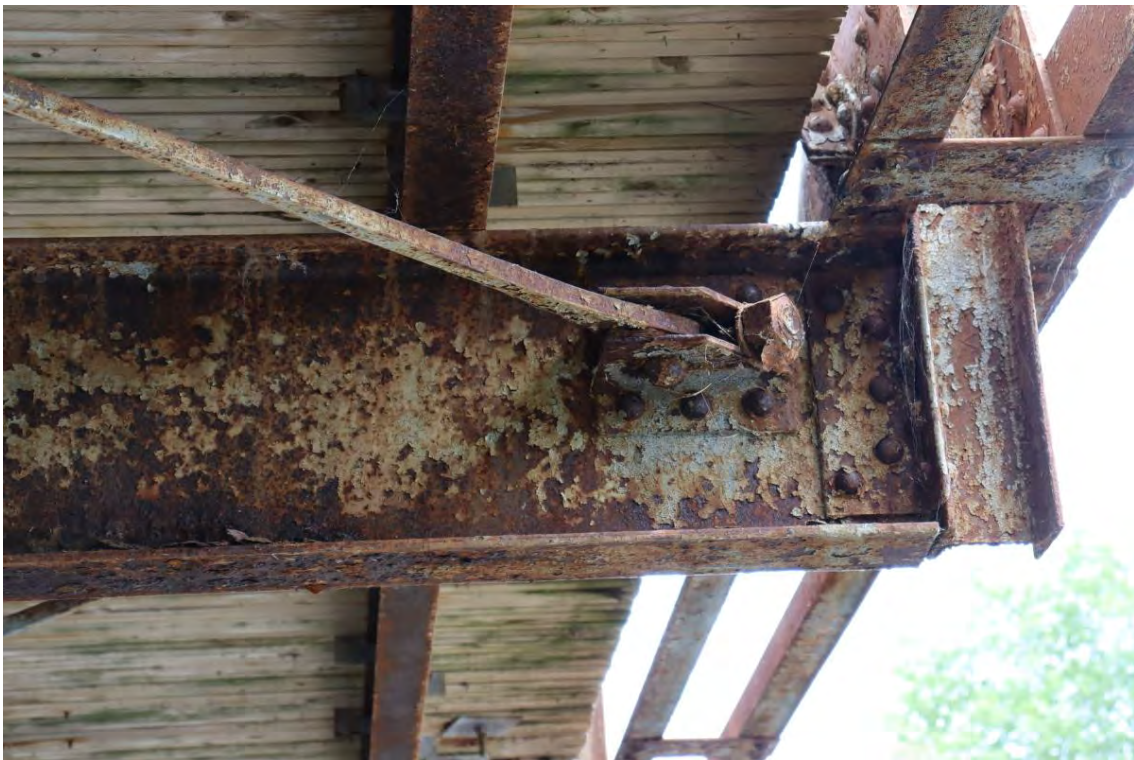
*Figure 14: Floor beam 6 south end*

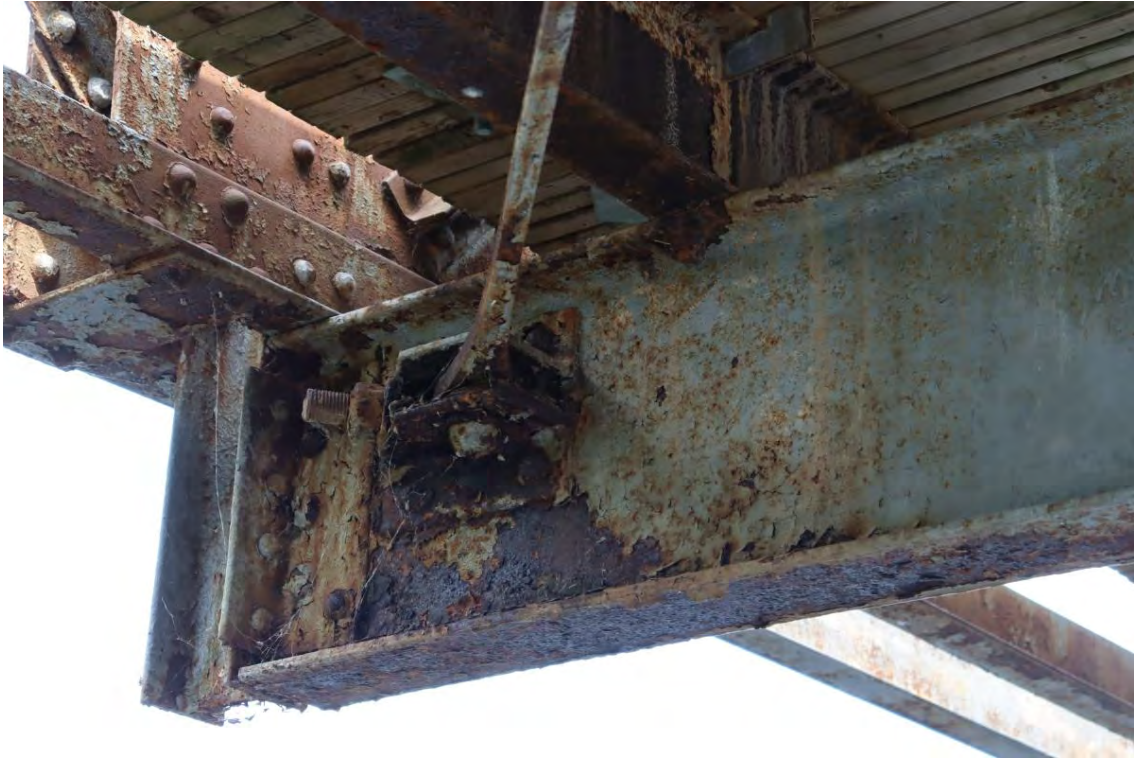
*Figure 15: Floor beam 5 north end*

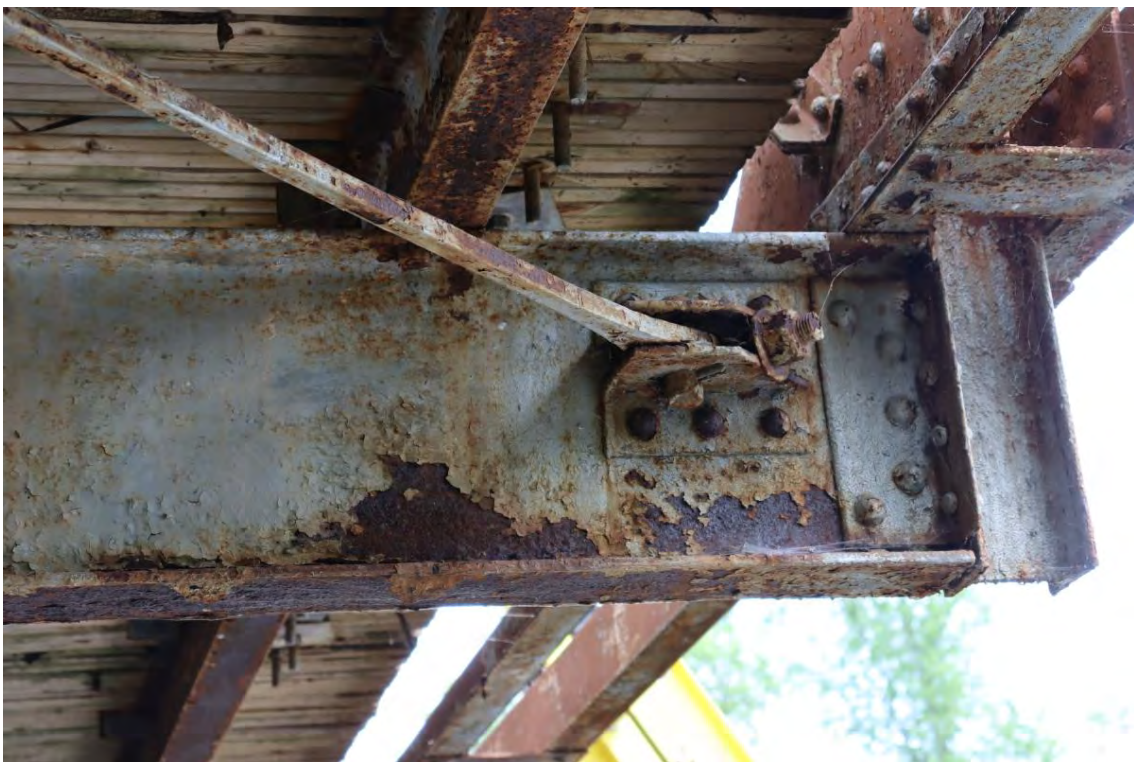
*Figure 16: Floor beam 5 south end*

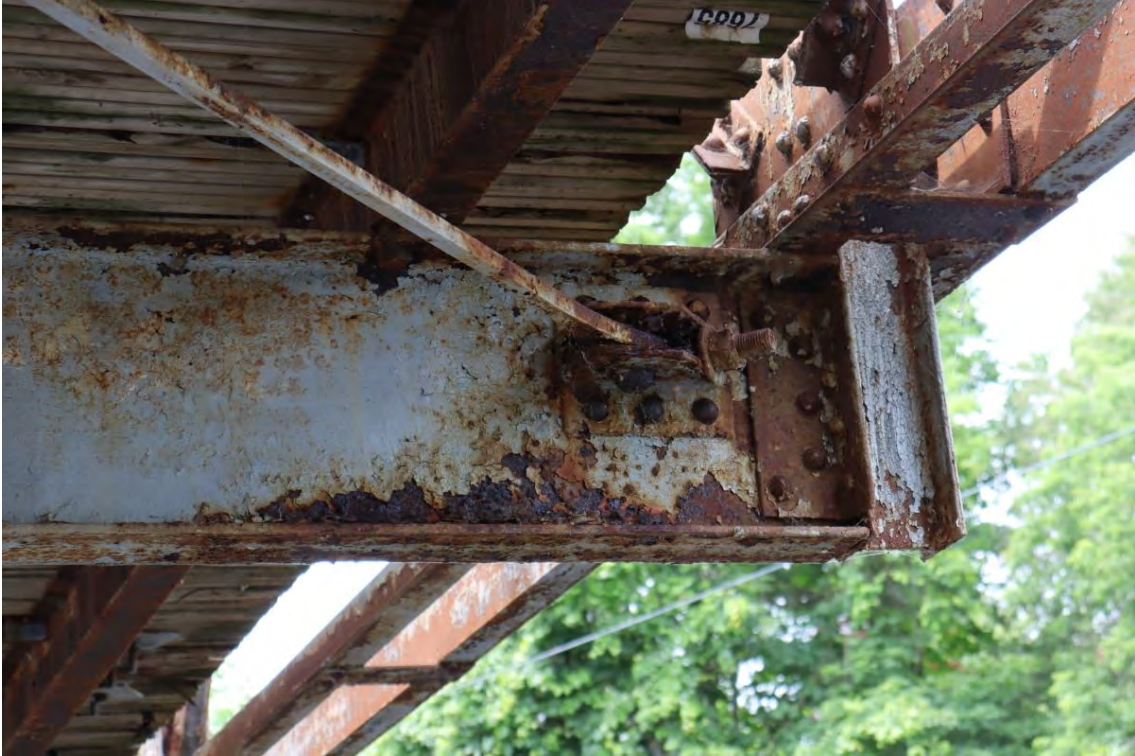
Figure 17: Floor beam 4 north end

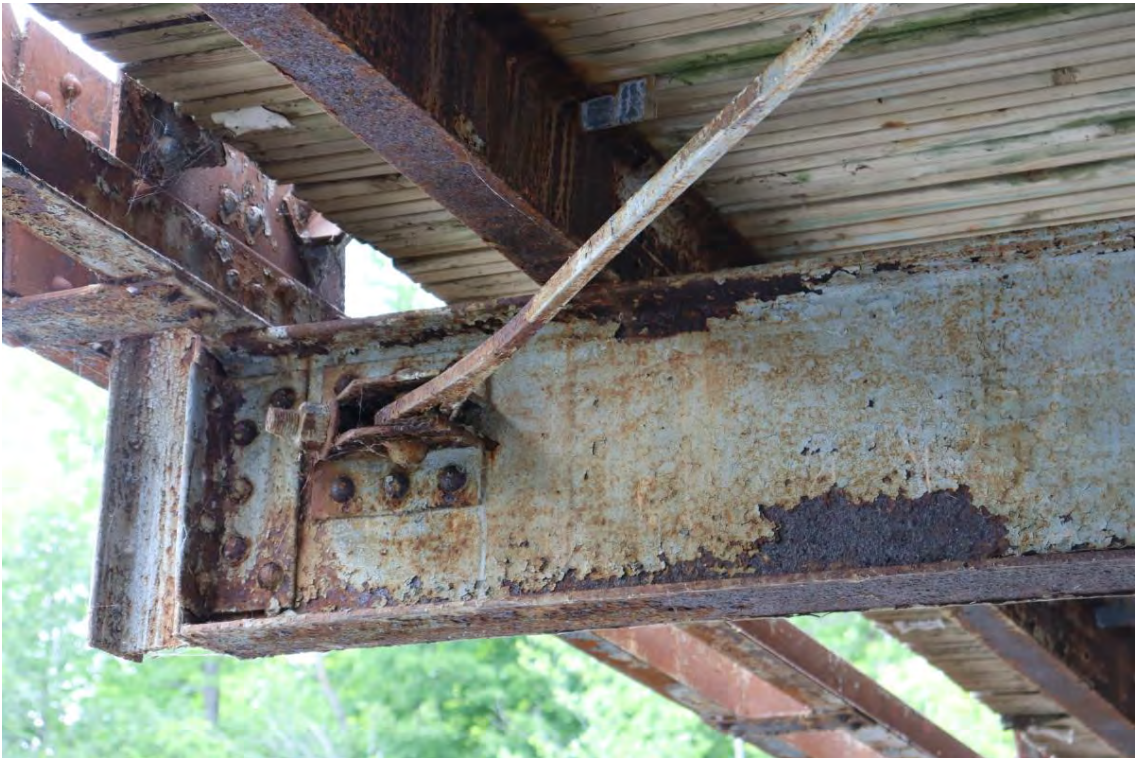
Figure 18: Floor beam 4 south end

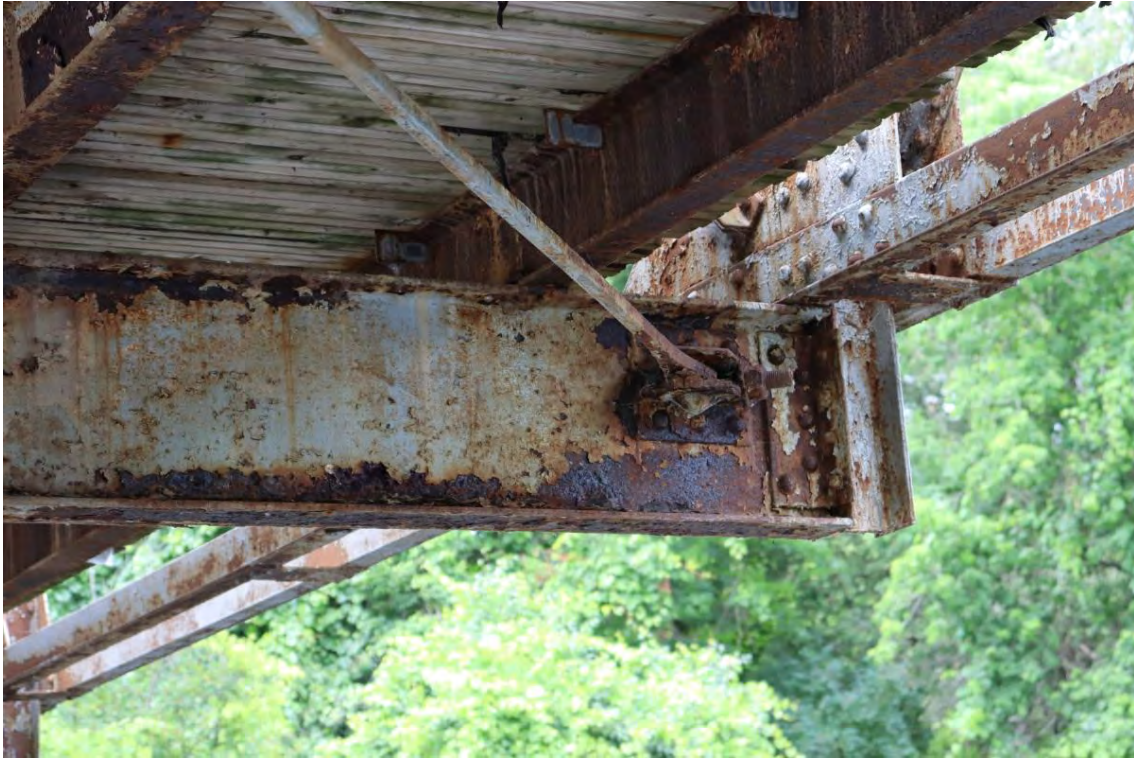
*Figure 19: Floor beam 3 north end*

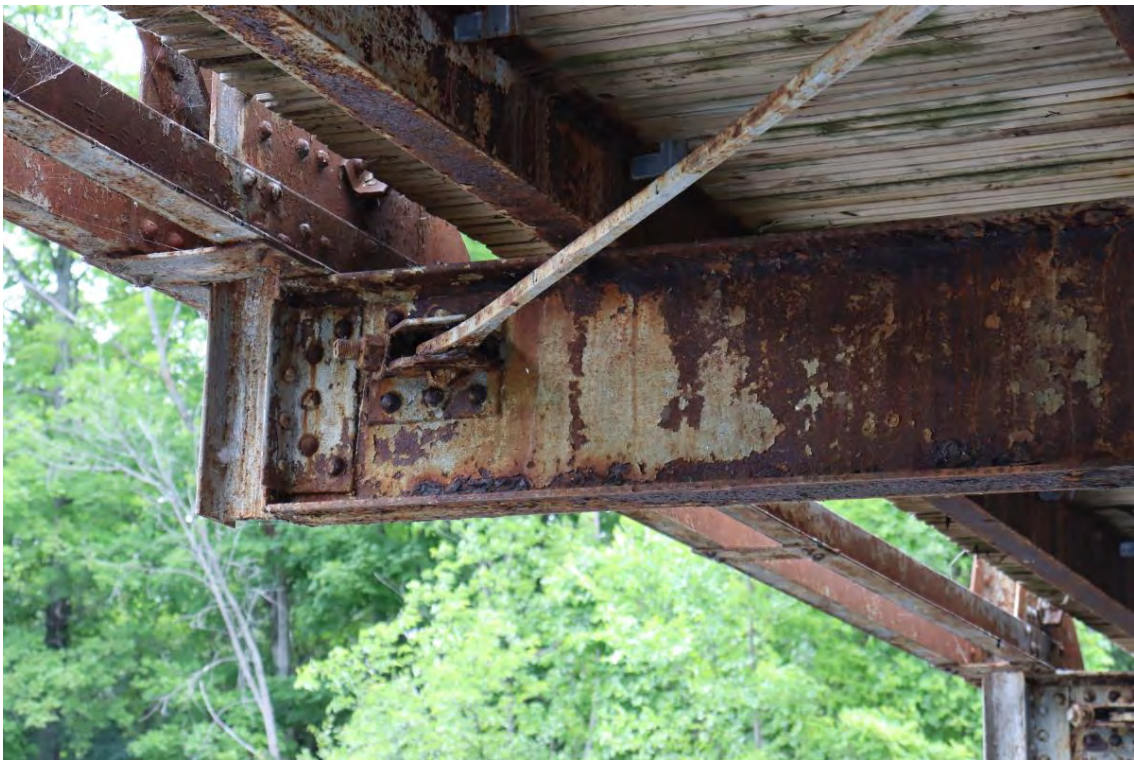
*Figure 20: Floor beam 3 south end*
