# ANDREWSVILLE BRIDGE

## SUMMARY OF EVENTS FROM 2005 TO 2022

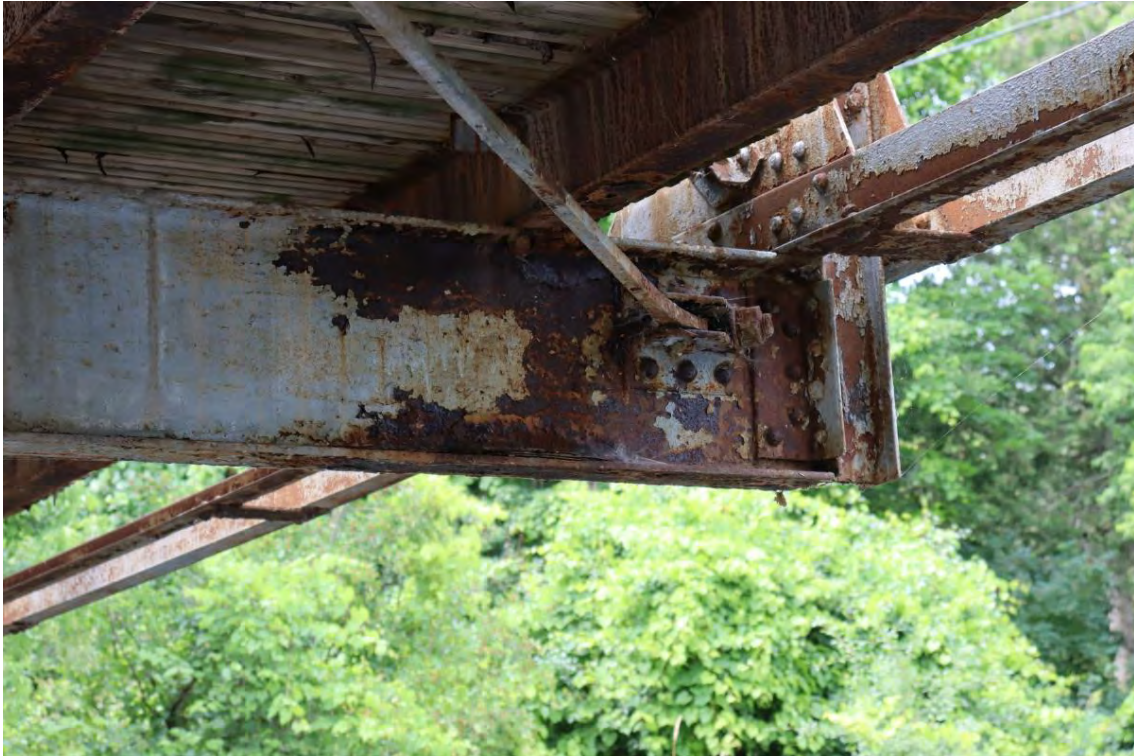
*Figure 21: Floor beam 2 north end*

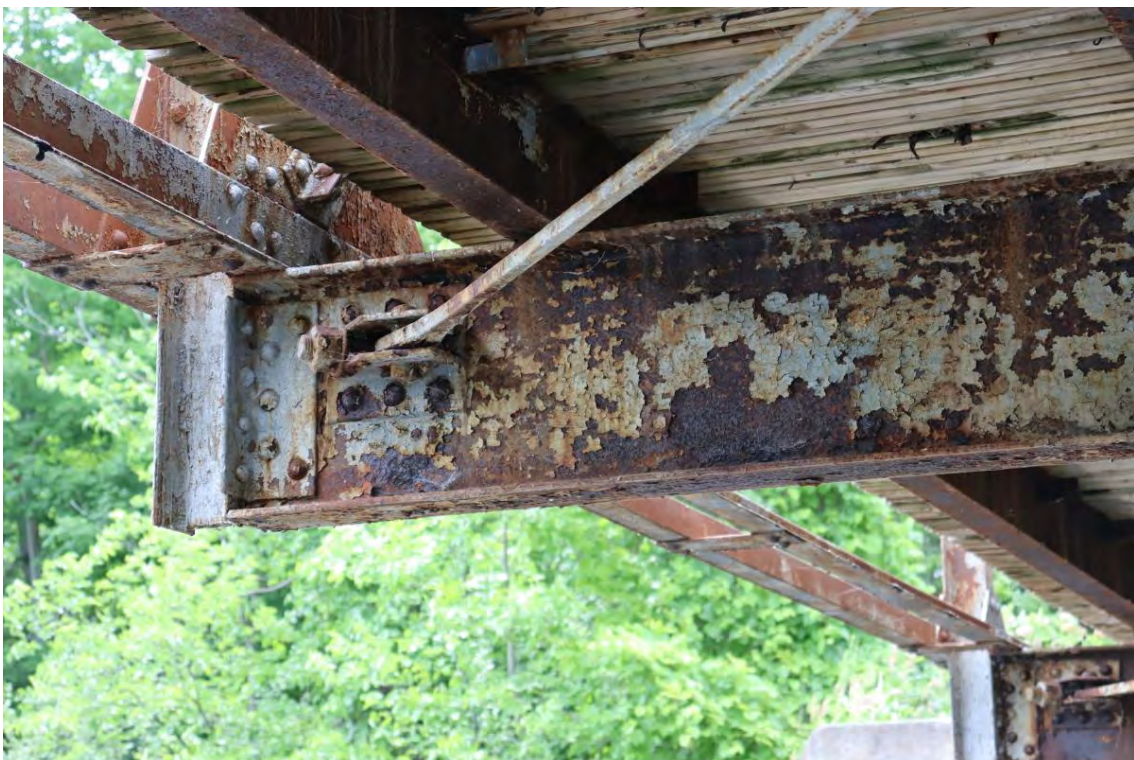
*Figure 22: Floor beam 2 south end*

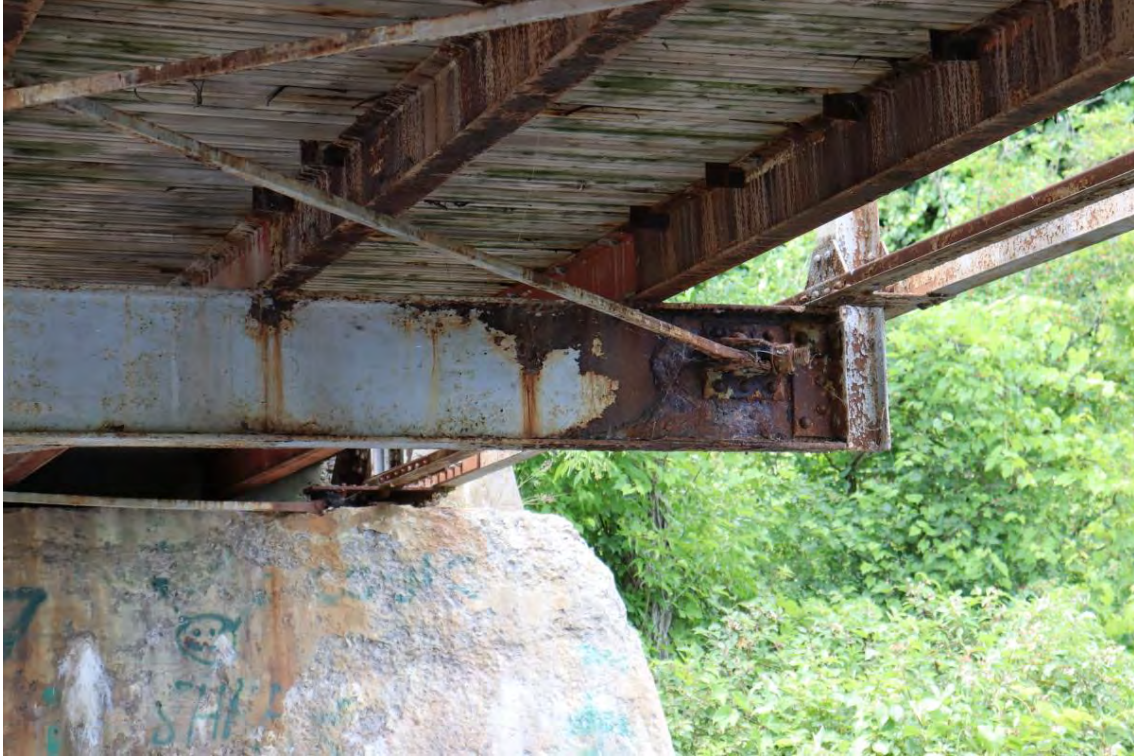
Figure 23: Floor beam 1 north end

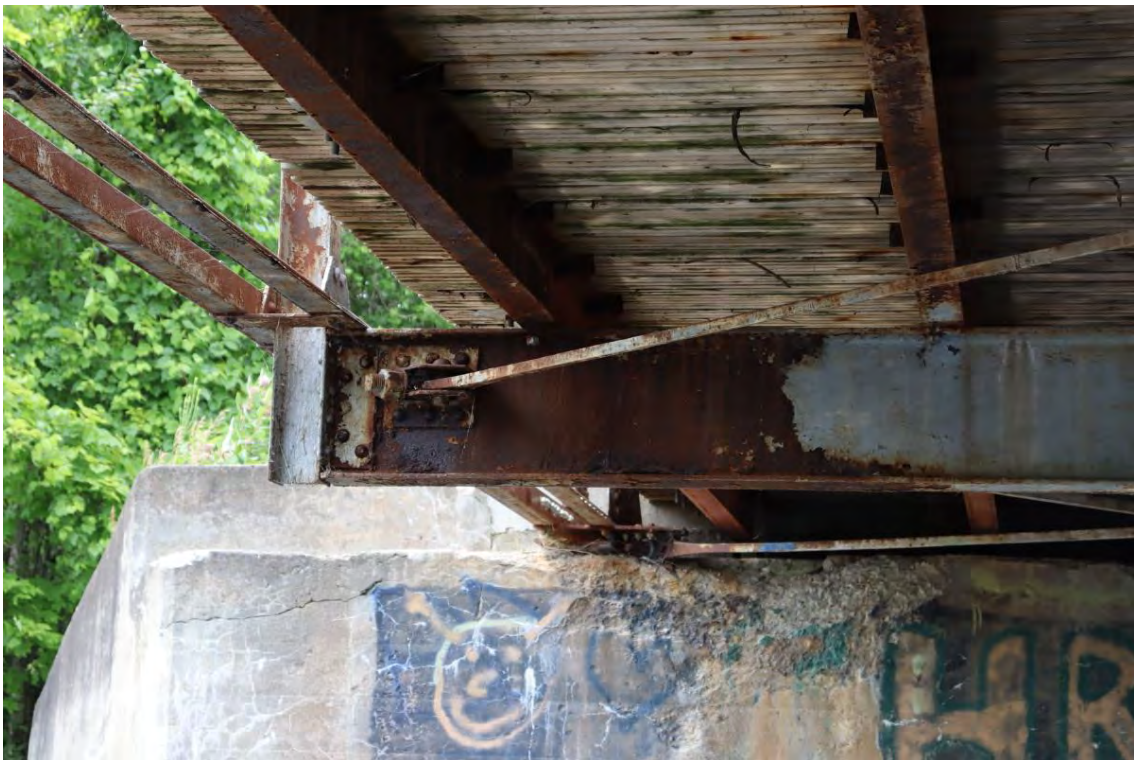
Figure 24: Floor beam 1 south end

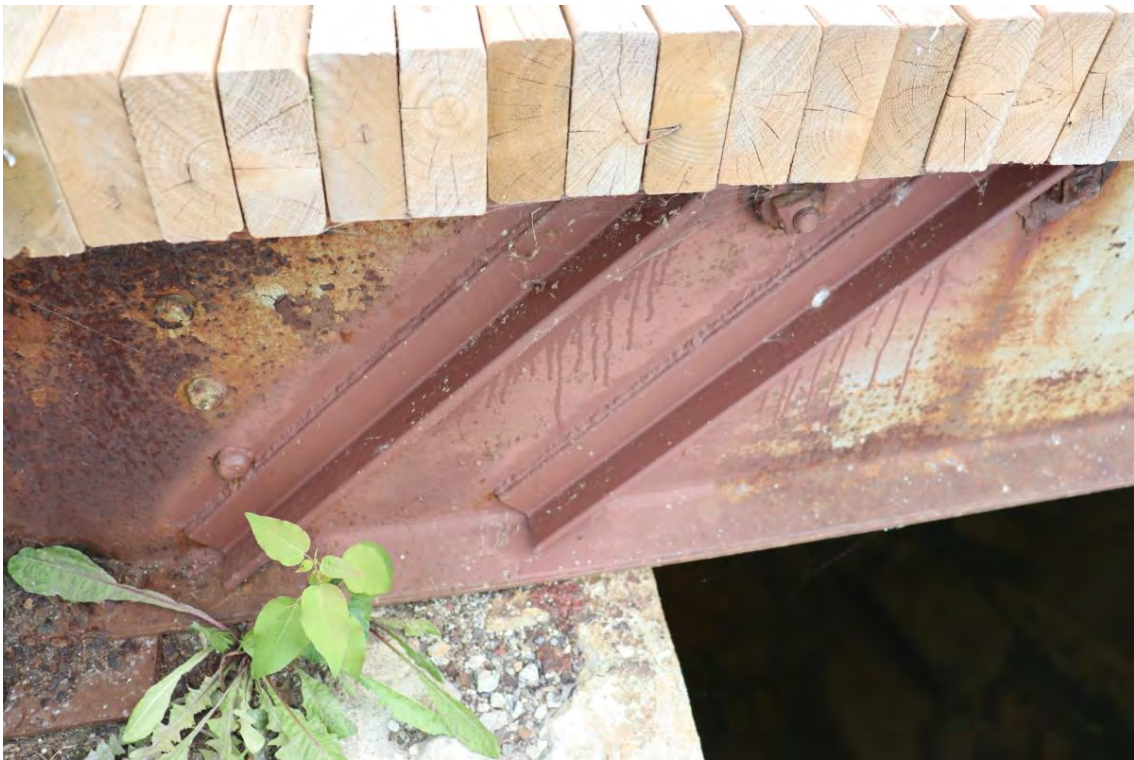
*Figure 26: NE girder end web stiffening*

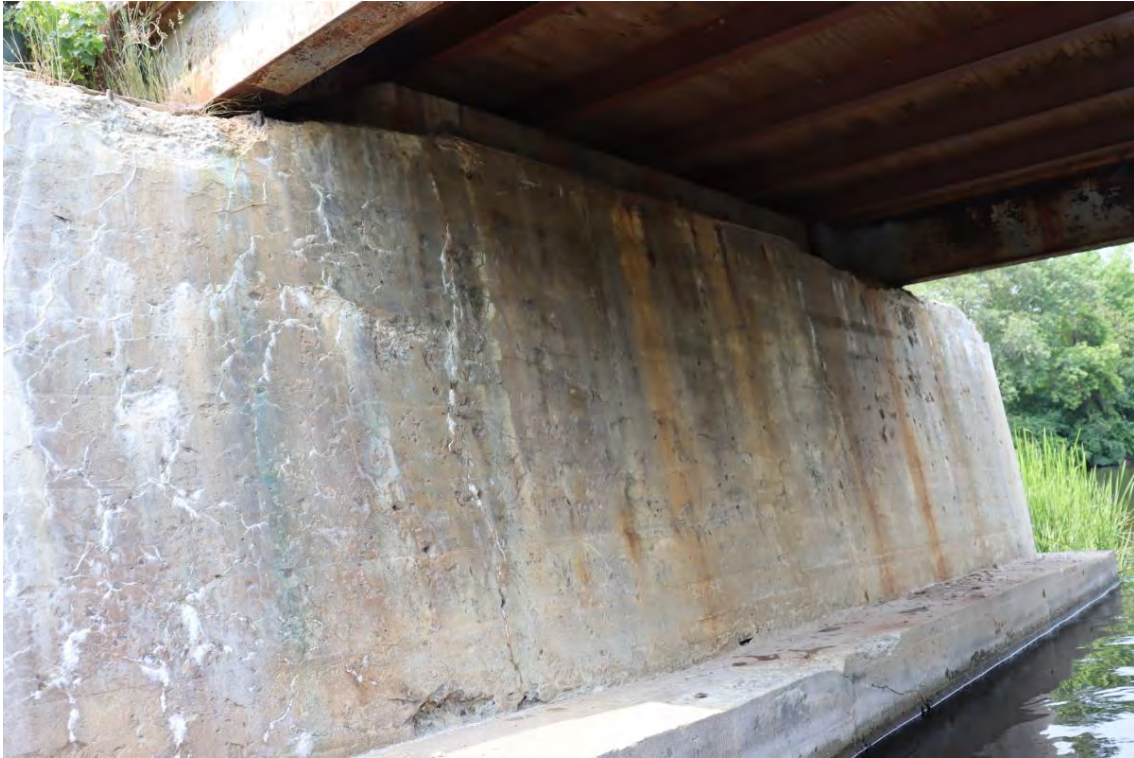
*Figure 27: East face of pier*

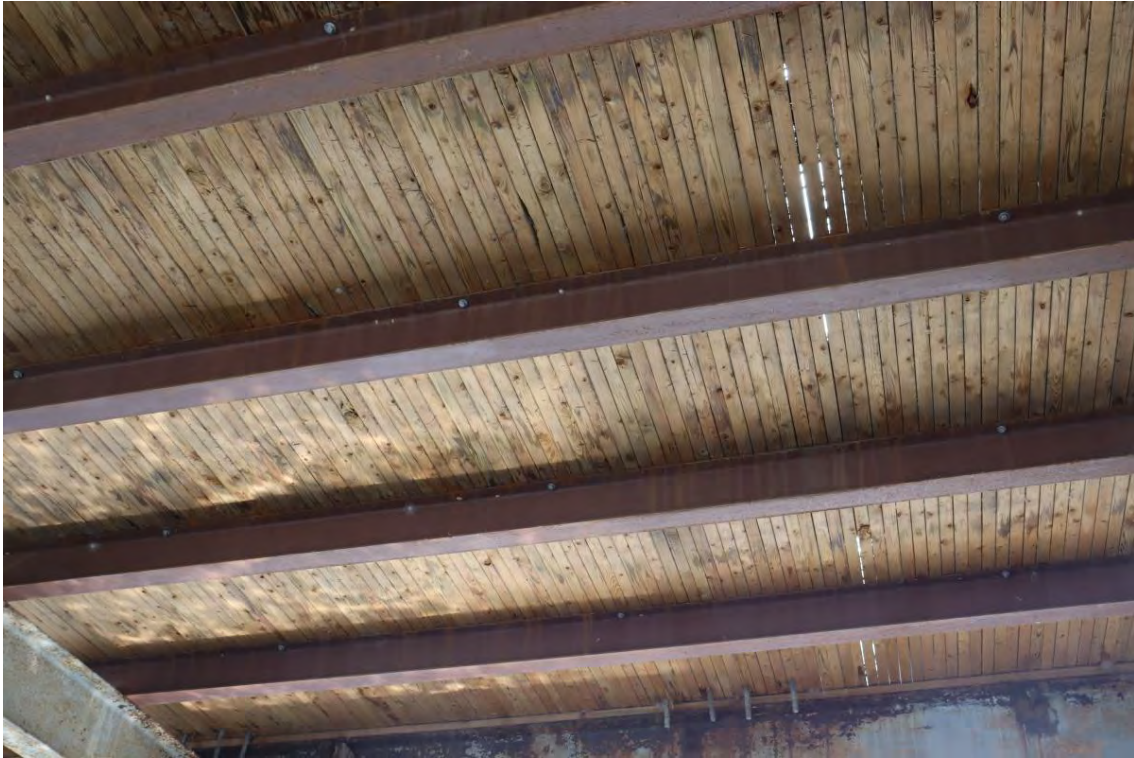
*Figure 29: East span west end soffit*

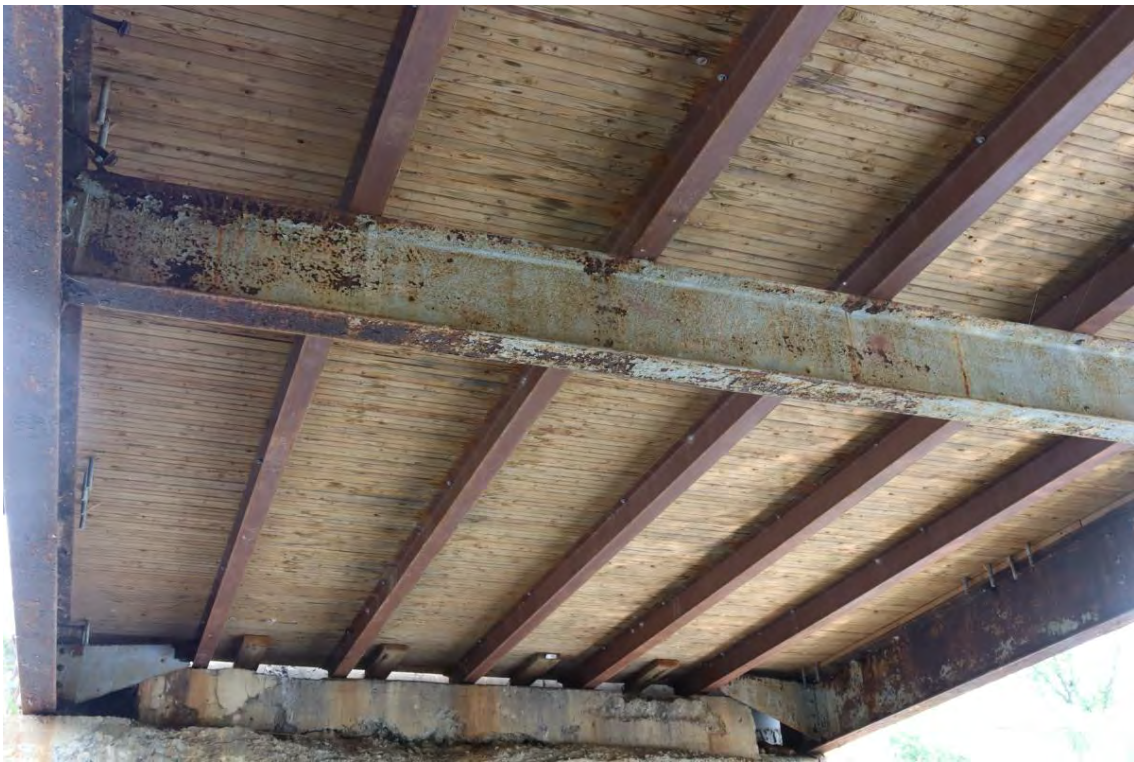
*Figure 30: East span east end soffit*

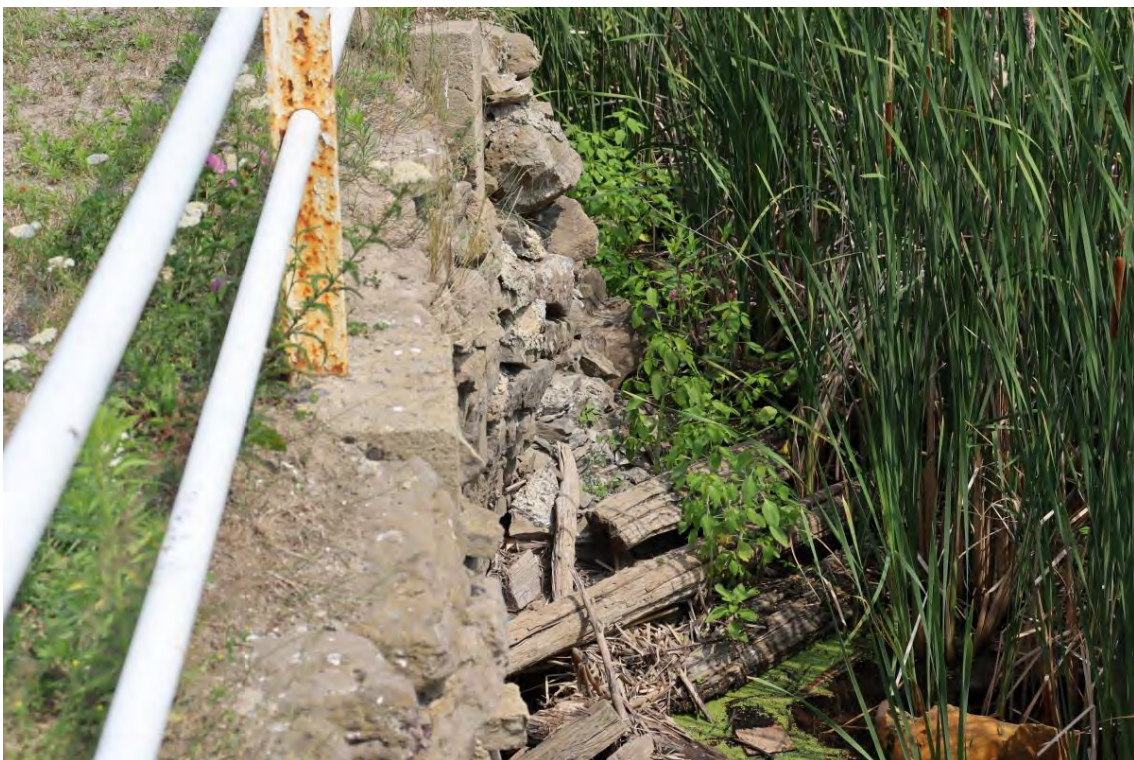
*Figure 32: Bulging retaining wall in SE*

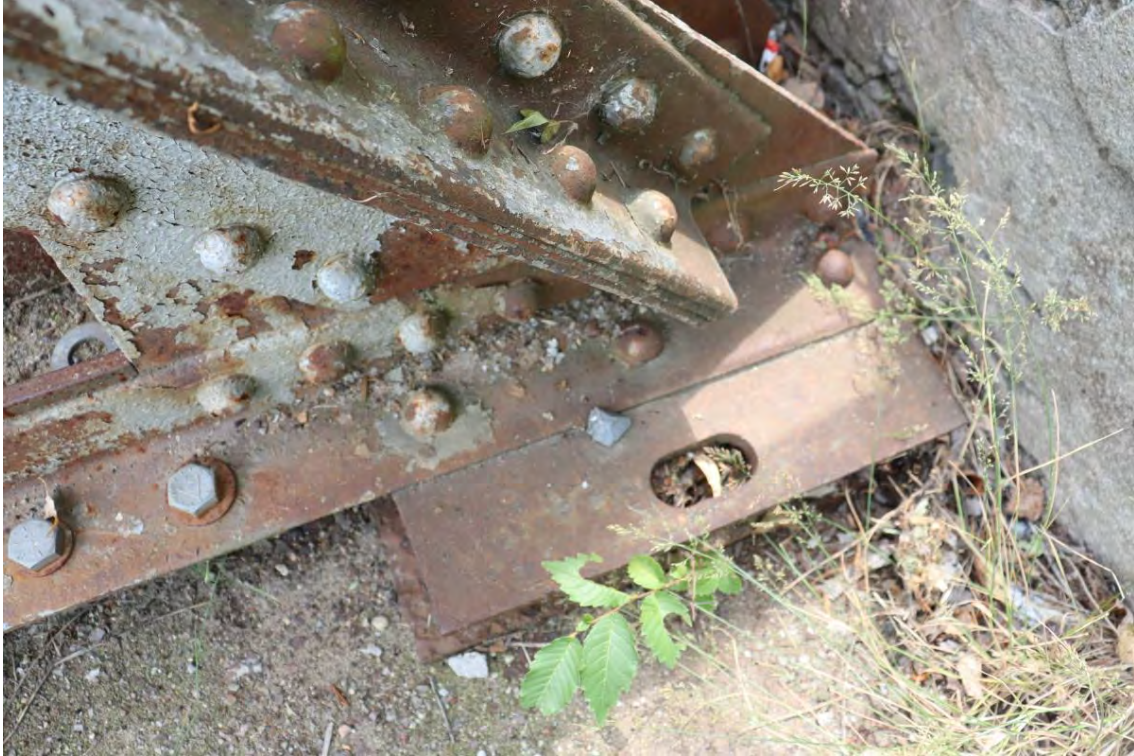
Figure 33: NW truss bearing

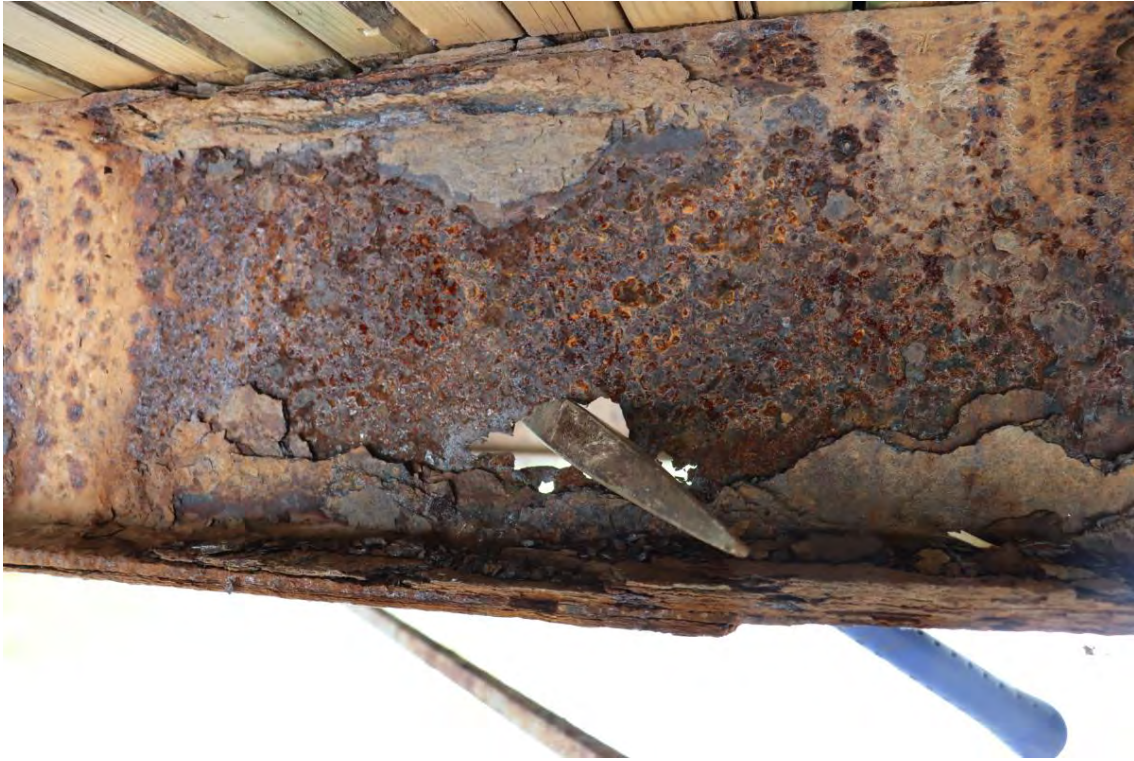
*Figure 39: Stringer 3 perforation in bay 5*

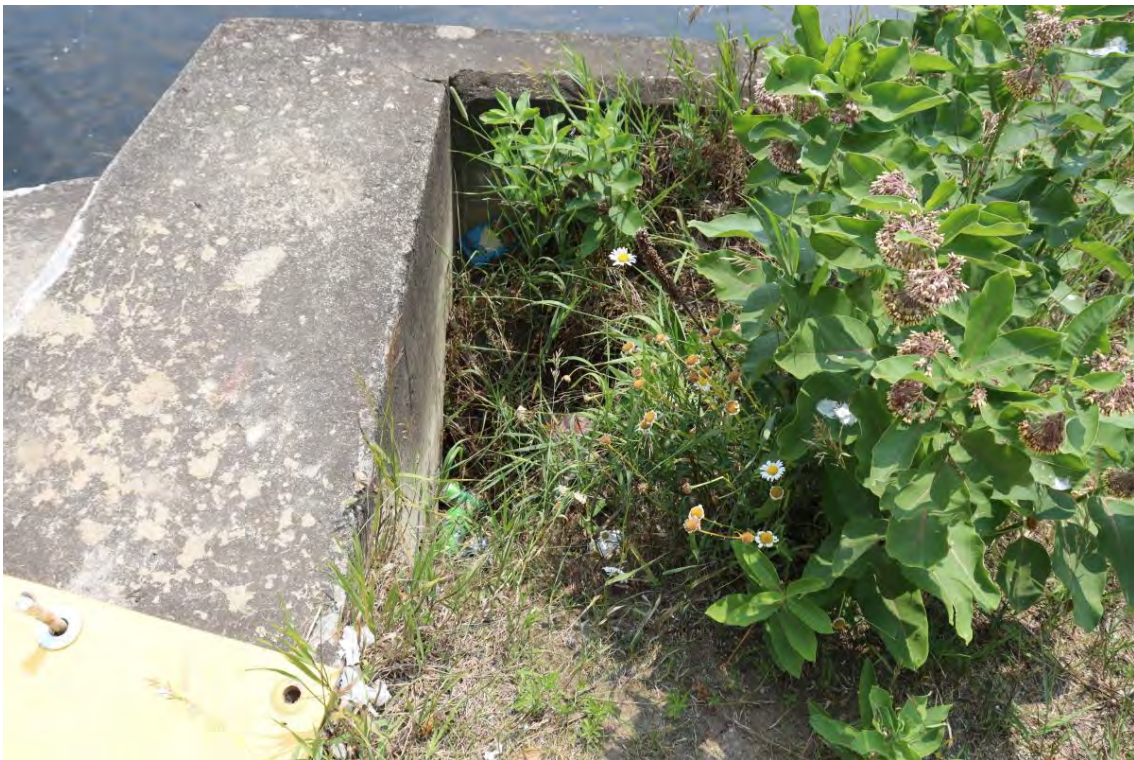
*Figure 42: Sinkhole in SW corner*

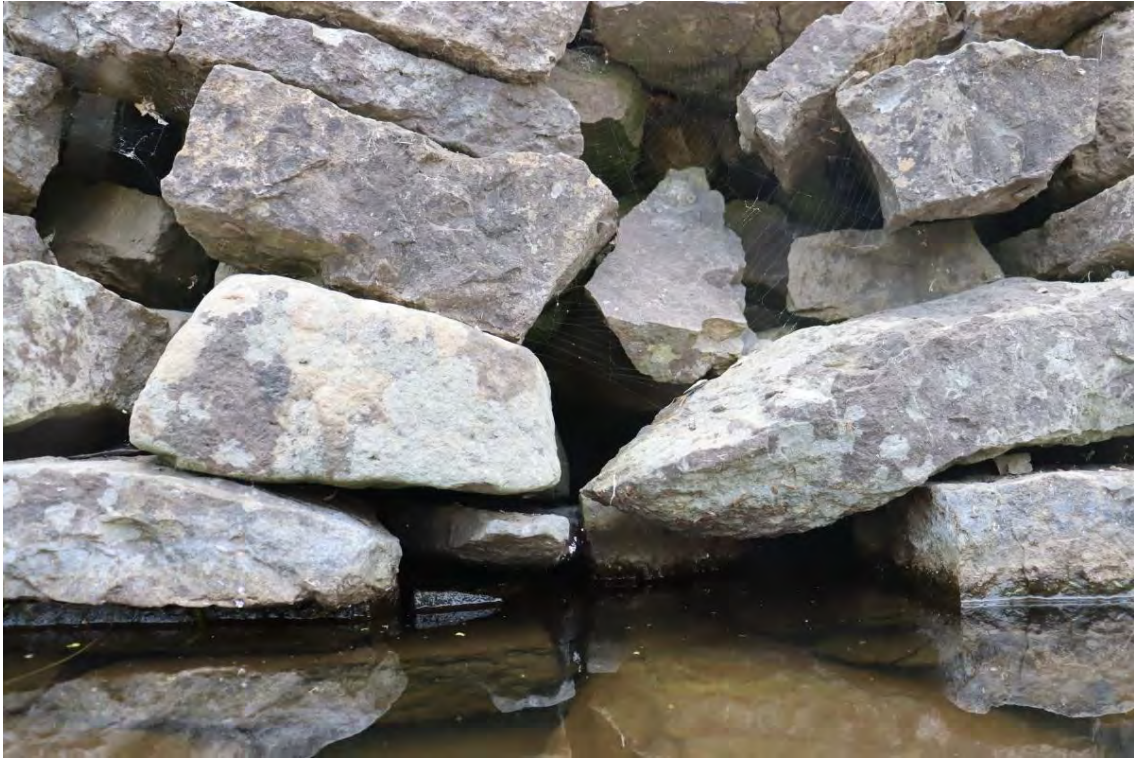
*Figure 49: Blocked drainage opening through causeway*

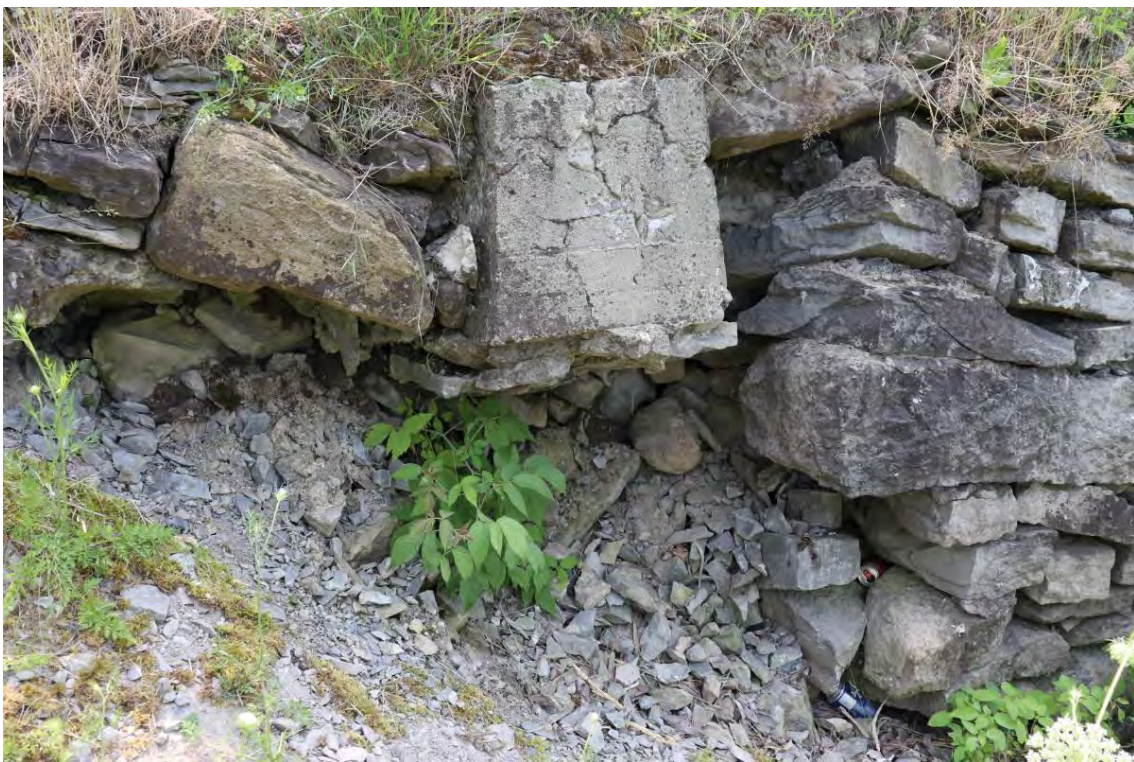
*Figure 52: Undercut railing base in north retaining wall east end*

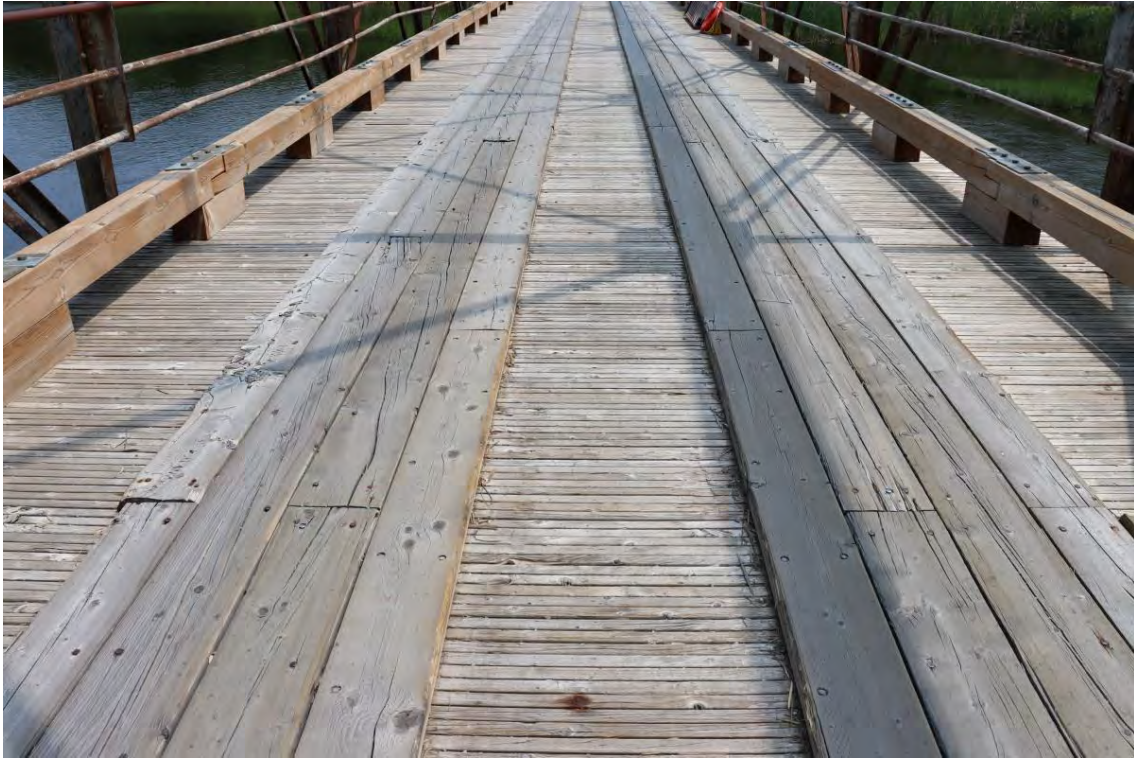
*Figure 60: Damaged running boards*
