Geotechnical Investigation

Proposed Residential Development

Brown Lands - County Road No. 29 and Strathburn Street
Almonte, Ontario

Report PG6260 – 2 dated January 25, 2023

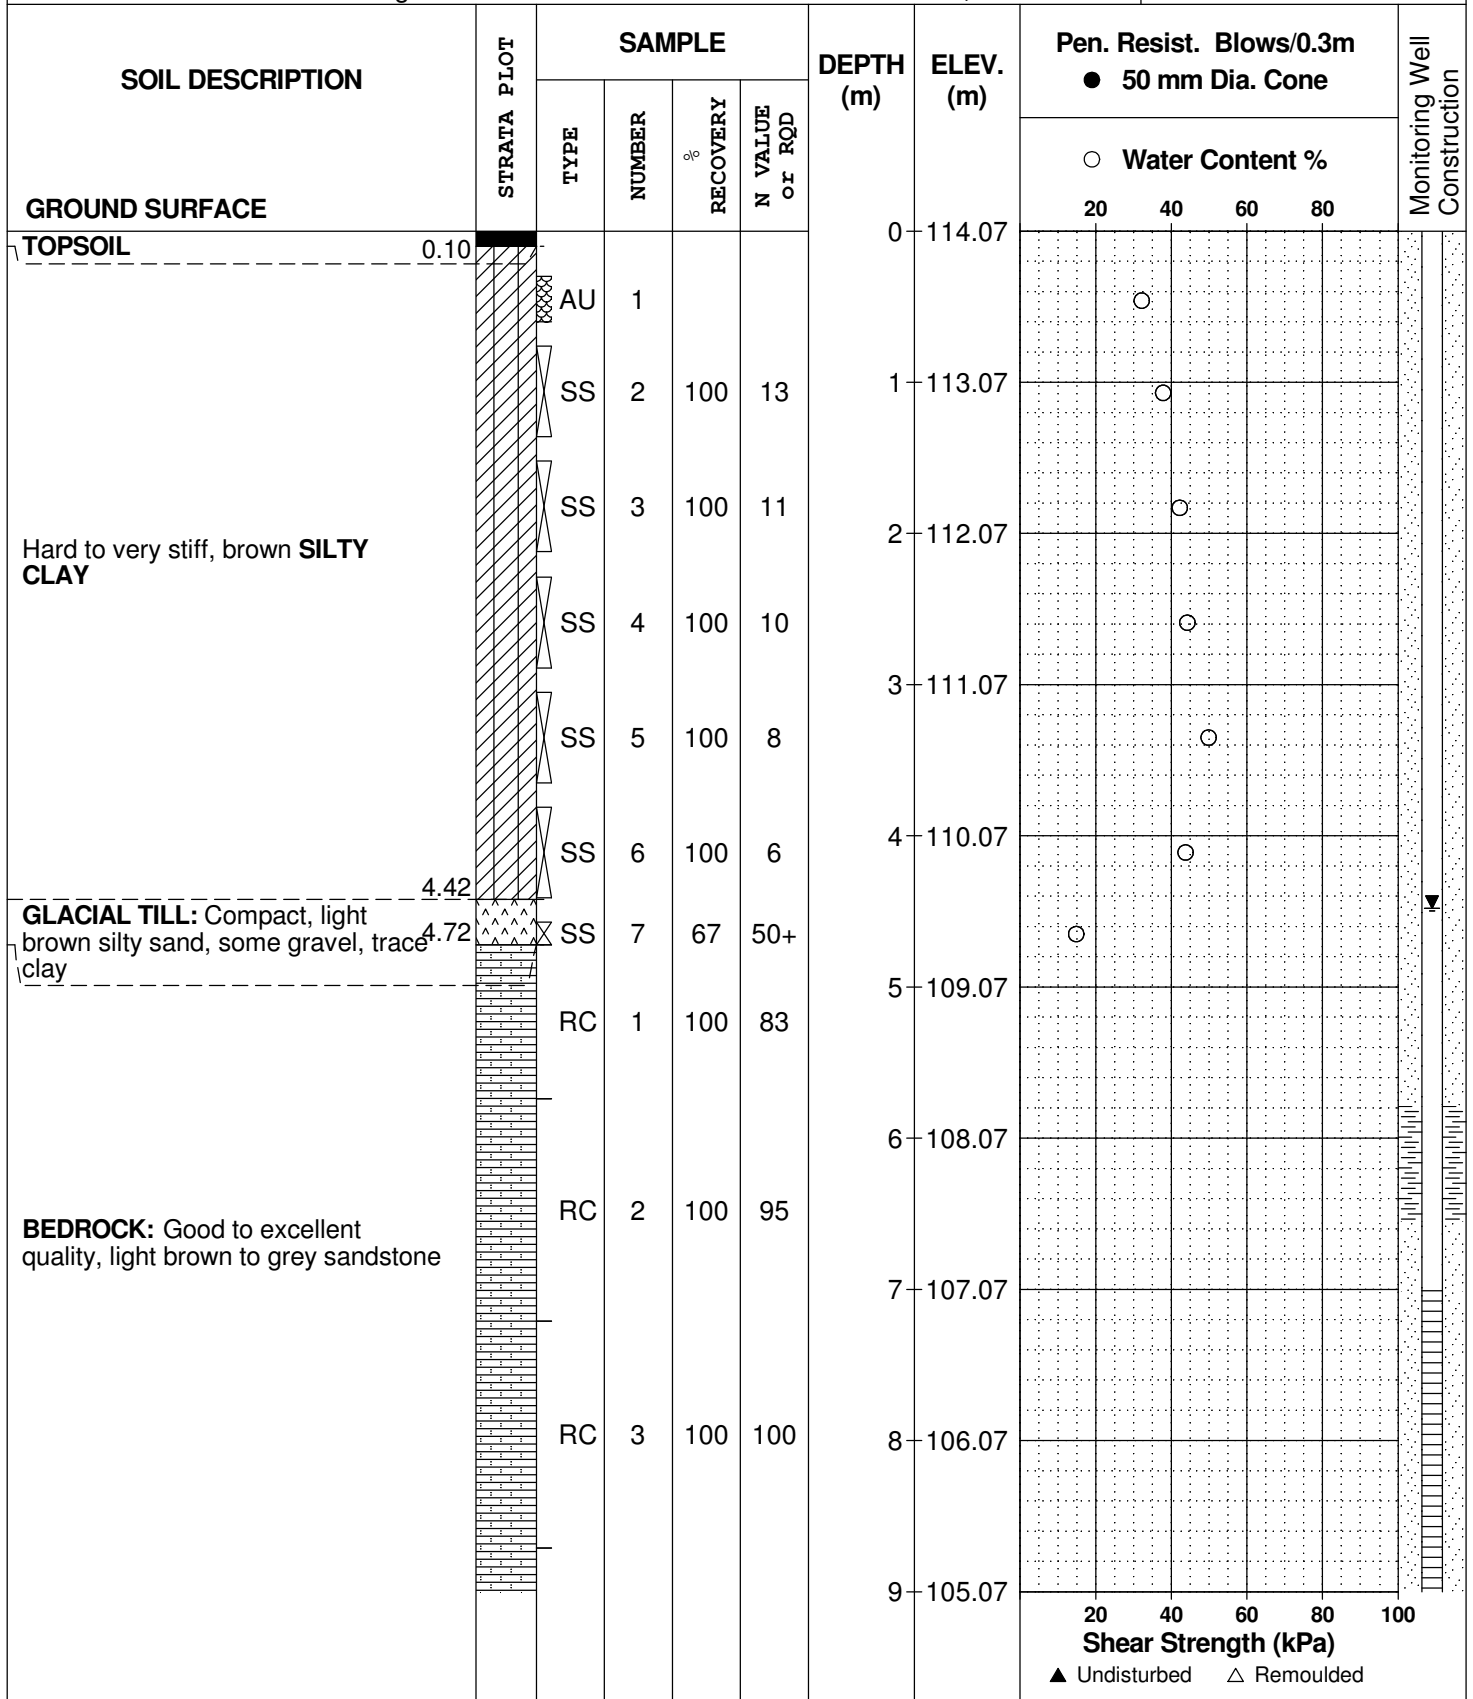
HOLE NO.
BH 7-22

At borehole BH 7-22, where bedrock was cored with the drilling equipment, the bedrock was observed to consist of good to excellent, light brown to grey sandstone.

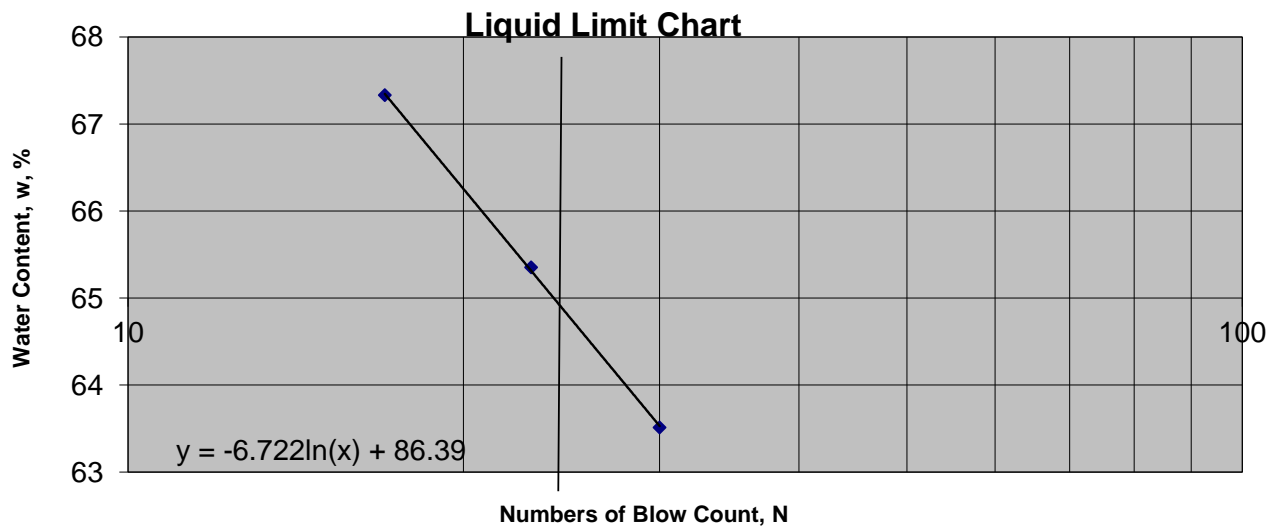
**ATTERBERG LIMITS
LS-703/704**

RESULTS	
LIQUID LIMIT	65
PLASTIC LIMIT	35
PLASTICITY INDEX	30

Based on these current testing results, the plasticity index for all of the tested clay samples were found to be less than 40%, which would indicate the presence of a clay of low to medium potential for soil volume change. Buildings considered throughout the area with these clays may be provided a reduced tree-to-foundation setbacks.

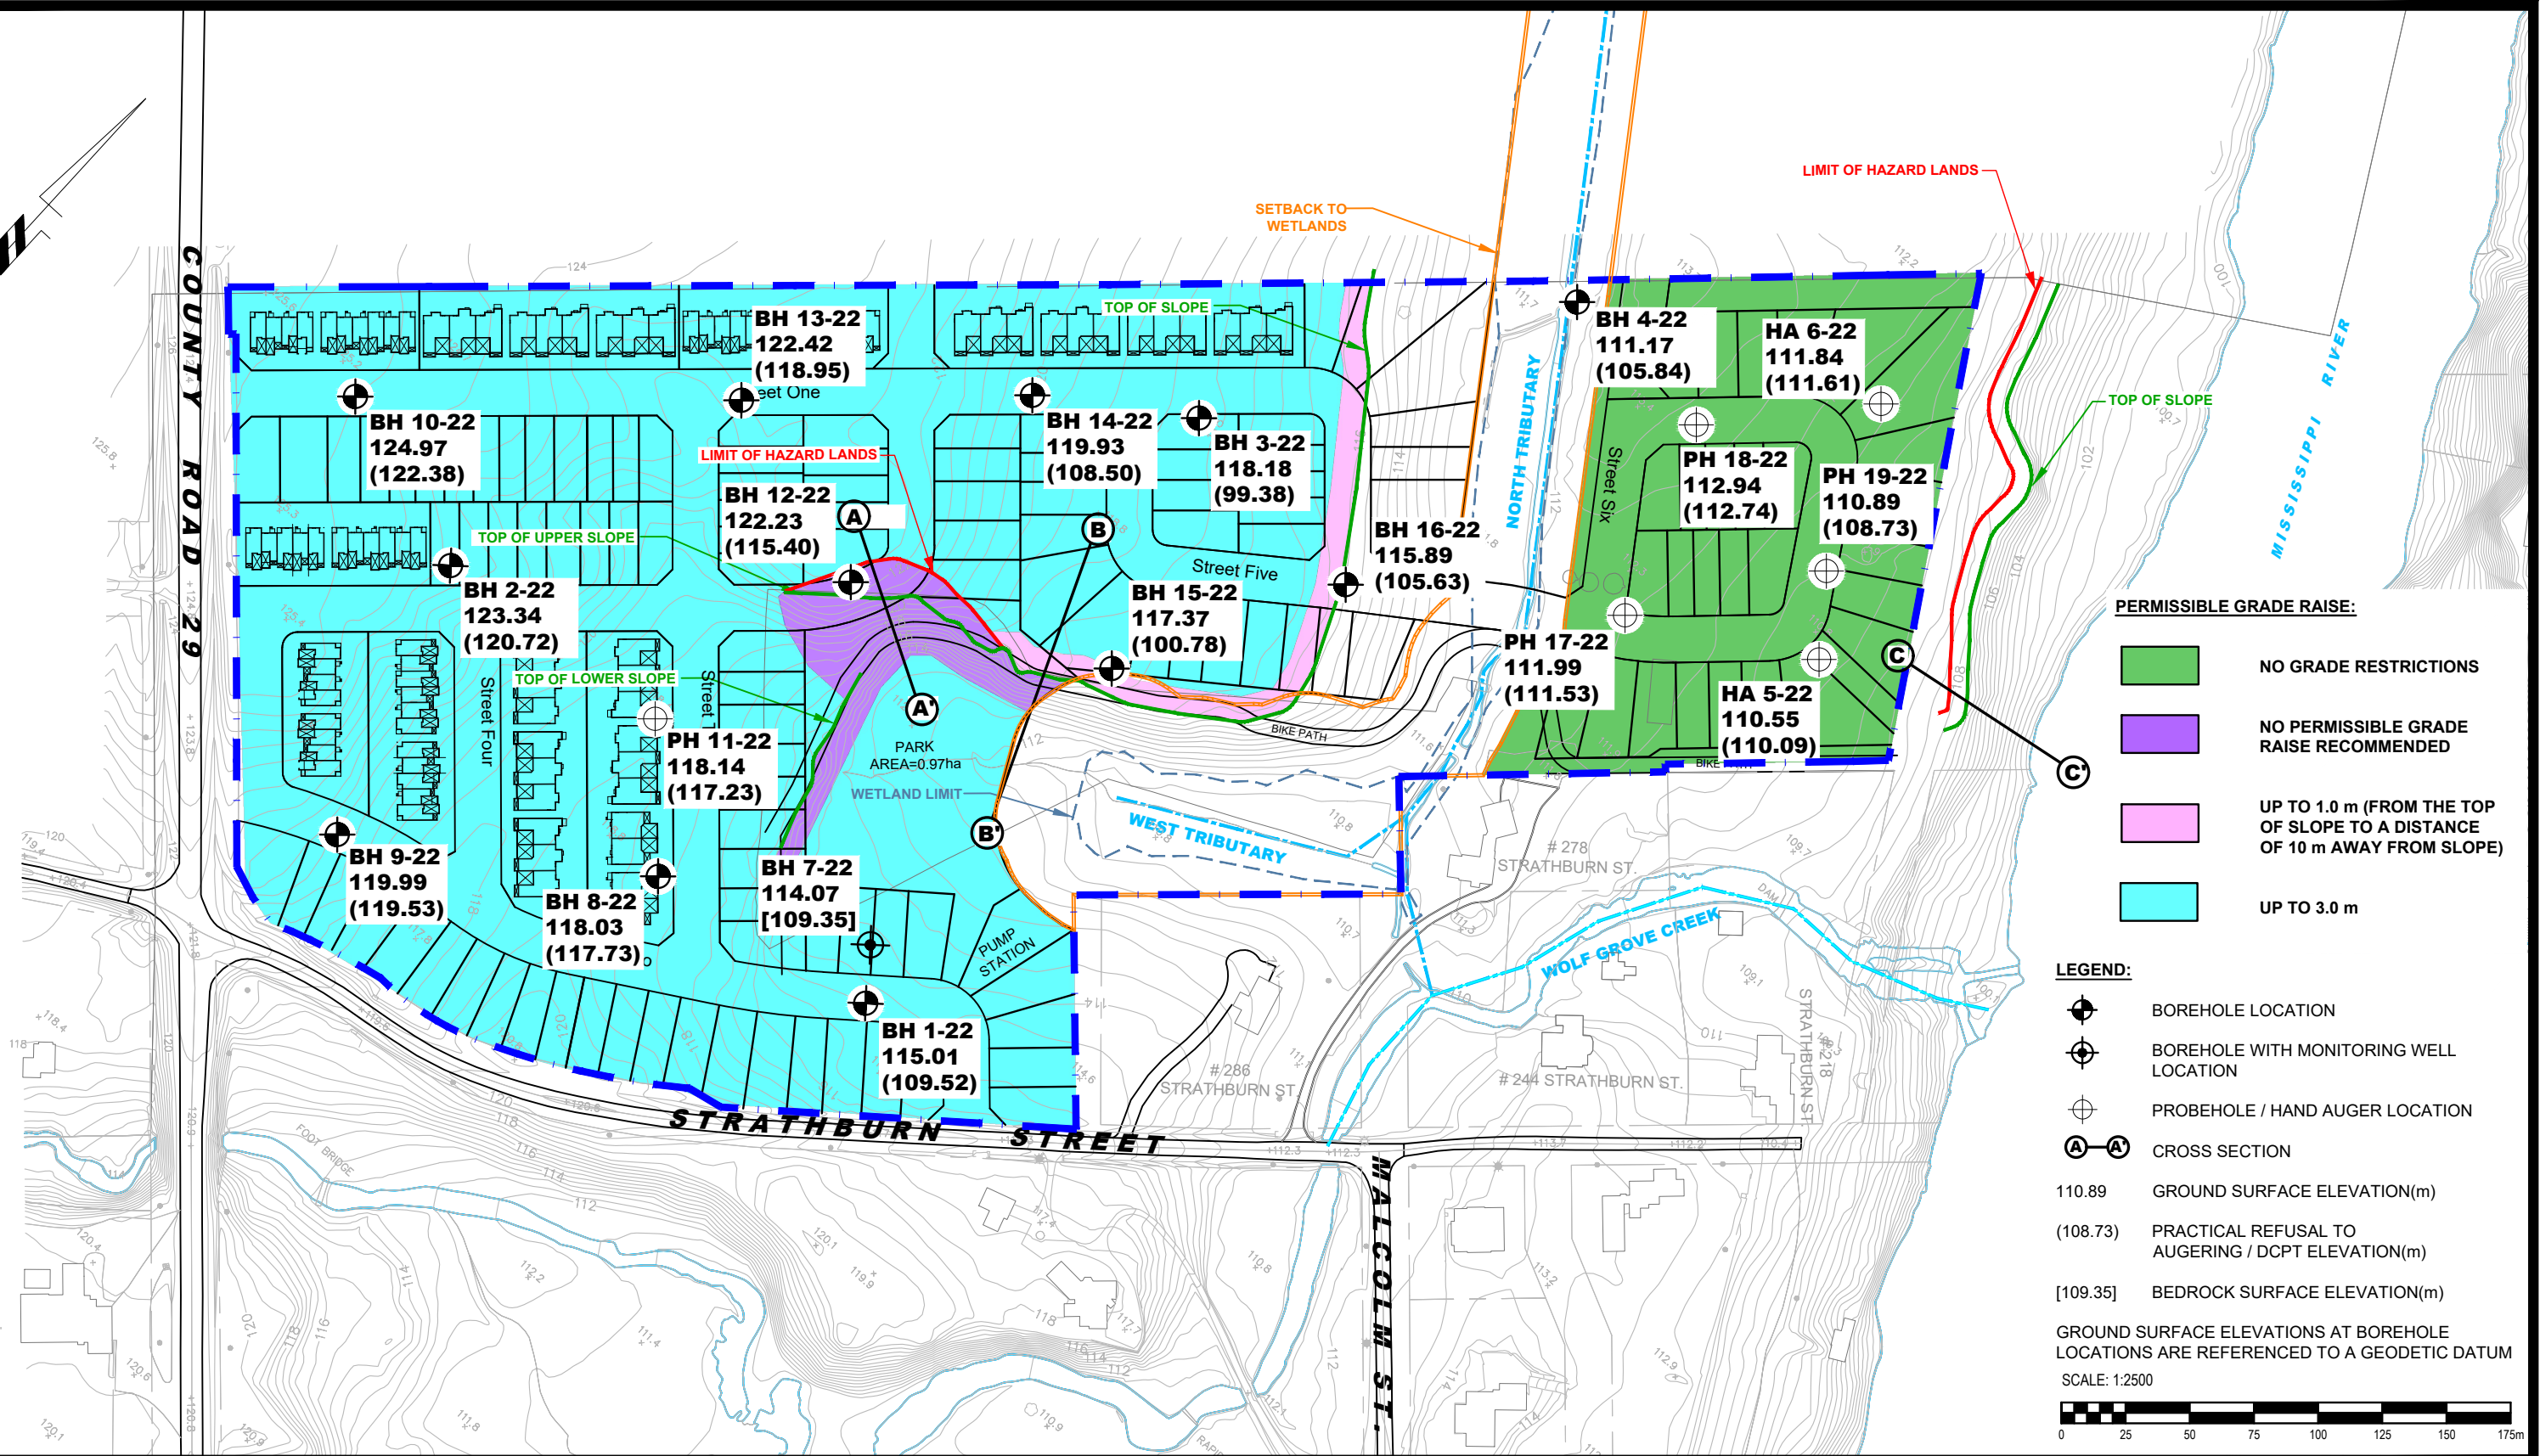
DRAWING PG6260-2 – PERMISSIBLE GRADE RAISE RESTRICTION PLAN

- PERMISSIBLE GRADE RAISE:**
- NO GRADE RESTRICTIONS
 - NO PERMISSIBLE GRADE RAISE RECOMMENDED
 - UP TO 1.0 m (FROM THE TOP OF SLOPE TO A DISTANCE OF 10 m AWAY FROM SLOPE)
 - UP TO 3.0 m

Due to the presence of the silty clay deposit throughout the western portion of the subject site, a permissible grade raise restriction is recommended for grading at the subject site where silty clay is present. Reference should be made to Drawing PG6260-2 – Permissible Grade Raise Plan in Appendix 2 of this report for the areas where the permissible grade raise restriction are recommended.

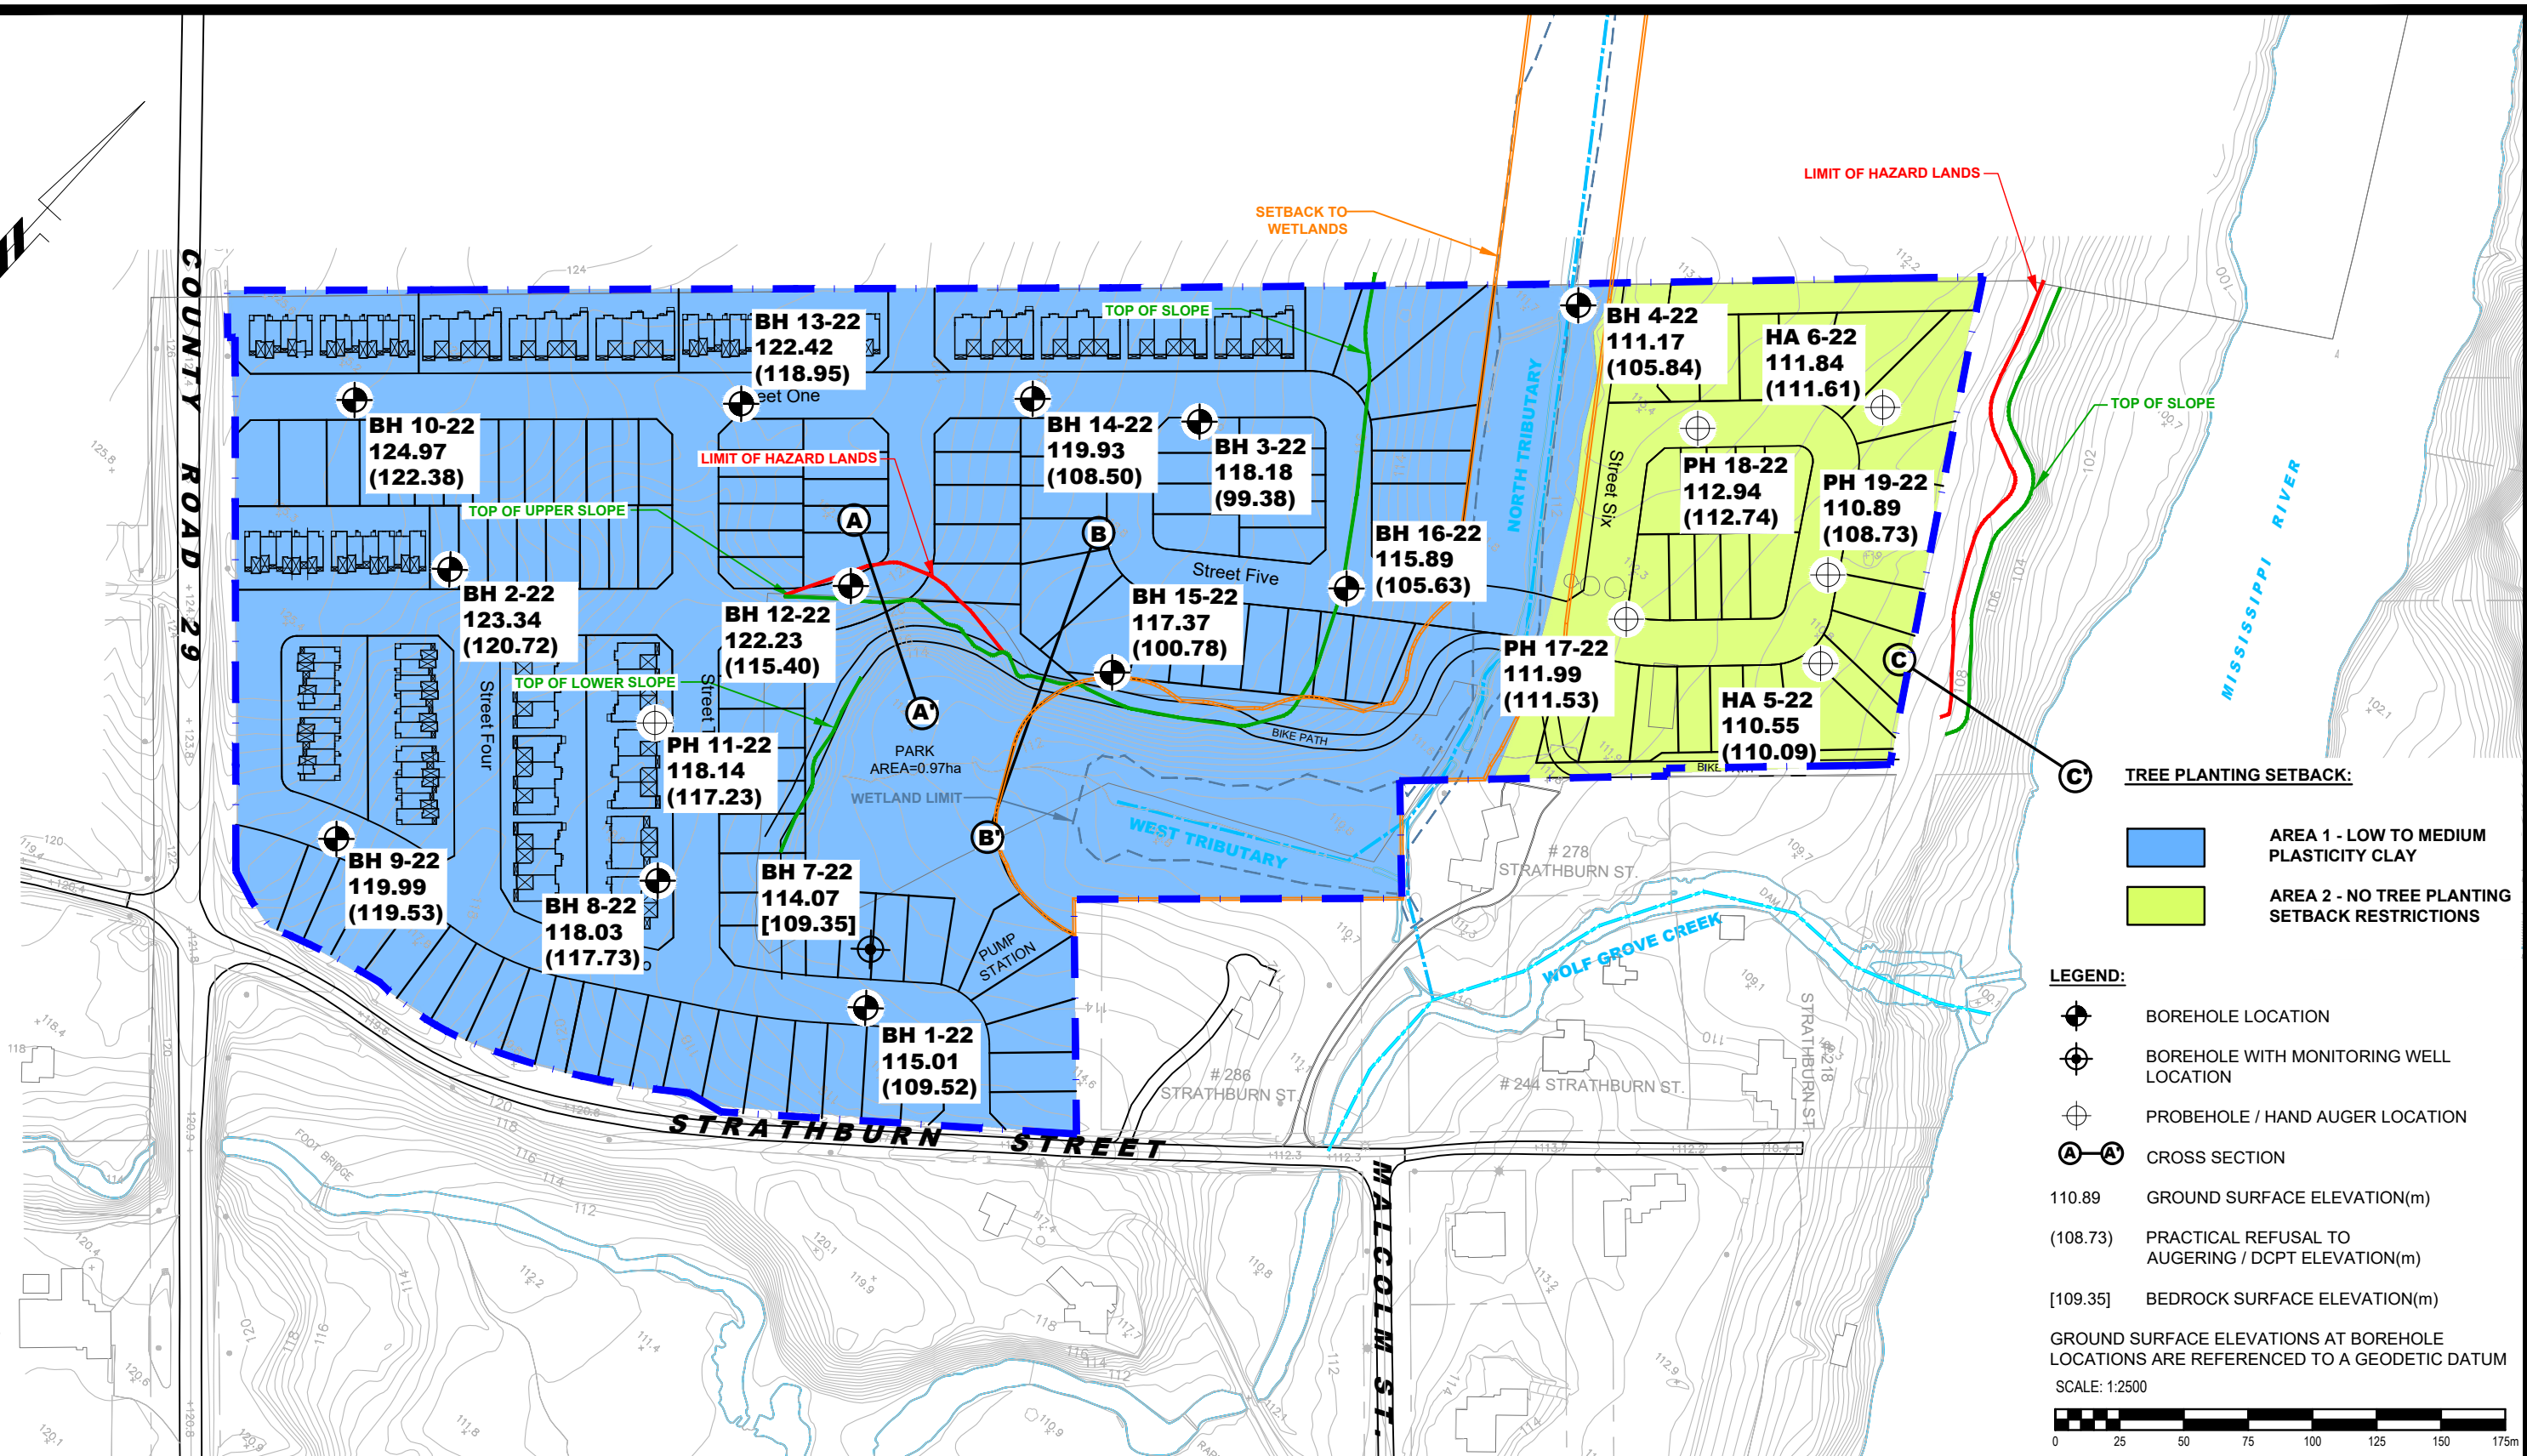
DRAWING PG6260-3 – TREE PLANTING SETBACK PLAN

- AREA 1 - LOW TO MEDIUM PLASTICITY CLAY
- AREA 2 - NO TREE PLANTING SETBACK RESTRICTIONS

Based on the current guidelines, large trees (mature height over 14 m) can be planted within Area 1 provided a tree to foundation setback equal to the full mature height of the tree can be provided (e.g., in a park or other green space). Tree planting setback limits may be reduced to **4.5 m** for small (mature tree height up to 7.5m) and medium size trees (mature tree height 7.5 m to 14 m) provided that the conditions noted below are met:
