# ANDREWSVILLE BRIDGE

## SUMMARY OF EVENTS FROM 2005 TO 2022

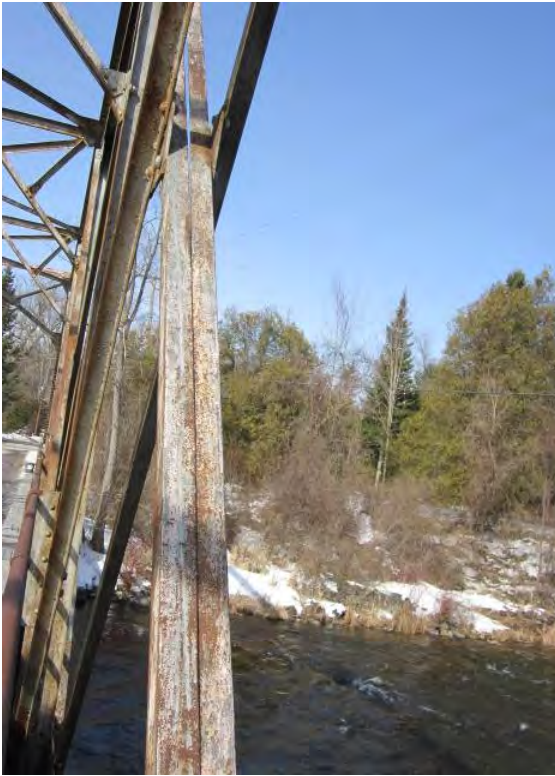
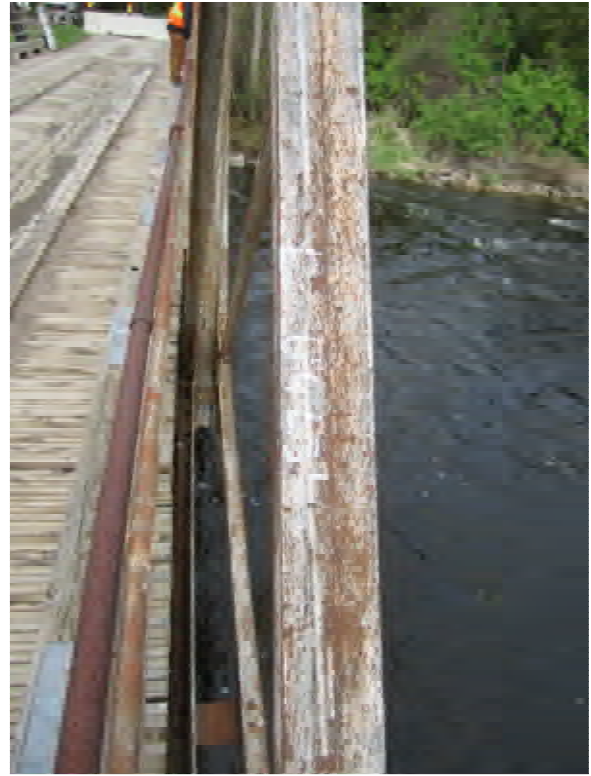
MRC noted that the buckling of the diagonal U4L3' of the east truss has progressed since the March 2012 inspection. The double angles are now overlapping as opposed to nearly touching in the previous inspection (Photograph 1). Additionally, a moderate deformation (twist) of the interior angle of the west truss diagonal U3L4 was observed near L4 (Photograph 2), which was not observed in the March 2012 inspection. While these members are primarily tension members, load reversal into compression will occur under certain live loading conditions. The deformation will significantly lower the compressive resistance of these members. However, MRC determined in the March 2012 Structural Inspection and Evaluation Report that the 5 load limit (as posted) is not large enough to cause the load reversal; accordingly, no further action is required provided the vehicles do not exceed the posted load limit.

Photograph 1: Diagonal U4L3', east truss. The horizontal legs of the double angles were nearly touching in March 2012 (left) but were overlapping in May 2012 (right).

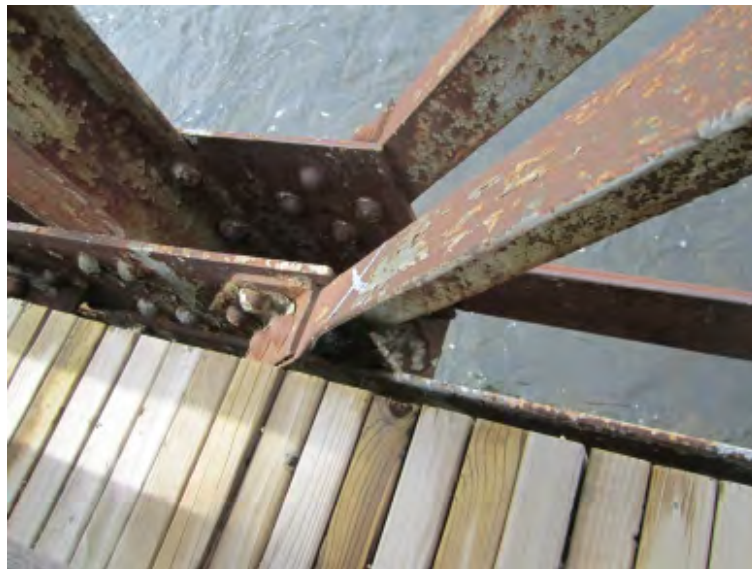
Photograph 2: Deformation in interior angle of U3L4, west truss.

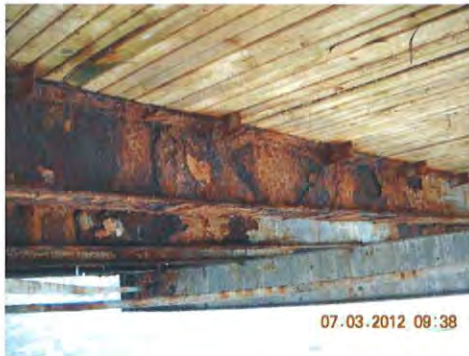
The steel superstructure is in fair condition with widespread surface corrosion. The structural steel is generally in better condition above deck than below deck. The stringers in the end bays of the truss span have widespread surface corrosion with moderate section loss in the web and both flanges (Photograph 2). The section loss has been measured at several locations and was calculated to be up to 30% of the flange area. For the purposes of the inspection and structural evaluation, truss joints are numbered as shown in Figure 1 below.

*Photograph 2: Typical stringer corrosion in end bay of truss span.*

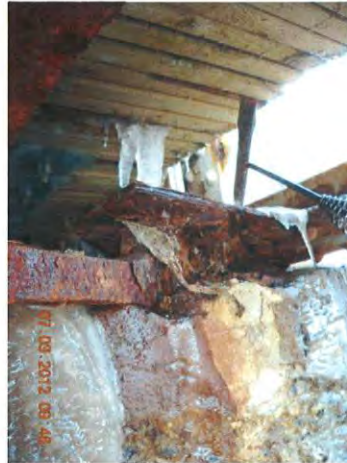
*Photograph 5: Severely corroded bottom lateral connection plate at L0*

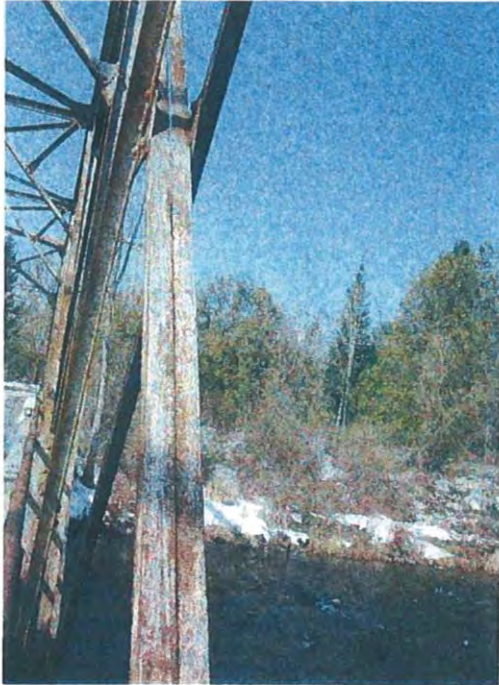
MRC noted that the buckling of the diagonal U4L3' of the east truss has progressed since the March 2012 inspection. The double angles are now overlapping as opposed to nearly touching in the previous inspection (Photograph 1). Additionally, a moderate deformation (twist) of the interior angle of the west truss diagonal U3L4 was observed near L4 (Photograph 2), which was not observed in the March 2012 inspection. While these members are primarily tension members, load reversal into compression will occur under certain live loading conditions. The deformation will significantly lower the compressive resistance of these members. However, MRC determined in the March 2012 Structural Inspection and Evaluation Report that the 5 load limit (as posted) is not large enough to cause the load reversal; accordingly, no further action is required provided the vehicles do not exceed the posted load limit. It is recommended that measures to ensure compliance with the posted load limit be implemented prior to reopening the bridge to vehicular traffic.

Photograph 1: Diagonal U4L3', east truss. The horizontal legs of the double angles were nearly touching in March 2012 (left) but were overlapping in May 2012 (right).

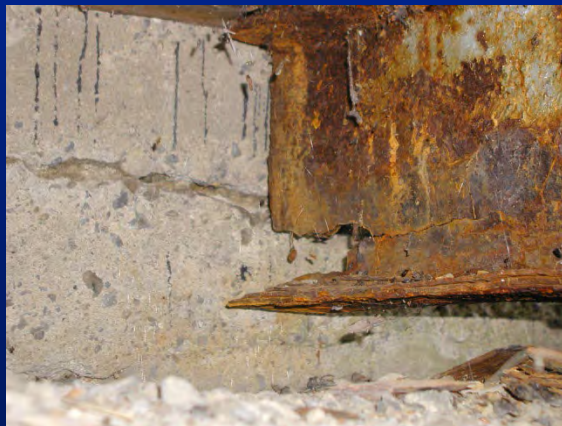
- Crossing was generally in poor condition.
- Asphalt had numerous wide cracks and potholes, timber deck below exhibited signs of rot and had detached from stringers.

Steel had widespread light corrosion with areas of severe corrosion and perforated steel below-deck.

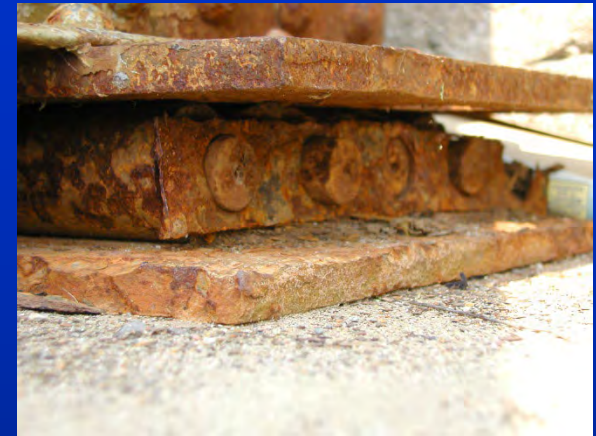
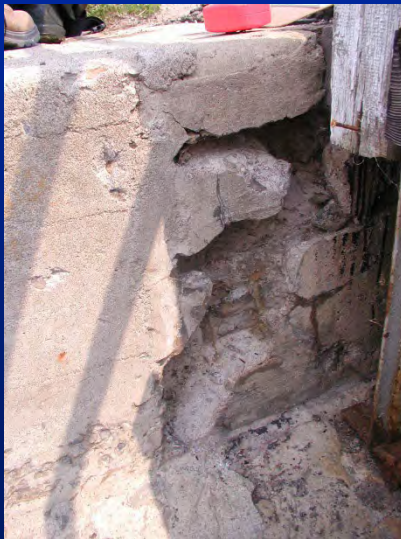
- Roller bearings were seized and do not adequately permit movements due to thermal expansion and contraction

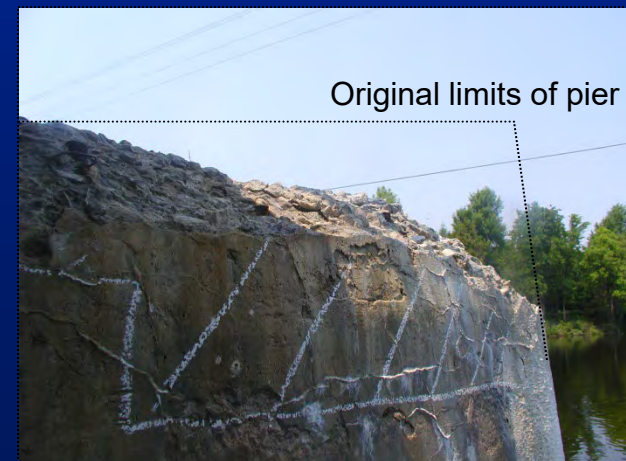
- Concrete in pier and abutments was severely deteriorated

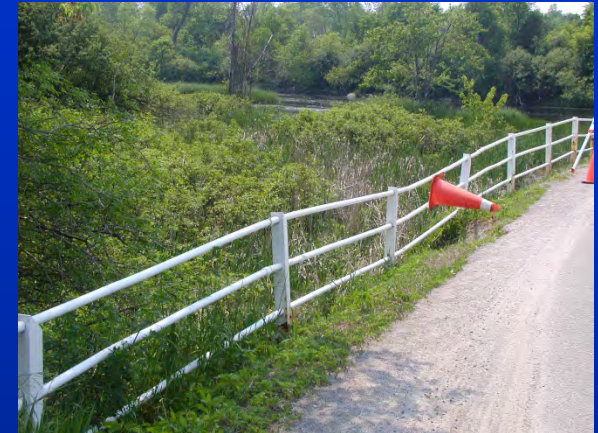
- Retaining walls on causeway had subsided and had undermined approach approach railing
  - During spring runoff, water flows through the walls above the storm pipe

- Existing bridge railings were attached directly to truss and had been damaged by vehicular impact in several locations.

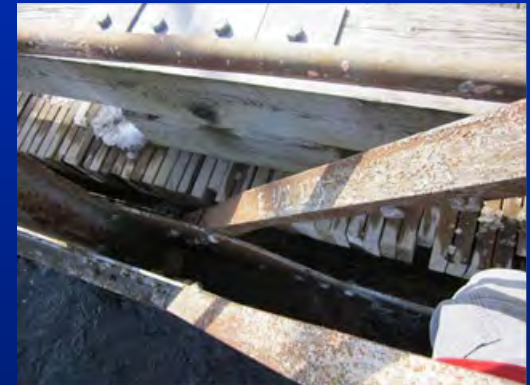
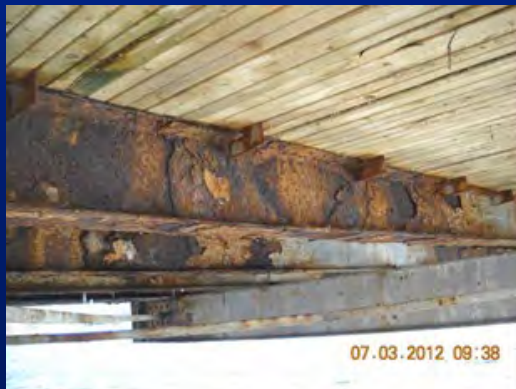
- Structural steel continues to deteriorate
- Deck replacement actually increased the capacity of some of the truss members
- Evidence of distortion of truss members not witnessed in previous inspections

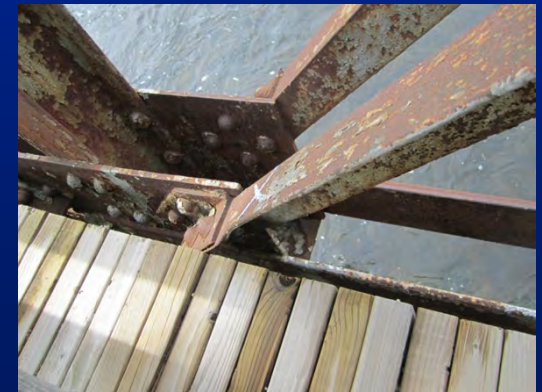
- Vehicle in excess of 5t used the Crossing
- Evidence of damage to the truss bridge and the swing bridge over the Rideau Canal
- Crossing was closed to effect repairs to the swing bridge
- 5t load posting to remain; however, it was recommended that the Crossing remain closed until repairs to deteriorated members could be completed and load limit could be strictly enforced

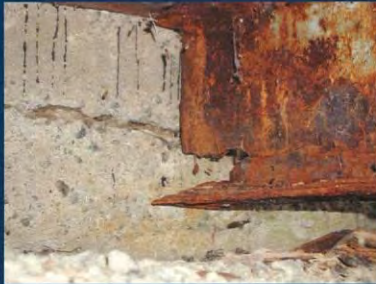
- Crossing was generally in poor condition.
- Asphalt had numerous wide cracks and potholes, timber deck below exhibited signs of rot and had detached from stringers.

Steel had widespread light corrosion with areas of severe corrosion and perforated steel below-deck.

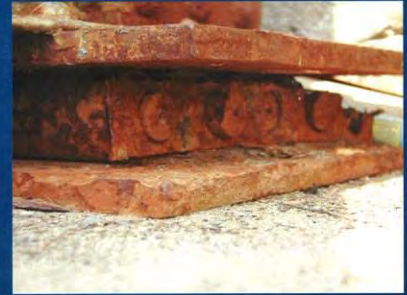
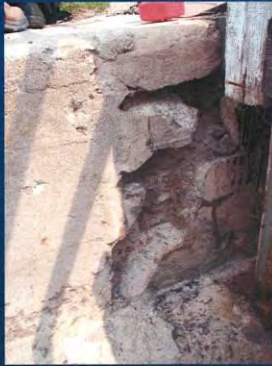
- Roller bearings were seized and do not adequately permit movements due to thermal expansion and contraction

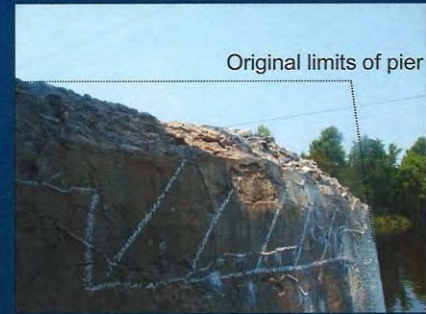
- Concrete in pier and abutments was severely deteriorated

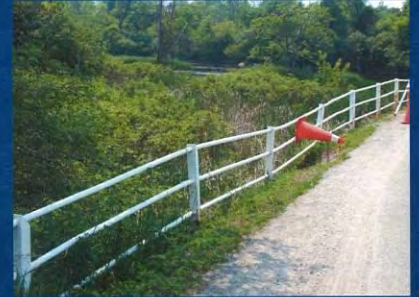
- Retaining walls on causeway had subsided and had undermined approach railing
  - During spring runoff, water flows through the walls above the storm pipe

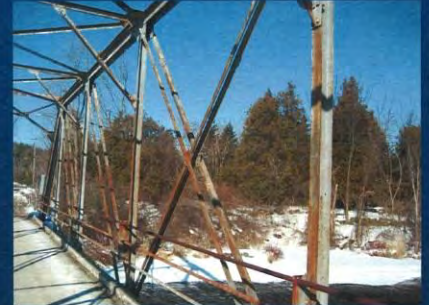
- Existing bridge railings were attached directly to truss and had been damaged by vehicular impact in several locations.

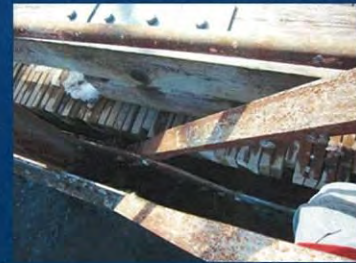
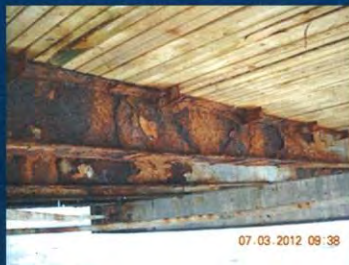
- Structural steel continues to deteriorate
- Deck replacement actually increased the capacity of some of the truss members
- Evidence of distortion of truss members not witnessed in previous inspections

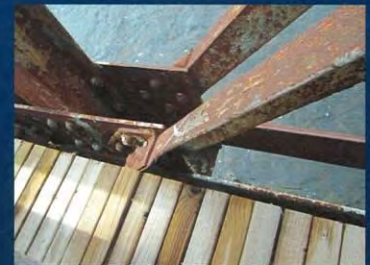
- Vehicle in excess of 5t used the Crossing
- Evidence of damage to the truss bridge and the swing bridge over the Rideau Canal
- Crossing was closed to effect repairs to the swing bridge
- 5t load posting to remain; however, it was recommended that the Crossing remain closed until repairs to deteriorated members could be completed and load limit could be strictly enforced

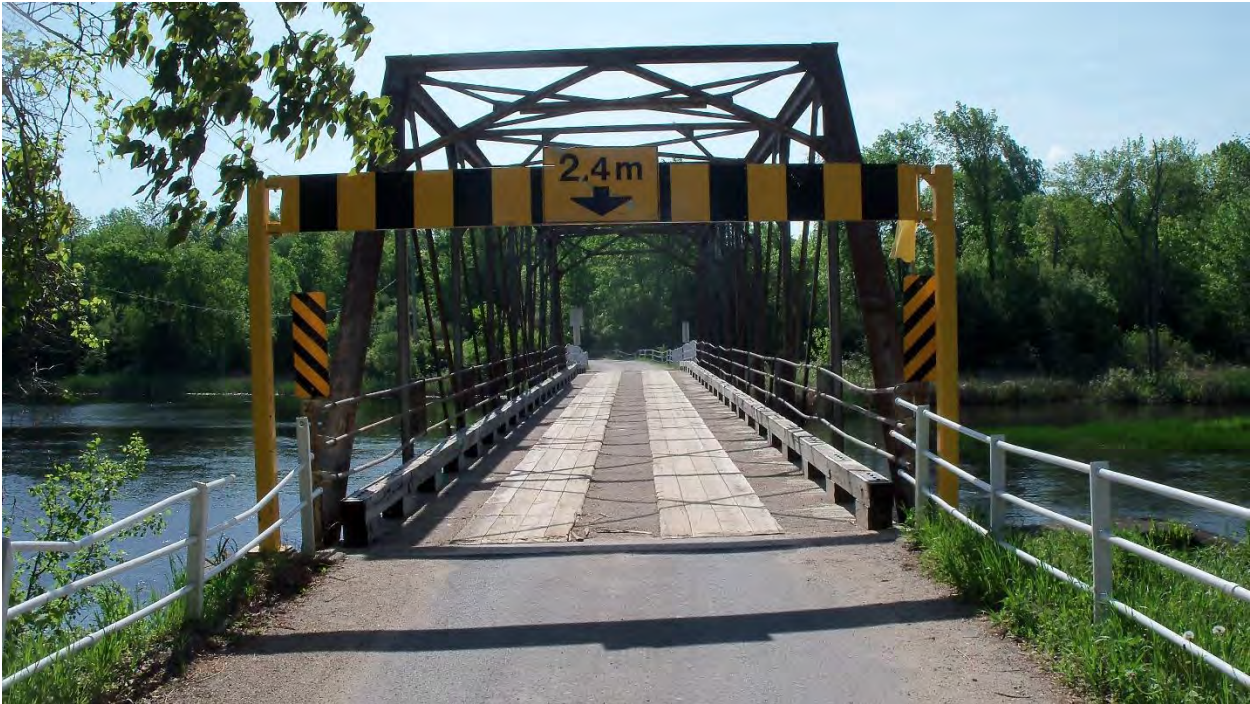
Approach view of the structure

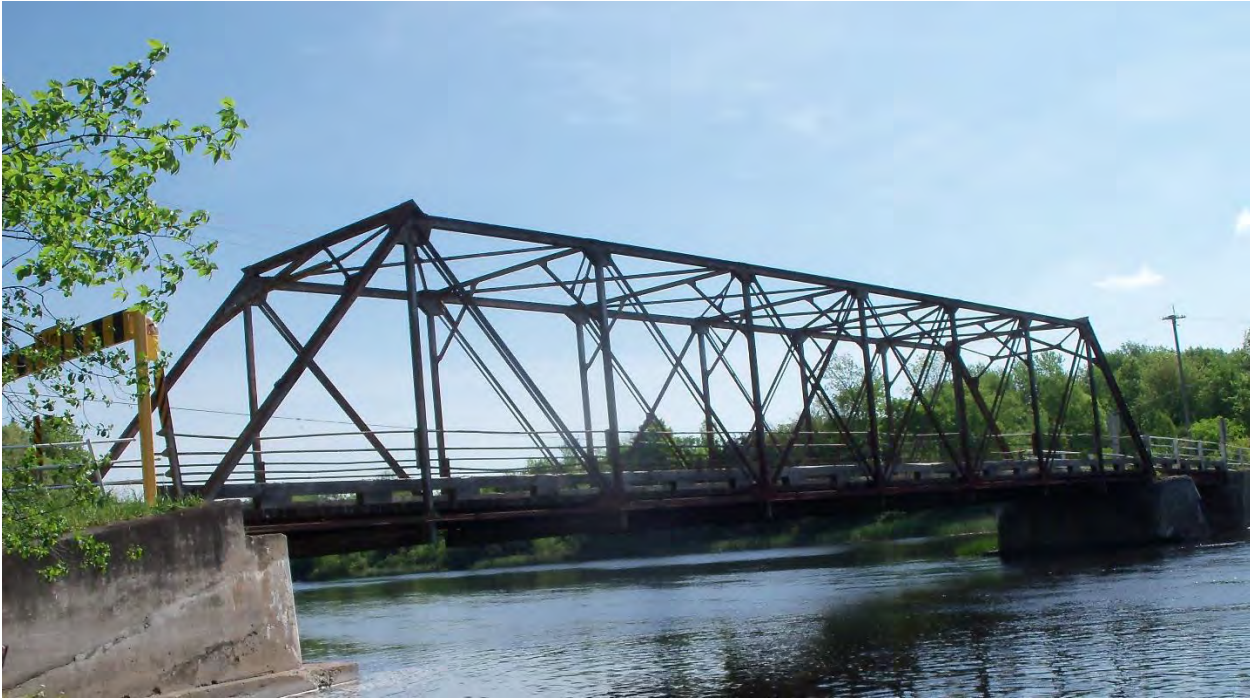
Elevation view

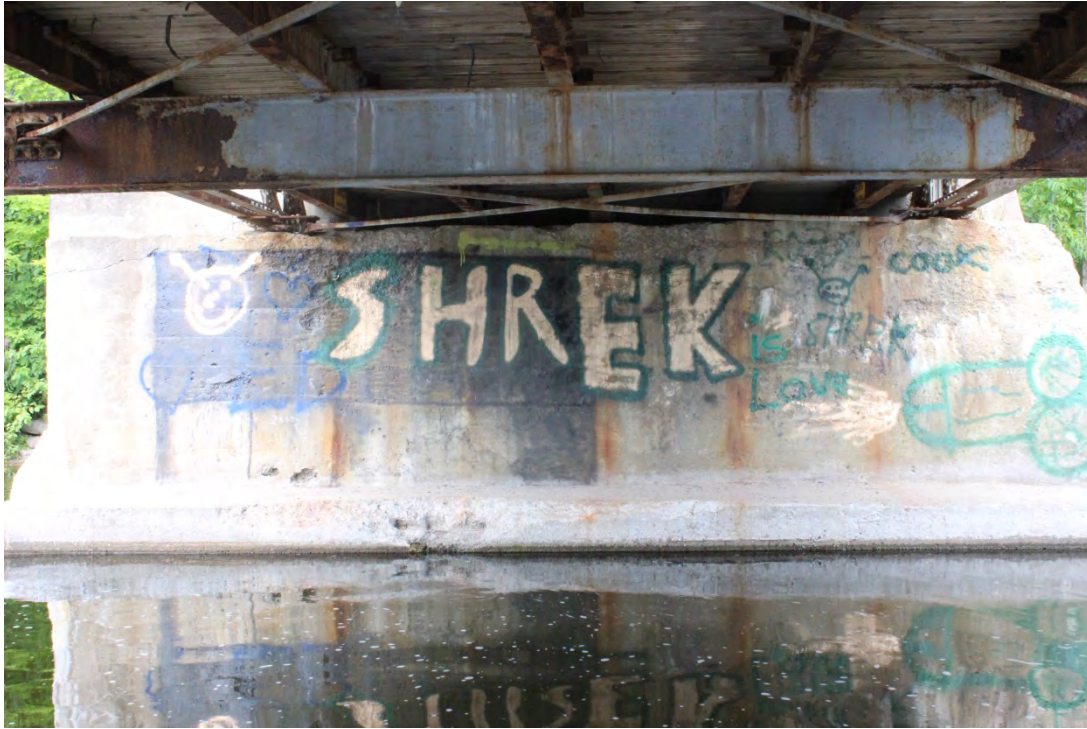
Image 23. West abutment

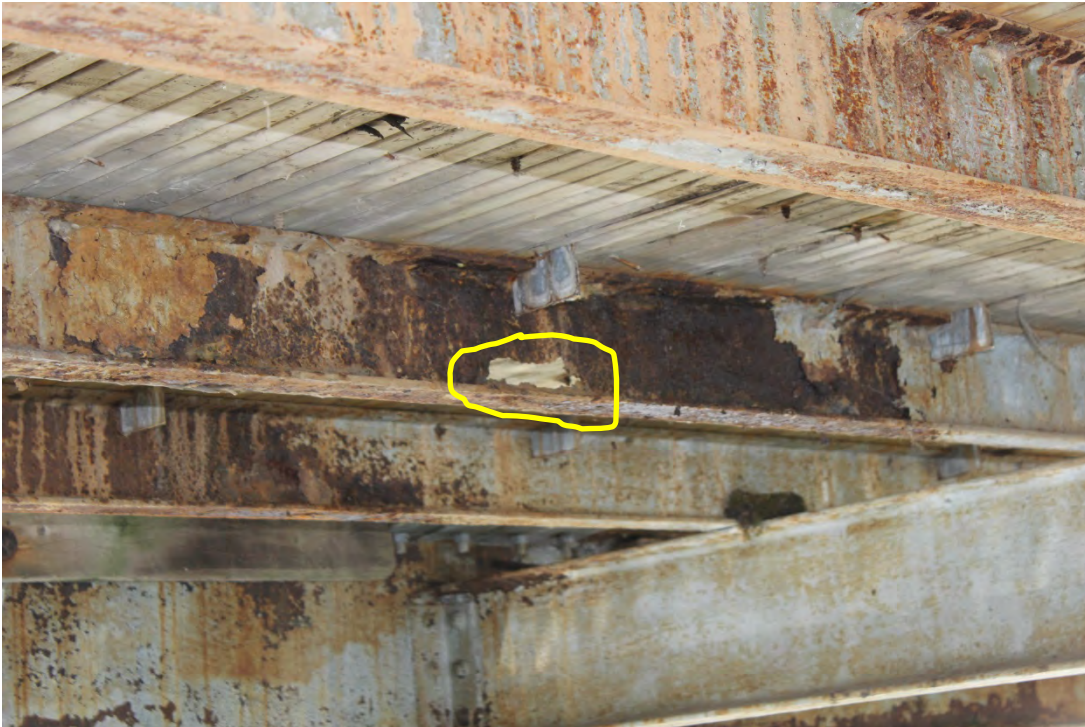
Image 33. East bay of east approach span with perforation in Stringer 2

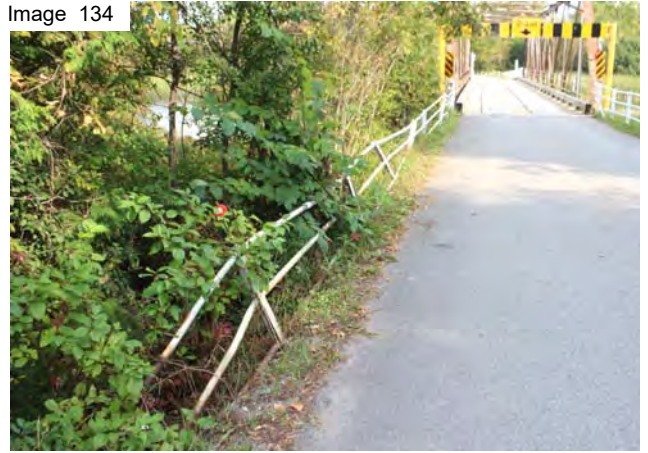
Image 134

Damaged pipe railing NE quadrant

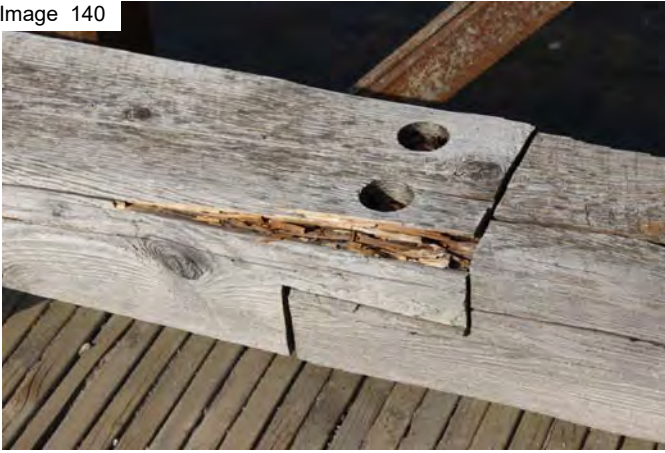
Image 140

Decay in curb timber

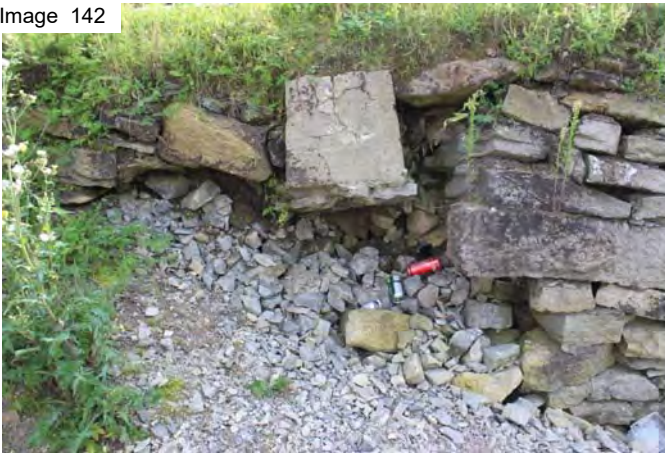
Image 142

Under-cut rail post foundation SE quadrant

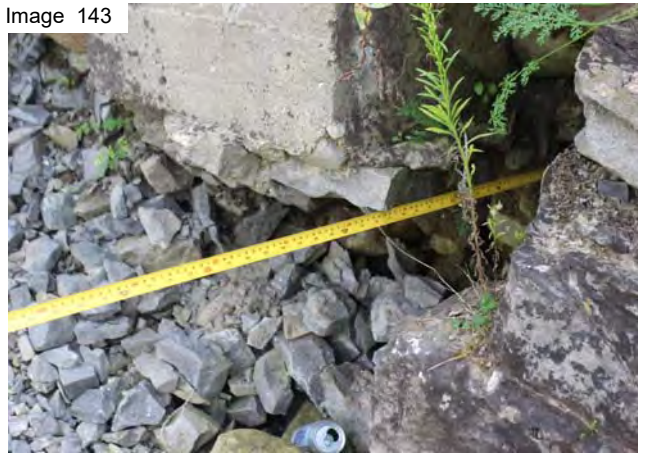
Image 143

600 mm under-cut SE quadrant

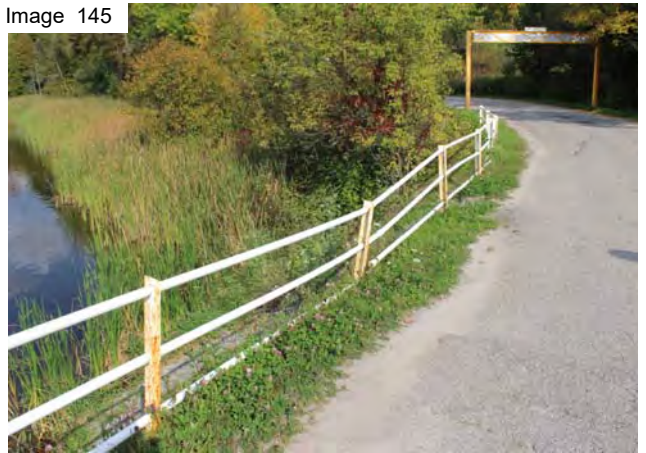
Image 145

Sagged rail at under-cut location

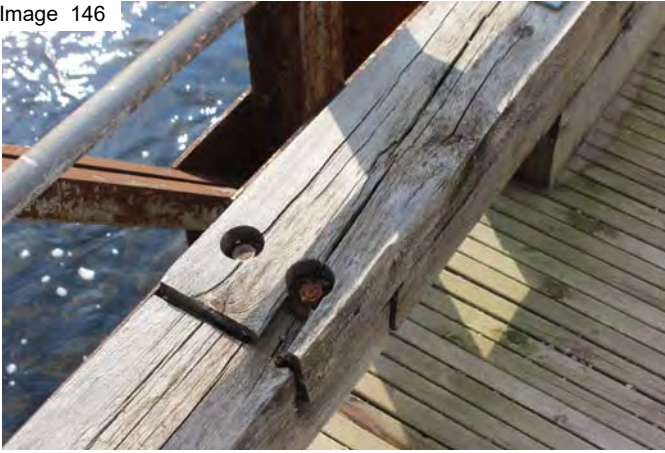
Image 146

Curb timber decay on truss

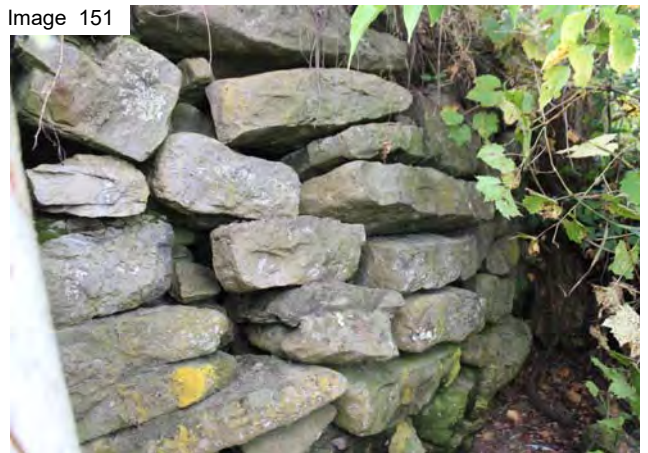
Image 151

Bulging dry stone embankment wall NE quadrant

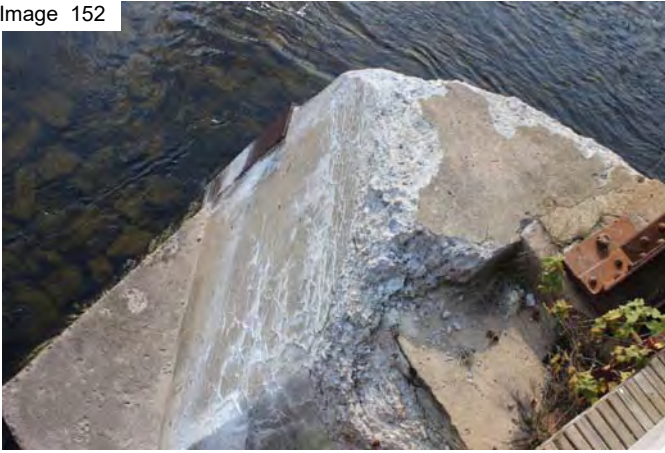
Image 152

Disintegrating pier nosing

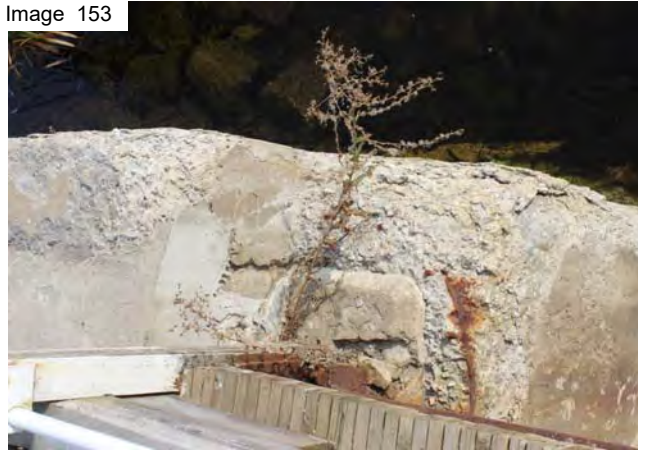
Image 153

Disintegrating south abutment west side

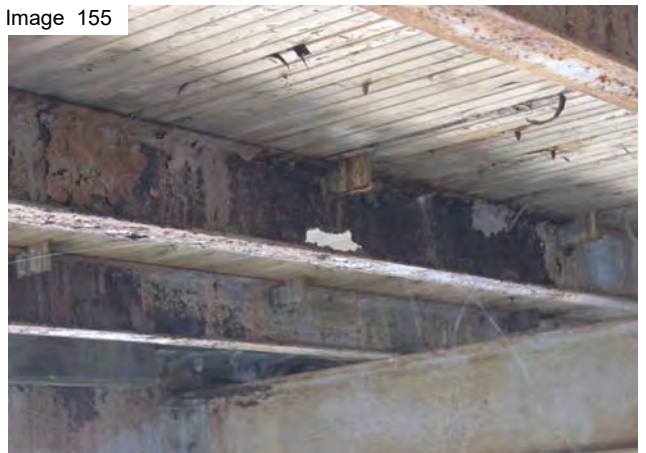
Image 155

Perforation stringer 2 approach span south end

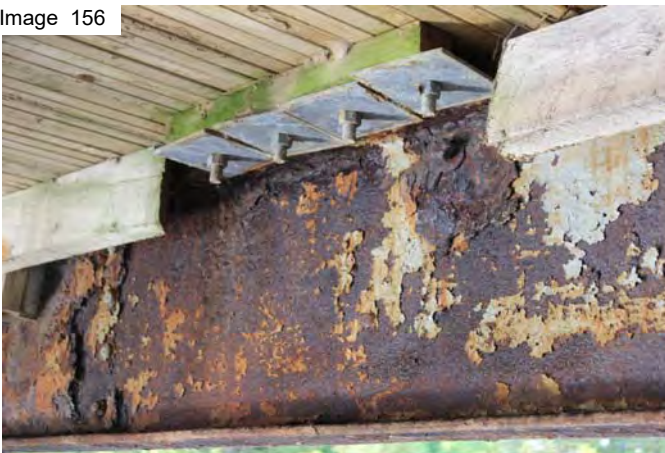
Image 156

Slab rust on east girder of south approach span

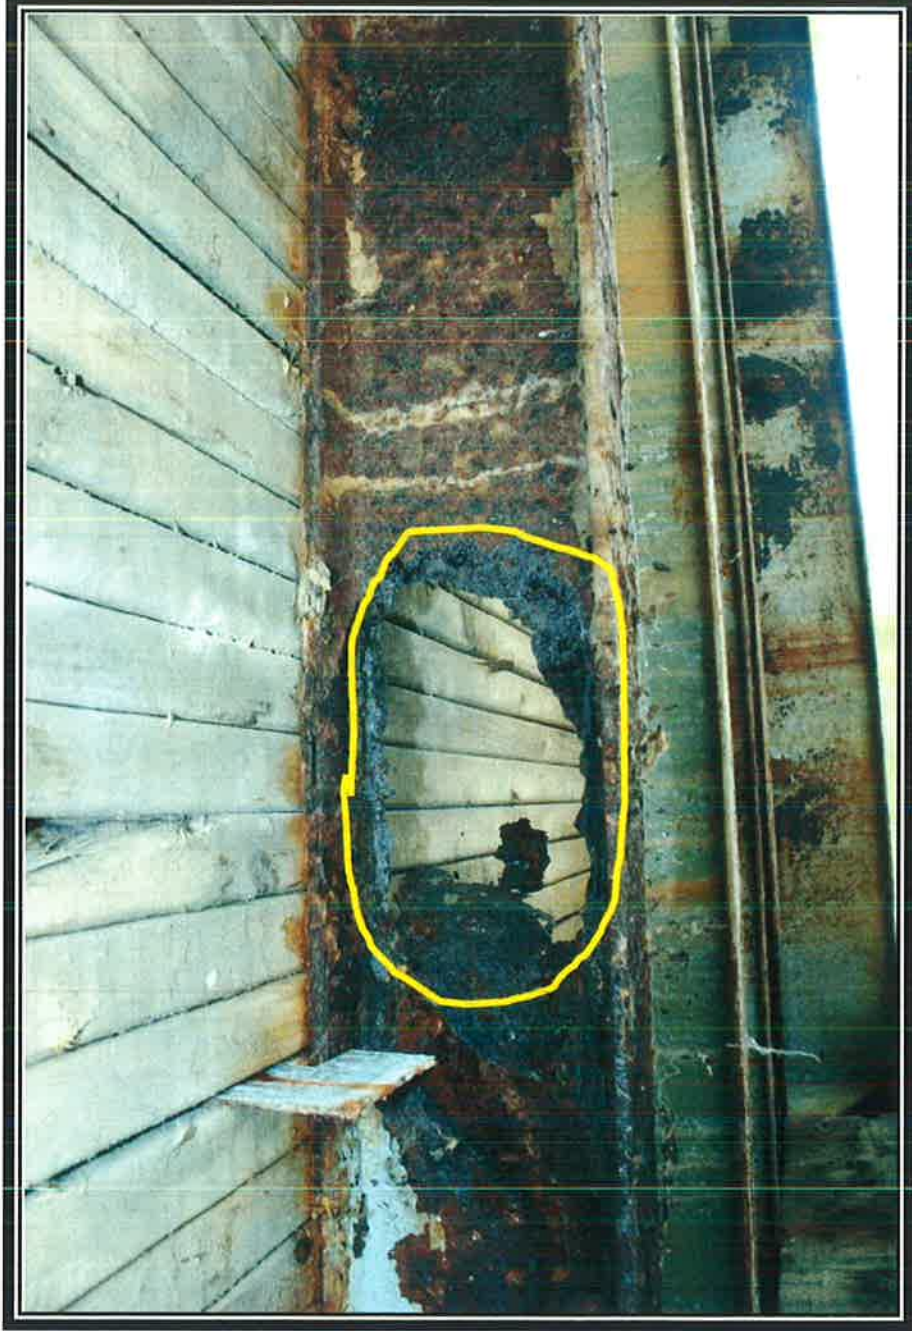
# PERFORATION OF APPROACH STRINGER 2 AFTER PROBING

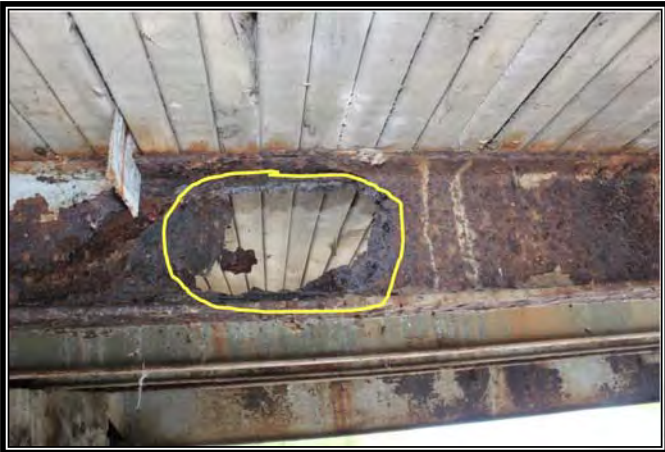
### PERFORATION OF APPROACH STRINGER 2 AFTER PROBING

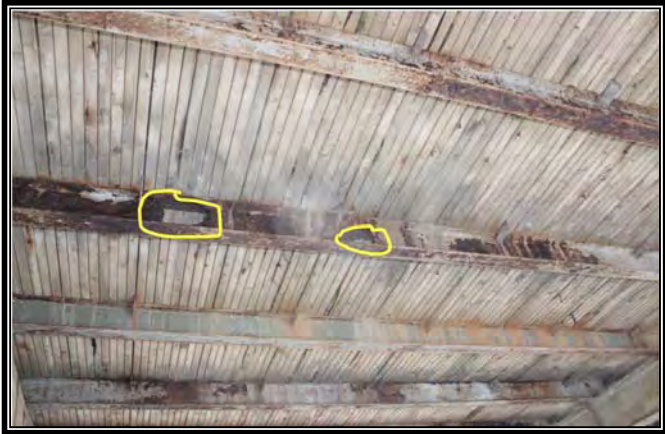
GENERAL VIEW OF WEST BAY OF  
APPROACH SPAN LOOKING DOWNSTREAM.  
PERFORATIONS CIRCLED.

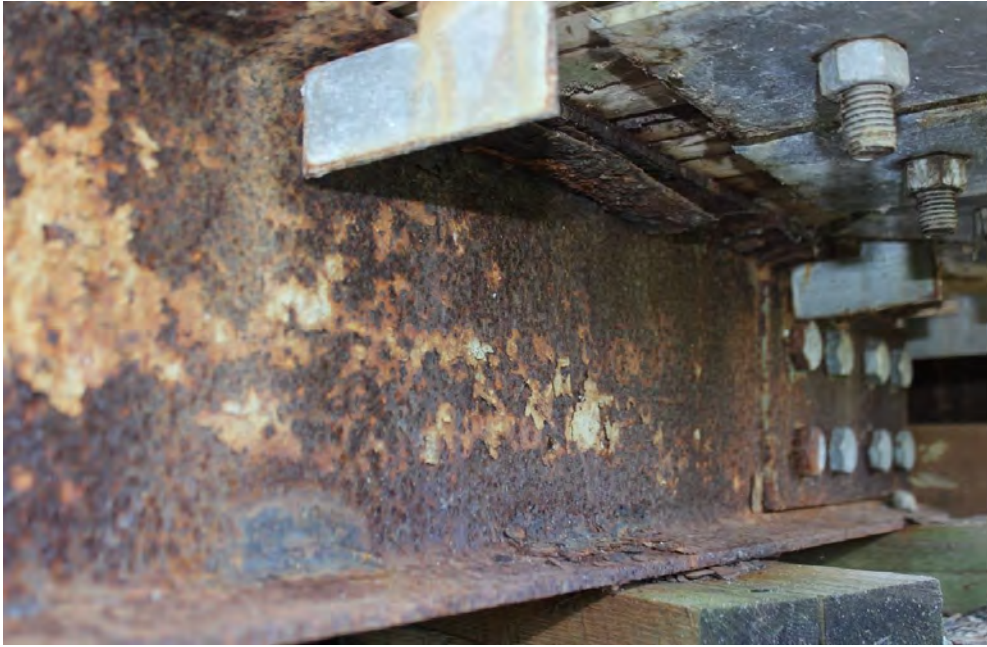
**Image 11.** South face of main truss Stringer 5 at pier bearing

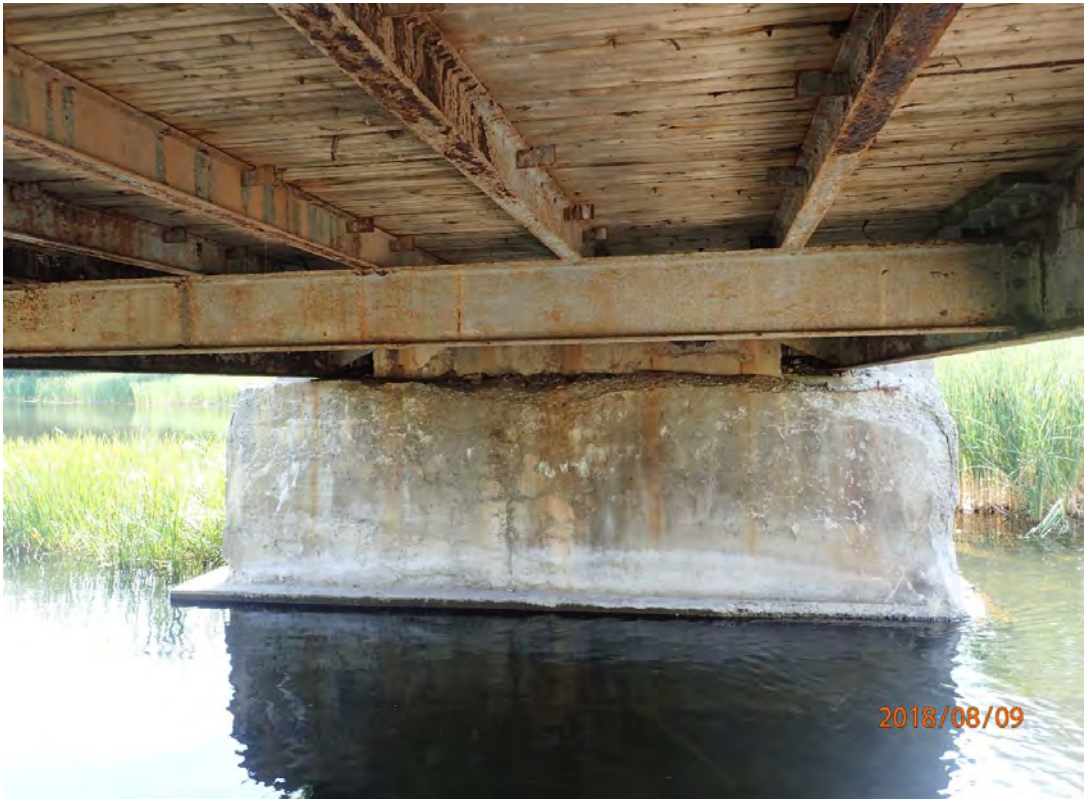
**Image 19. Floor beam, stringers and east abutment at east approach span.**

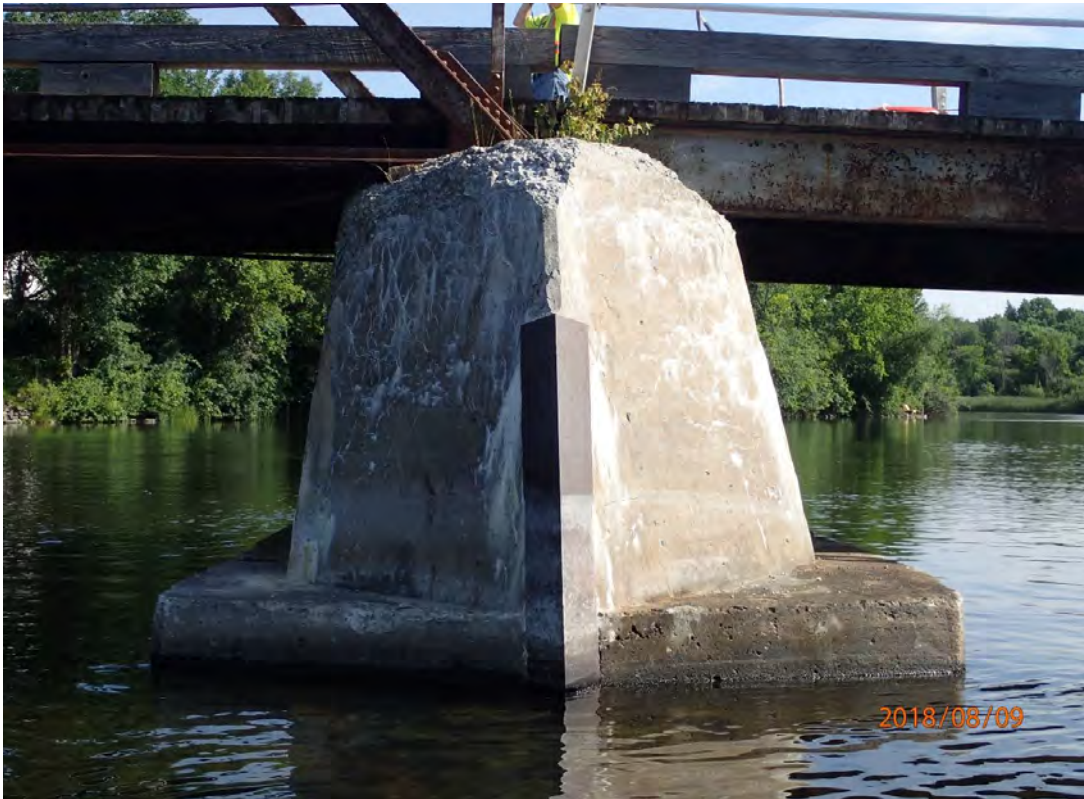
**Image 20. Upstream face of pier between truss and east approach span**

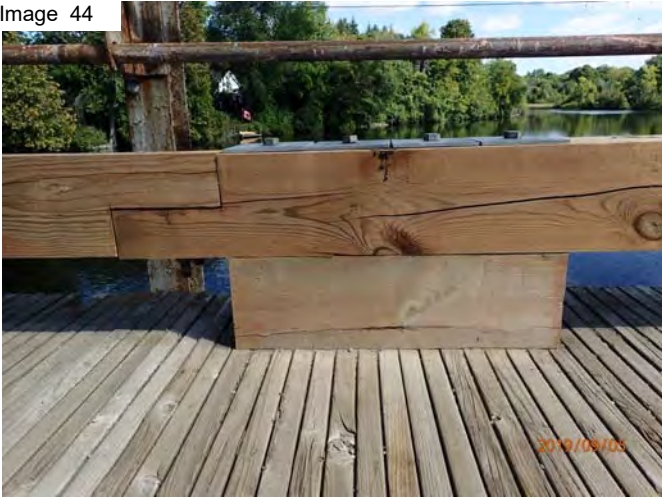
Curb splice typ

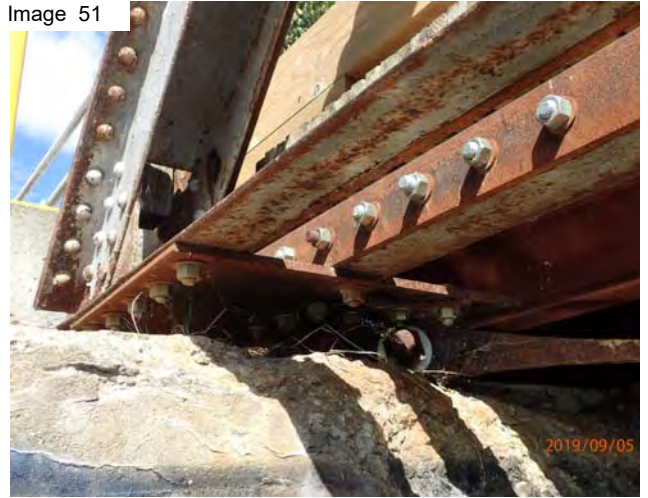
Image 51

West end of deck

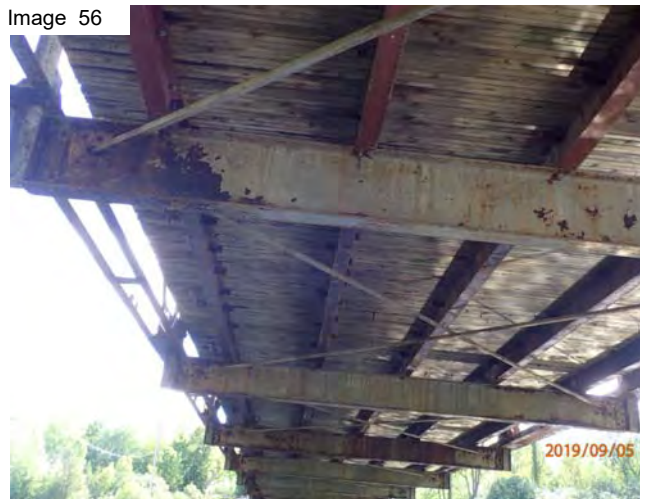
Image 56

NE corner detail

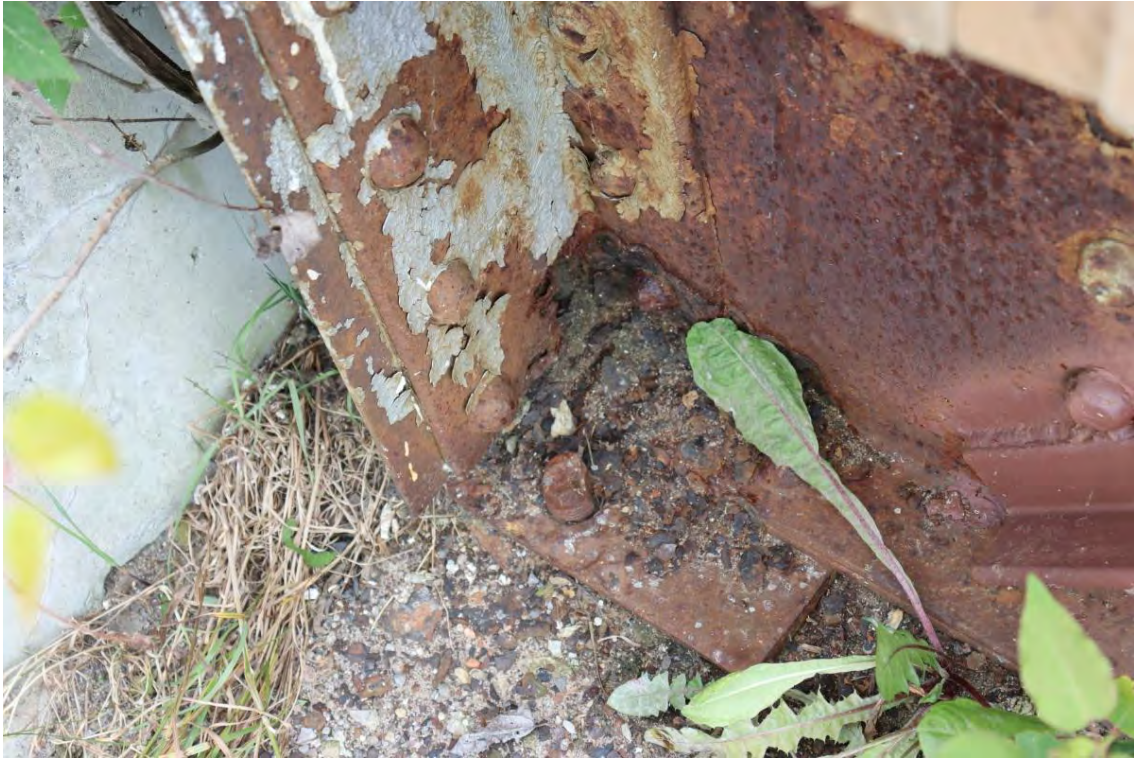
*Figure 25: NE bearing*

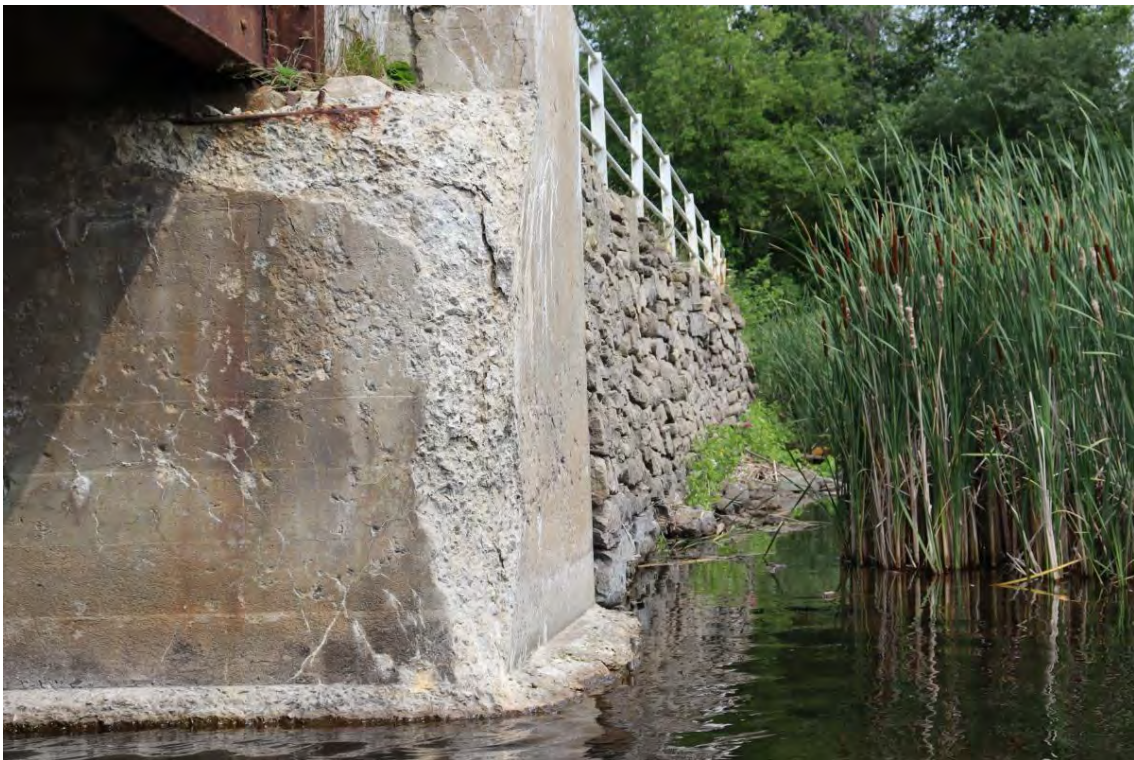
*Figure 28: East abutment and causeway from south*

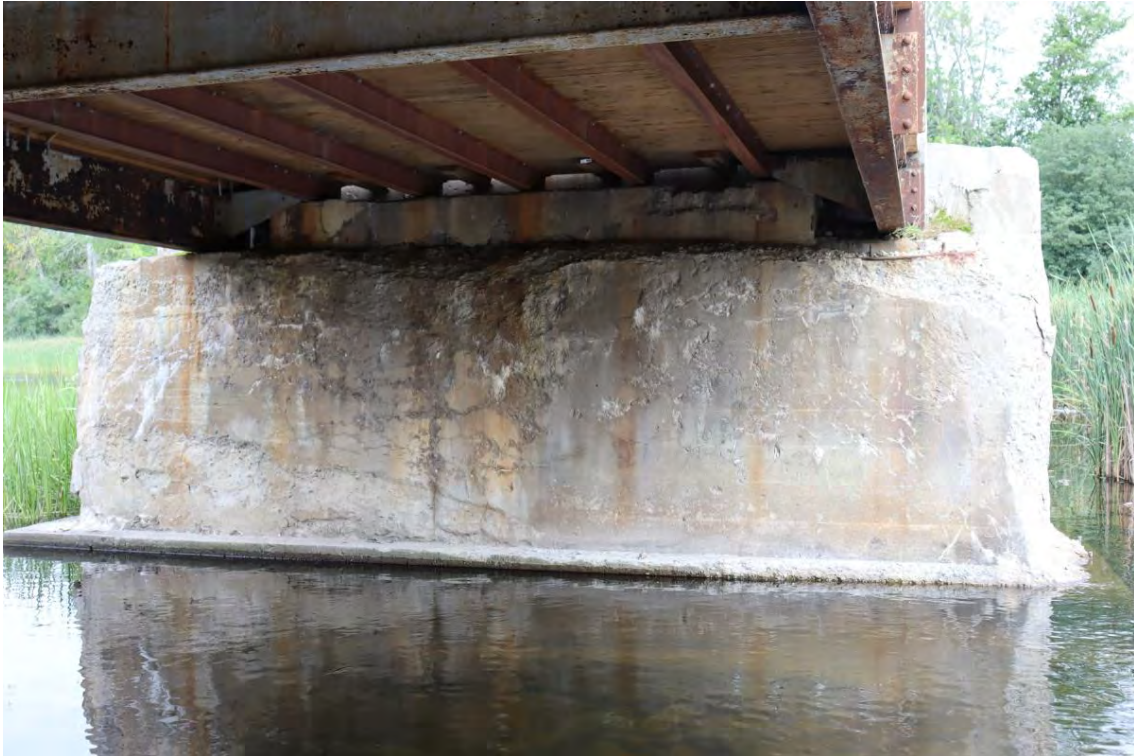
*Figure 31: East abutment*

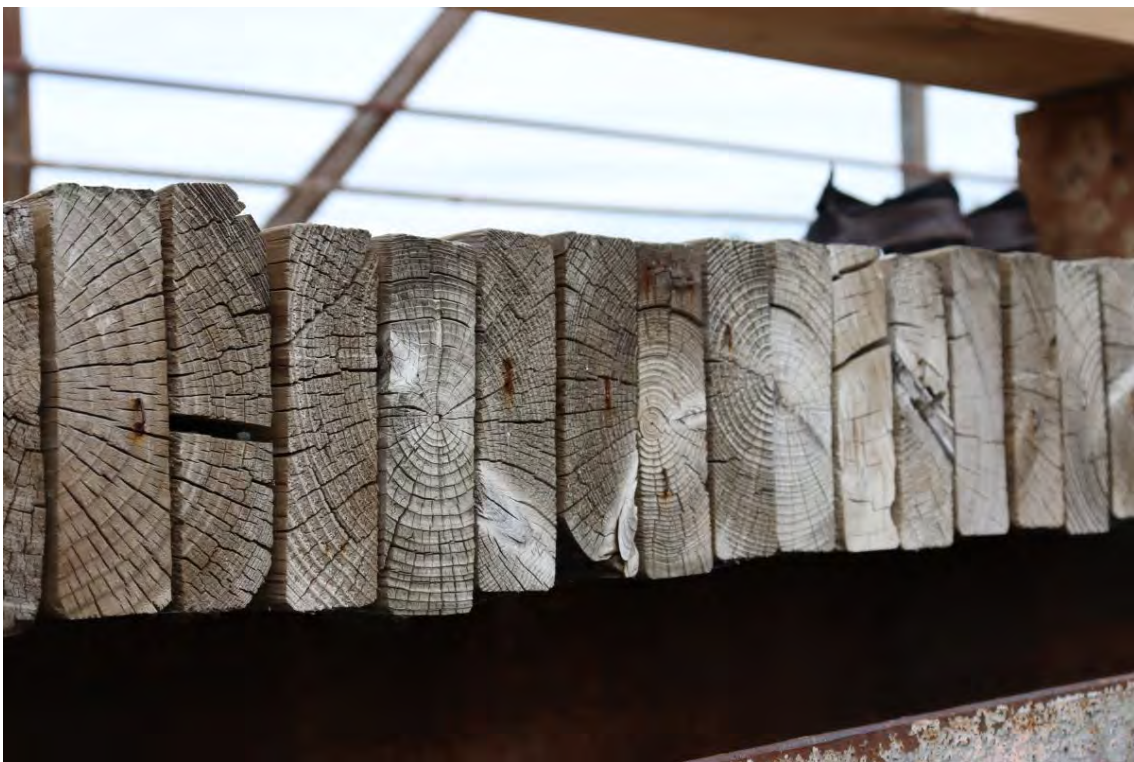
*Figure 36: Deck boards end detail*

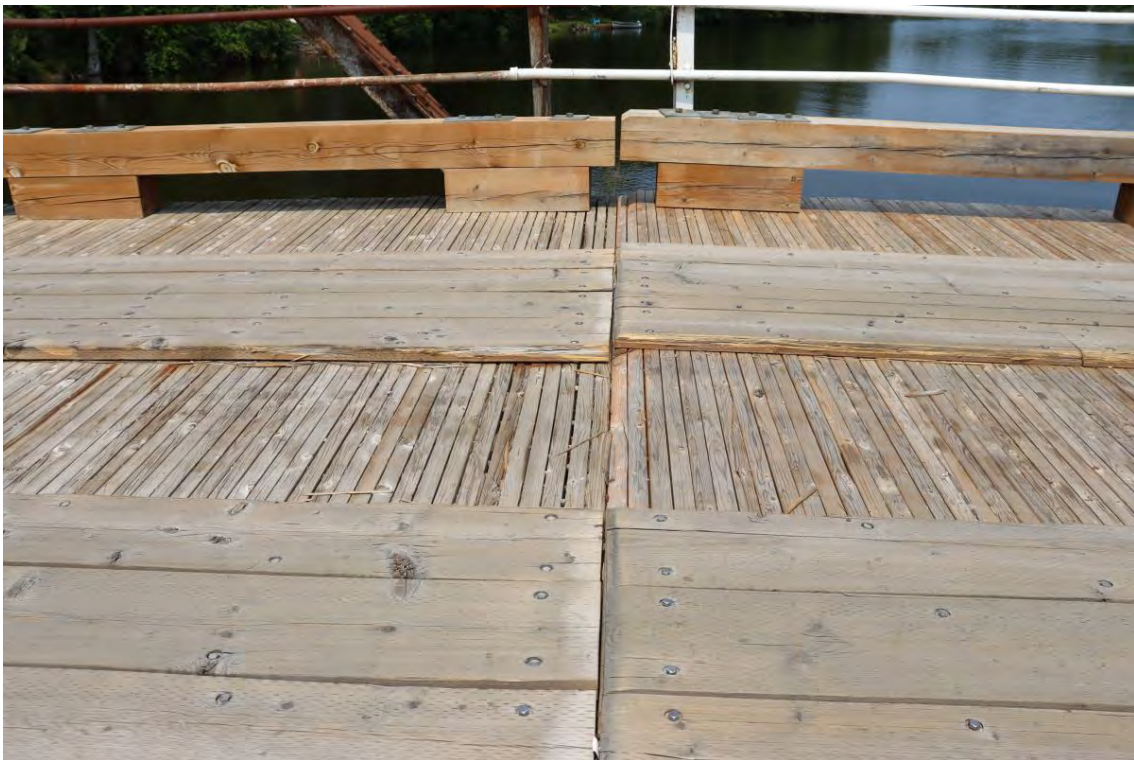
*Figure 54: Grade change / bump over pier*

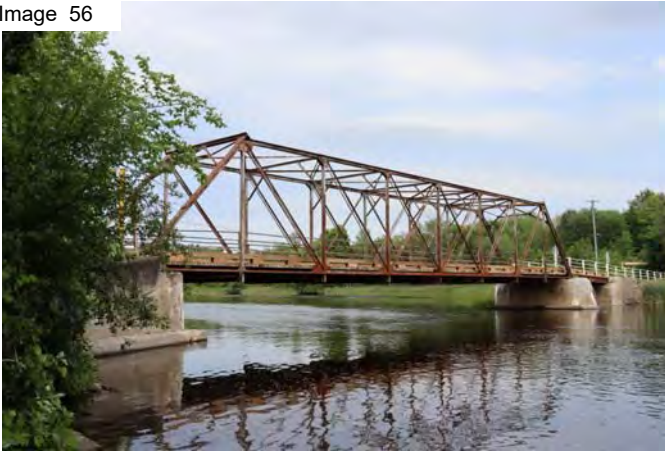
South elevation
