# ANDREWSVILLE BRIDGE

## SUMMARY OF EVENTS FROM 2005 TO 2022

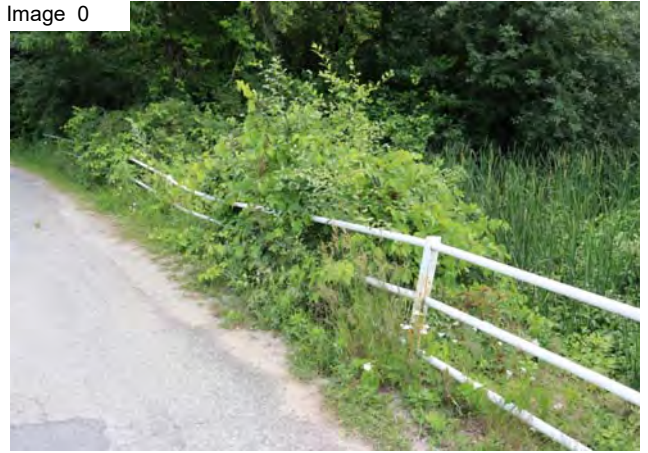
Railing over south retaining wall

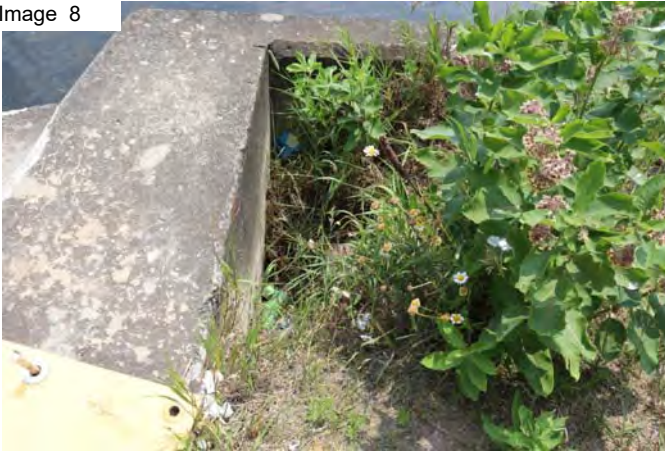
Image 8

Sinkhole in SW

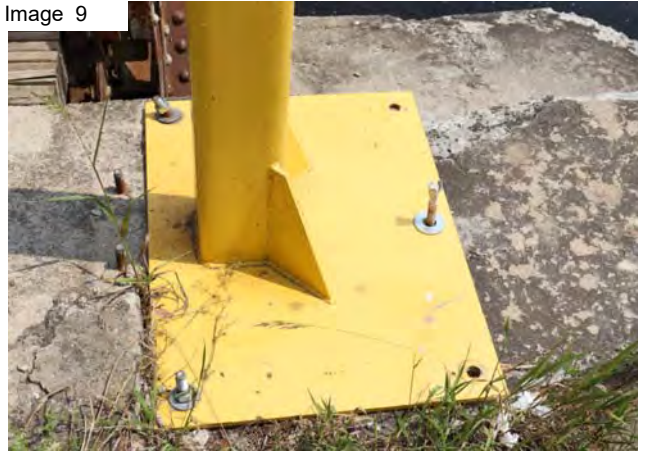
Image 9

SW portal footing

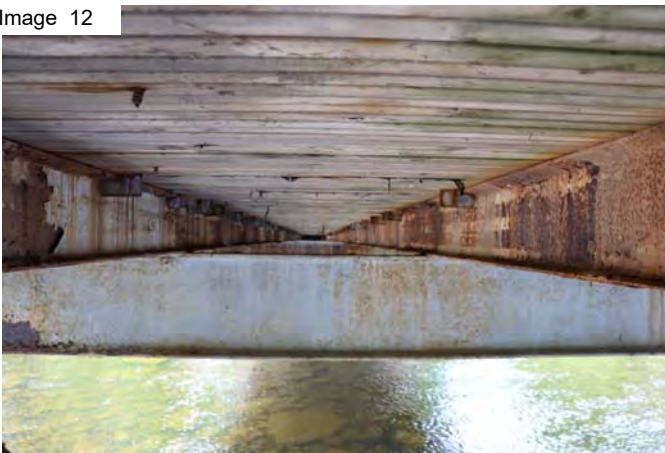
Image 12

Stringer 3 perforation in bay 5

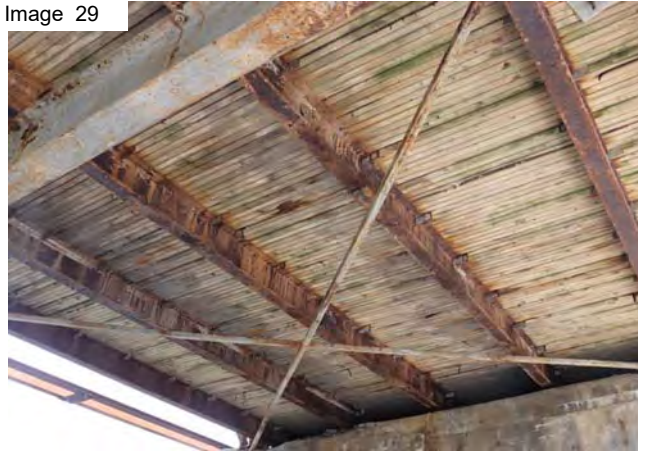
Image 29

Stringer 2 perforation in bay 8

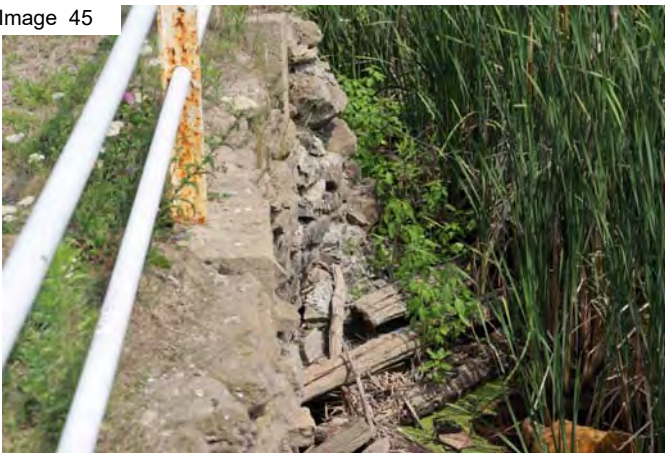
Image 45

South retaining wall bulging

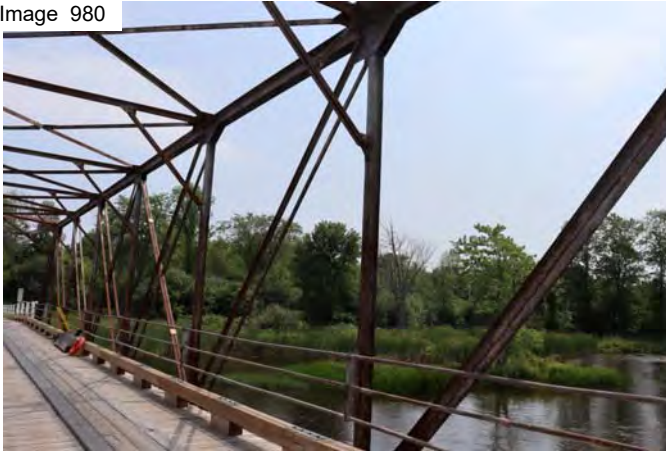
Image 981

Deck surface on truss looking west

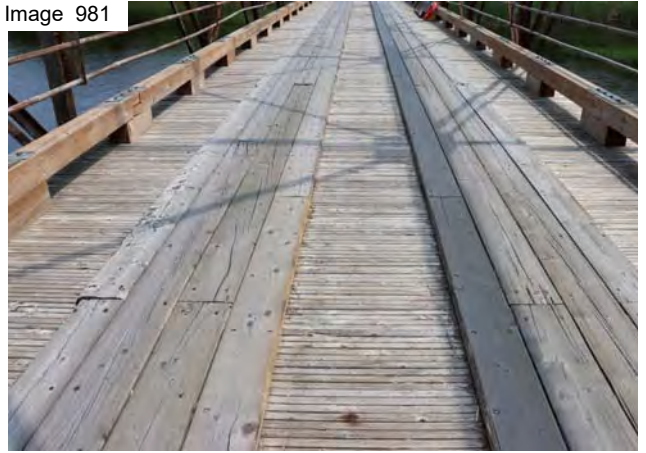
Image 982

Running boards damage

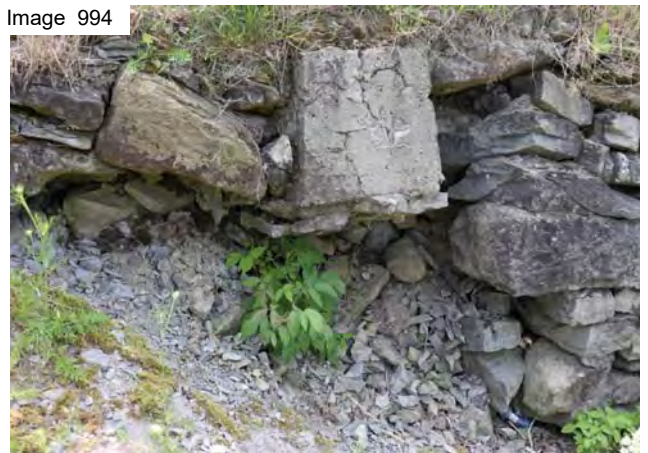
Image 995

Culvert through causeway

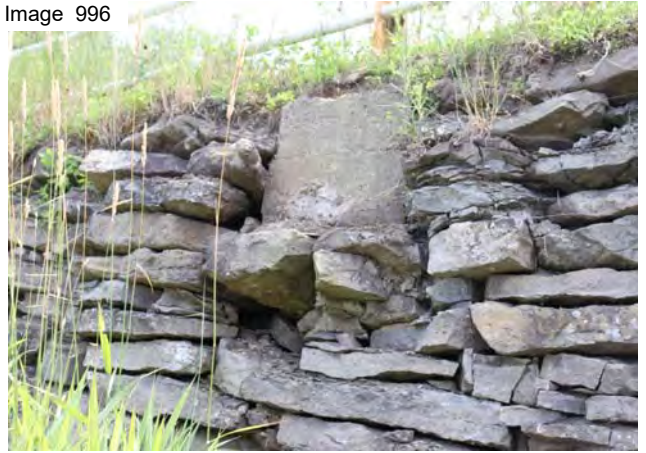
Image 998

| | <i>There is significant flow penetrating through the causeway on the south approach. The dry stone walls on the sides of the embankment have bulged on the east side. Frost action has loosened and disintegrated some of the stonework to a depth of 0.3 m. There is a strong possibility of partial collapse of in particular the east side of the causeway. This collapse could occur with little or no warning. Severe bulging of dry stone wall at NE quadrant, and is in serious condition. Water has partly undercut portions of wall on south approach. Sink hole developing in SW corner adjacent retaining wall noted in 2021. This could be due to scour effects.</i> | |

North retaining wall bulging

| Width: | Capital Rec. <b>Repair in 5 years</b> | | <b>Perf Def: Bulging</b> |
